CATALOG OF SONOMA COUNTY STREAM CROSSINGS WITH CULVERTS LOCATED ON FISH-BEARING STREAM REACHES WITHIN THE RUSSIAN RIVER BASIN

By
Ross Taylor and Associates

Site ID# S-001: Unnamed Tributary/Willow Creek Road; Willow Creek; Russian River **Road Ownership** County

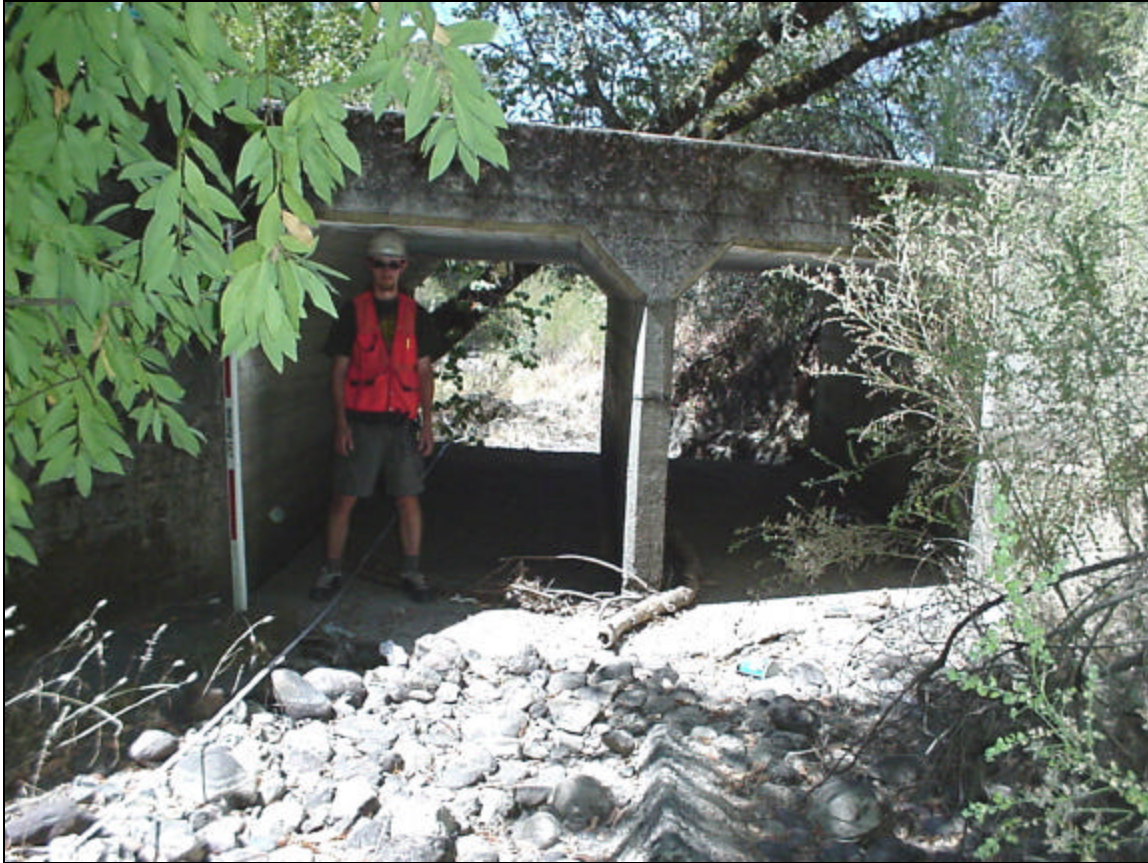
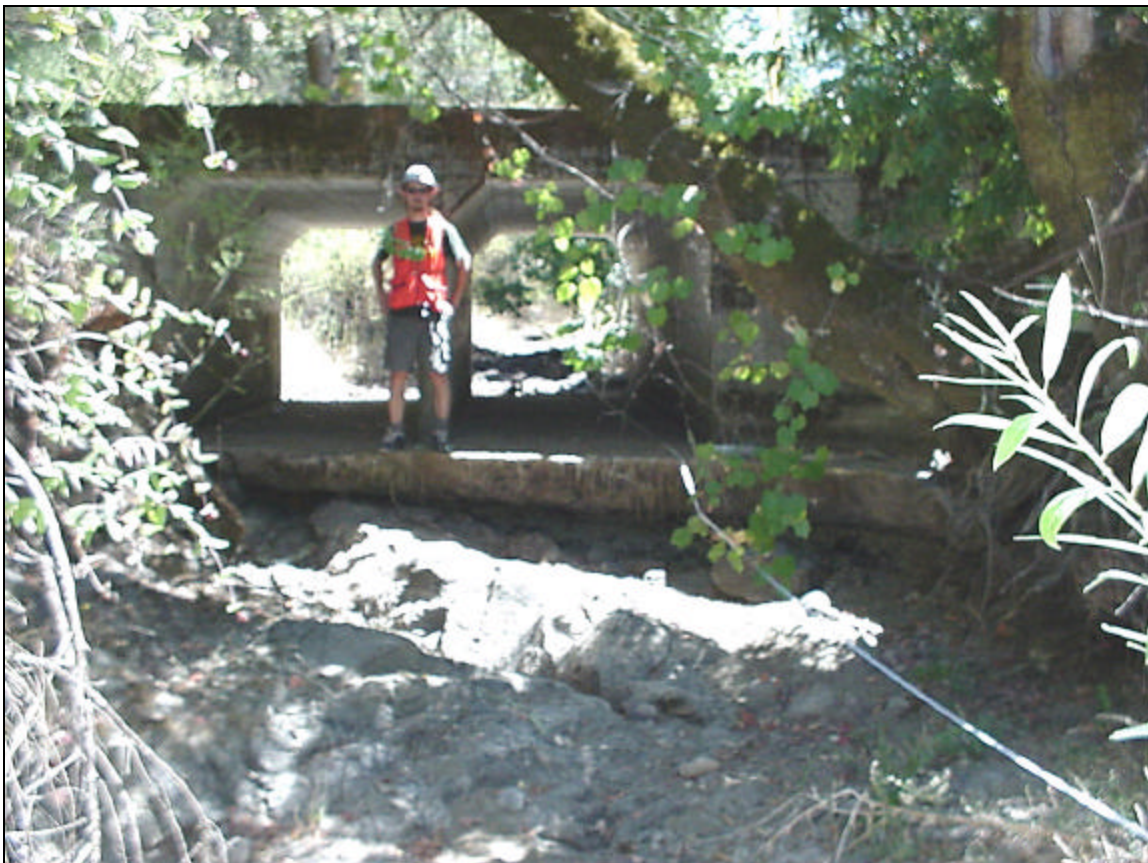
Site ID #S-105: Brooks Creek/Spurgeon Road; Russian River

Barrier Status: **GRAY:** FishXing determined this crossing meets the 8-16-16 ft/sec passage criteria for adult steelhead on 36% of the range of estimated migration flows and fails to meet passage criteria for all age classes of juvenile salmonids. Perched outlet (2.5 feet) impedes juvenile migration.

Preferred Treatment: Three to four downstream boulder weirs would be required to raise tail-water elevation to improve passage into the culvert. Corner baffles would increase depths and reduce velocities within the culvert. However, the limited upstream habitat makes a retrofit of this crossing a low-priority fisheries restoration project.

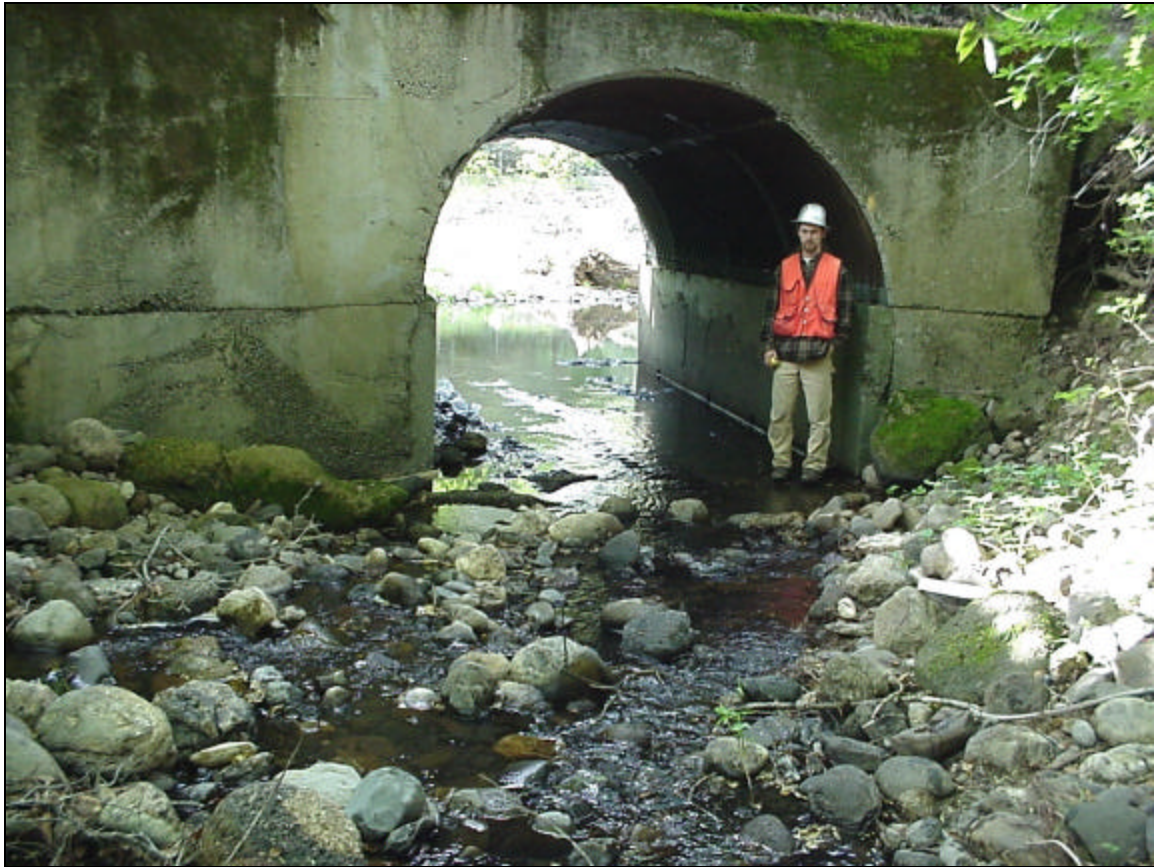
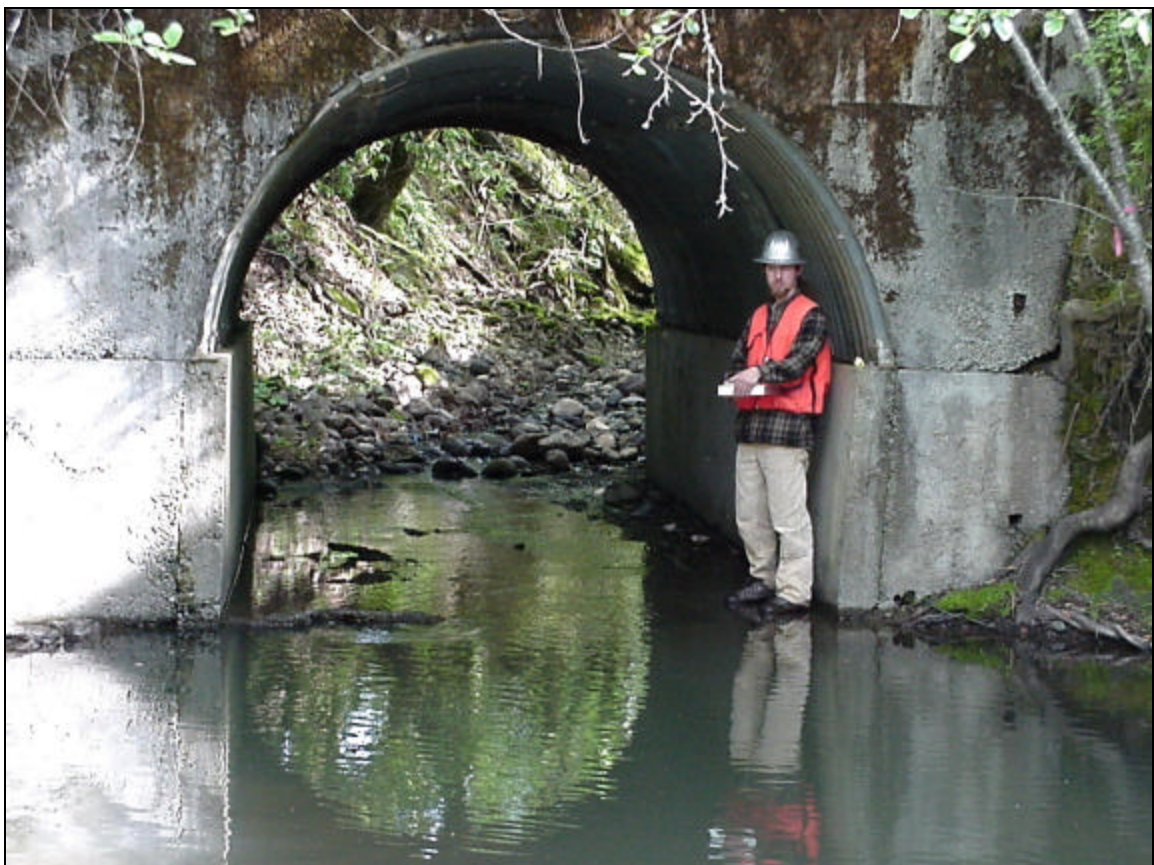
Culvert Type: Box, Concrete with Pipe Arch top. **Corrugations:** None. **Dimensions:** 8.8' height x 9.5' width
Length: 25.0' **Slope:** -0.60% **Modifications:** None. **Rustline Height:** N/A **Average Active Channel Width:** 11.4' **Fill Estimate:** 349 cubic yards. **Overall Condition:** Poor, floor is broken, and flow goes under it.
Sizing: Undersized; HW/D = 1 on a storm flow with approximately a 60-year recurrence interval. Spurgeon Road is overtopped on more than a 250-year storm flow.

Barrier Status: **GRAY:** FishXing determined this crossing meets the 8-16-16 ft/sec passage criteria for adult steelhead on 87% of the range of estimated migration flows, meets passage criteria for resident trout/2+ juveniles on 47% of the range of estimated migration flows, and fails to meet passage criteria for 1+/young-of-year juveniles.

Preferred Treatment: Repair the broken and failing culvert floor. Examine feasibility of removing culvert floor to allow a natural streambed to form through crossing – might require reinforcing the footings. If access to private property is provided, evaluate fish passage at the hardened ford located downstream on Barnes Creek.

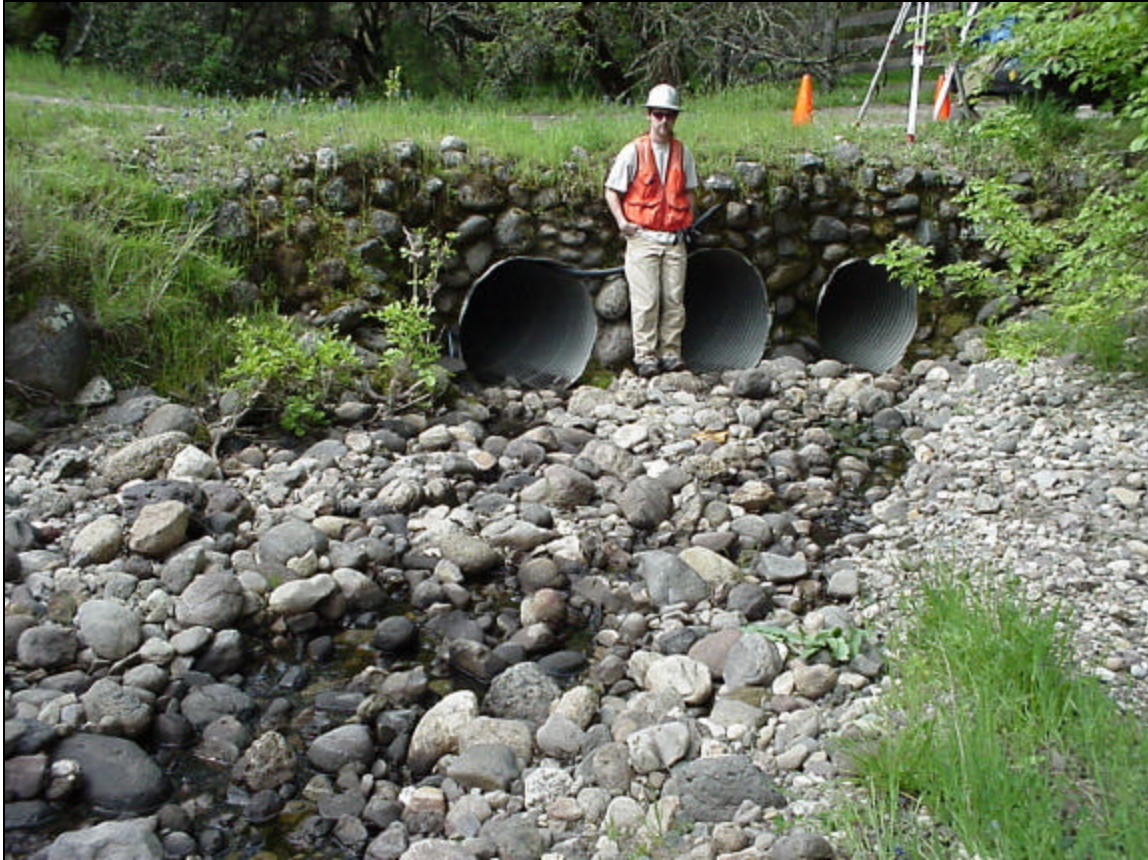
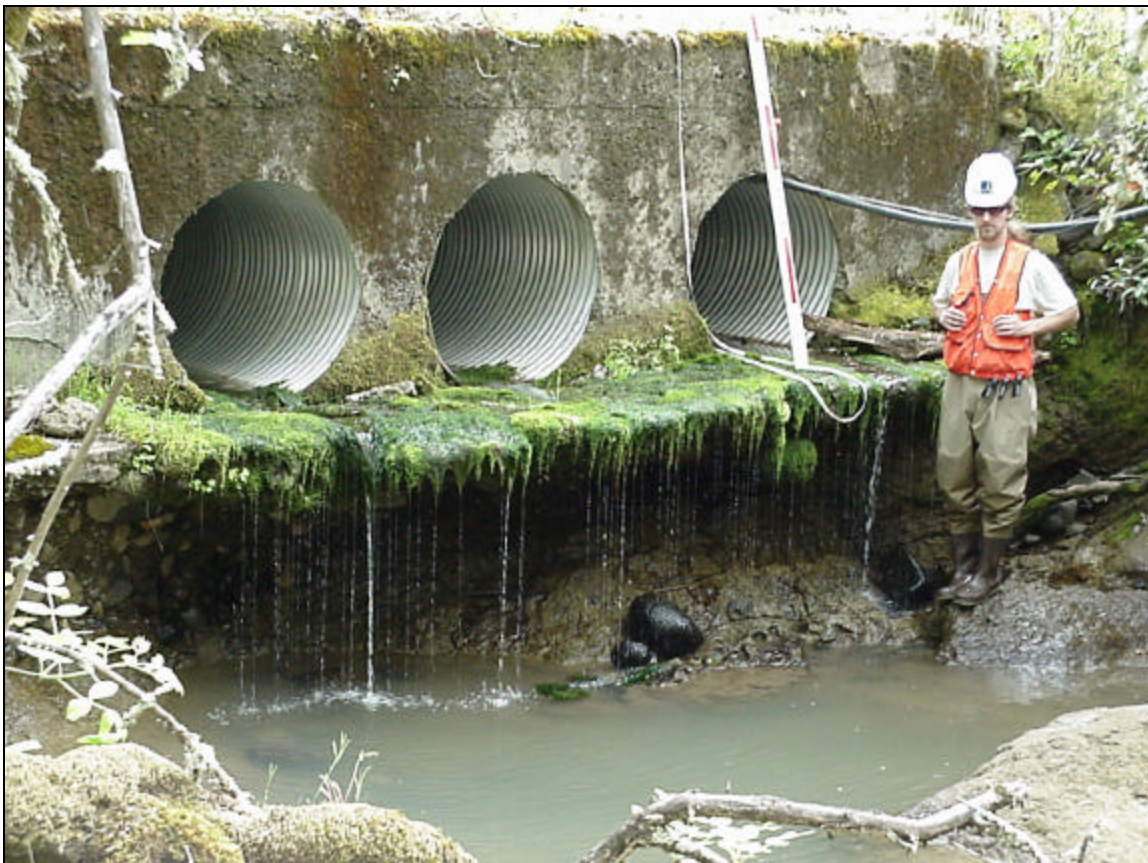
Site ID #S-107: Unnamed Tributary/Private Drive; Barnes Ck; Brooks Ck; Russian River **Road Ownership:** Private
County Ranking: Tied for #17 = Moderate-Priority **Basin-wide Ranking:** Tied for #23 = Moderate-Priority

Overall Condition: Fair, outlet is scouring and undermining the crossing. **Sizing:** Properly sized; HW/D = 1 on a storm flow with approximately a three-year recurrence interval. This Private Road is overtopped on approximately a 24-year storm flow.

Barrier Status: **RED:** the Green-Gray-Red filter determined this crossing fails to meet passage criteria for adult steelhead and all age classes of juvenile salmonids due to the extremely perched outlet (3.5 feet). The undersized crossing is also disrupting the geomorphic processes of bedload transport and maintenance of a natural gradient.

Preferred Treatment: Replacement with a properly sized open-bottom arch set on concrete footings or a bridge is the only feasible option to restore fish passage and improve hydraulic capacity of the crossing. Grade control weirs may be required to minimize potential impacts of rapid channel headcutting and readjustment of natural gradient.

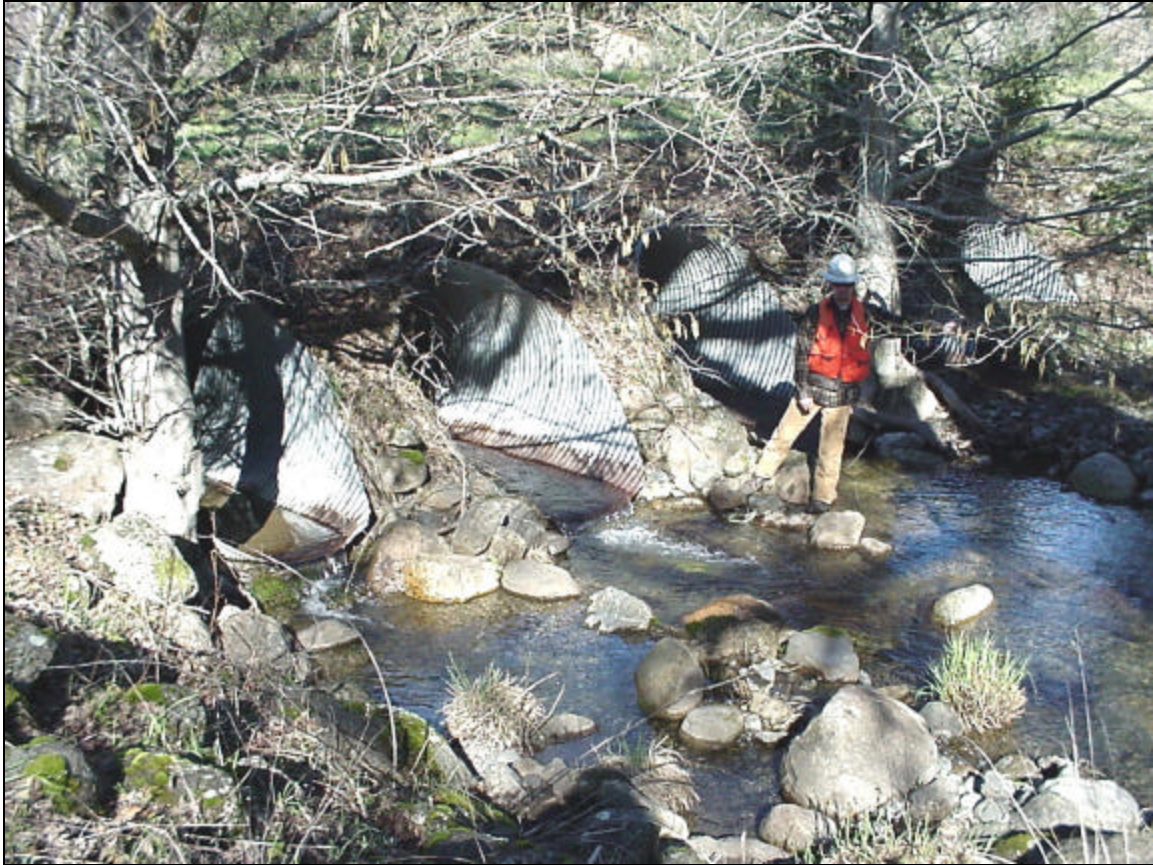
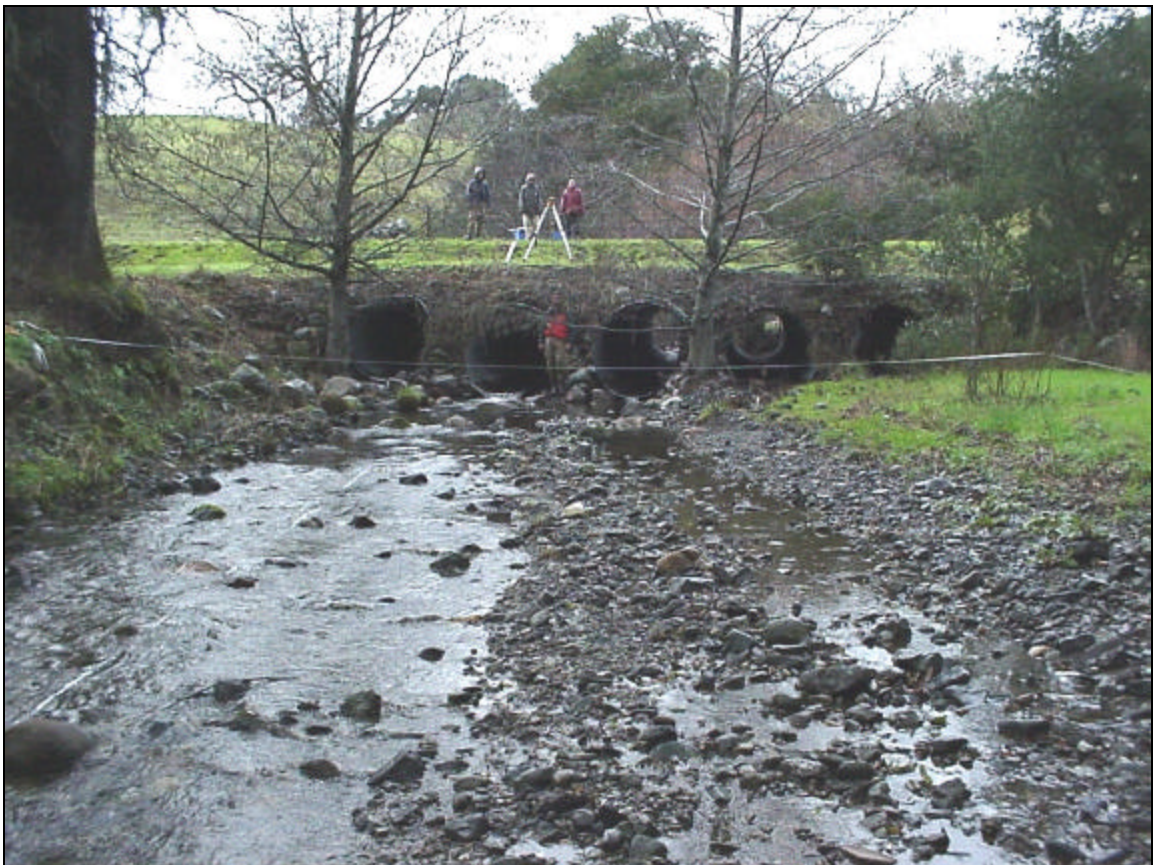
Site ID #S-108: Little Briggs Creek/Santa Angelina Ranch; Briggs Creek; Maacama Creek; Russian River
Road Ownership: Private

Barrier Status: **GRAY:** FishXing determined three culverts at this crossing meet the 8-16-16 ft/sec passage criteria for adult steelhead on (LB = 78%; MRB = 8%; RB = 77%) of the range of migration flows and two culverts meet passage criteria for resident trout/2+ juveniles on (LB = 22%; RB = 44%) of the range of migration flows, and all five culverts fail to meet passage criteria for 1+/young-of-year juvenile salmonids.

Preferred Treatment: None recommended because current crossing allows adequate adult passage and some juvenile passage. Crossing is also adequately sized and conveys more than a 100-year storm flow.

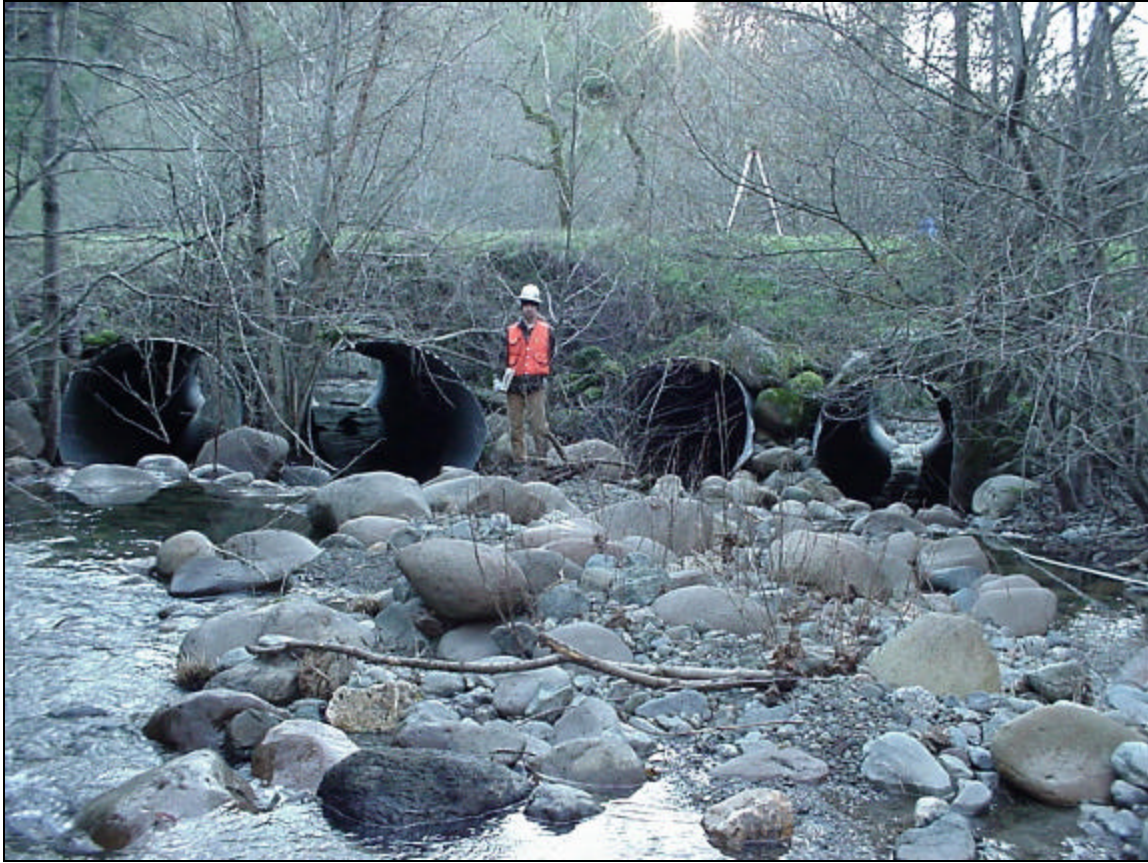
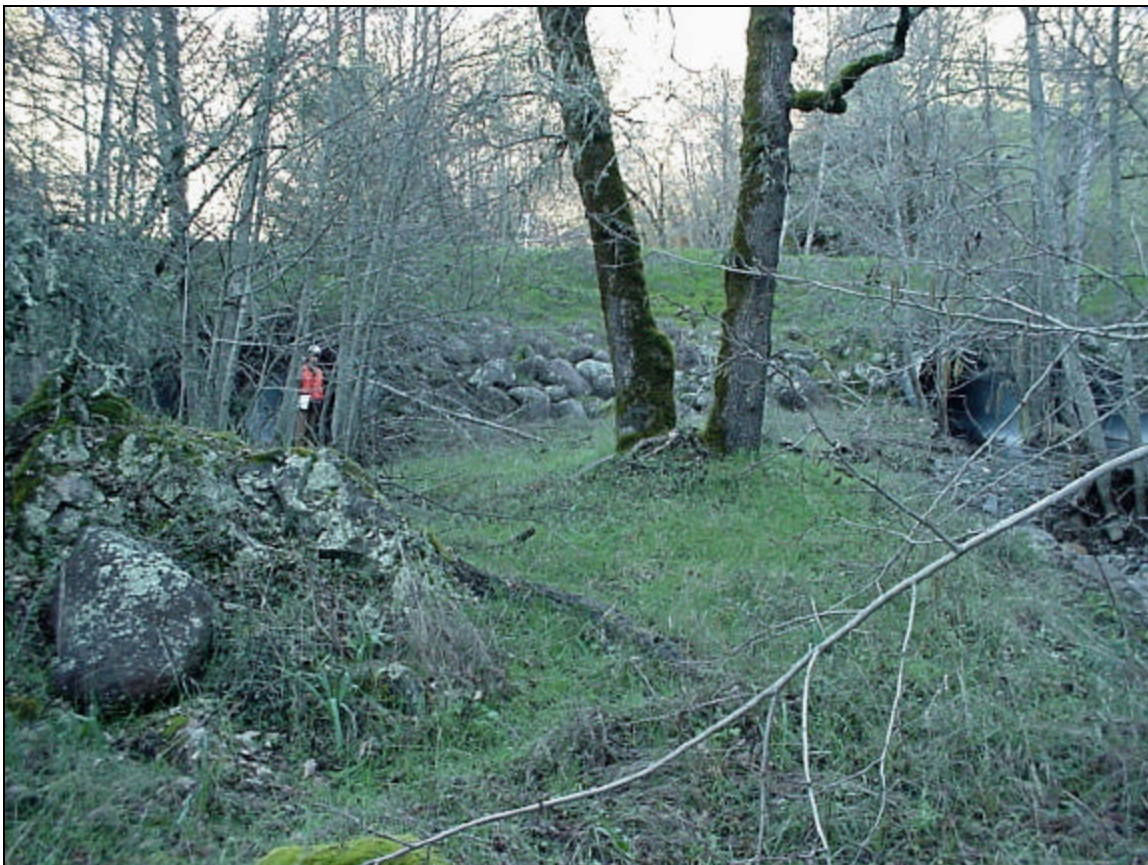
Site ID #S-110: Gird Creek #1/Geysers Road; Russian River **Road Ownership:** County

Culvert Type: Box, Concrete. **Corrugations:** None. **Dimensions:** 8.1' height x 16.0' width **Length:** 63.5' **Slope:** -0.63% **Modifications:** None. **Rustline Height:** N/A **Average Active Channel Width:** 11.0' **Fill Estimate:** 945 cubic yards. **Overall Condition:** Good.

Preferred Treatment: None recommended because current crossing provides unimpeded passage for all age classes of steelhead. Crossing is also adequately sized and conveys more than a 250-year storm flow.

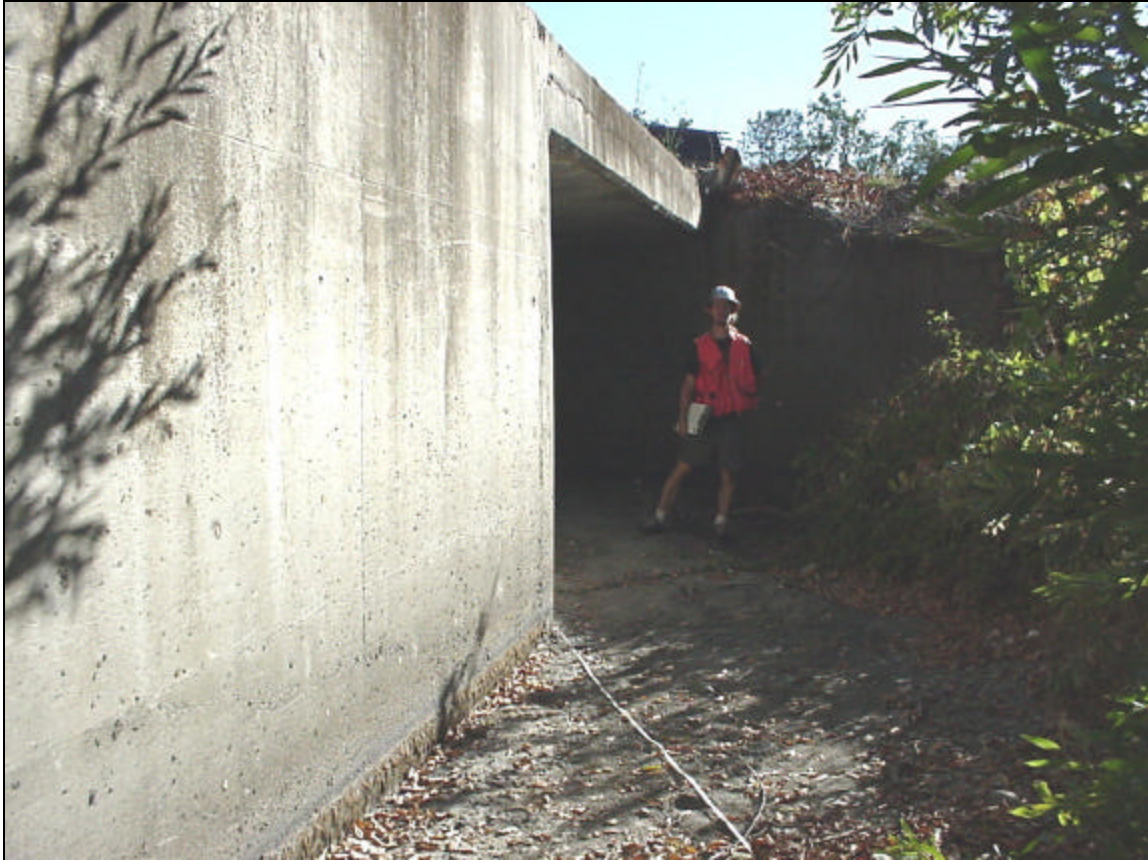
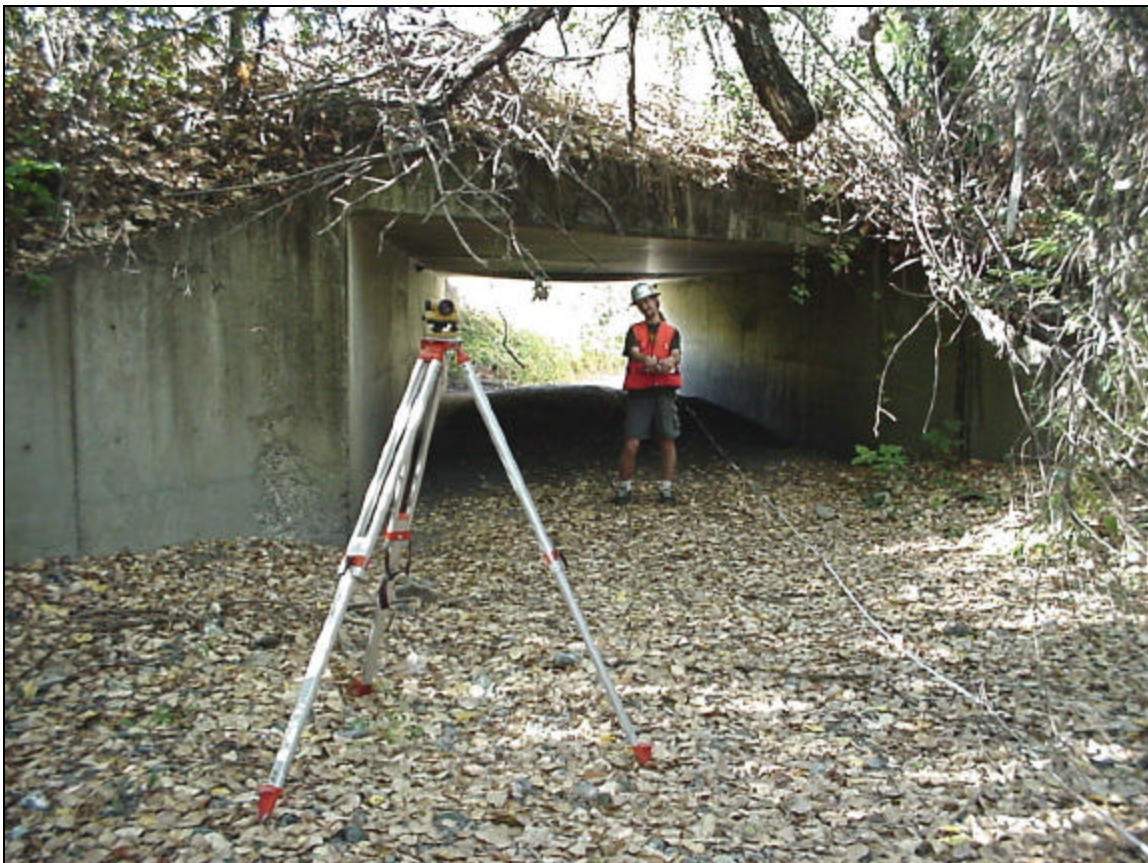
Site ID #S-111: Gird Creek #2/Wilson Road; Russian River **Road Ownership:** County

Culvert Type: Box, Concrete. **Corrugations:** None. **Dimensions:** 10.1' height x 11.9' width **Length:** 25.5' **Slope:** -0.55% **Modifications:** None. **Rustline Height:** N/A **Average Active Channel Width:** 11.1'

Fill Estimate: 166 cubic yards. **Overall Condition:** Good.

Preferred Treatment: None recommended because current crossing provides adequate passage for most age classes of steelhead. Crossing is also adequately sized and conveys more than a 250-year storm flow.

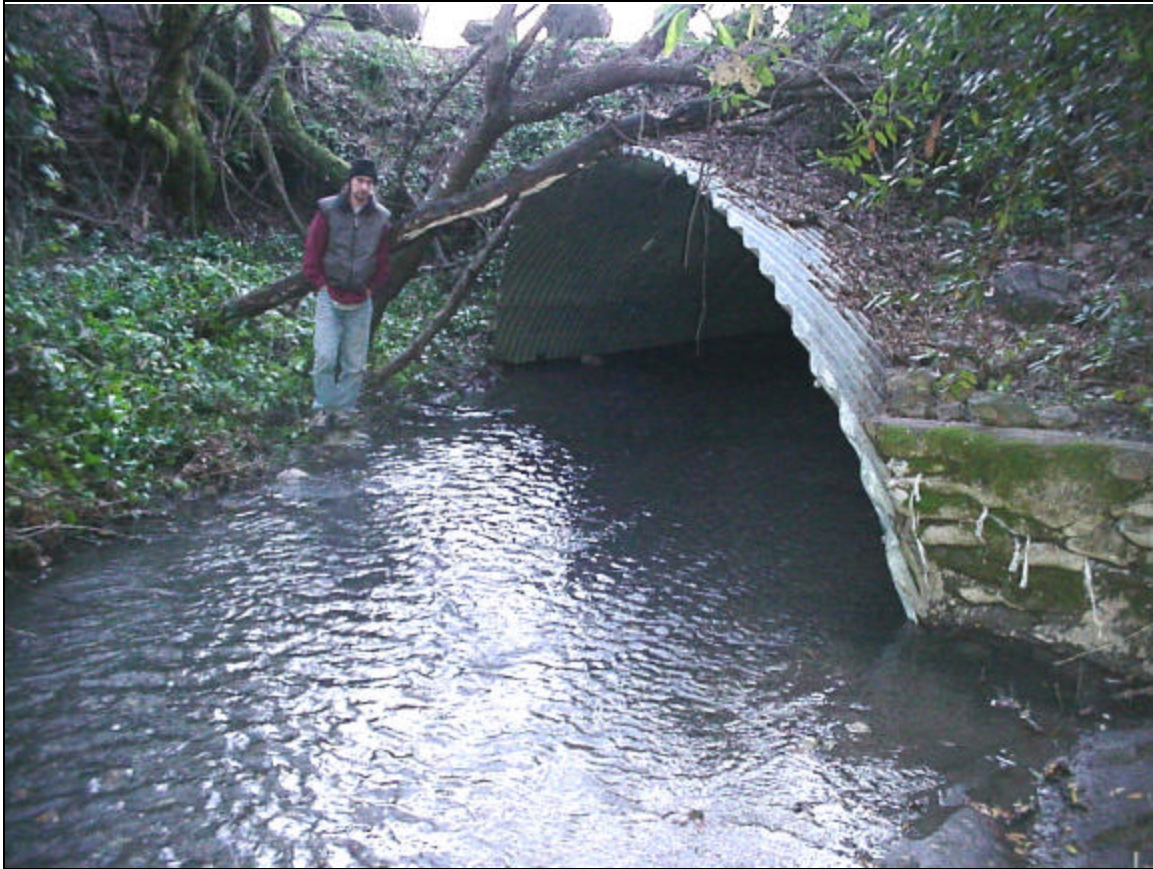
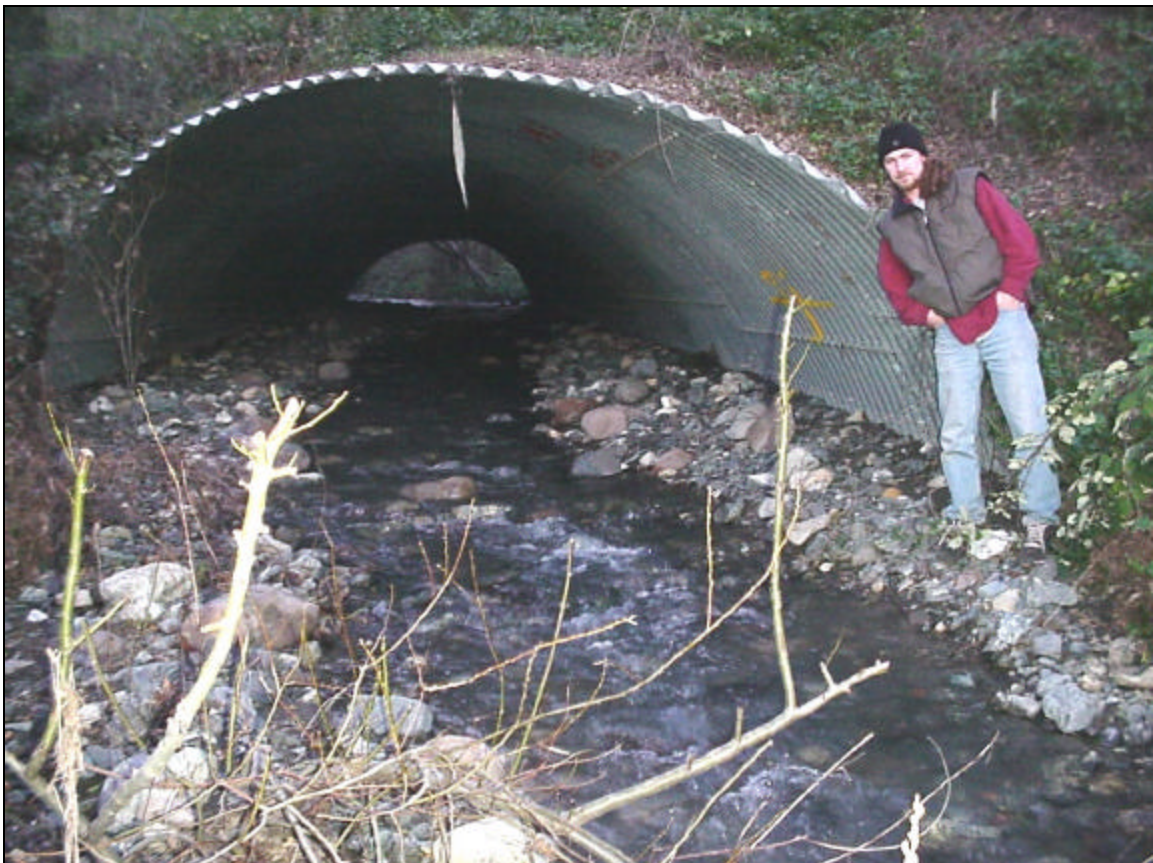
Site ID #S-112: Gird Creek #3/Geysers Road; Russian River

Culvert Type: Open Bottom Arch, SSP. **Corrugations:** 6" x 2" **Dimensions:** 7.2' rise x 19.2' span
Length: 116.5' **Slope:** 1.51% **Modifications:** None. **Rustline Height:** None.
Average Active Channel Width: 11.7' **Fill Estimate:** 1,107 cubic yards. **Overall Condition:** Good.

Preferred Treatment: None recommended because current crossing provides unimpeded passage of all age classes of steelhead. Crossing is also adequately sized and conveys more than a 250-year storm flow.

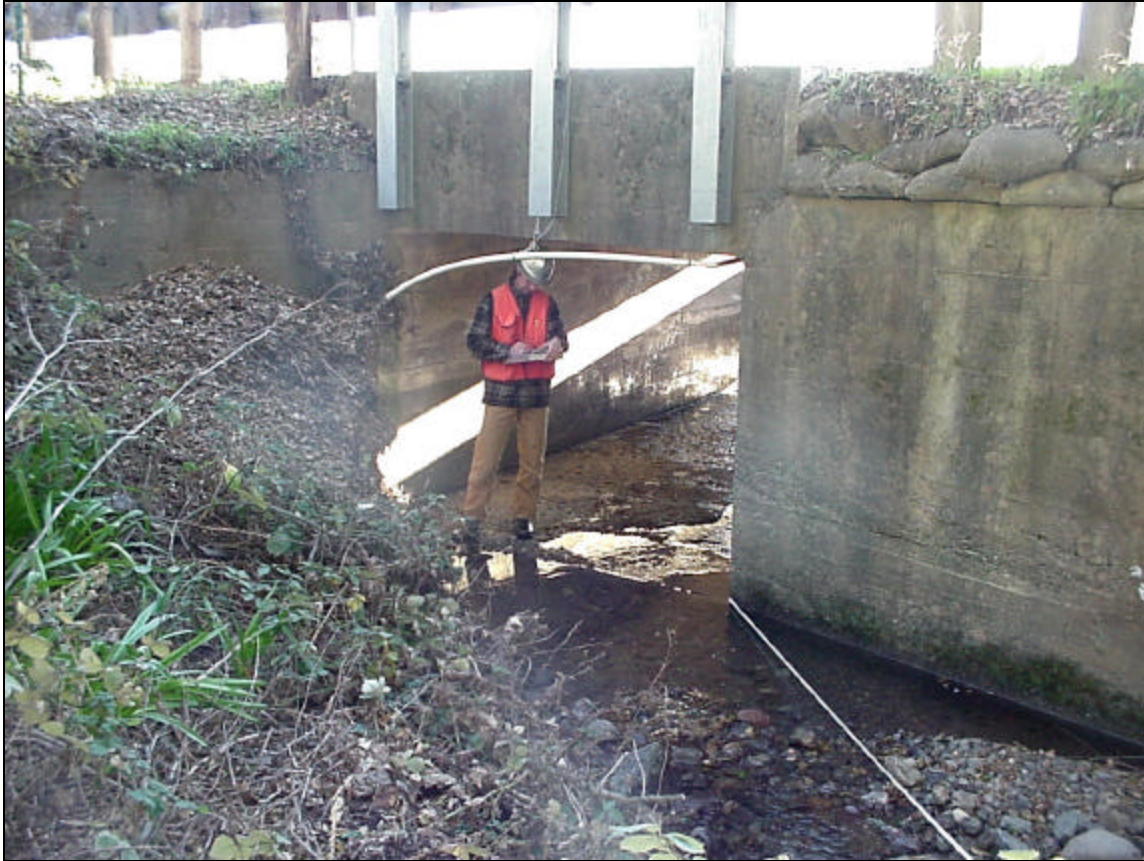
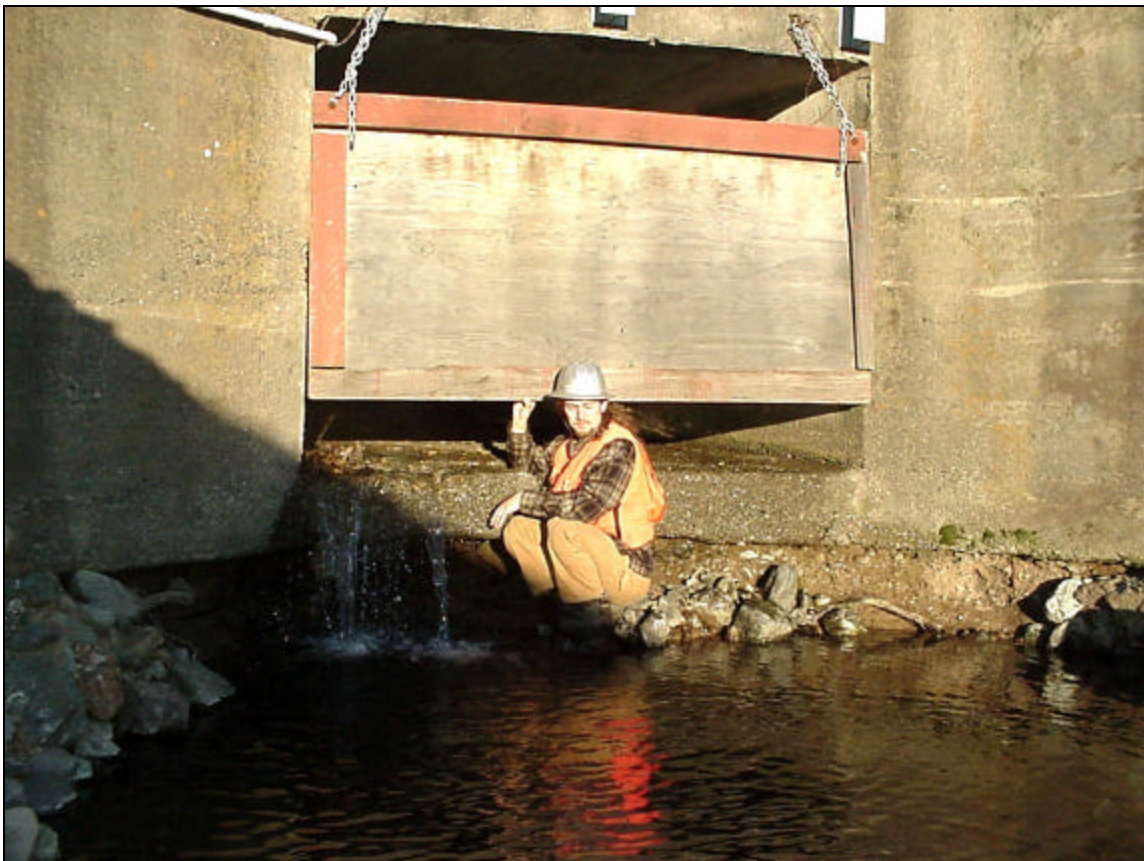
Site ID #S-113: Indian Creek/Highway 128; Russian River **Road Ownership:** State

Culvert Type: Box, Concrete. **Corrugations:** None. **Dimensions:** 6.0' height x 7.9' width **Length:** 26.2'
Slope: 0.99% **Modifications:** None. **Rustline Height:** N/A **Average Active Channel Width:** 8.1'
Fill Estimate: 261 cubic yards. **Overall Condition:** Fair.

Barrier Status: **RED:** FishXing determined this crossing fails to meet the 8-16-16 ft/sec passage criteria for adult steelhead and all age classes of juvenile salmonids. For adults the only violation of the passage criteria is lack-of-depth - however the cattle exclusion gate across the outlet probably works effectively in preventing fish migration too. For all age classes of juvenile salmonids the perched outlet impedes migration.

Preferred Treatment: Because the current crossing is properly sized, a retrofit is recommended to improve passage. Three to four downstream boulder weirs are needed to raise the tail-water elevation and corner baffles within the box culvert will increase depths and decrease velocities. Also recommend immediate removal or modification of the cattle guard – at least raise it higher so fish have an opportunity to successfully leap into the culvert’s outlet.

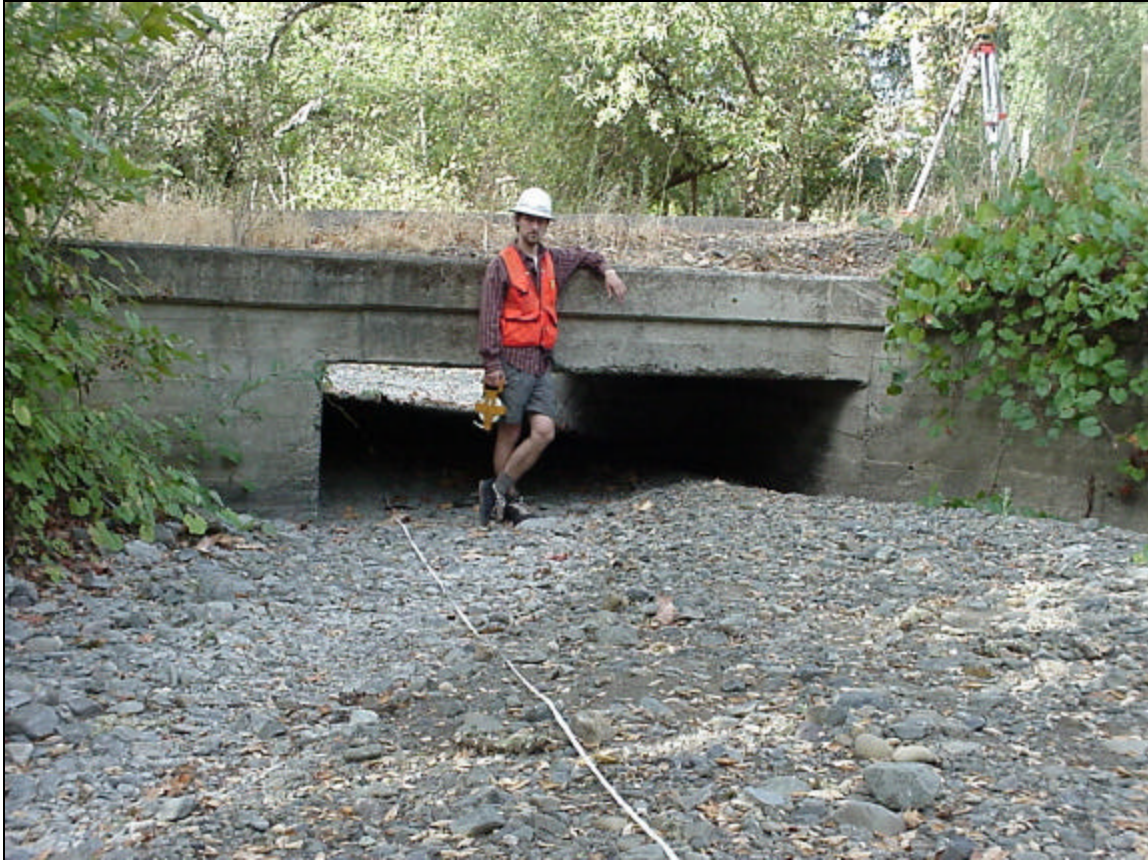
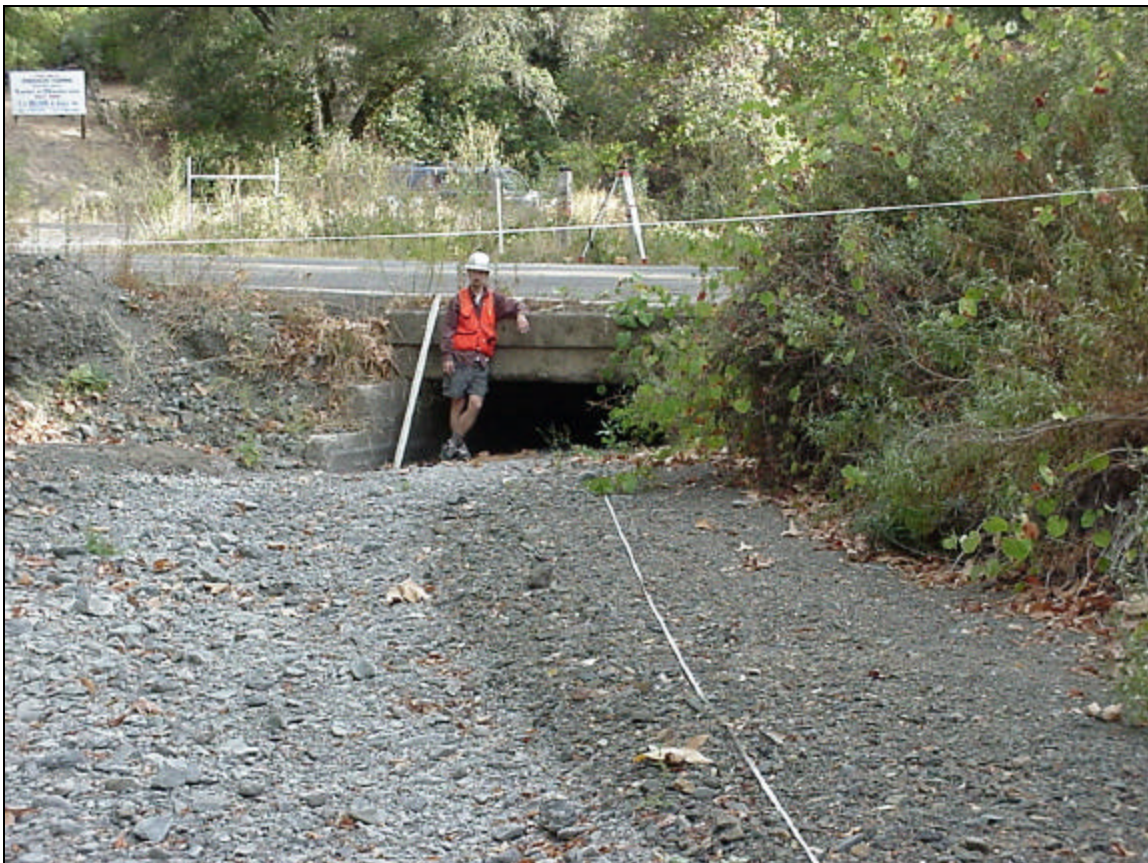
Site ID #S-114: Crocker Creek/River Road; Russian River **Road Ownership:** County

Culvert Type: Box, Concrete. **Corrugations:** None. **Dimensions:** 3.1' height x 10.0' width **Length:** 29.8' **Slope:** 0.13% **Modifications:** None. **Rustline Height:** N/A **Average Active Channel Width:** 14.9' **Fill Estimate:** 159 cubic yards. **Overall Condition:** Good. **Sizing:** Extremely undersized; HW/D = 1 on a storm flow with approximately a one-year recurrence interval. River Road is overtopped on approximately a three-year storm flow.

Preferred Treatment: None recommended because current crossing provides adequate passage of most steelhead life stages. Culvert is currently aggraded with sediment moving through Crocker Creek from 1995 dam failure. Periodically inspect for condition and maintenance.

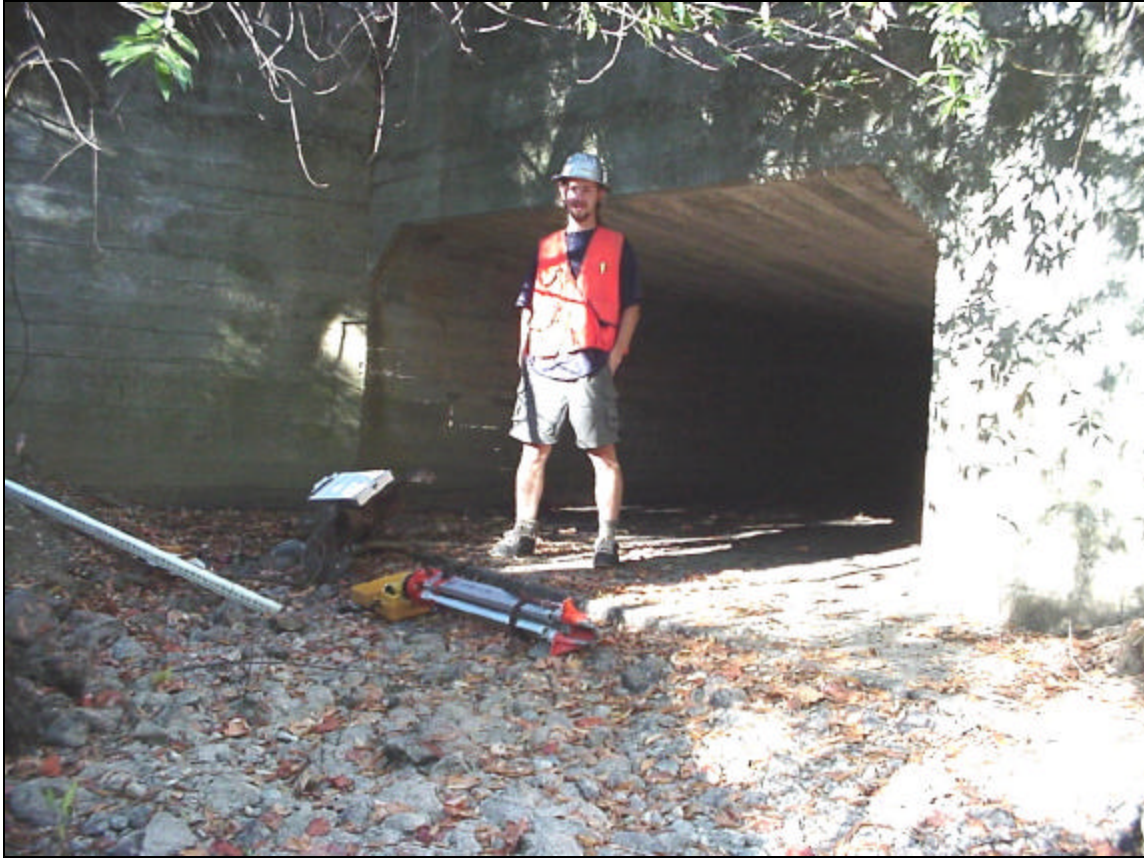
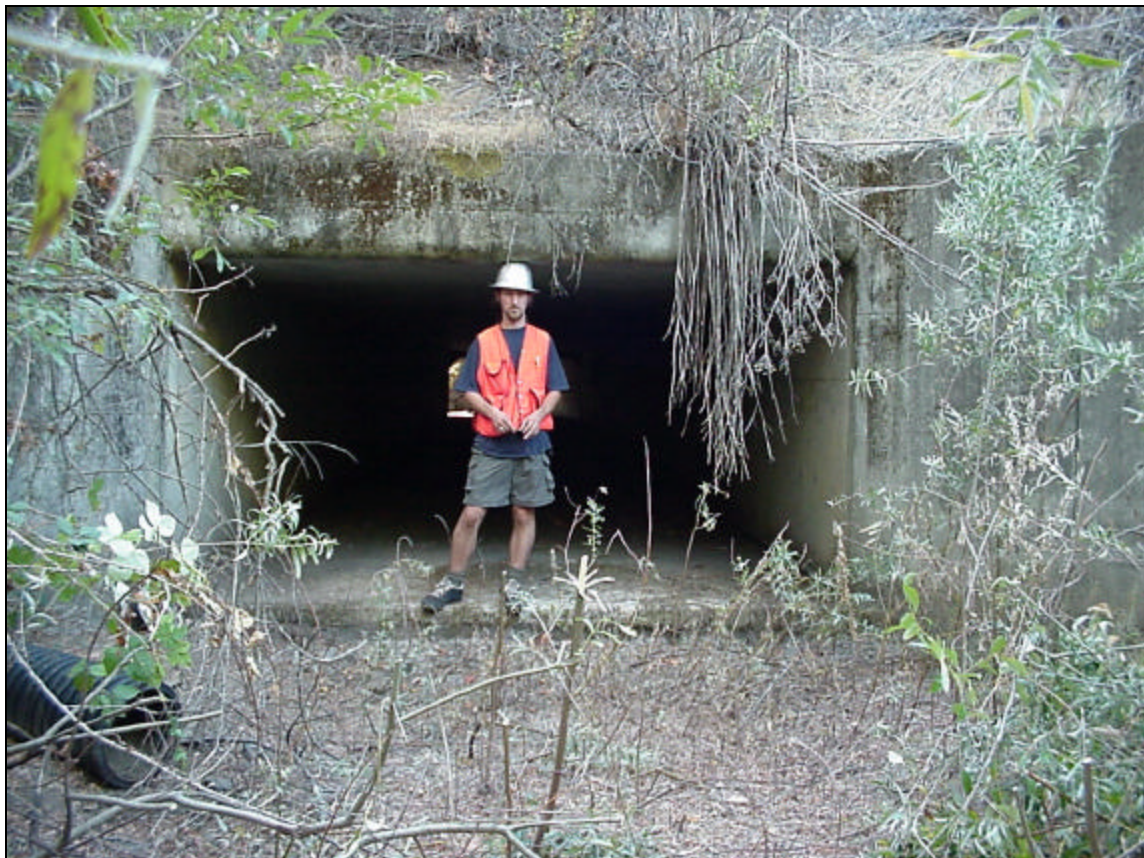
Site ID #S-115: Barrelli Creek/Dutcher Creek Road; Russian River

Culvert Type: Box, Concrete. **Corrugations:** None. **Dimensions:** 5.5' height x 12.0' width **Length:** 111.4' **Slope:** 2.20% **Modifications:** None. **Rustline Height:** N/A **Average Active Channel Width:** 10.1' **Fill Estimate:** 3,205 cubic yards. **Overall Condition:** Good. **Sizing:** Properly sized; HW/D = 1 on a storm flow with more than a 250-year recurrence interval. Dutcher Ck Road is overtopped on more than a 250-year storm flow.

Barrier Status: **RED:** FishXing determined this crossing fails to meet the 8-16-16 ft/sec passage criteria for adult steelhead and the passage criteria for all age classes of juvenile salmonids. The culvert's length (>100 feet), set at a moderate slope (2.2%), and a smooth invert (concrete) creates both a lack-of-depth and excessive velocities that impede migration.

Preferred Treatment: Because the current crossing is properly sized and in good condition a retrofit is recommended to improve conditions for fish passage. Construct one to two downstream boulder weirs to raise the tail-water elevation and possibly back-water the culvert. Install corner baffles within the culvert to increase depths and decrease velocities.
