CATALOG OF SONOMA COUNTY STREAM CROSSINGS WITH CULVERTS LOCATED ON FISH-BEARING STREAM REACHES WITHIN THE RUSSIAN RIVER BASIN

By
Ross Taylor and Associates

Site ID# S-001: Unnamed Tributary/Willow Creek Road; Willow Creek; Russian River **Road Ownership** County

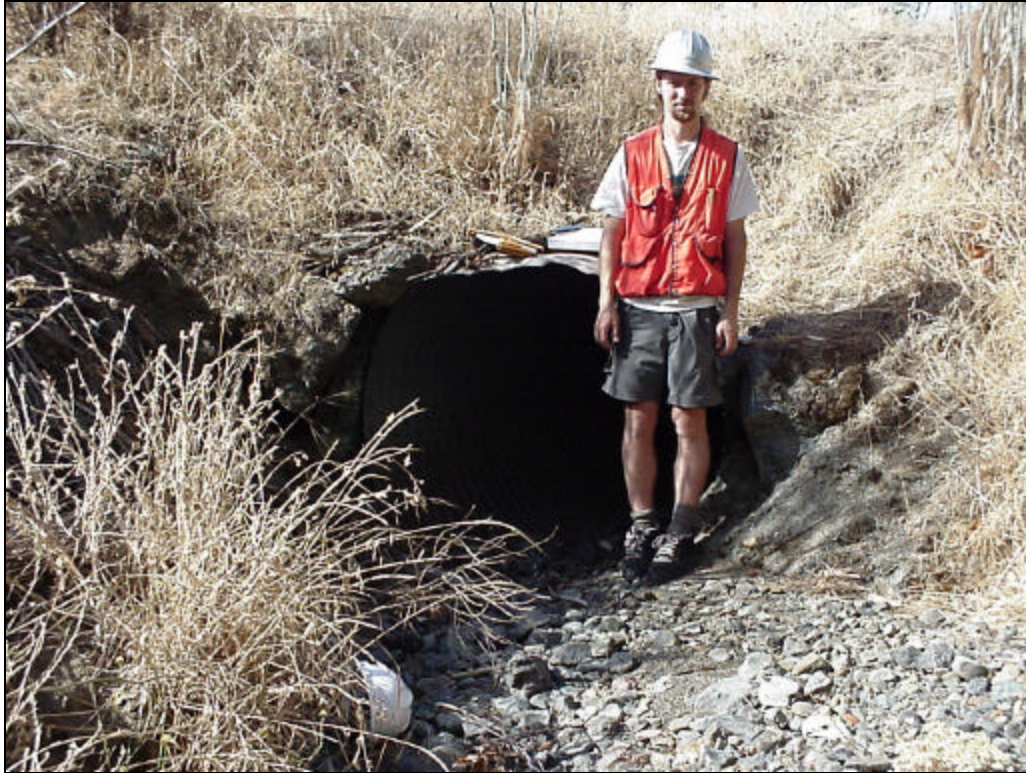
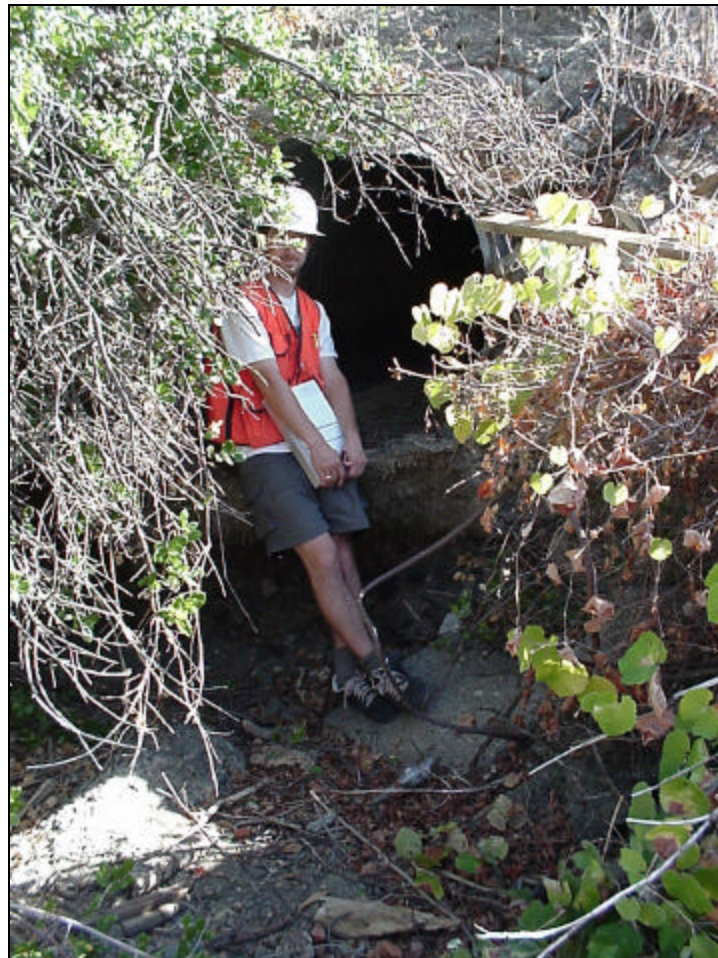
Site ID #S-116: Unnamed Tributary #1 to Russian River/River Road; Russian River

Culvert Type: Circular, SSP. **Corrugations:** 2-2/3" x 1/2" **Dimensions:** diameter = 4.0' **Length:** 69.8'
Slope: 1.56% **Modifications:** None. **Rustline Height:** 1.3' **Average Active Channel Width:** 7.2'
Fill Estimate: 248 cubic yards. **Overall Condition:** Fair – culvert invert is abraded.

Barrier Status: **GRAY:** FishXing determined this crossing meets the 8-16-16 ft/sec passage criteria for adult steelhead on 98% of the range of estimated migration flows and fails to meet the passage criteria for all age classes of juvenile salmonids. For adults, passage was scored as lower (40-50%) because FishXing failed to account for the lack-of-depth in the outlet pool for a fish to attempt a leap from.

Preferred Treatment: Because the current crossing is undersized, a replacement is the only feasible option for providing fish passage and increasing storm flow capacity. However, the limited reach of poor-quality habitat upstream of Site ID #S-116 makes this crossing a poor candidate to address with fisheries restoration funding.

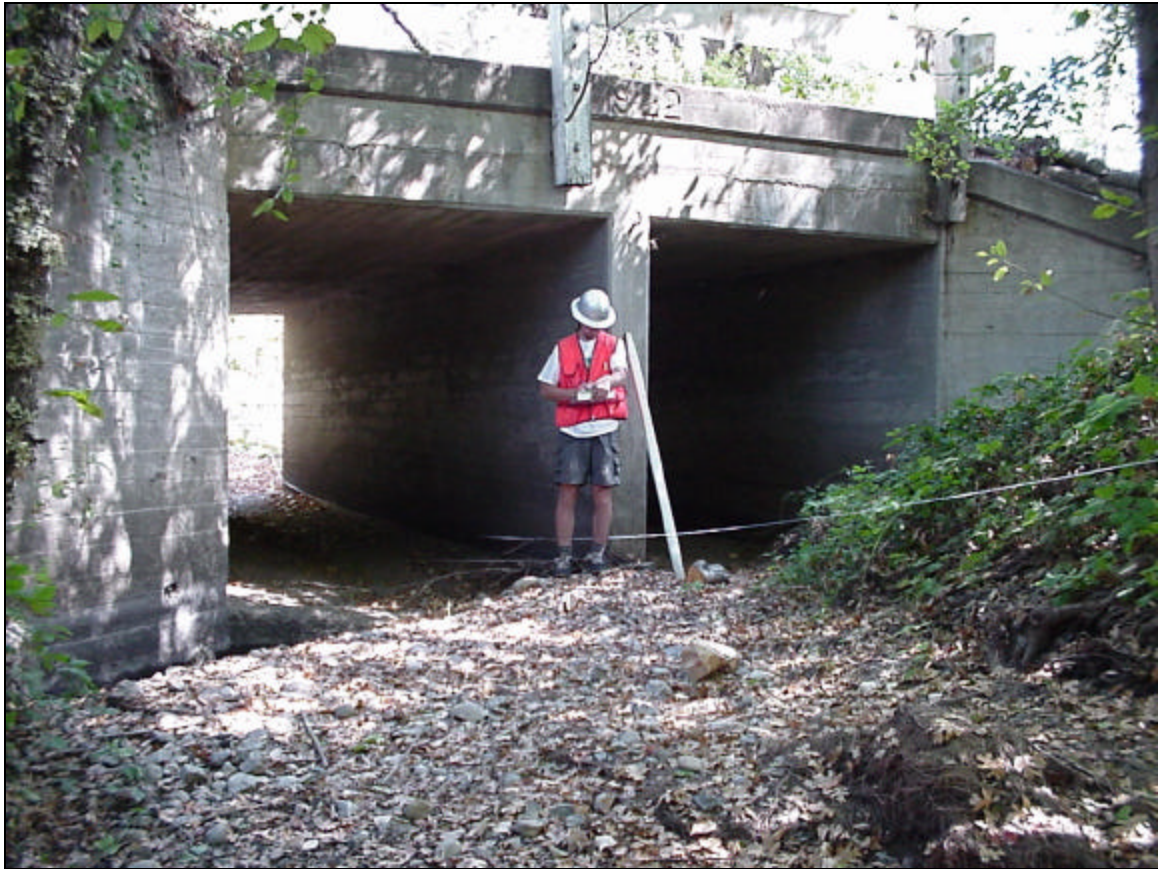
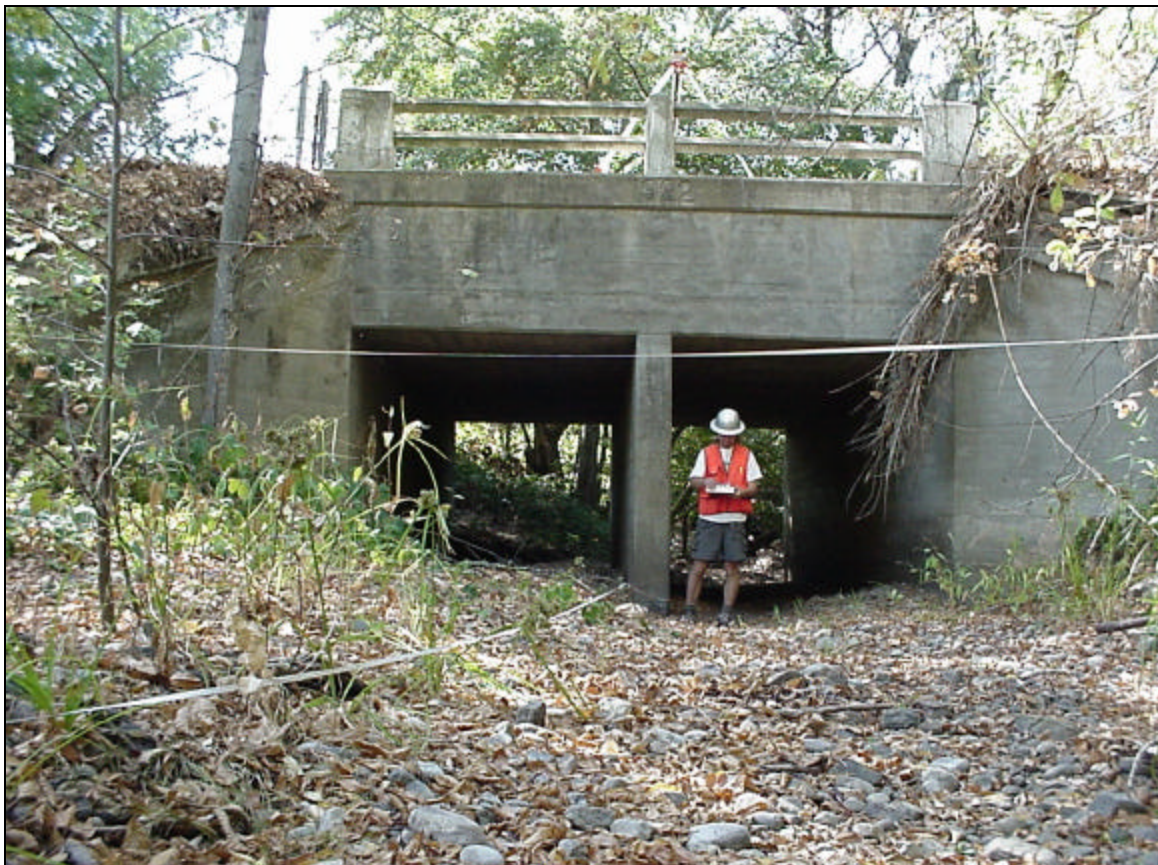
Site ID #S-117: Icaria Creek/Asti Road; Russian River **Road Ownership:** County

Culvert Type: Two Bay Box, Concrete. **Corrugations:** None. **Dimensions:** 8.1' height x 17.0' width
Length: 33.5' **Slope:** -0.24% **Modifications:** None. **Rustline Height:** N/A **Average Active Channel Width:** 13.0' **Fill Estimate:** 304 cubic yards. **Overall Condition:** Good. **Sizing:** Undersized; HW/D = 1 on a storm flow with approximately a 42-year recurrence interval. Asti Road is overtopped on more than a 250-year storm flow.

Preferred Treatment: None recommended because the current crossing provides adequate passage for all lifestages of steelhead, is sized to convey nearly a 50-year storm flow, and is in good condition. Periodically inspect for maintenance and condition – if outlet becomes perched consider treatment with downstream boulder weirs.

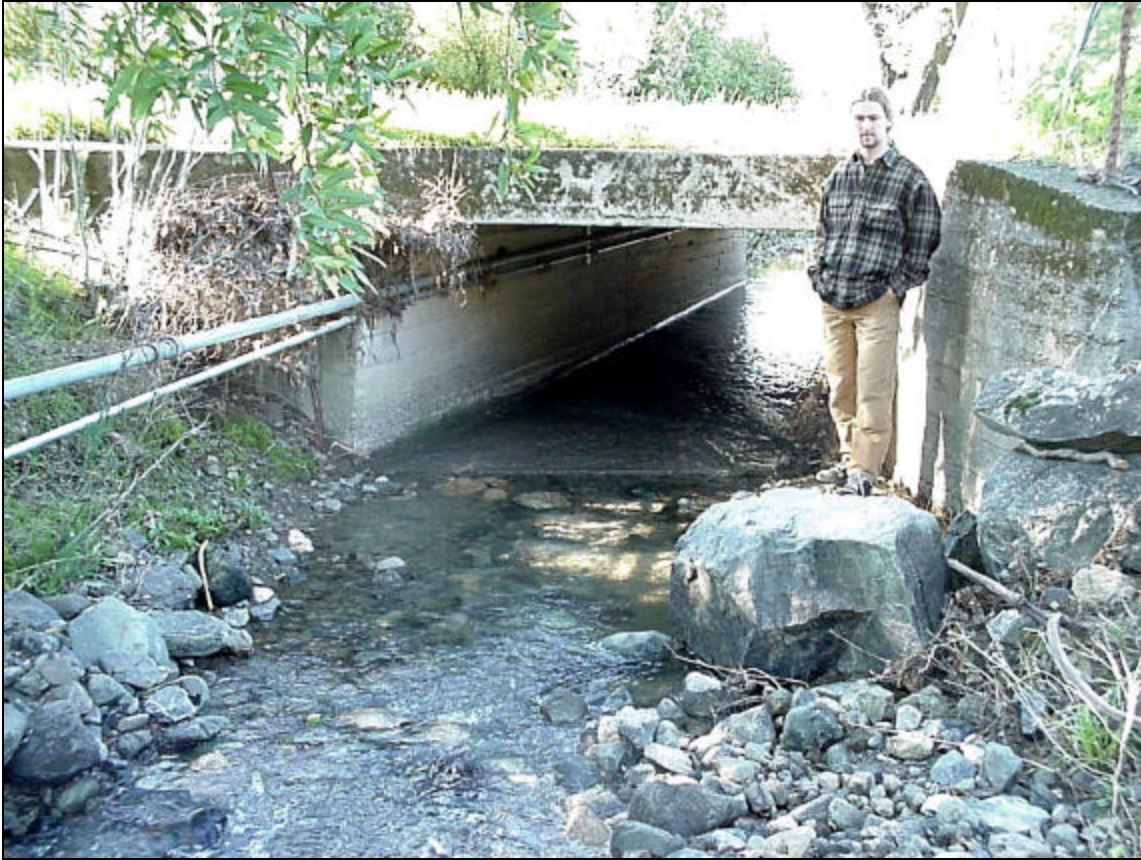
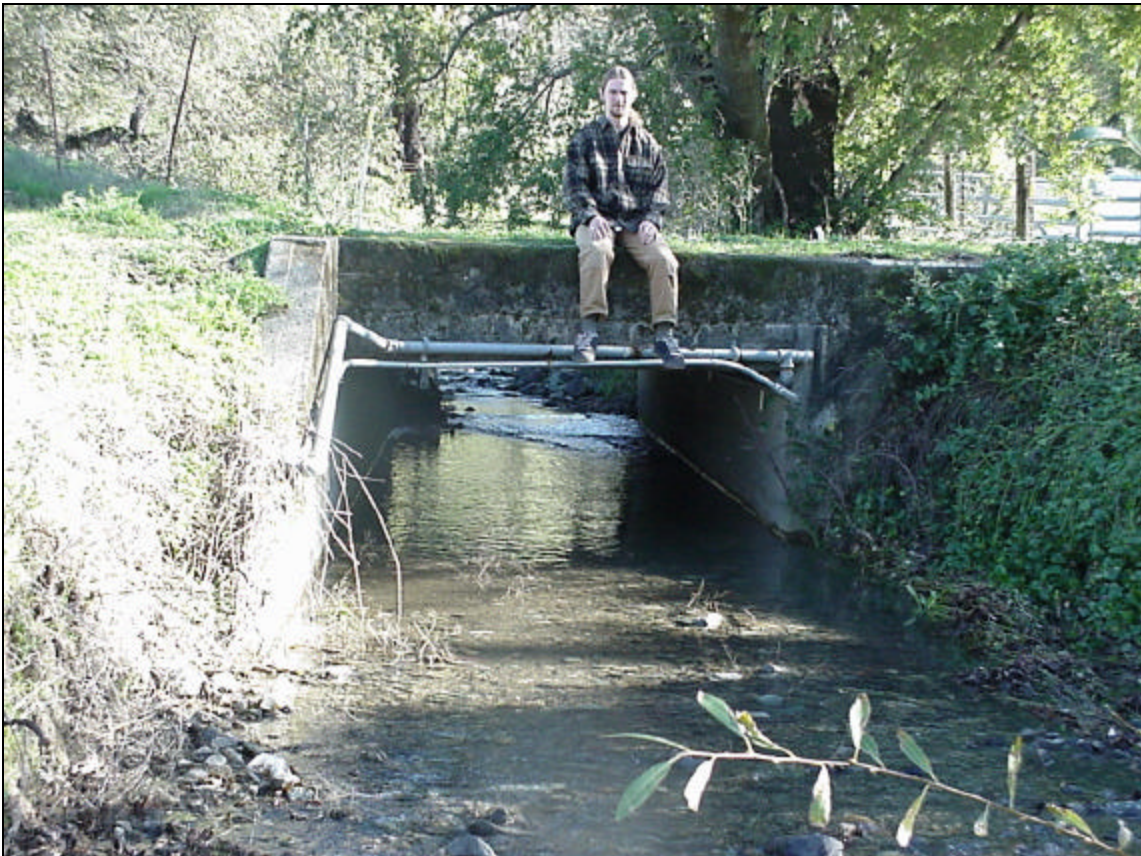
Site ID #S-118: Unnamed Tributary #2 to Russian River/River Road; Russian River

Culvert Type: Box, Concrete. **Corrugations:** None. **Dimensions:** 4.0' height x 8.1' width **Length:** 31.0'
Slope: 3.90% **Modifications:** None. **Rustline Height:** N/A **Average Active Channel Width:** 11.7'
Fill Estimate: 136 cubic yards. **Overall Condition:** Good.

Barrier Status: **RED:** FishXing determined this crossing fails to meet the 8-16-16 ft/sec passage criteria adult steelhead and all age classes of juveniles. For adults, the only passage criteria violation for adults was lack-of-depth, so some passage probably occurs. For all age classes of juveniles, the nearly 4% slope over a smooth concrete invert creates excessive velocities.

Preferred Treatment: Because the current crossing is sized for less than a 15-year storm flow, the use of downstream boulder weirs to raise tailwater elevation and corner baffles within the culvert to increase depths and decrease velocities should be cautiously considered. However, the very limited reach of poor-quality habitat upstream of Site ID #S-118 makes this crossing a poor candidate to address with fisheries restoration funding. Recommend dropping in final ranking.

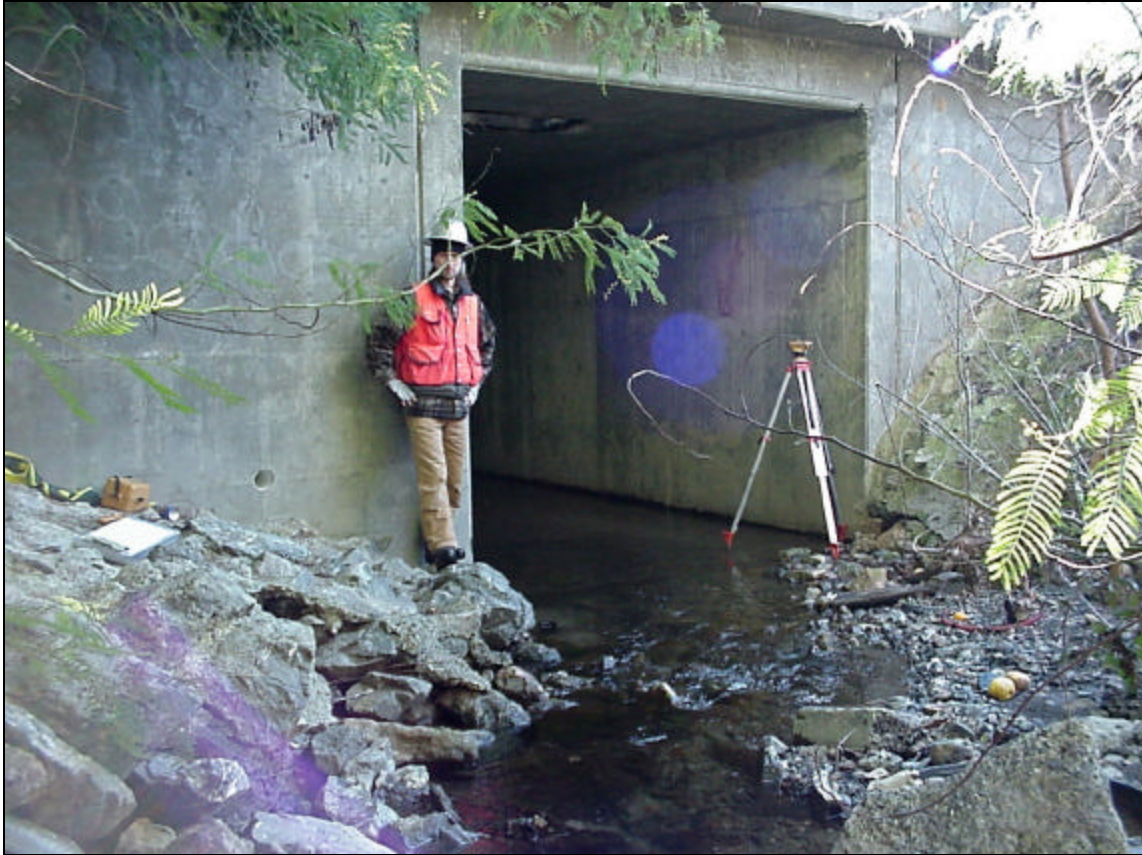
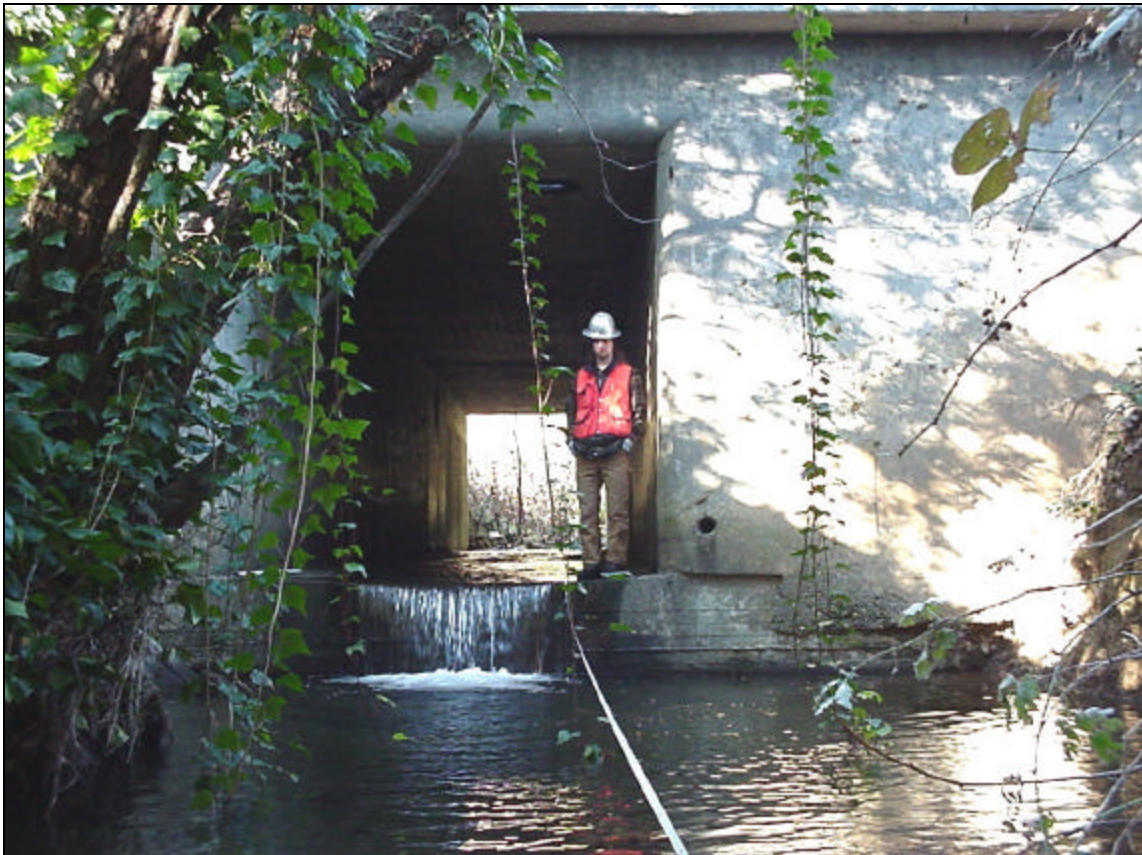
Site ID #S-119: Porterfield Creek/South Cloverdale Boulevard; Russian River **Road Ownership:** City of Cloverdale

Culvert Type: Box, Concrete. **Corrugations:** None. **Dimensions:** 10.0' height x 10.0' width **Length:** 83.3' **Slope:** 0.82% **Modifications:** None. **Rustline Height:** N/A **Average Active Channel Width:** 7.8' **Fill Estimate:** 1,196 cubic yards. **Overall Condition:** Good. **Sizing:** Properly sized; HW/D = 1 on a storm flow with more than a 250-year recurrence interval. South Cloverdale Boulevard is overtopped on more than a 250-year storm flow.

Barrier Status: **GRAY:** FishXing determined this crossing meets the 8-16-16 ft/sec passage criteria for adult steelhead on 70% of the range of estimated migration flows and fails to meet passage criteria for all age classes of juvenile salmonids. For adults the only criteria violation is lack-of-depth – thus actual passage may be higher than predicted by FishXing. The perched outlet (2.0 feet) impedes the migration of all age classes of juveniles.

Preferred Treatment: Because the current crossing is properly sized and in good condition a retrofit is recommended to improve conditions for fish passage. Construct one to two downstream boulder weirs to raise the tail-water elevation and possibly back-water the culvert. Install corner baffles within the culvert to increase depths and decrease velocities. However, this site provides adequate adult passage and treatment is a low-priority until the County addresses its high and moderate priority crossings.

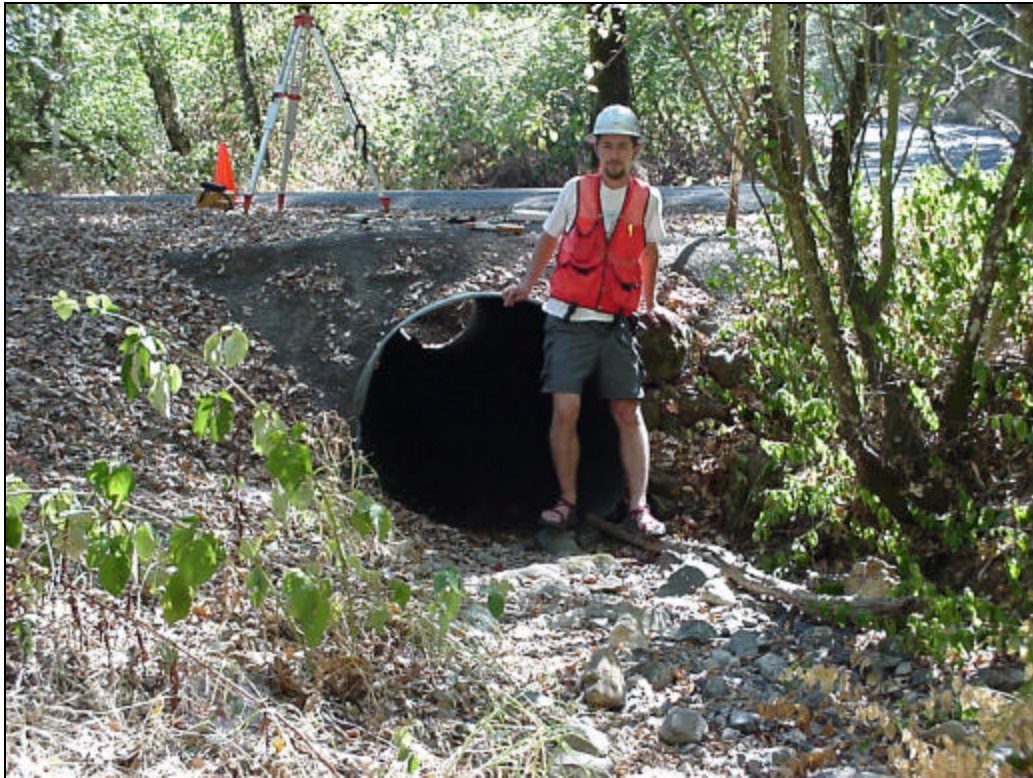
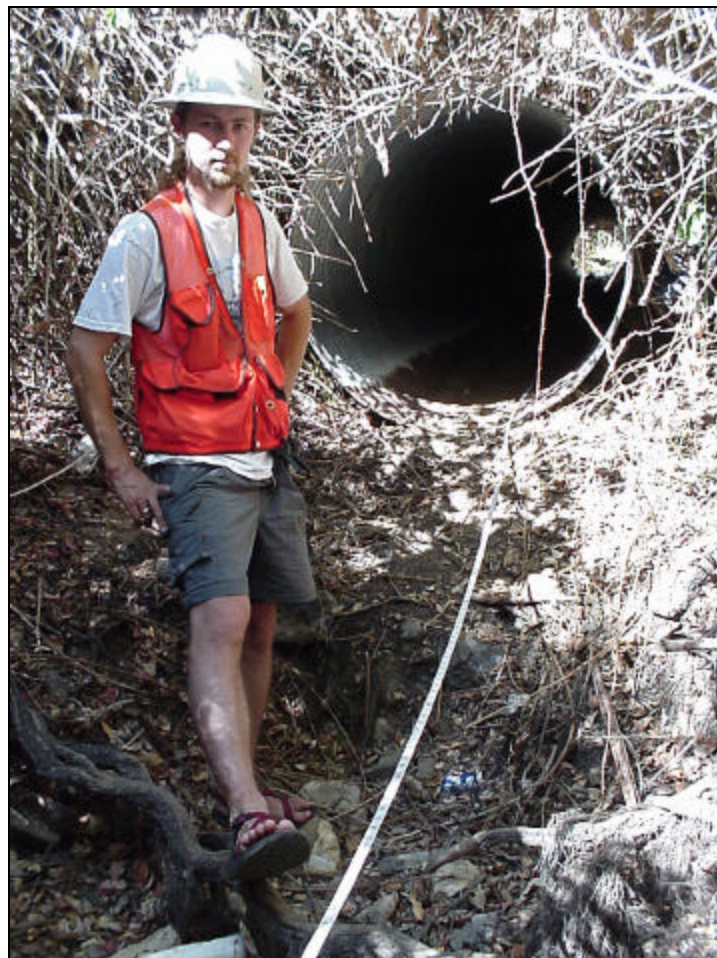
Site ID #S-120: North Branch/Cherry Creek Road; Porterfield Creek; Russian River **Road Ownership:** County

Culvert Type: Circular, CSP. **Corrugations:** 2-2/3" x 1/2" **Dimensions:** diameter = 4.0' **Length:** 60.0'
Slope: 5.58% **Modifications:** None. **Rustline Height:** 0.8' **Average Active Channel Width:** 7.1'
Fill Estimate: 202 cubic yards. **Overall Condition:** Poor – culvert invert is rusted through. **Sizing:** Extremely undersized; HW/D = 1 on a storm flow with approximately a six-year recurrence interval. Cherry Creek Road is overtopped on approximately a 15-year storm flow.

Barrier Status: **GRAY:** FishXing determined this crossing meets the 8-16-16 ft/sec passage criteria for adult steelhead on 54% of the range of estimated migration flows and fails to meet passage criteria for all age classes of juvenile salmonids. The perched outlet (1.9 feet) impedes the migration of all age classes of juveniles.

Preferred Treatment: Because the current crossing is undersized and in poor condition a replacement with a properly sized embedded SSP culvert is the only feasible option to improve conditions for fish passage and increase the crossing's hydraulic capacity. The crossing is due for an upgrade, however this site provides some adult passage and treatment with fisheries restoration funding is a low-priority due to the limited fisheries significance of the upstream habitat.

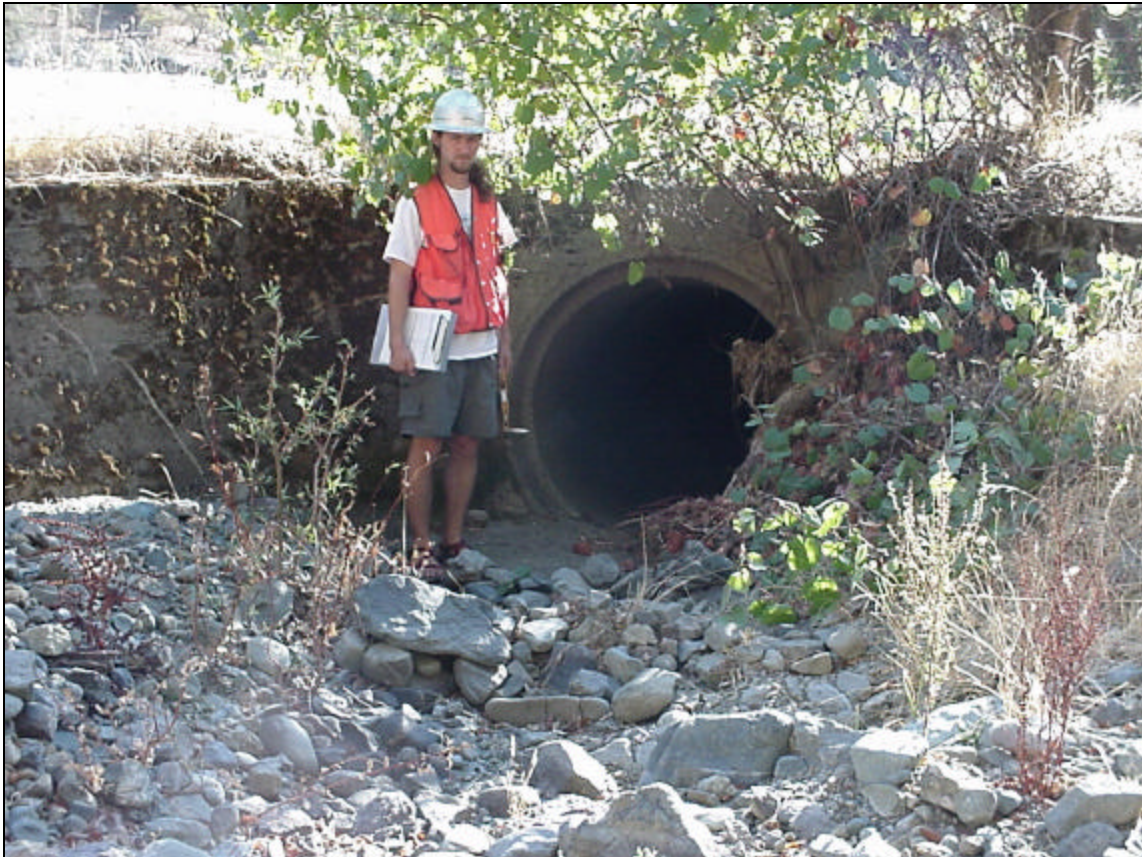
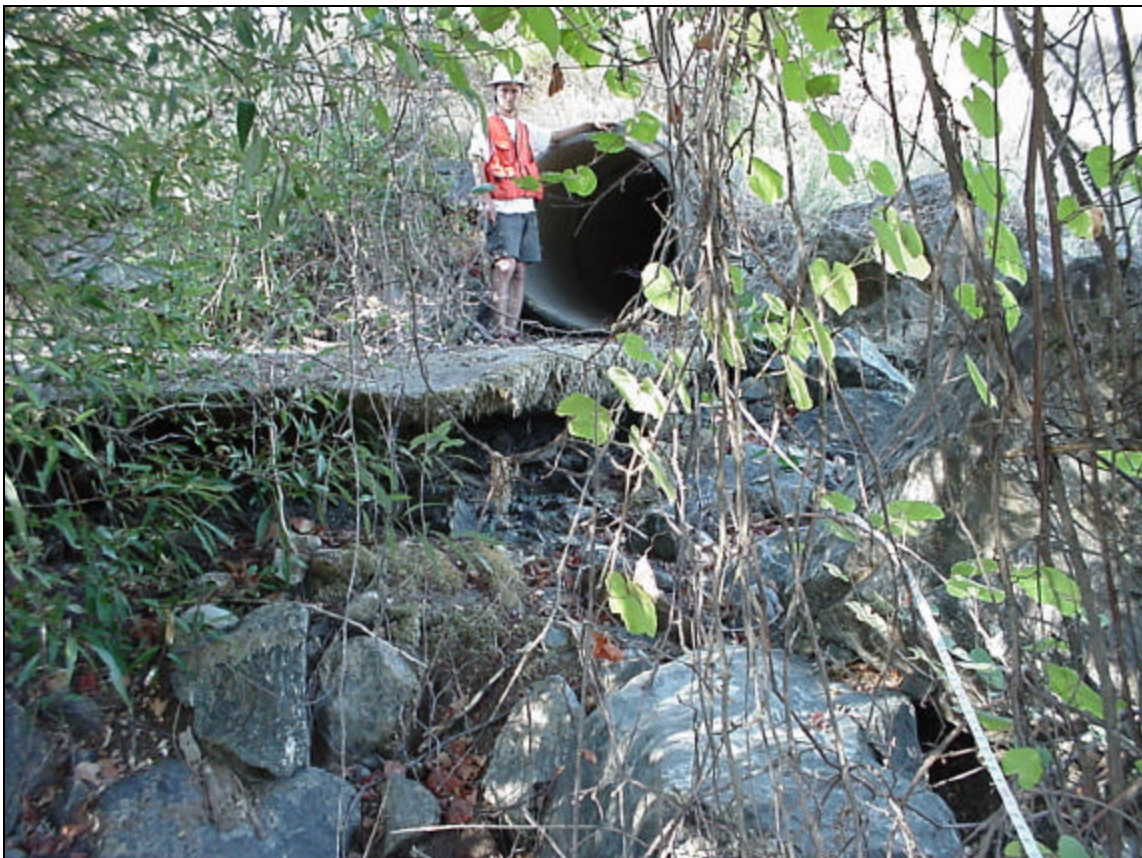
Culvert Type: Circular, Concrete. **Corrugations:** None. **Dimensions:** diameter = 4.0' **Length:** 57.1' **Slope:** 6.23% **Modifications:** None. **Rustline Height:** N/A **Average Active Channel Width:** 8.8'

Fill Estimate: 439 cubic yards. **Overall Condition:** Fair – culvert invert is abraded.

Barrier Status: **RED:** the Green-Gray-Red filter determined this crossing fails to meet passage criteria for of adult sateelhead and all age classes of juvenile salmonids due to the crossing's perched outlet and steep slope.

Habitat: Quantity = approximately 650' of potential fish-bearing habitat upstream of Site ID# S-123. Quality = rated as "poor" for the ranking matrix as based on CDFG's professional judgment (Coey, pers. comm.). The crossing was surveyed on 10/01/01 and the channel was dry. The survey crew described the habitat as "poor" and noted a sparse riparian zone of hardwoods along a steeply-sloped channel and questioned whether this is a fish-bearing stream channel.

Preferred Treatment: Because the current crossing is extremely undersized, a replacement with a properly sized embedded SSP culvert is the best option for improving fish passage and increasing the crossing's hydraulic capacity. However, due to the limited reach of poor-quality habitat this site should be **dropped** in the final ranking and is a poor candidate for treatment with fisheries restoration funding.

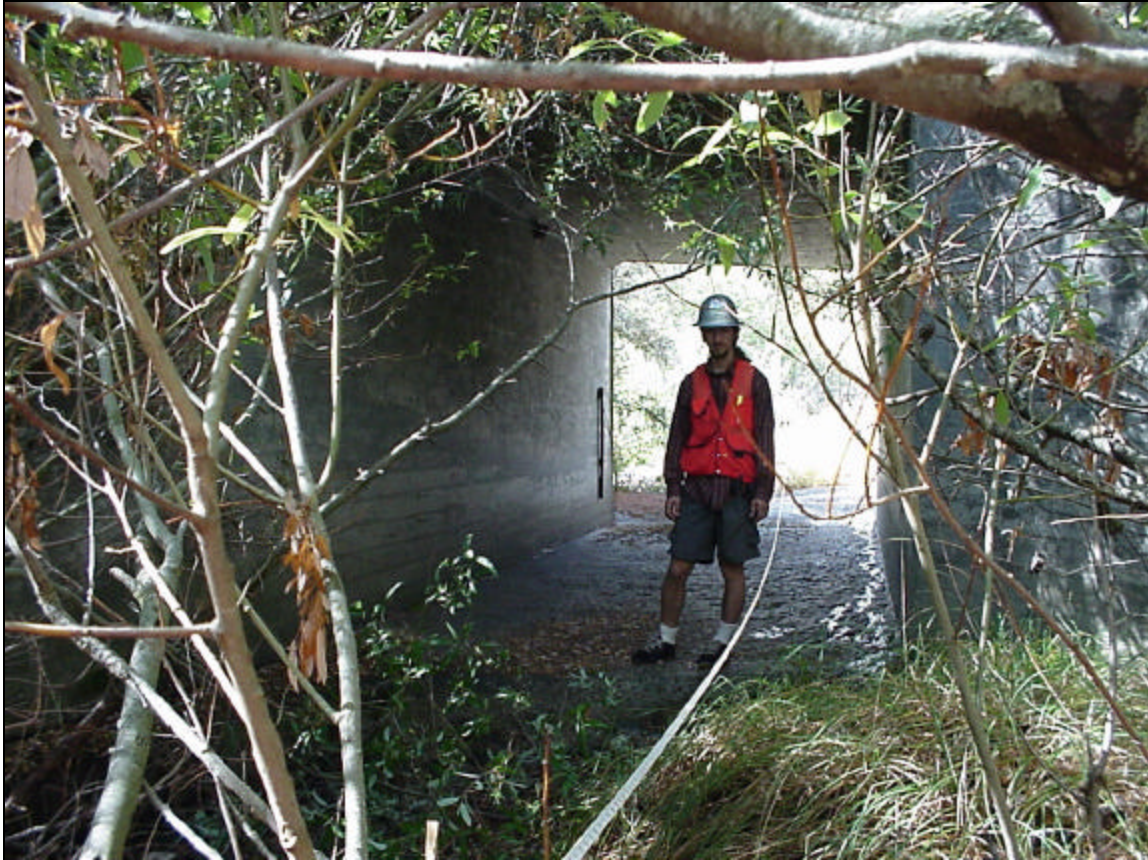
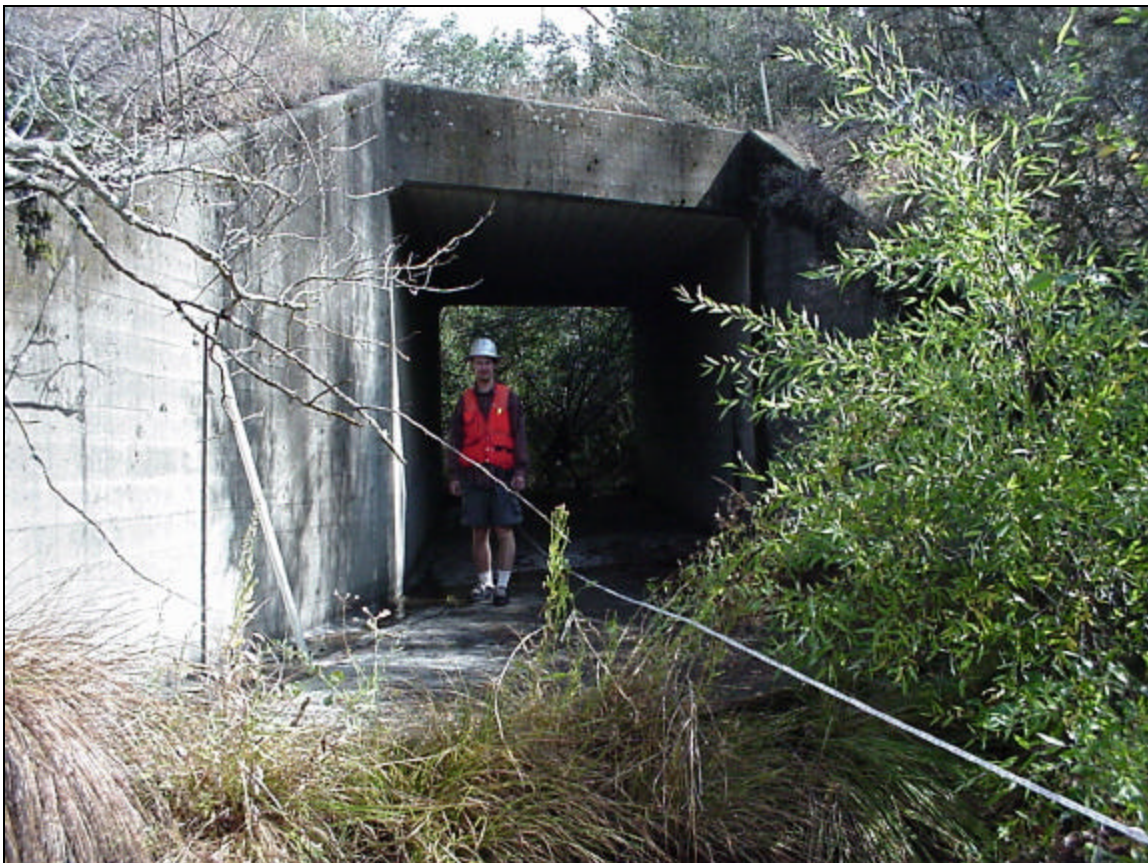
Site ID #S-124: Anna Belcher Creek/Pine Flat Road; Little Sulphur Creek; Big Sulphur Creek; Russian River

Culvert Type: Box, Concrete. **Corrugations:** None. **Dimensions:** 10.0' height x 13.7' width **Length:** 32.5' **Slope:** 3.51% **Modifications:** None. **Rustline Height:** N/A **Average Active Channel Width:** 13.1' **Fill Estimate:** 445 cubic yards. **Overall Condition:** Good. **Sizing:** Properly sized; HW/D = 1 on a storm flow with more than a 250-year recurrence interval. Pine Flat Road is overtopped on more than a 250-year storm flow.

Barrier Status: **RED:** FishXing determined this crossing fails to meet the 8-16-16 ft/sec passage criteria for adult steelhead and the passage criteria for all age classes of juvenile salmonids. For adults, some passage probably occurs because the only violation of the passage criteria is lack-of-depth. For all juveniles, the 3.5% slope over a smooth concrete invert creates excessive velocities.

Habitat: Quantity = approximately 4,350' of potential fish-bearing habitat upstream of Site ID# S-124. Quality = rated as "fair" for the ranking matrix as based on CDFG's professional judgment (Coey, pers. comm.). CDFG conducted a habitat typing survey of Big Sulphur Creek and its major tributaries, but the data were unavailable for this stream crossing evaluation project. The crossing was surveyed by Taylor and Associates on 9/25/01 and the channel was dry. The survey crew described the habitat as "fair" and noted a moderately dense riparian zone of hardwoods.

Preferred Treatment: Because the current crossing is properly sized and in good condition a retrofit is recommended to improve conditions for fish passage. Construct one to two downstream boulder weirs to raise the tail-water elevation and possibly back-water the culvert. Install corner baffles within the culvert to increase depths and decrease velocities.

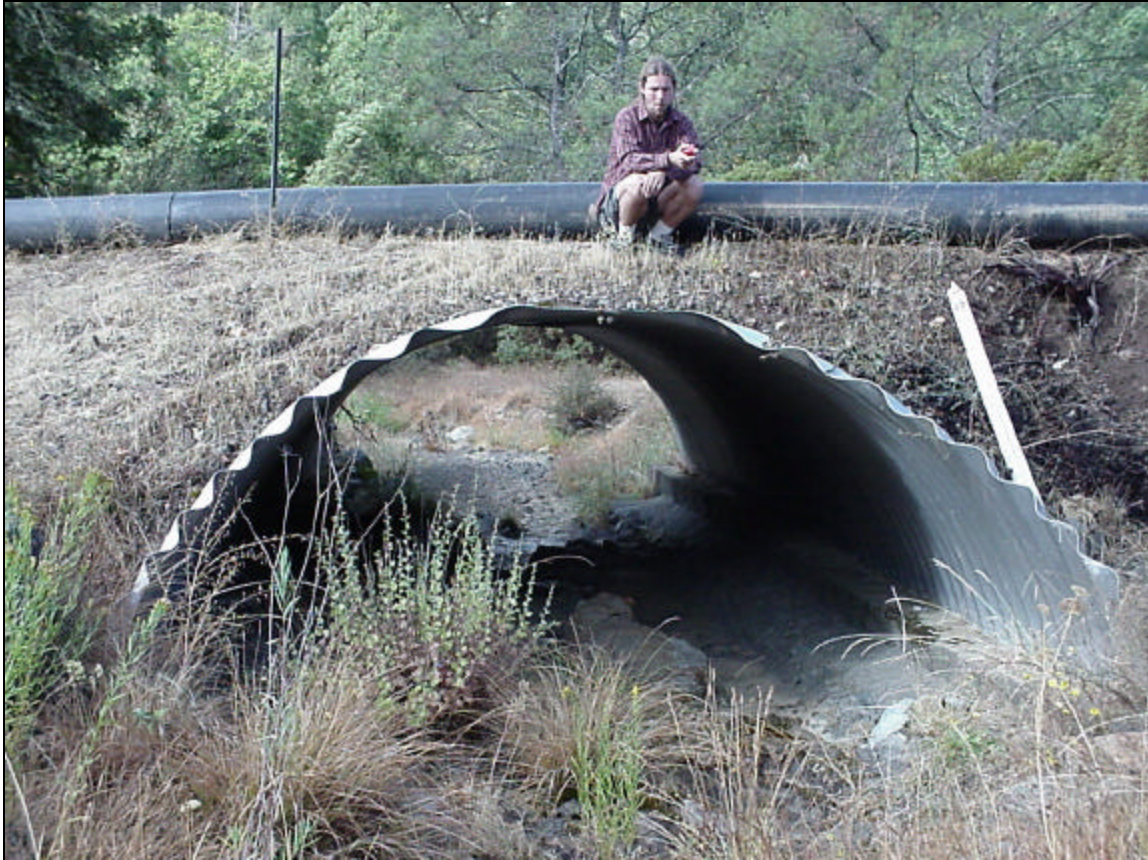
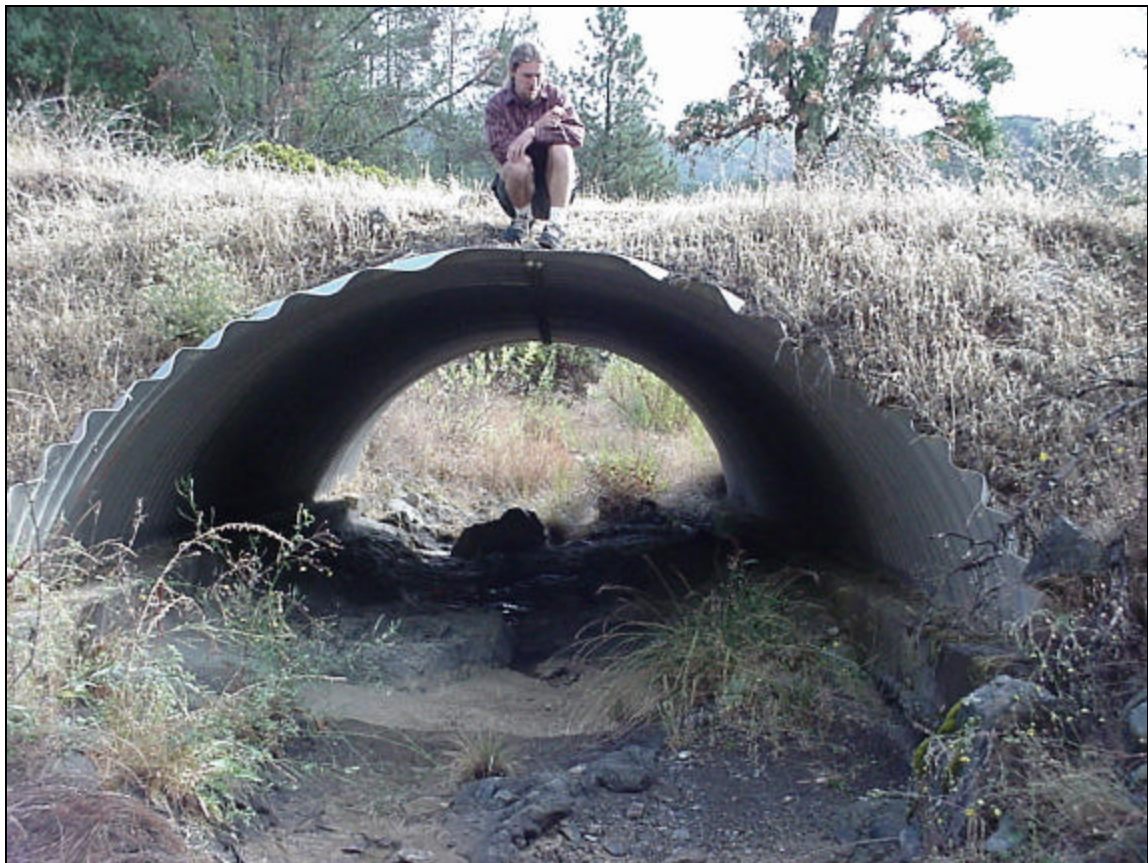
Site ID #S-125: Hurley Creek/Pine Flat Road; Little Sulphur Creek; Big Sulphur Creek; Russian River

Culvert Type: Open Bottom Arch, SSP. **Corrugations:** 9.0" x 2.5" **Dimensions:** 7.0' rise x 14.0' span
Length: 35.3' **Slope:** 2.78% **Modifications:** None. **Rustline Height:** 0.0' **Average Active Channel Width:** 9.2' **Fill Estimate:** 142 cubic yards. **Overall Condition:** Sides of culvert are abraded. **Sizing:** Properly sized; HW/D = 1 on a storm flow with more than a 250-year recurrence interval. Pine Flat Road is overtopped on more than a 250-year storm flow.

Barrier Status: **RED:** FishXing determined this crossing fails to meet the 8-16-16 ft/sec passage criteria for adult steelhead and the passage criteria for all age classes of juvenile salmonids. For adults, some passage probably occurs because the only violation of the passage criteria is lack-of-depth. For all juveniles, the small watershed drainage area above the crossing resulted in a narrow range of flows for passage assessment.

Habitat: Quantity = approximately 5,200' of potential fish-bearing habitat upstream of Site ID# S-125. Quality = rated as "poor" for the ranking matrix as based on Taylor and Associates survey crew's field notes. CDFG conducted a habitat typing survey of Big Sulphur Creek and its major tributaries, but the data were unavailable for this stream crossing evaluation project. The crossing was surveyed by Taylor and Associates on 9/25/01 and the channel was dry. The survey crew described the habitat as "poor" and noted a sparse riparian zone along a poorly defined channel of questionable value for anadromous salmonids.

Preferred Treatment: Because the current crossing is properly sized and in good condition a retrofit is recommended to improve conditions for fish passage. Construct one to two downstream boulder weirs to raise the tail-water elevation and possibly back-water the culvert to increase depths and decrease velocities. Recommend dropping site in final ranking and treat sites with higher fisheries value before treating Site ID #S-125.
