MEMORANDUM

Date: June 12, 2007
To: Matt Carpenter and Corey Harpole
Organization: Newhall Land and Farming Company
From: Andrew Collison
PWA Project #: 1820.02
PWA Project Name: Newhall Ranch
Subject: Channel geomorphic assessment of Lion Canyon
Copy(ies) To: Lisa Austin, File

Geomorphic Reconnaissance

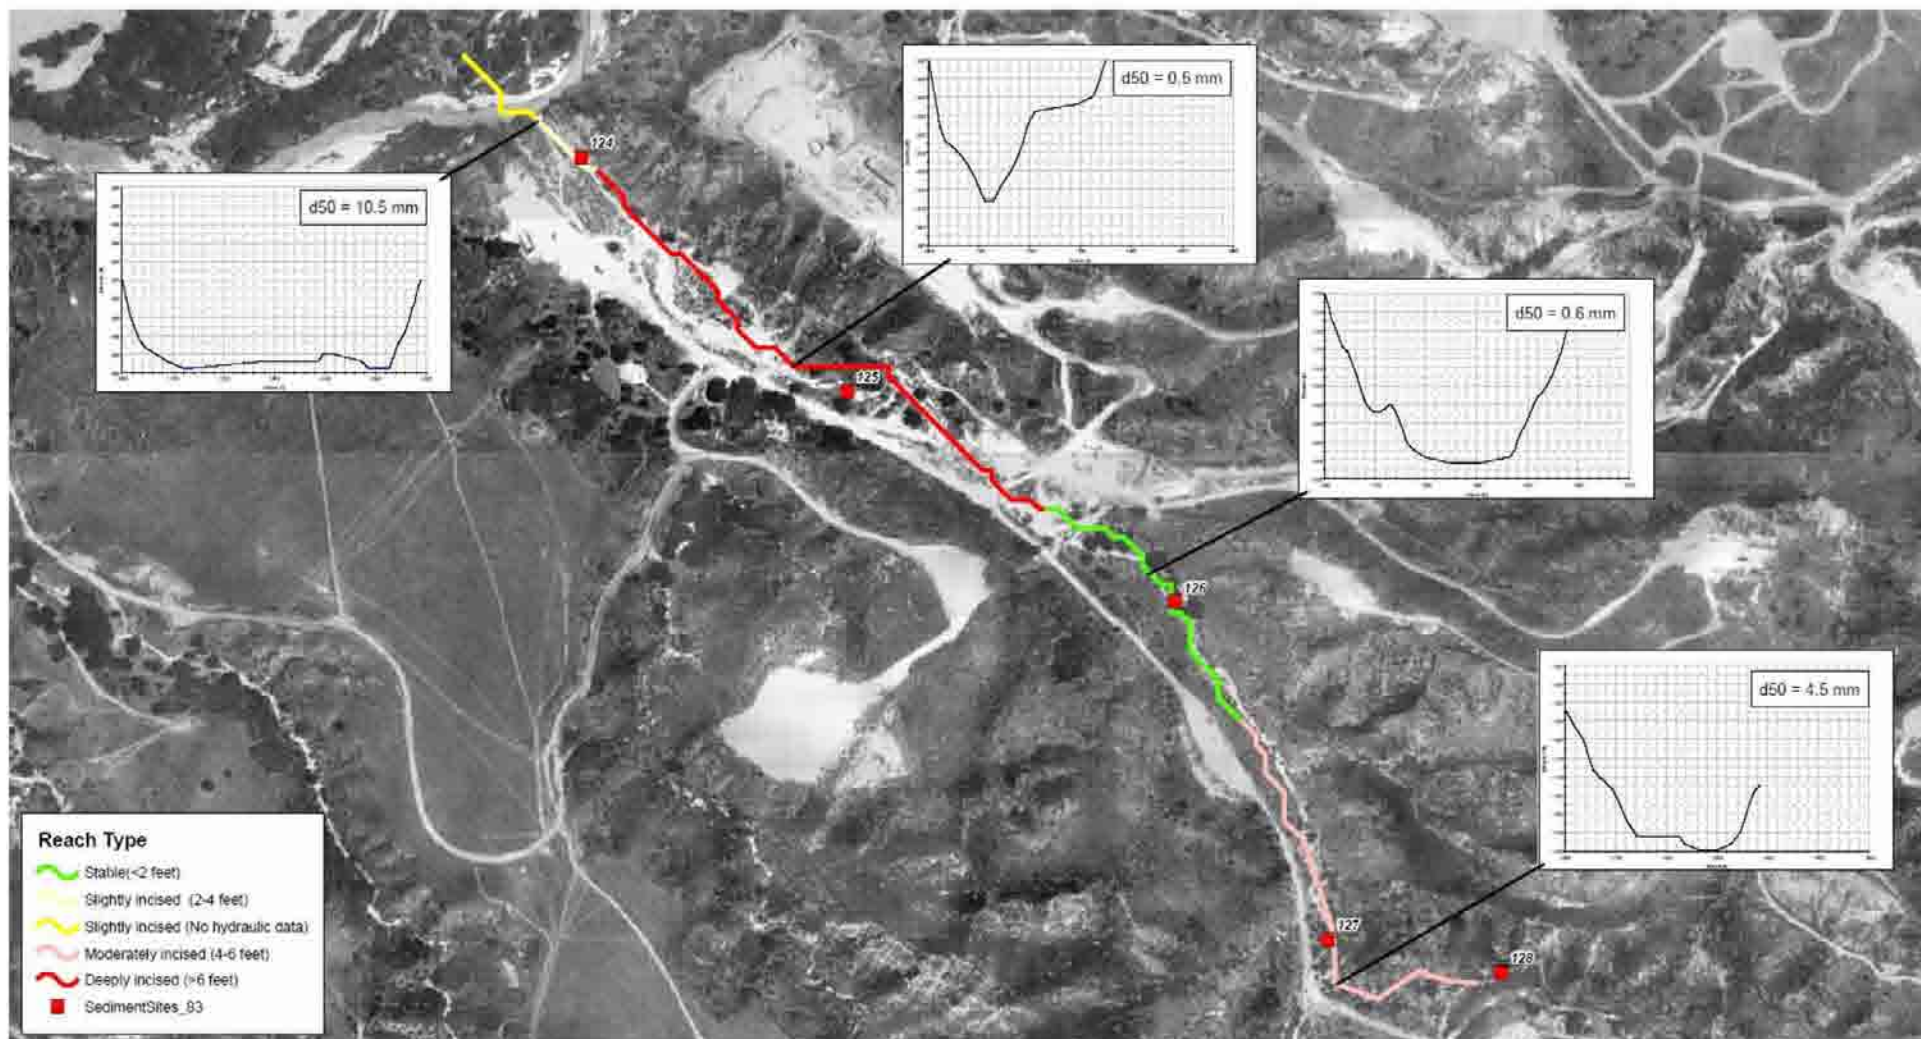
Reach distribution

Lion Canyon has steep headwaters (above the project boundary) that feed into a slightly eroded upper channel reach (Images #1 – 6) transitioning gradually to a more stable reach with a well connected and vegetated floodplain (Images 7-9). This incorporates a reach with mature oaks (Images 10-13) before transitioning back to additional stable floodplain (Image 14). There is a very sharp transition from stable to unstable conditions at the road crossing, which acts as a grade control protecting the upper reaches from incision. The source of the incision is likely uncontrolled drainage from the unimproved road surface. Downstream of the grade control is a 12 foot high knickpoint (Image 15) and a reach of deeply incised channel with some failing banks (Images 16 and 17 near to more mature oaks. This reach opens up into a wider section (Images 18-20) where the channel is eroding into relict terraces, triggering extensive bank collapses. Downstream the channel become slightly more stable but still remains incised with erosion on the outside bends and the formation of a small new floodplain on the inner bends (Images 21-22). The right valley side looking downstream is undercut by the creek, creating a high unstable slope. This reach culminates in a 8 foot high knickpoint (further evidence of incision) leading to the Santa Clara River.
