**California Department of Fish and Wildlife
East Marin County
San Francisco Bay Watersheds
Stream Habitat Assessment Reports**

Sleepy Hollow Creek

*Surveyed 2009
Report Completed in 2013*

STREAM INVENTORY REPORT

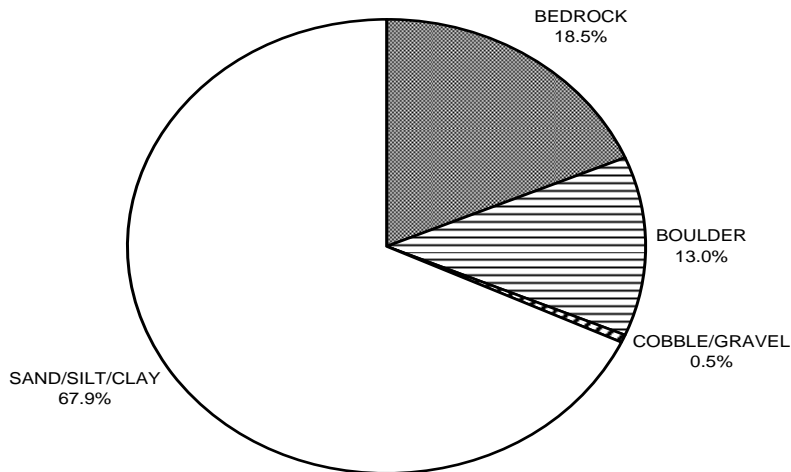
GRAPH 10

For the stream reach surveyed, the mean percent right bank vegetated was 48%. The mean percent left bank vegetated was 52% (Table 7). The dominant elements composing the structure of the stream banks consisted of 68% sand/silt/clay, 18% bedrock, 13% boulder, 1% cobble/gravel (Graph 10). Deciduous trees were the dominant vegetation type observed in 71% of the units surveyed. Additionally, 23% of the units surveyed had brush as the dominant vegetation type, and 5% had grass as the dominant vegetation type (Graph 11).

**SLEEPY HOLLOW CREEK 2009
DOMINANT BANK COMPOSITION IN SURVEY REACH**

The percentage of right and left bank covered with vegetation was 48% and 52%, respectively. In areas of stream bank erosion or where bank vegetation is sparse, planting endemic species of coniferous and hardwood trees, in conjunction with bank stabilization, is recommended.

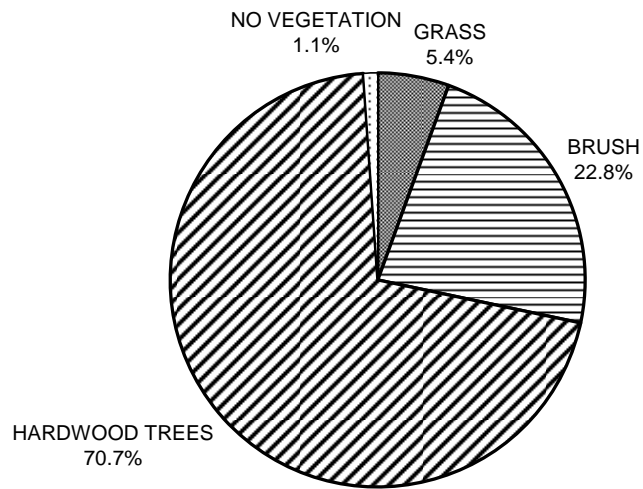
GRAPH 11

**SLEEPY HOLLOW CREEK 2009
DOMINANT BANK VEGETATION IN SURVEY REACH**
