**California Department of Fish and Wildlife
East Marin County
San Francisco Bay Watersheds
Stream Habitat Assessment Reports**

Warner Creek

Surveyed 2009

STREAM INVENTORY REPORT

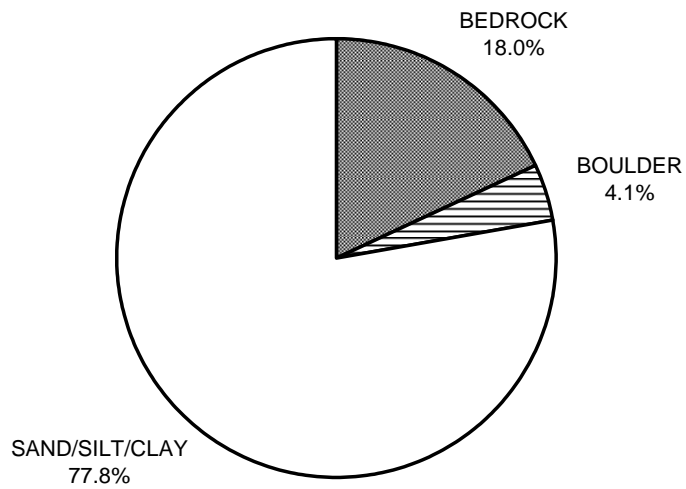
GRAPH 10

For the stream reach surveyed, the mean percent right bank vegetated was 54%. The mean percent left bank vegetated was 59%. The dominant elements composing the structure of the stream banks consisted of 18% bedrock, 4% boulder, 78% sand/silt/clay, (Graph 10). Deciduous trees were the dominant vegetation type observed in 66% of the units surveyed. Additionally, 20% of the units surveyed had brush as the dominant vegetation type, and 12% had grass as the dominant vegetation (Graph 11).

The percentage of right and left bank covered with vegetation was 54% and 59%, respectively. In areas of stream bank erosion or where bank vegetation is sparse, planting endemic species of coniferous and hardwood trees, in conjunction with bank stabilization, is recommended.
