**California Department of Fish and Wildlife
Contra Costa County
San Pablo Bay Watershed
Stream Habitat Assessment Reports**

Wildcat Creek

Surveyed 2010

STREAM INVENTORY REPORT

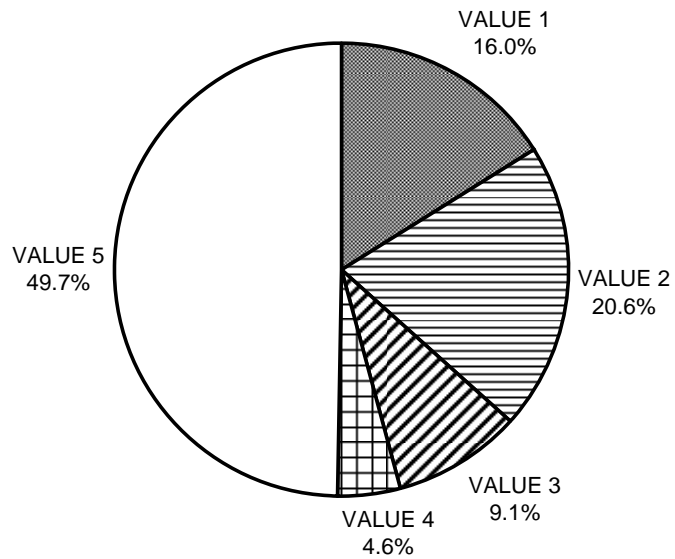
GRAPH 6

The depth of cobble embeddedness was estimated at pool tail-outs. Of the 175 pool tail-outs measured, 28 had a value of 1 (16%); 36 had a value of 2 (20.6%); 16 had a value of 3 (9.1%); 8 had a value of 4 (4.6%); 87 had a value of 5 (49.7%) (Graph 6). On this scale, a value of 1 indicates the best spawning conditions and a value of 4 the worst. Additionally, a value of 5 was assigned to tail-outs deemed unsuited for spawning due to inappropriate substrate such as bedrock, log sills, boulders, or other considerations.

WILDCAT CREEK 2010 PERCENT EMBEDDEDNESS

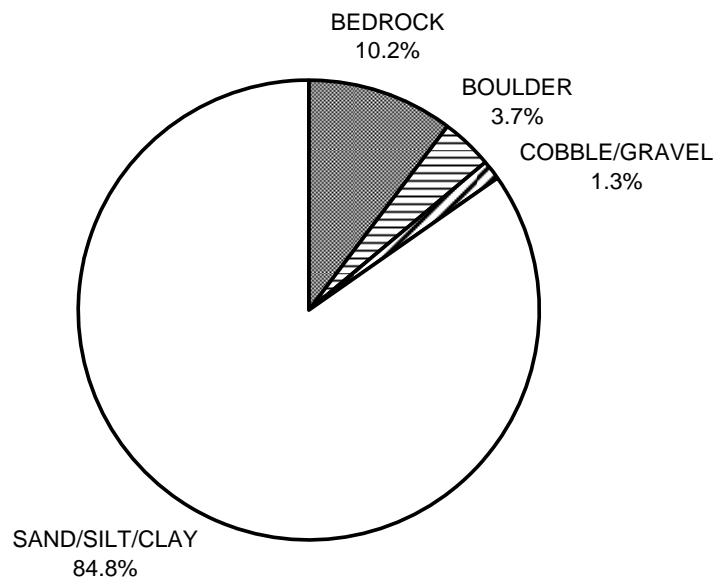
GRAPH 10

For the stream reach surveyed, the mean percent right bank vegetated was 70%. The mean percent left bank vegetated was 73%. The dominant elements composing the structure of the stream banks consisted of 10% bedrock, 4% boulder, 1% cobble/gravel, 85% sand/silt/clay, (Graph 10). Hardwood trees were the dominant vegetation type observed in 88% of the units surveyed. Additionally, 10% of the units surveyed had brush as the dominant vegetation type, and 1% had coniferous trees as the dominant vegetation (Graph 11).

**WILDCAT CREEK 2010
DOMINANT BANK COMPOSITION IN SURVEY REACH**

The percentage of right and left bank covered with vegetation was 70% and 73%, respectively. In areas of stream bank erosion or where bank vegetation is sparse, planting endemic species of coniferous and hardwood trees, in conjunction with bank stabilization, is recommended.
