2014–2015 Detailed Fish Passage Assessment Evaluations

District 4 – Marin and San Mateo Counties | Highway 1

April 2015
Revised May 2016

Prepared For:
California Department of Transportation
Division of Environmental Analysis
Office of Biology and Technical Assistance
Sacramento, CA USA

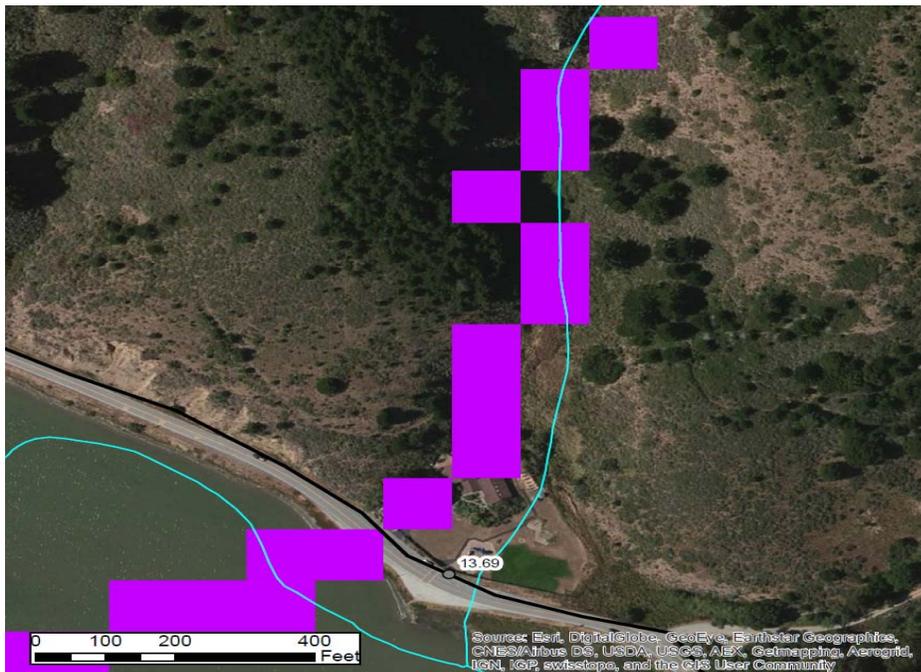
Figure 6. Aerial view of MRN 1 13.69 and its upstream drainage.

Hydrologic GIS analyses indicate that this drainage may have historically crossed through the location of an existing school property, and may have been moved just to the south of the property (**Figure 6** – purple highlighting indicates the natural stream pathway based on elevation). Site photos indicate grass growing in the vicinity of the inlet and the outlet, and downstream of the outlet, with a lack of a definable channel

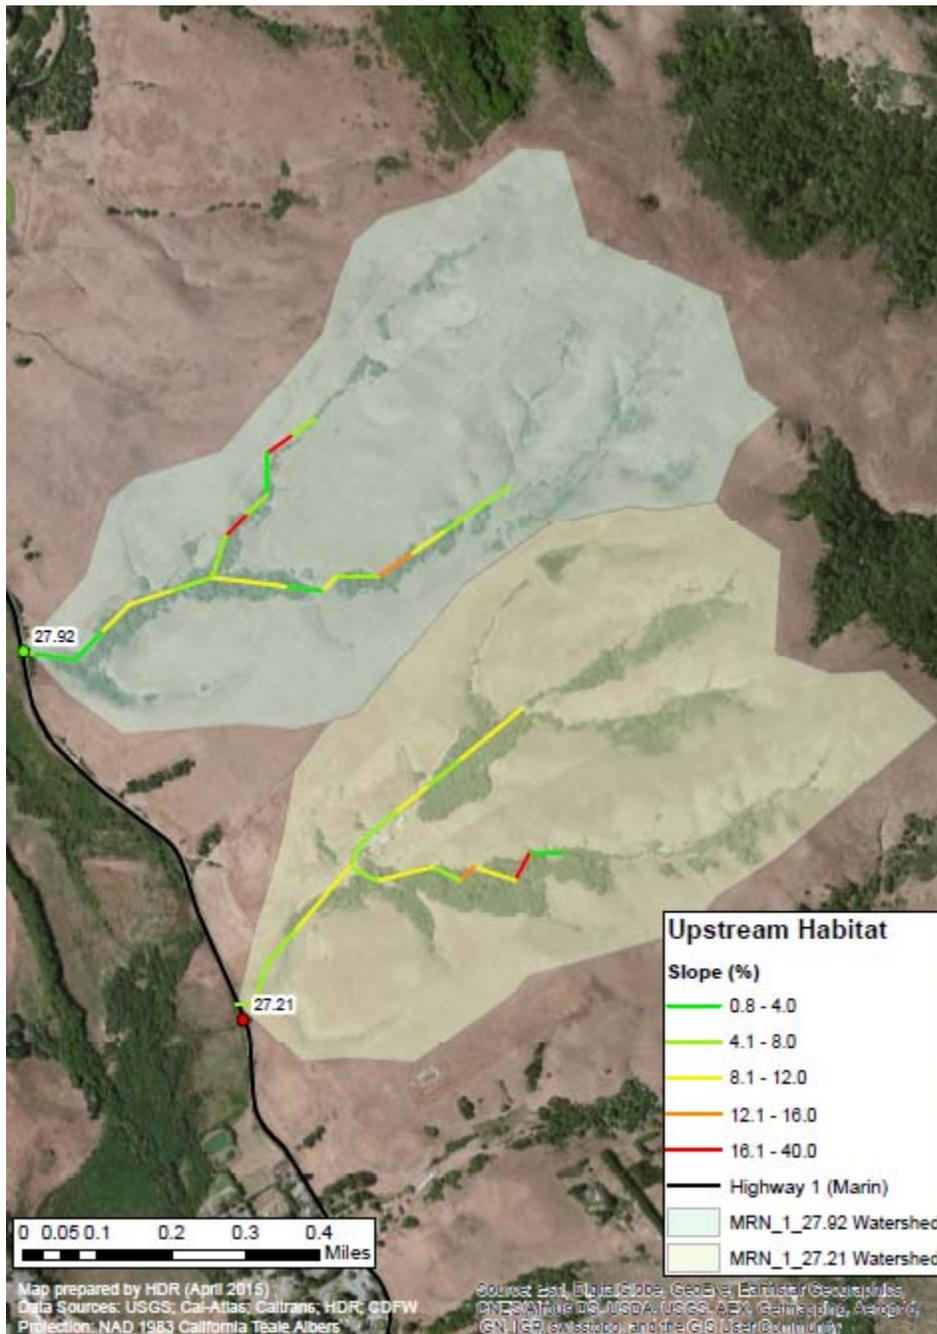
Figure 15. Stream gradient upstream of MRN 1 27.92 and 27.21.

As previously described, this site was initially identified as “green” according to the CDFW Passage Evaluation Filter, but this determination was ignored due to the culvert being nearly filled with sediment at the downstream end. It is recommended that this site be re-surveyed after the excess sediment is removed from the site. Potential upstream habitat available was estimated at approximately 0.6 miles based on stream gradient (Figure 15).

As previously described, this site was identified as “red” according to the CDFW Passage Evaluation Filter. In addition to stream gradient, estimated upstream habitat also was restricted due to habitat fragmentation associated with a residential property at the mouth of a tributary to this creek. Potential upstream habitat available was estimated at approximately 0.5 miles (Figure 15).

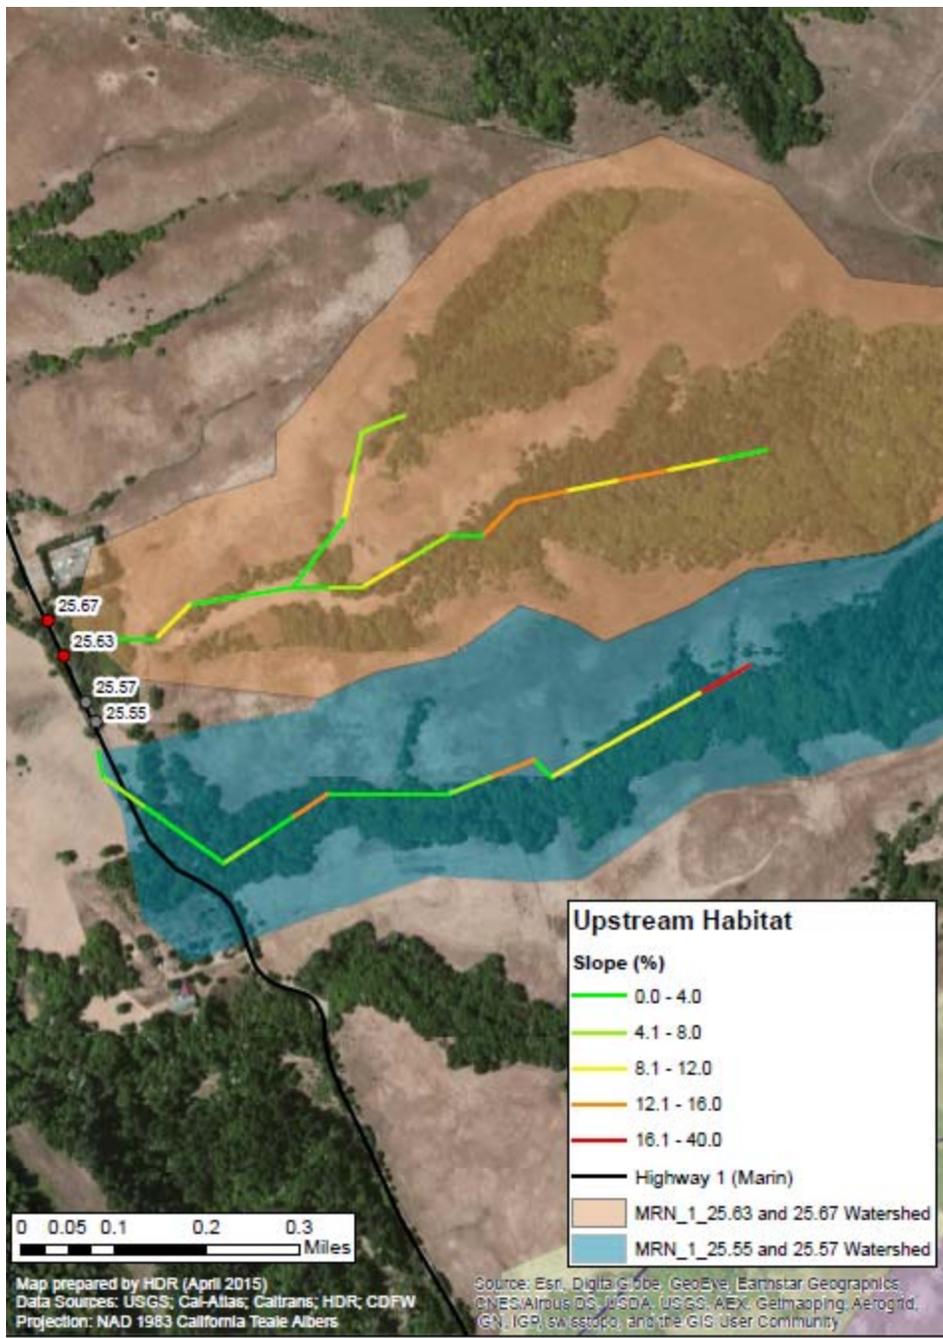
Figure 16. Stream gradient upstream of MRN 1 25.63 and 25.67, and MRN 1 25.55 and 25.57.

Both crossings were identified as “red” by the CDFW Passage Evaluation Filter. The upstream watershed for these two sites was estimated to include approximately 1.1 miles of habitat upstream of the crossings (Figure 16). In reaches where excessive gradient was identified but the stream representation was not consistent with the actual stream path based on aerial imagery, the excessive gradient at that segment was ignored. Although not shown on the stream representation for the watershed upstream of these sites, additional habitat length was included based on additional stream channel and riparian corridor shown in the aerial imagery but not represented by the stream network representation based on the DEM, in order to minimize the potential for underestimating possible upstream habitat.

Both sites were identified as “gray” according to the CDFW Passage Evaluation Filter. Due to discrepancies between the stream network representation based on the DEM in this watershed and the stream channel and riparian corridor shown in the aerial imagery, the potential upstream habitat was not limited to the stream network displayed for this watershed (Figure 16). In addition, two stream segments shown as exceeding the 12% gradient threshold were ignored due to the segments not accurately representing the actual direction of streamflow. In order to avoid underestimating potential upstream habitat, estimated potential habitat included these segments, and was stopped when stream gradient exceeded 16% (symbolized as red), as shown in the figure. Estimated potential habitat upstream of these crossings was estimated to be approximately 0.8 miles.

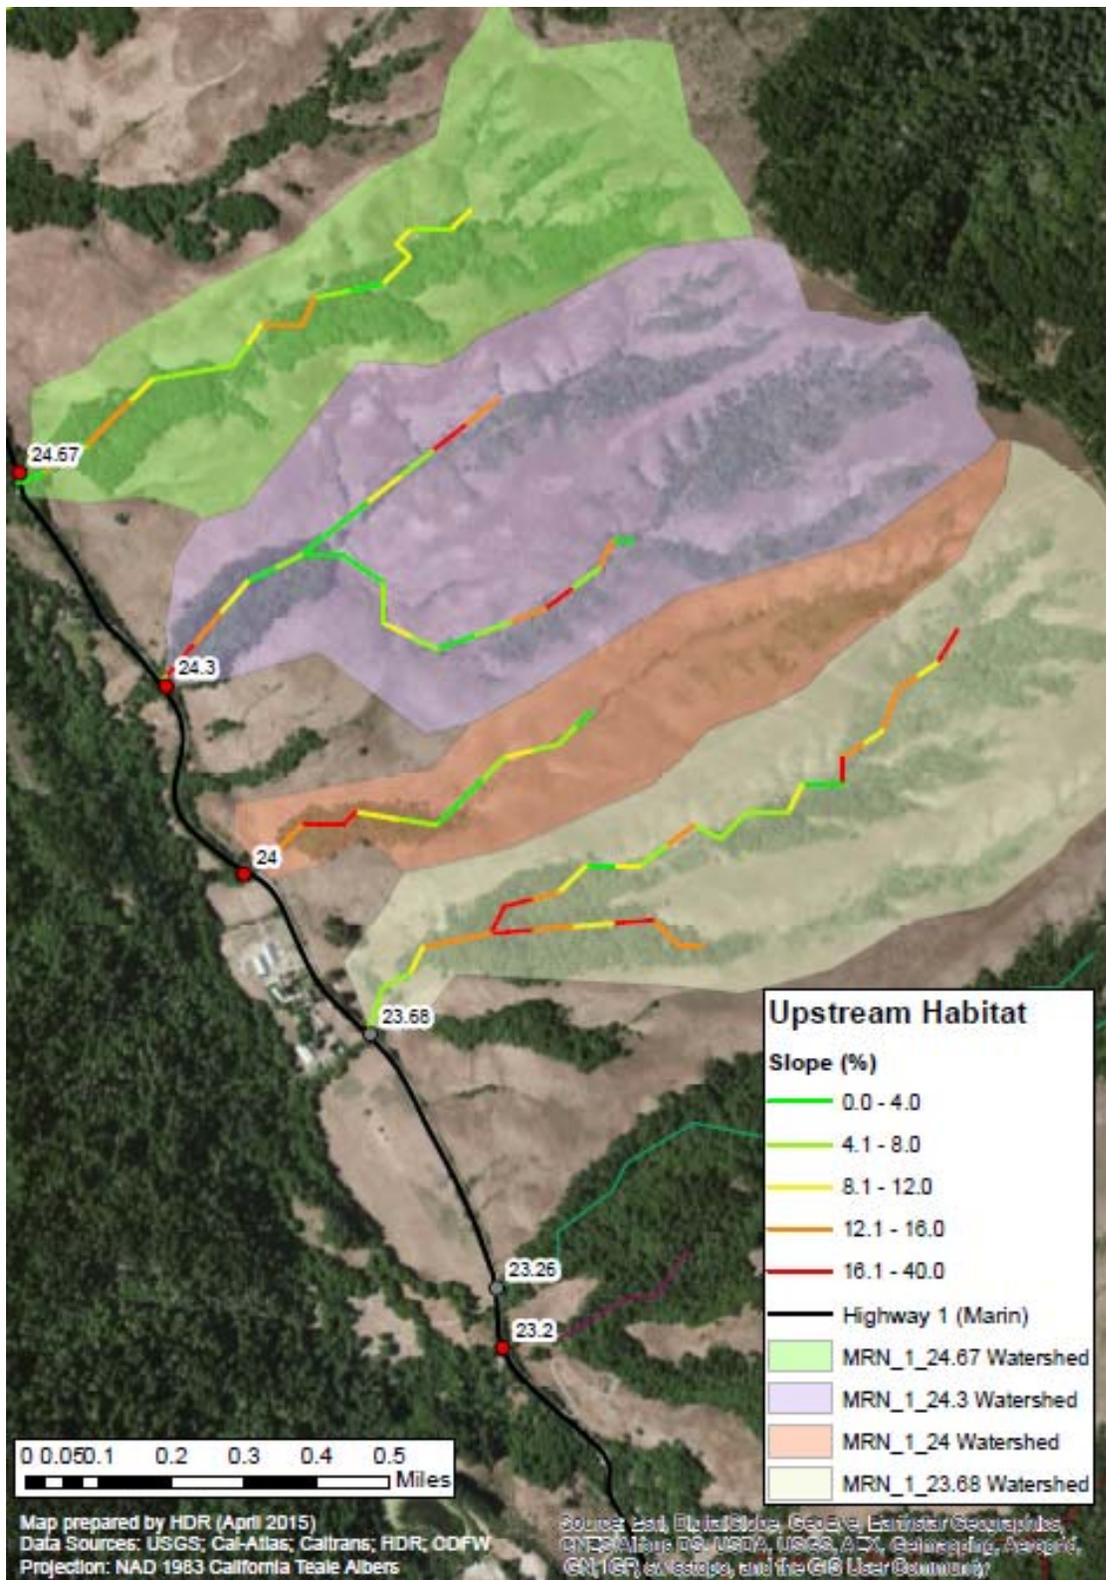
Figure 17. Stream gradient upstream of MRN 1 24.67, 24.3, 24.0 and 23.68.

This crossing was identified as “red” by the CDFW Passage Evaluation Filter. Estimated potential habitat upstream of the crossing was estimated to be fairly limited (approximately 0.3 miles) before the stream gradient increased above 12% over more than 100m in stream length (Figure 17). Although not shown in the stream representation, the stream is divided into two segments before it enters the crossing upstream, which was accounted for in the estimation of potential length of upstream habitat. In addition, the initial stream pathway based on the stream representation just upstream of the crossing indicated excessive

This crossing was identified as “red” by the CDFW Passage Evaluation Filter. Estimated potential habitat upstream of the crossing was estimated to be fairly limited (approximately 0.1 miles) before the stream gradient increased above 12% over more than 100 m in stream length (Figure 17). Marin County (2003) also reported that potential upstream habitat was limited (800 feet).

This crossing was identified as “red” by the CDFW Passage Evaluation Filter. Estimated potential habitat upstream of the crossing was estimated to be fairly limited (approximately 0.1 miles) before the stream gradient increased above 12% over more than 100 m in stream length (Figure 17).

This crossing was identified as “gray” by the CDFW Passage Evaluation Filter. Estimated potential habitat upstream of the crossing was estimated to be fairly limited (approximately 0.3 miles) before the stream gradient increased above 12% over more than 100 m in stream length (Figure 17).

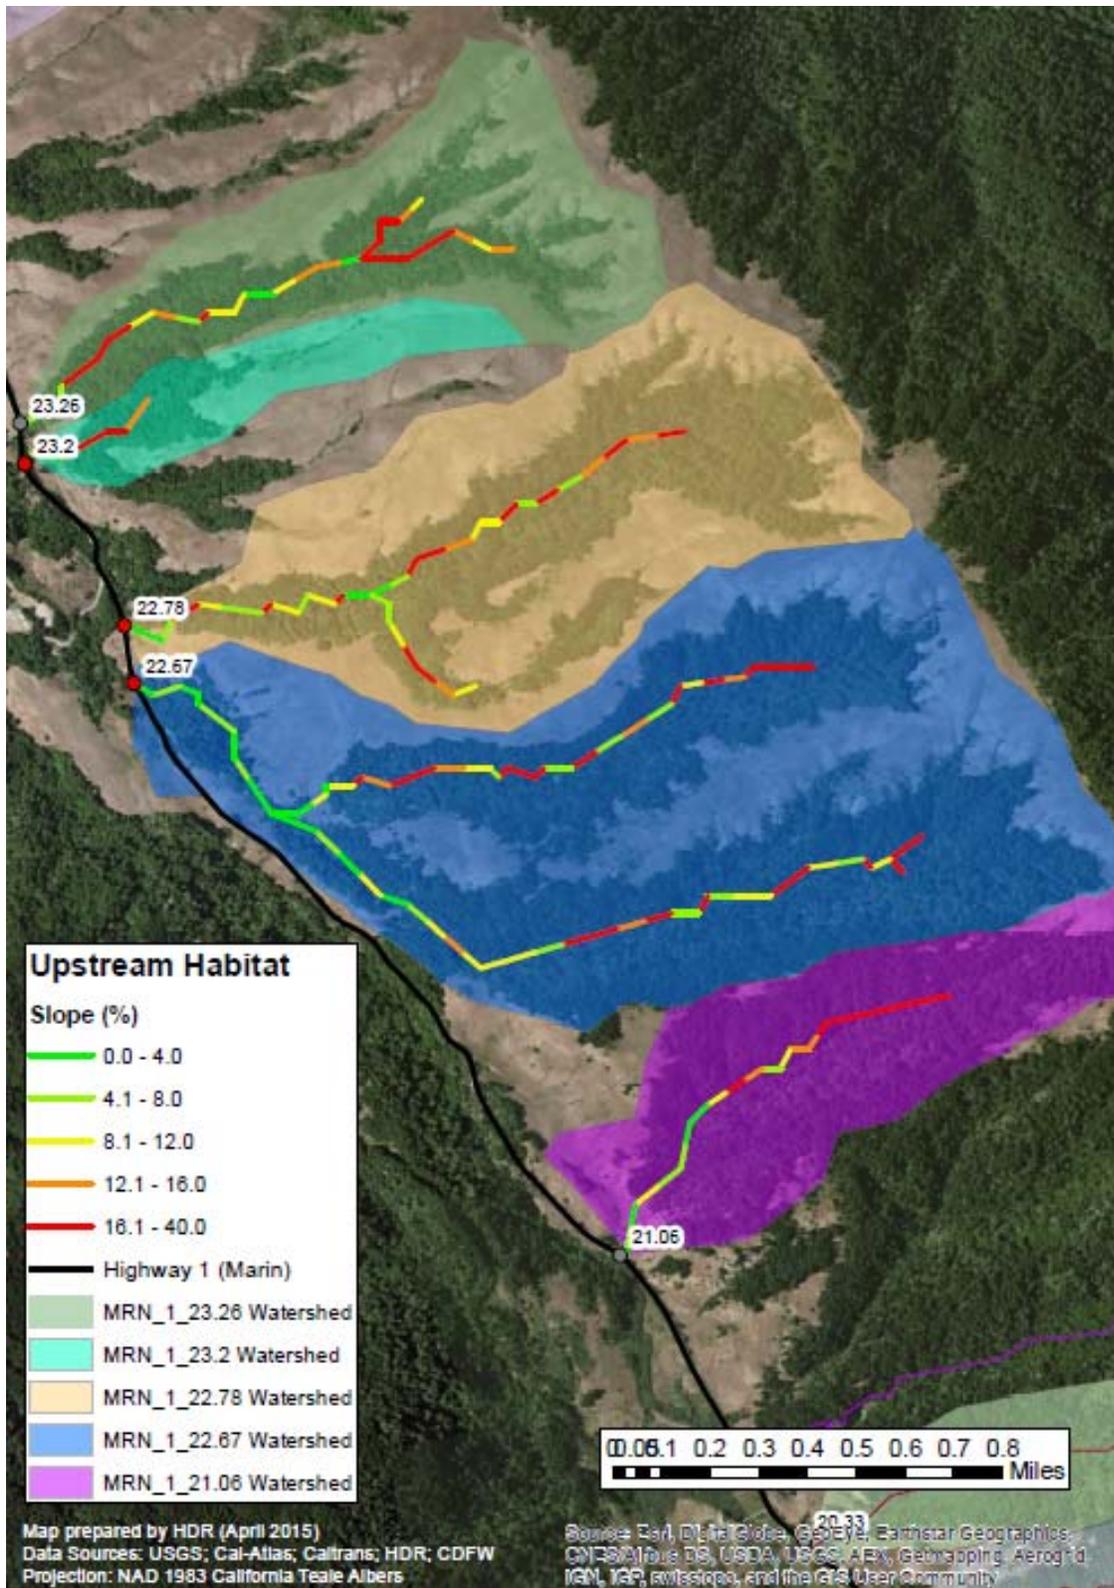
Figure 18. Stream gradient upstream of MRN 1 23.26, 23.2, 22.78, 22.67 and 21.06.

This crossing was identified as “gray” by the CDFW Passage Evaluation Filter. Estimated potential habitat upstream of the crossing was fairly limited (approximately 0.2 miles) before the stream gradient increased above 12% over more than 100 m in stream length (**Figure 18**). This is similar to the reported 1,300 feet of available habitat estimated by Marin County (2003).

This crossing was identified as “red” by the CDFW Passage Evaluation Filter. Estimated potential habitat upstream of the crossing was limited (approximately 0.1 miles) before the stream gradient increased above 12% over more than 100m in stream length (Figure 18).

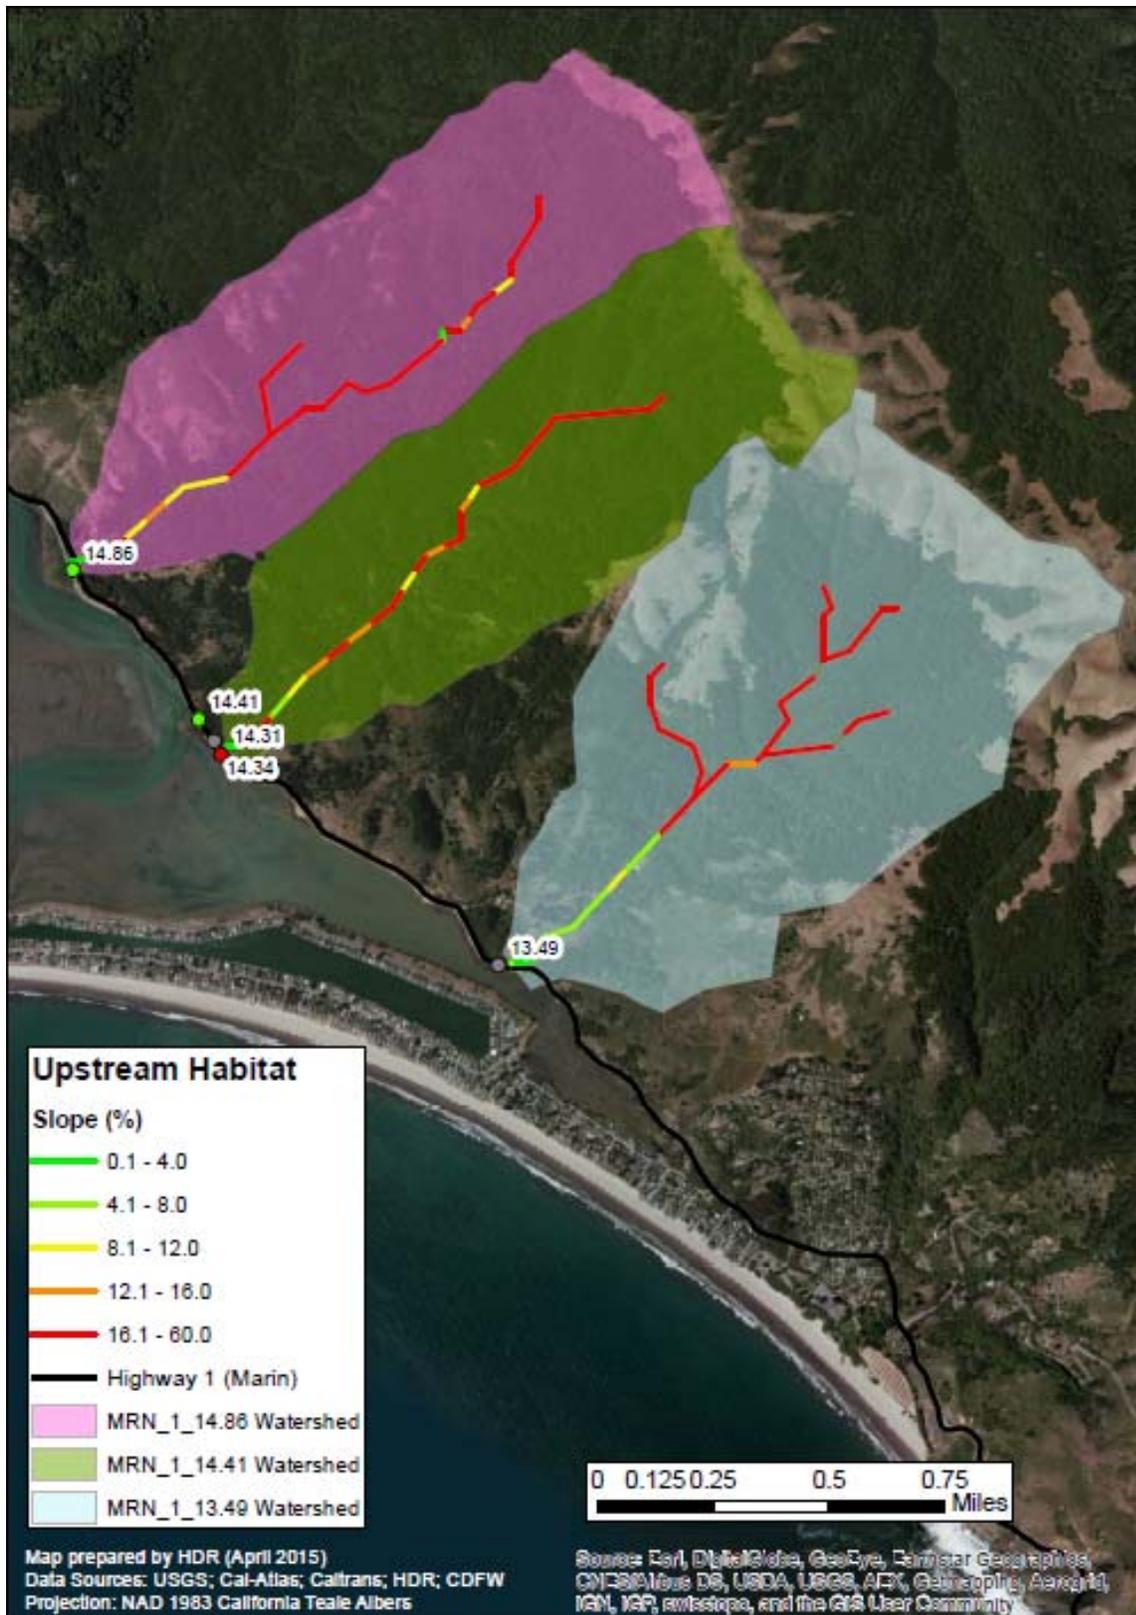
Figure 21. Stream gradient upstream of MRN 1 14.86, 14.41/14.34/14.31 and 13.49.

This crossing was identified as “green” by the CDFW Passage Evaluation Filter, however, this classification was discarded because the culvert was nearly full with sediment. It is recommended that this site be re-surveyed after the excess sediment is removed from the site. The estimated potential habitat upstream of the crossing was approximately 0.4 miles before the stream gradient increased above 12% over more than 100 m in stream length (Figure 21). Due to discrepancies between the stream channel and the stream network representation, initial high gradient segments just upstream of the crossing were ignored. Fong (2002) estimated the length of potential habitat in Wilkins Gulch as approximately 1 km (.6 miles), with the upstream extent an 8 m tall waterfall.

This site was identified as “gray” by the CDFW Passage Evaluation Filter. The estimated potential habitat upstream of the crossing was approximately 0.6 miles before the stream gradient increased above 12% over more than 100 m in stream length (Figure 21, above). Due to discrepancies between the existing stream channel and the stream network representation, initial high gradient segments just upstream of the crossing were ignored. Fong (2002) estimated the length of potential habitat in Stinson Gulch as greater than 1 km (.6 miles), with an unknown upstream extent.

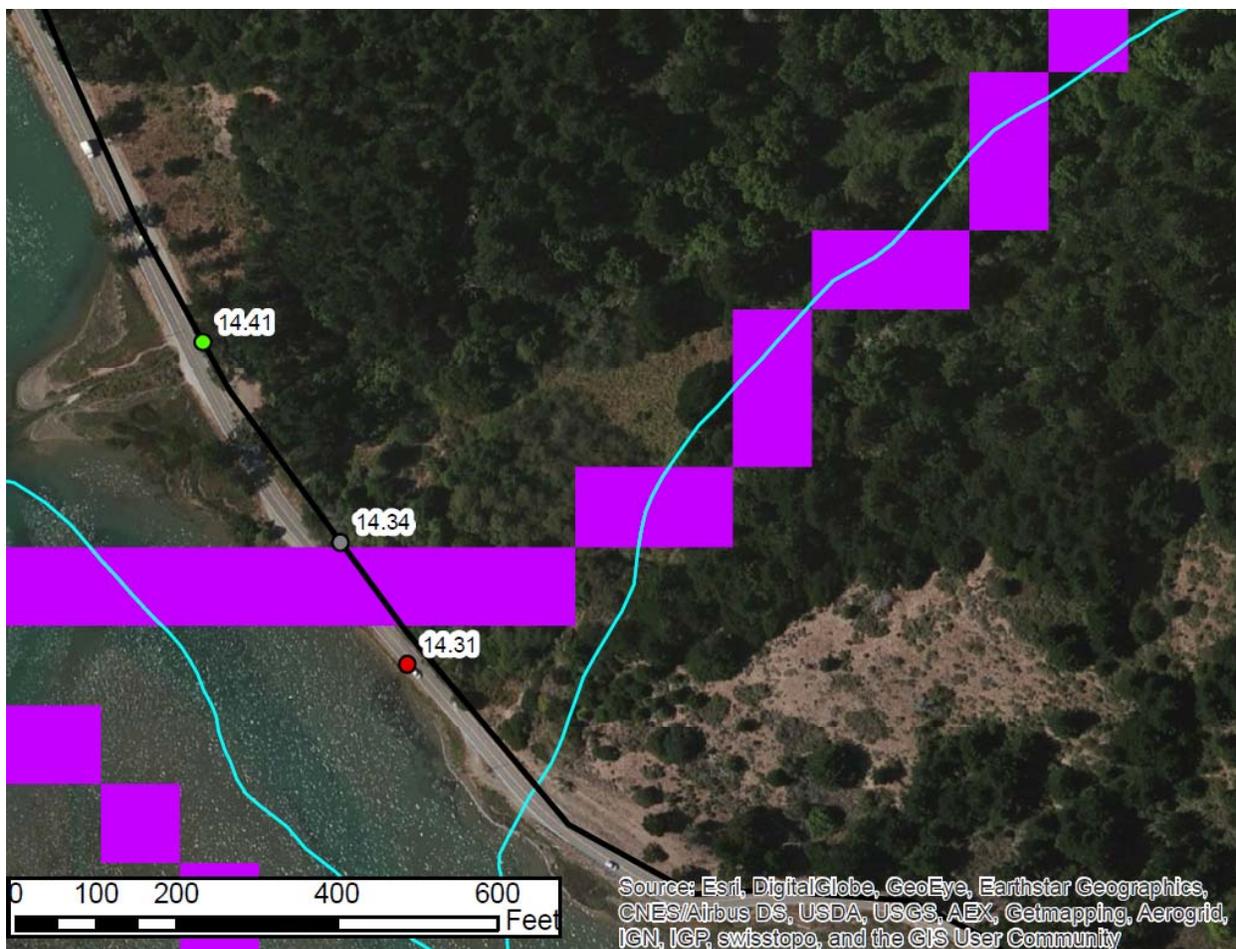
Figure 22. Crossings draining the McKinnon Gulch Watershed (purple highlighting indicates the natural pathway of the stream relative to the existing stream channel discharging at PM 14.41).

As previously described, the historical and current channel of McKinnon Gulch has been altered, resulting in the current channel passing through postmile 14.41, but with the historical outlet occurring in the vicinity of postmiles 14.31 and 14.34. This is corroborated by hydrologic GIS analysis, which suggests water would have flowed to the south of postmile 14.41 (**Figure 22**). Fong (2002) reported that the sites south of postmile 14.41 were not connected to the current main channel, and that the water passing through these sites was from an emergent wetland. Fong (2002) also reported that although the crossing at postmile 14.41 represents the outlet of the existing discharge location of McKinnon Gulch, it is now generally dry upstream of the crossing during most of the year.

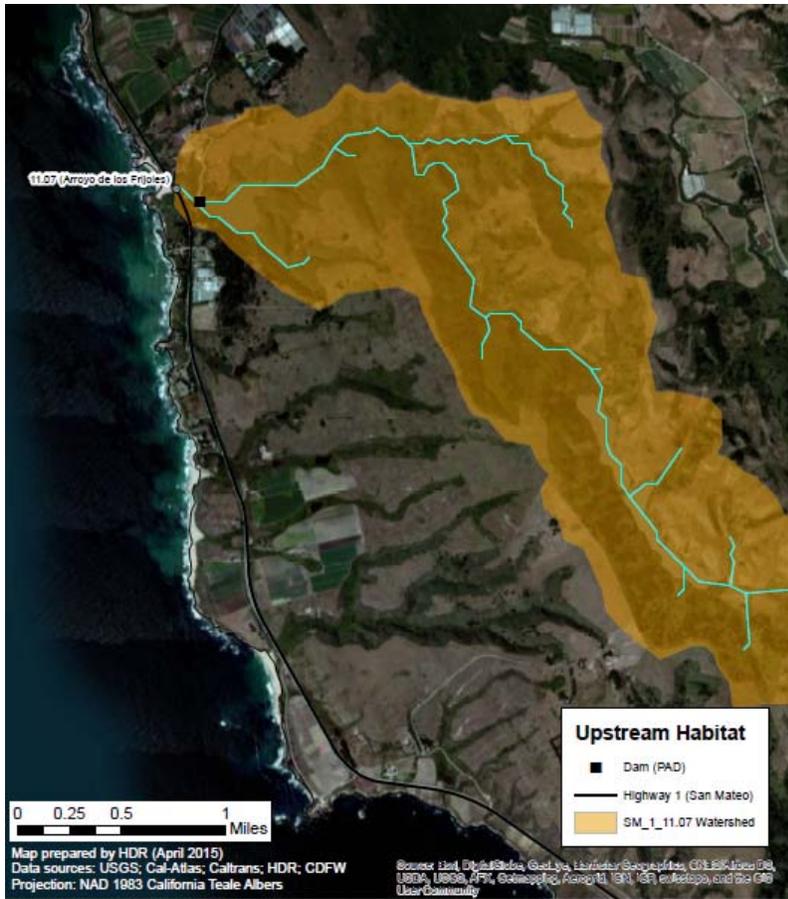
Figure 27. Watershed upstream of SM 1 11.07 (Arroyo de los Frijoles).

An impassable dam forming Lake Lucerne is located on Arroyo de los Frijoles about 0.2 miles upstream from the mouth (CEMAR 2008; **Figures 27 and 28**). Therefore, a stream gradient analysis was not performed on the watershed upstream of this crossing. Because no spawning habitat is available to anadromous fish on this creek, it is unclear if any substantive benefits to anadromous fish would be realized if this crossing was remediated to allow unimpeded fish passage (if needed). However, because no upstream spawning habitat is accessible, there are unlikely to be steelhead rearing in the lagoon upstream of the highway 1 crossing. Although it may be conceivable that non-natal juvenile steelhead may enter the lagoon from a nearby lagoon during the spring, no thermal refugia would be accessible to juvenile steelhead upstream of the lagoon as water temperatures warm during the summer. Therefore, it is not expected that the lagoon upstream of the highway 1 crossing currently represents suitable steelhead habitat.

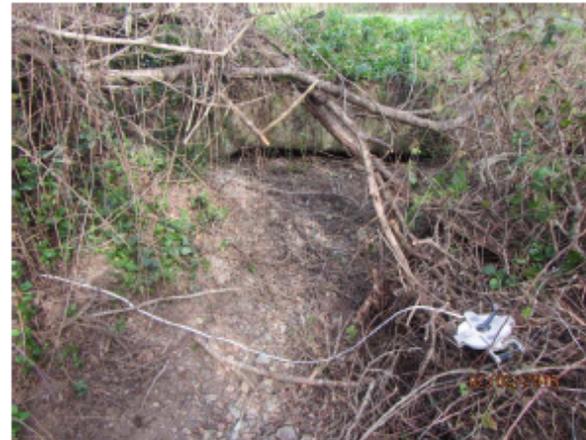
Postmile: 14.86

MRN 1 14.86 – Although this site ranked as “green”, unimpeded fish passage is not provided due to the concrete box culvert being nearly full with sediment (**Figure 10**). Sediment excavation is recommended prior to re-surveying the site and making a fish passage determination.

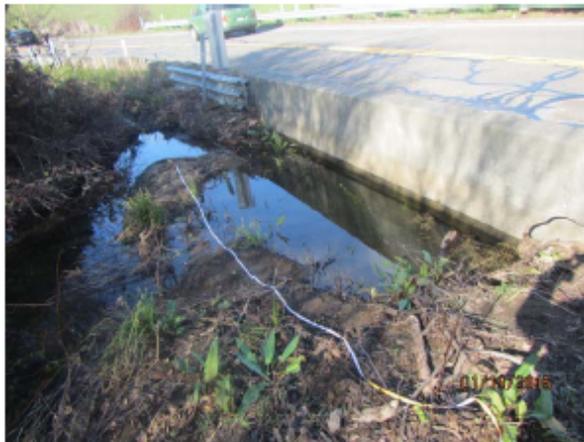
Postmile: 27.92

MRN 1 27.92 – Although this site ranked as “green”, unimpeded fish passage is not provided due to the concrete box culvert outlet being nearly full with sediment (**Figure 11**). Sediment excavation is recommended prior to re-surveying the site. In addition, the channel enters the culvert at a 90 degree angle.

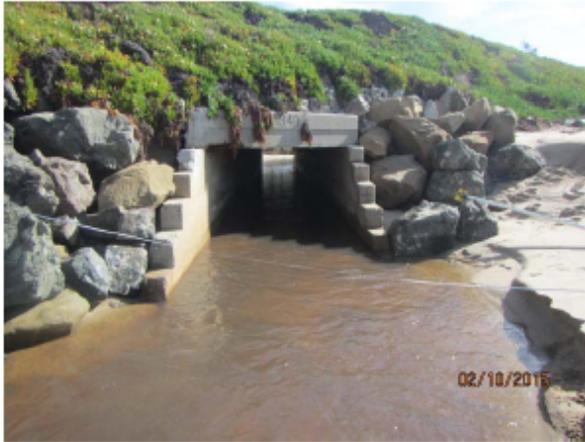
Postmile: 11.07

This site was identified as “gray” by the CDFW Passage Evaluation Filter. However, as previously discussed, this determination was due to insufficient inlet width and insufficient residual outlet depth. As shown in **Figure 26**, due to the highly variable sediment dynamics at the crossing, the residual outlet depth is highly variable depending on freshwater outflow and potentially tidal conditions. Therefore, it is recommended that this site be surveyed during the upstream migration season and when hydrologic conditions allow for adult salmonid access to the site, and take additional measurements not required by the Caltrans survey protocols (e.g. water depth through the crossing at different outflows and tidal conditions), prior to conducting hydraulic modeling for the site and making a fish passage determination.
