CALIFORNIA DEPARTMENT OF FISH AND WILDLIFE

STREAM INVENTORY REPORT

Blanton Creek

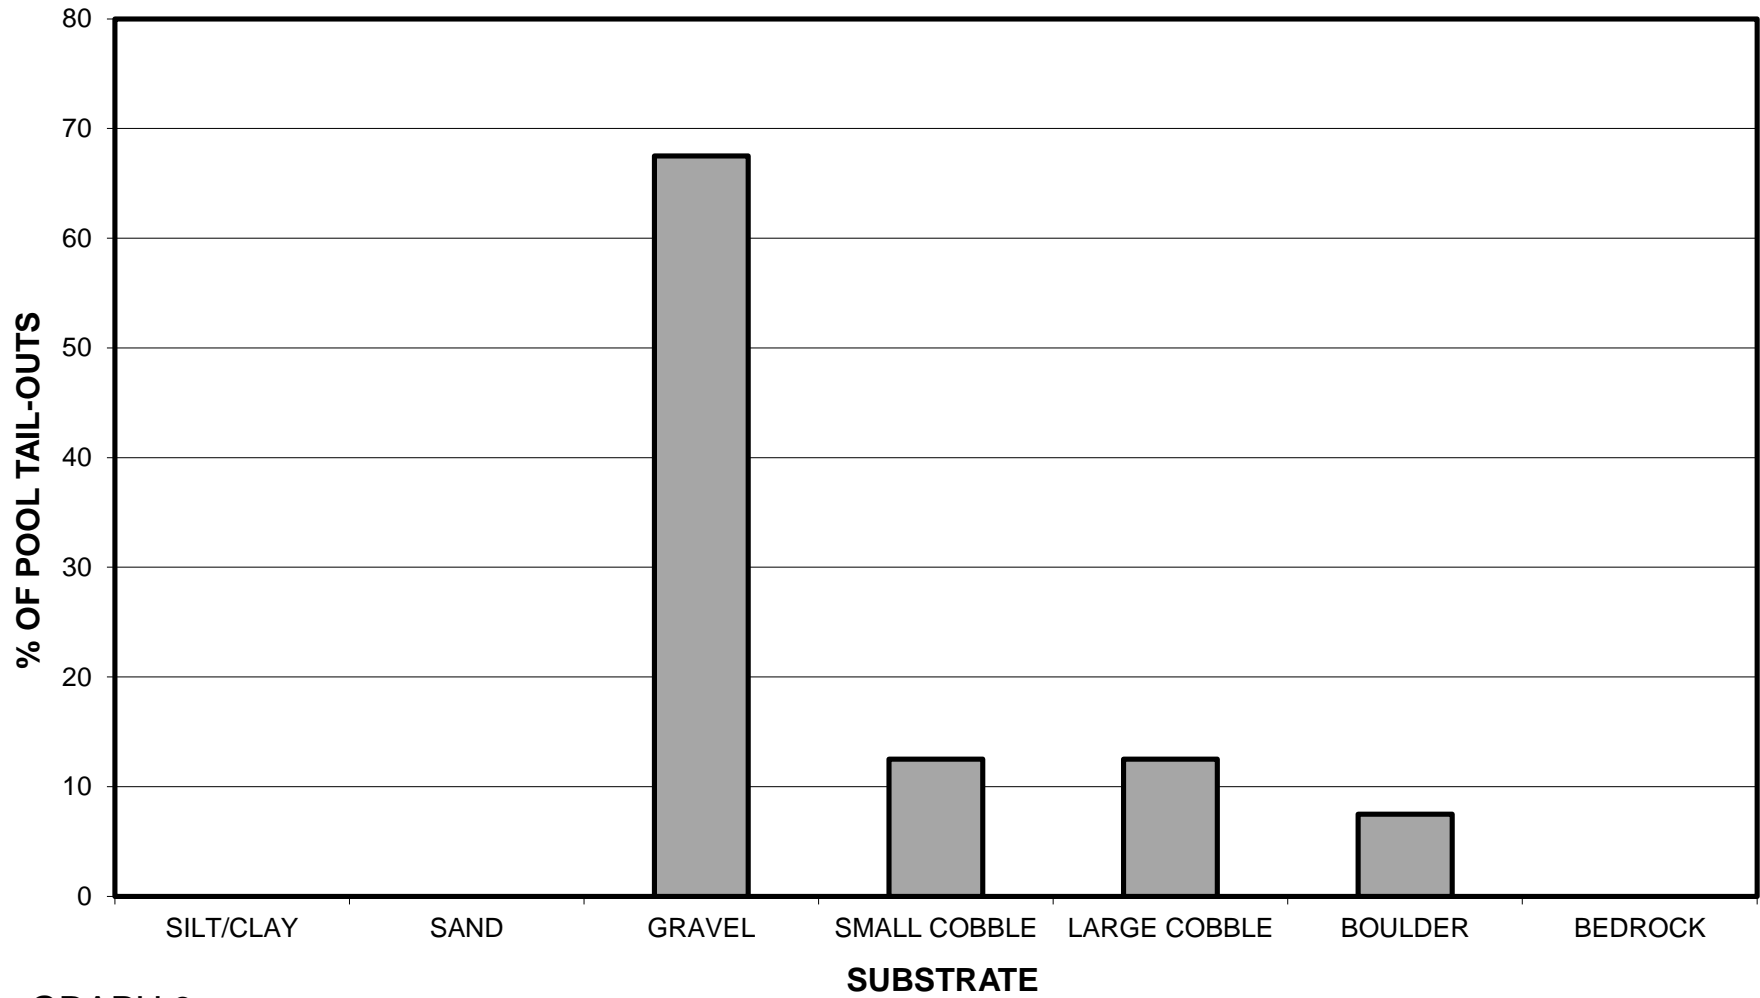
GRAPH 8

Table 6 summarizes the dominant substrate by habitat type. Graph 8 depicts the dominant substrate observed in pool tail-outs. Gravel was the dominant substrate observed in 68% of the pool tail-outs. Small cobble was the next most frequently observed dominant substrate type and occurred in 12% of the pool tail-outs.
