# 2014–2015 Detailed Fish Passage Assessment Evaluations

District 4 – Marin and San Mateo Counties | Highway 1

April 2015

California Department of Transportation  
Division of Environmental Analysis  
Office of Biology and Technical Assistance  
Sacramento, CA USA

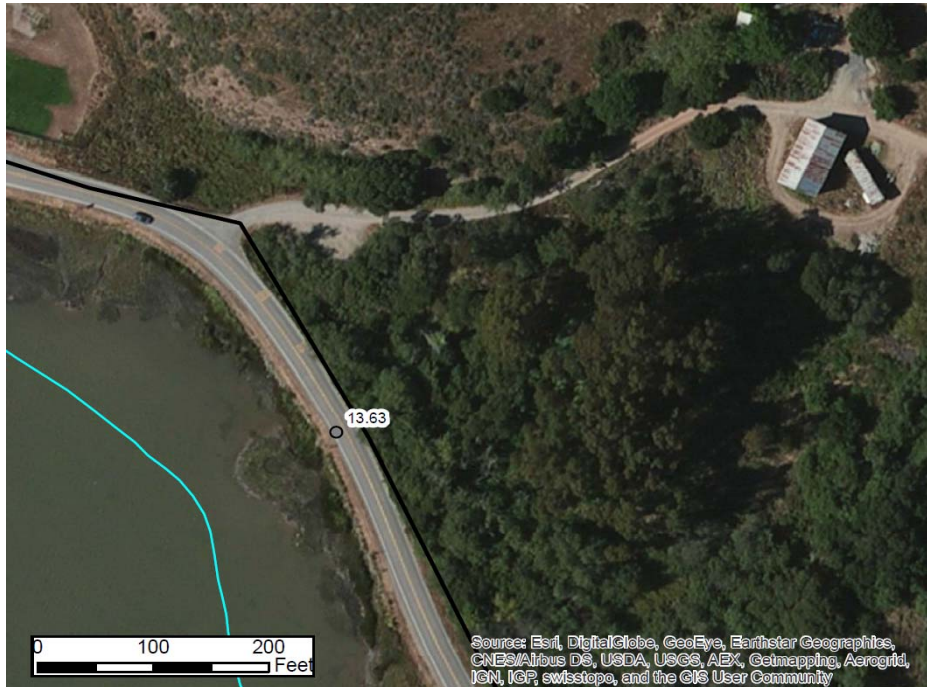
**Figure 5. Aerial view of MRN 1 13.63 and its upstream drainage.**

Aerial imagery and hydrologic analyses conducted in GIS indicate a lack of a substantive stream channel upstream of the crossing (**Figure 5**). U.S. Geological Survey (USGS) National Hydrography Dataset (NHD) data and the USGS StreamStats web application also does not indicate a stream at this location. The area of the watershed upstream of the crossing was calculated in ArcGIS to be less than 0.1 square miles, preventing a reasonable estimation of fish passage flows required to run FishXing. Examination of site photos in conjunction with aerial imagery indicate that this drainage is unlikely to be capable of supporting anadromous salmonid spawning or rearing. Due to the lack of a definable stream upstream of the crossing, the very small size of the watershed upstream of the crossing, and the lack of suitable anadromous fish habitat in the vicinity of the crossing, this site was not further evaluated for anadromous fish passage.

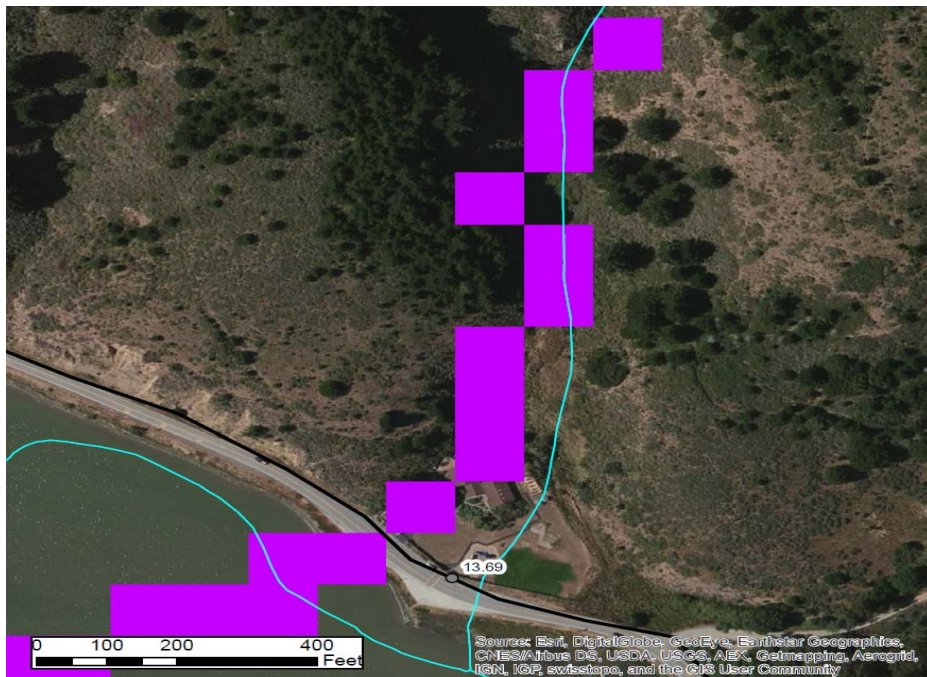
**Figure 6. Aerial view of MRN 1 13.69 and its upstream drainage.**

Hydrologic GIS analyses indicate that this drainage may have historically crossed through the location of an existing school property, and may have been moved just to the south of the property (**Figure 6** – purple highlighting indicates the natural stream pathway based on elevation). Site photos indicate grass growing in the vicinity of the inlet and the outlet, and downstream of the outlet, with a lack of a definable channel

downstream of the outlet. It is also difficult to determine whether there is a definable channel upstream of the crossing. The NPS (Fong 2002) conducted a fisheries assessment of tributaries to east Bolinas Bay on NPS-managed land, but did not identify this drainage as a steelhead-bearing stream. Based on aerial imagery and site photos, the crossing appears to drain a swale and not an anadromous fish-bearing stream. Therefore, this crossing was not further evaluated for fish passage.

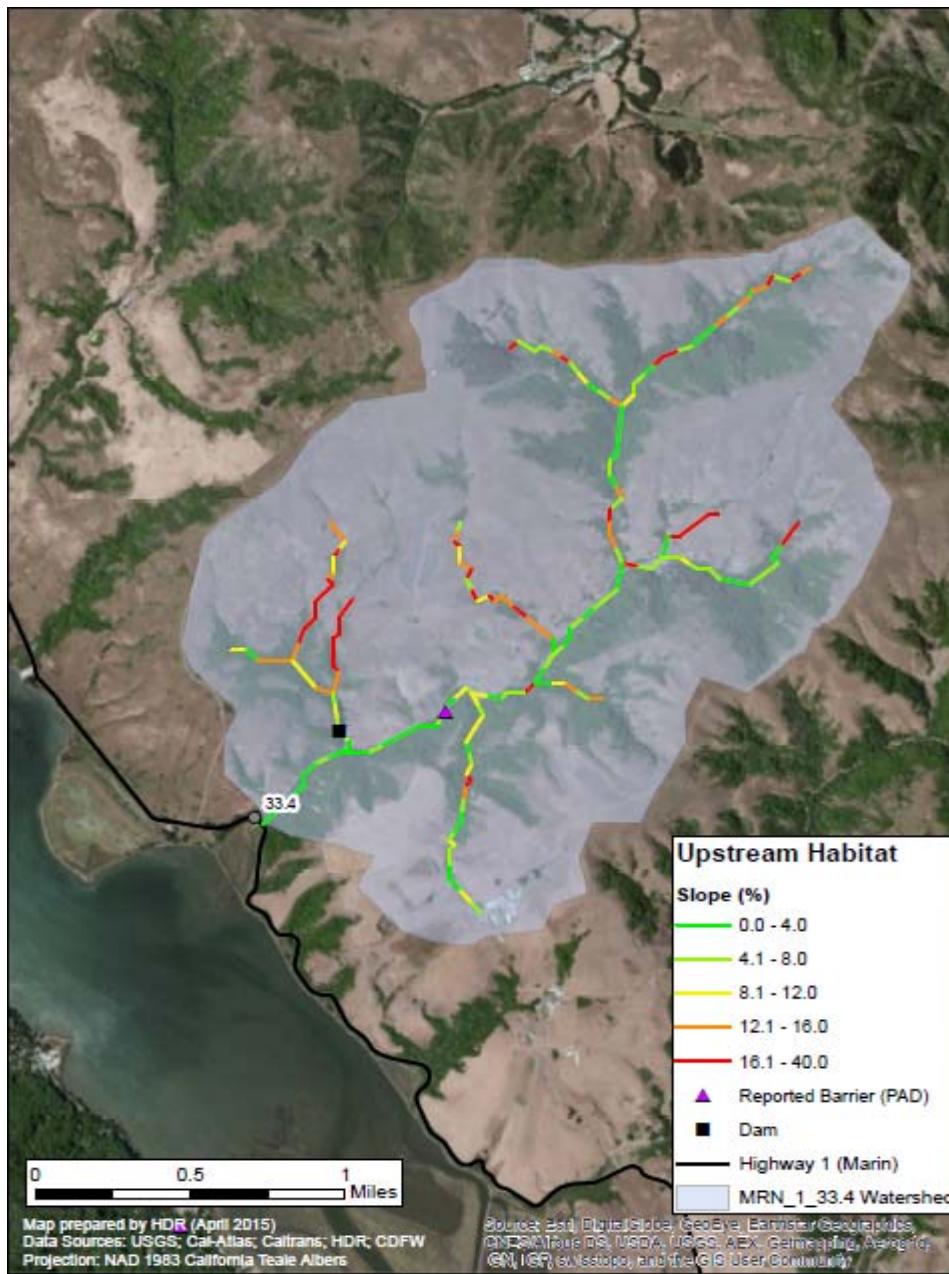
Figure 14. Stream gradient and fish passage barriers upstream of MRN 1 33.4 (Millerton Gulch).

Potential upstream habitat available in Millerton Gulch and its tributaries was estimated to be approximately 1.4 miles, based on the 12% gradient criterion (**Figure 14**). Potential upstream habitat was reduced in part due to a dam and reservoir present near the mouth of one of the stream's tributaries. According to the PAD, a waterfall acts as a barrier on the mainstem of Millerton Gulch. It could not be determined if this barrier is still present based on aerial imagery, and therefore, was not assumed to limit upstream habitat availability.

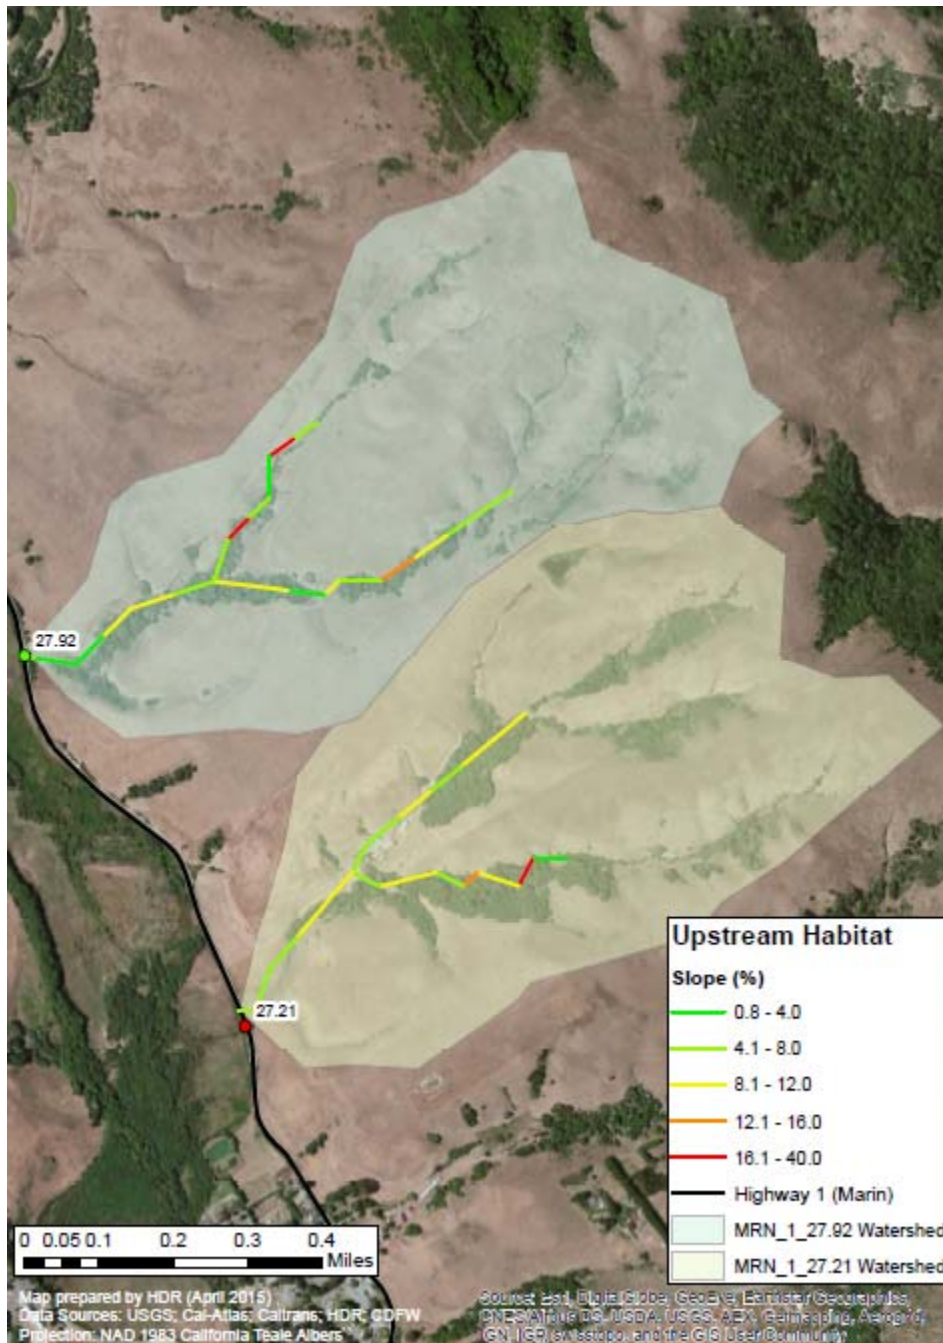
Figure 15. Stream gradient upstream of MRN 1 27.92 and 27.21.

As previously described, this site was initially identified as “green” according to the CDFW Passage Evaluation Filter, but this determination was ignored due to the culvert being nearly filled with sediment at the downstream end. It is recommended that this site be re-surveyed after the excess sediment is removed from the site. Potential upstream habitat available was estimated at approximately 0.6 miles based on stream gradient (Figure 15).

As previously described, this site was identified as “red” according to the CDFW Passage Evaluation Filter. In addition to stream gradient, estimated upstream habitat also was restricted due to habitat fragmentation associated with a residential property at the mouth of a tributary to this creek. Potential upstream habitat available was estimated at approximately 0.5 miles (Figure 15).

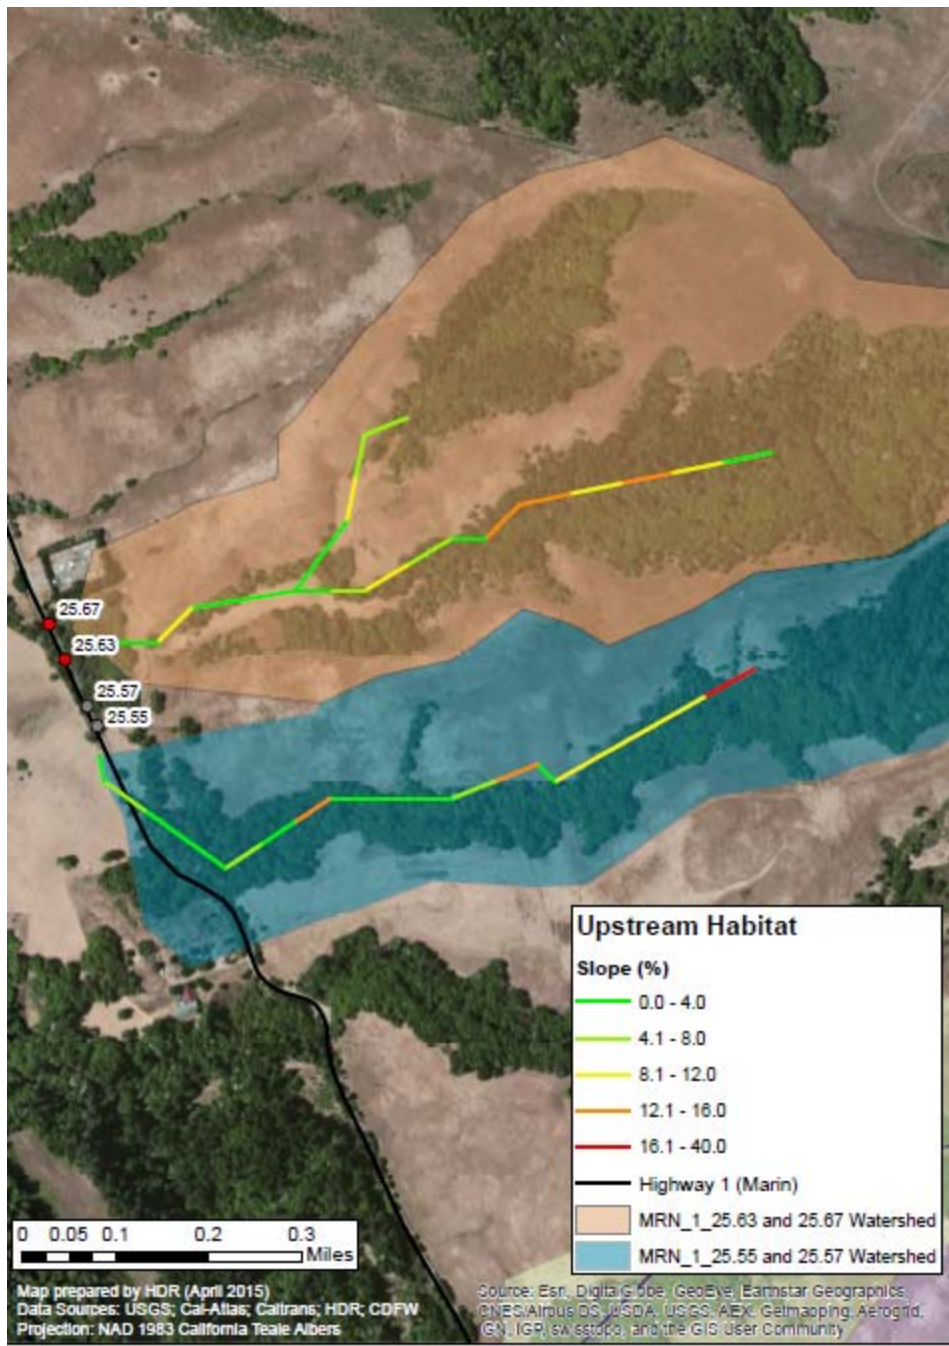
Figure 16. Stream gradient upstream of MRN 1 25.63 and 25.67, and MRN 1 25.55 and 25.57.

Both crossings were identified as “red” by the CDFW Passage Evaluation Filter. The upstream watershed for these two sites was estimated to include approximately 1.1 miles of habitat upstream of the crossings (Figure 16). In reaches where excessive gradient was identified but the stream representation was not consistent with the actual stream path based on aerial imagery, the excessive gradient at that segment was ignored. Although not shown on the stream representation for the watershed upstream of these sites, additional habitat length was included based on additional stream channel and riparian corridor shown in the aerial imagery but not represented by the stream network representation based on the DEM, in order to minimize the potential for underestimating possible upstream habitat.

Both sites were identified as “gray” according to the CDFW Passage Evaluation Filter. Due to discrepancies between the stream network representation based on the DEM in this watershed and the stream channel and riparian corridor shown in the aerial imagery, the potential upstream habitat was not limited to the stream network displayed for this watershed (Figure 16). In addition, two stream segments shown as exceeding the 12% gradient threshold were ignored due to the segments not accurately representing the actual direction of streamflow. In order to avoid underestimating potential upstream habitat, estimated potential habitat included these segments, and was stopped when stream gradient exceeded 16% (symbolized as red), as shown in the figure. Estimated potential habitat upstream of these crossings was estimated to be approximately 0.8 miles.

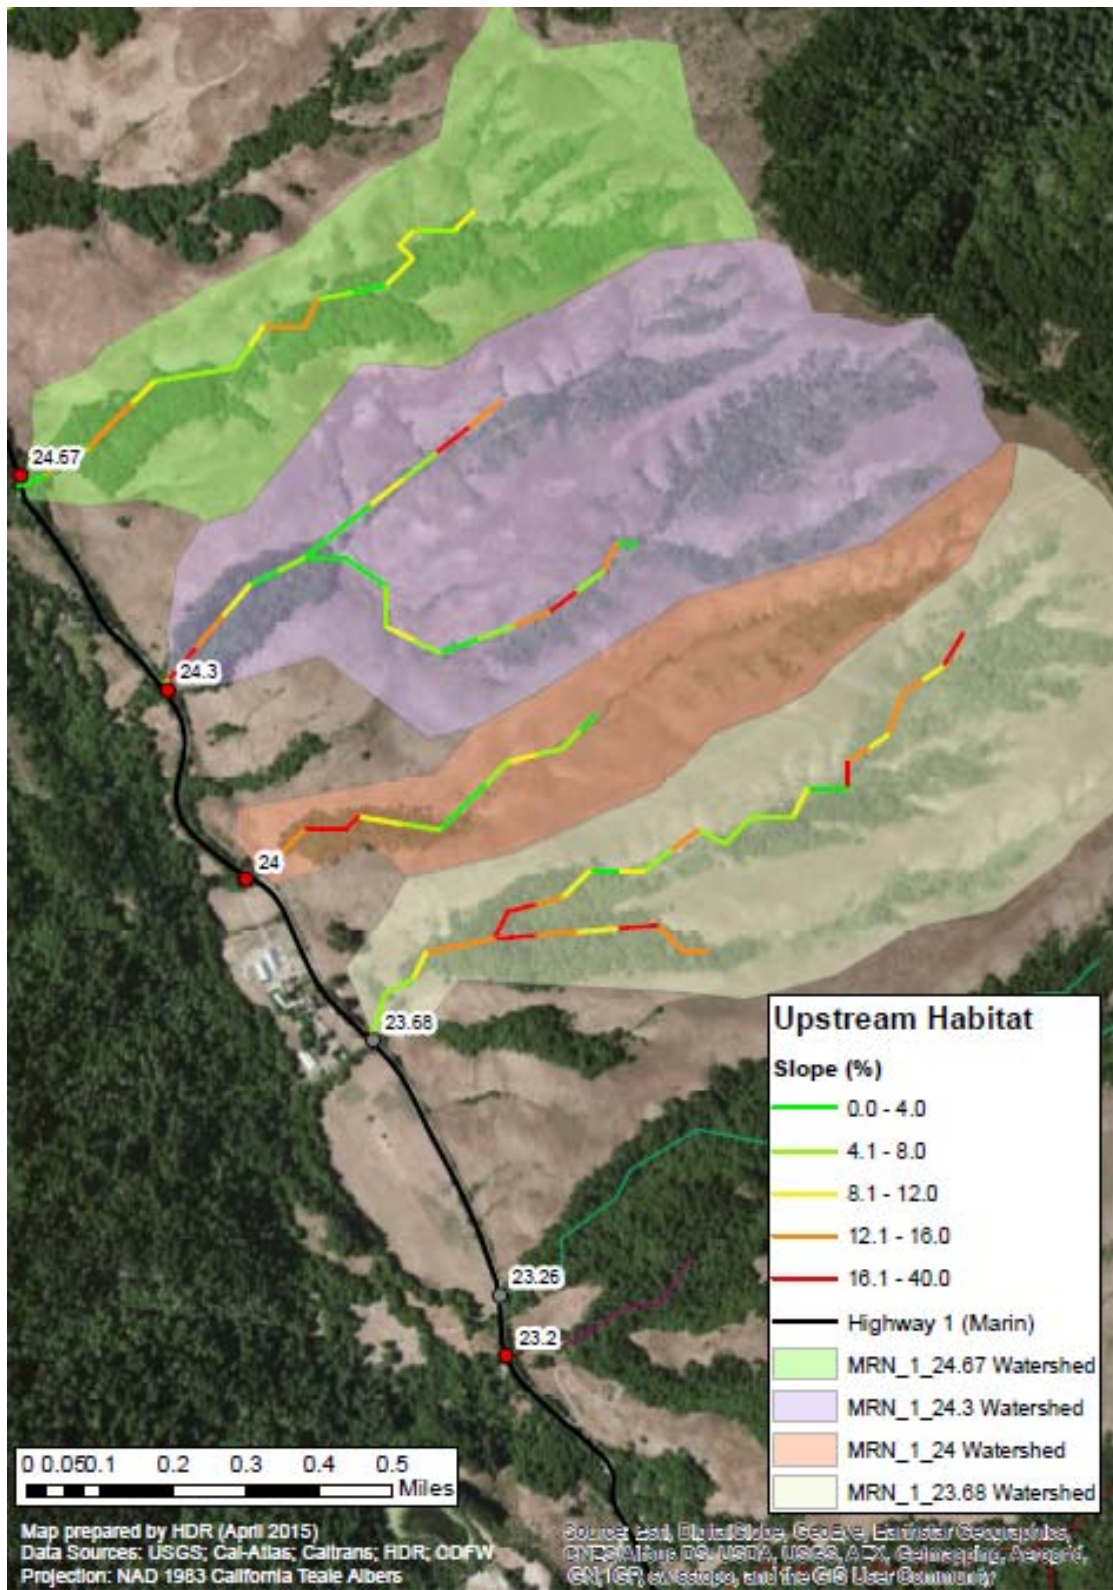
Figure 17. Stream gradient upstream of MRN 1 24.67, 24.3, 24.0 and 23.68.

This crossing was identified as “red” by the CDFW Passage Evaluation Filter. Estimated potential habitat upstream of the crossing was estimated to be fairly limited (approximately 0.3 miles) before the stream gradient increased above 12% over more than 100m in stream length (Figure 17). Although not shown in the stream representation, the stream is divided into two segments before it enters the crossing upstream, which was accounted for in the estimation of potential length of upstream habitat. In addition, the initial stream pathway based on the stream representation just upstream of the crossing indicated excessive

This crossing was identified as “red” by the CDFW Passage Evaluation Filter. Estimated potential habitat upstream of the crossing was estimated to be fairly limited (approximately 0.1 miles) before the stream gradient increased above 12% over more than 100 m in stream length (Figure 17). Marin County (2003) also reported that potential upstream habitat was limited (800 feet).

This crossing was identified as “red” by the CDFW Passage Evaluation Filter. Estimated potential habitat upstream of the crossing was estimated to be fairly limited (approximately 0.1 miles) before the stream gradient increased above 12% over more than 100 m in stream length (Figure 17).

This crossing was identified as “gray” by the CDFW Passage Evaluation Filter. Estimated potential habitat upstream of the crossing was estimated to be fairly limited (approximately 0.3 miles) before the stream gradient increased above 12% over more than 100 m in stream length (Figure 17).

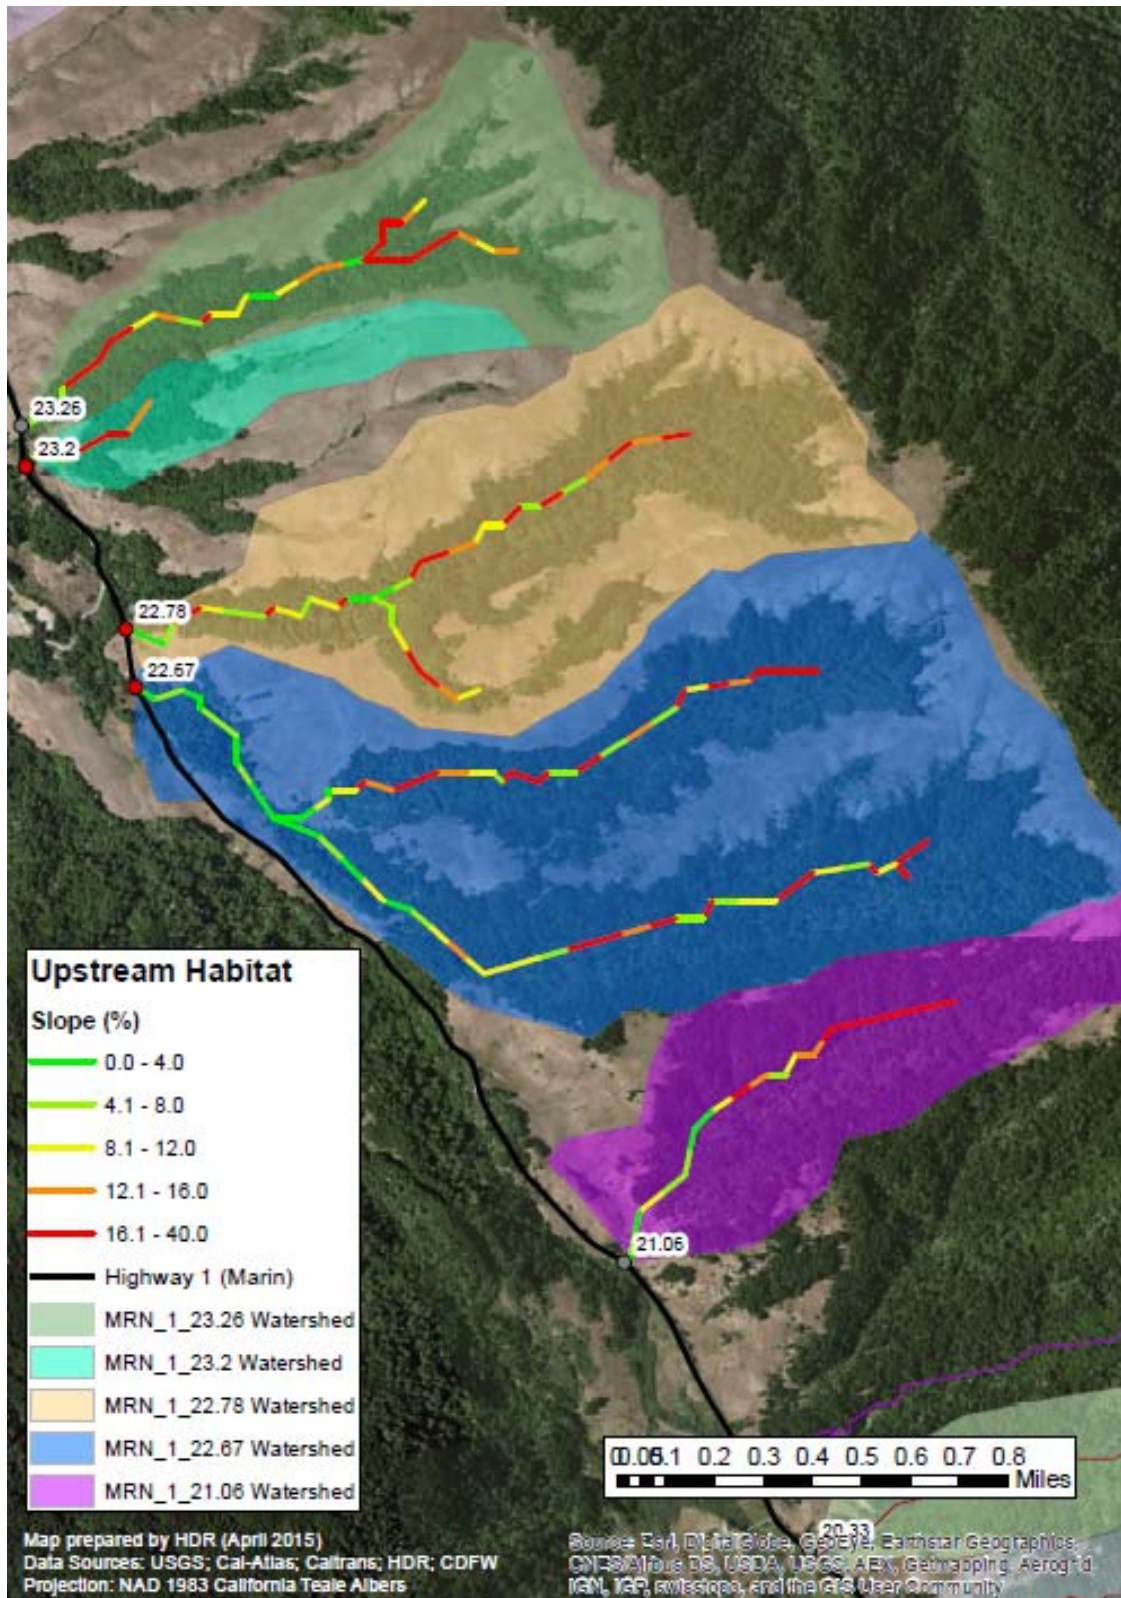
Figure 18. Stream gradient upstream of MRN 1 23.26, 23.2, 22.78, 22.67 and 21.06.

This crossing was identified as “gray” by the CDFW Passage Evaluation Filter. Estimated potential habitat upstream of the crossing was fairly limited (approximately 0.2 miles) before the stream gradient increased above 12% over more than 100 m in stream length (**Figure 18**). This is similar to the reported 1,300 feet of available habitat estimated by Marin County (2003).

This crossing was identified as “red” by the CDFW Passage Evaluation Filter. Estimated potential habitat upstream of the crossing was limited (approximately 0.1 miles) before the stream gradient increased above 12% over more than 100m in stream length (Figure 18).

This crossing was identified as “gray” by the CDFW Passage Evaluation Filter. Estimated potential habitat upstream of the crossing was approximately 0.5 miles before the stream gradient increased above 12% over more than 100m in stream length (Figure 18).

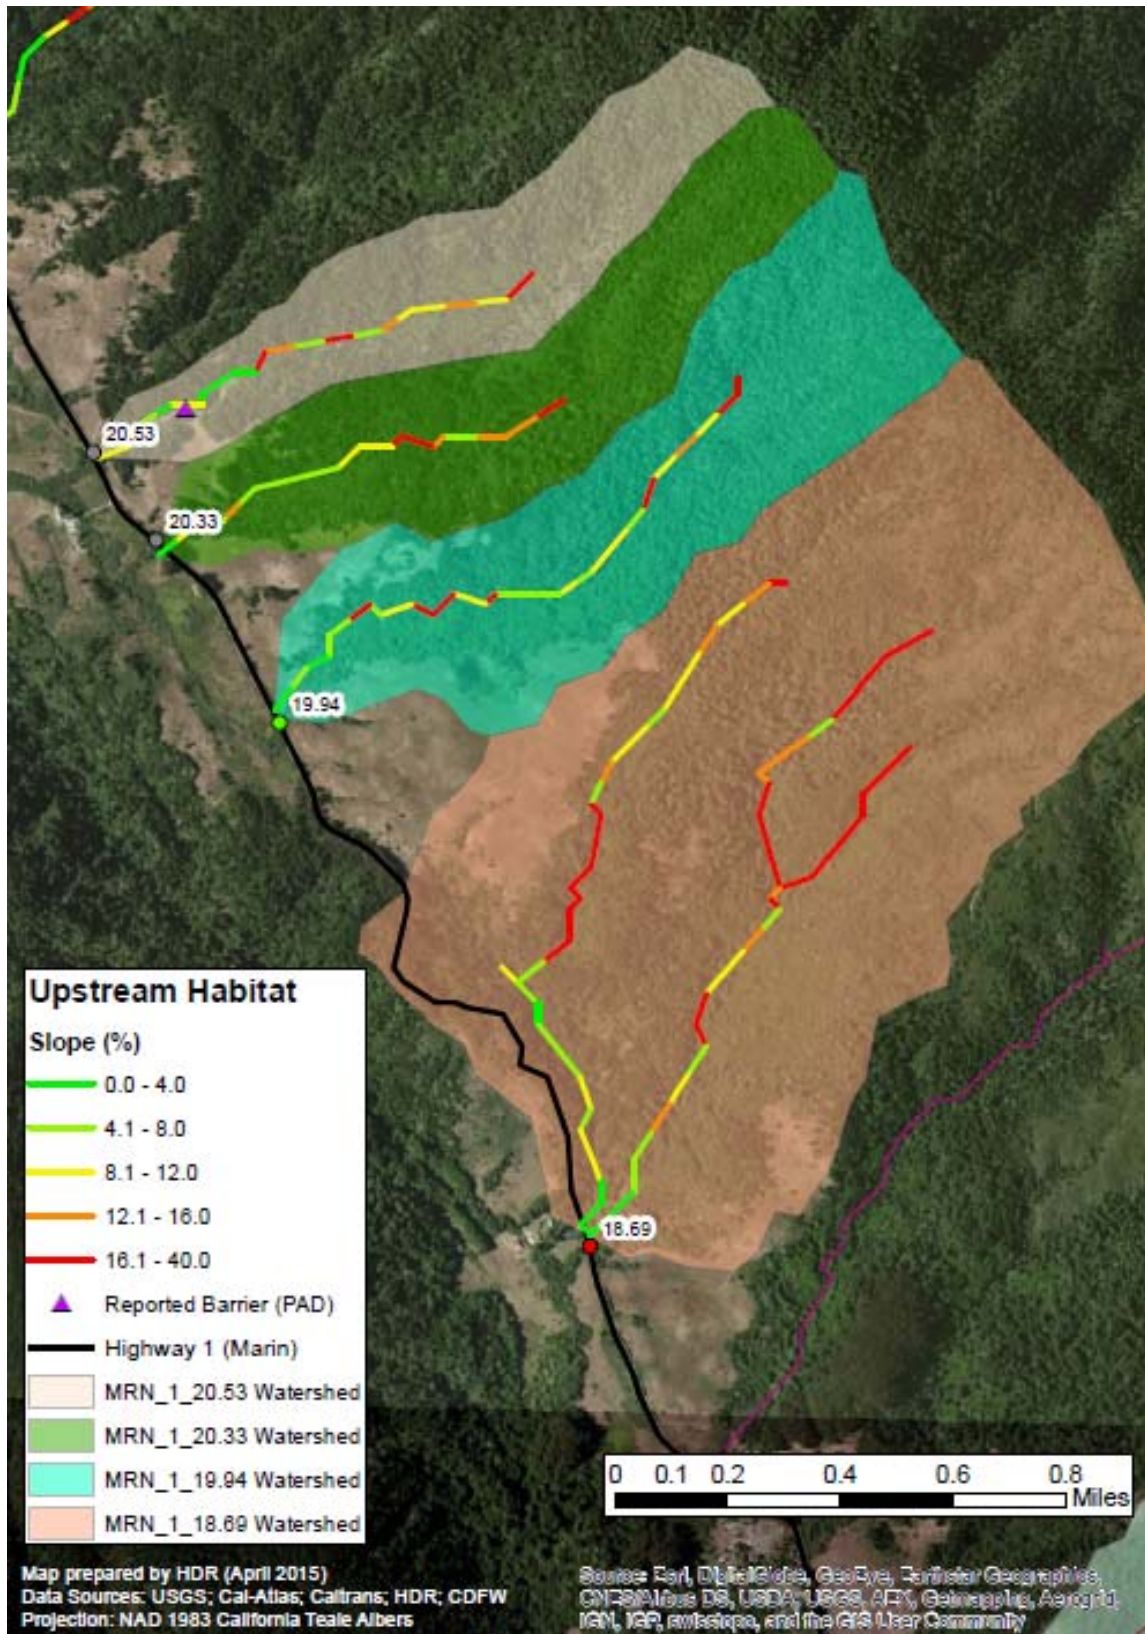
Figure 19. Stream gradient upstream of MRN 1 20.53, 20.33, 19.94 and 18.69.

This crossing was identified as “gray” by the CDFW Passage Evaluation Filter. Estimated potential habitat upstream of the crossing approximately was 0.2 miles prior to reaching South Hagamier Dam, reported as a total fish passage barrier by the PAD (Figure 19).

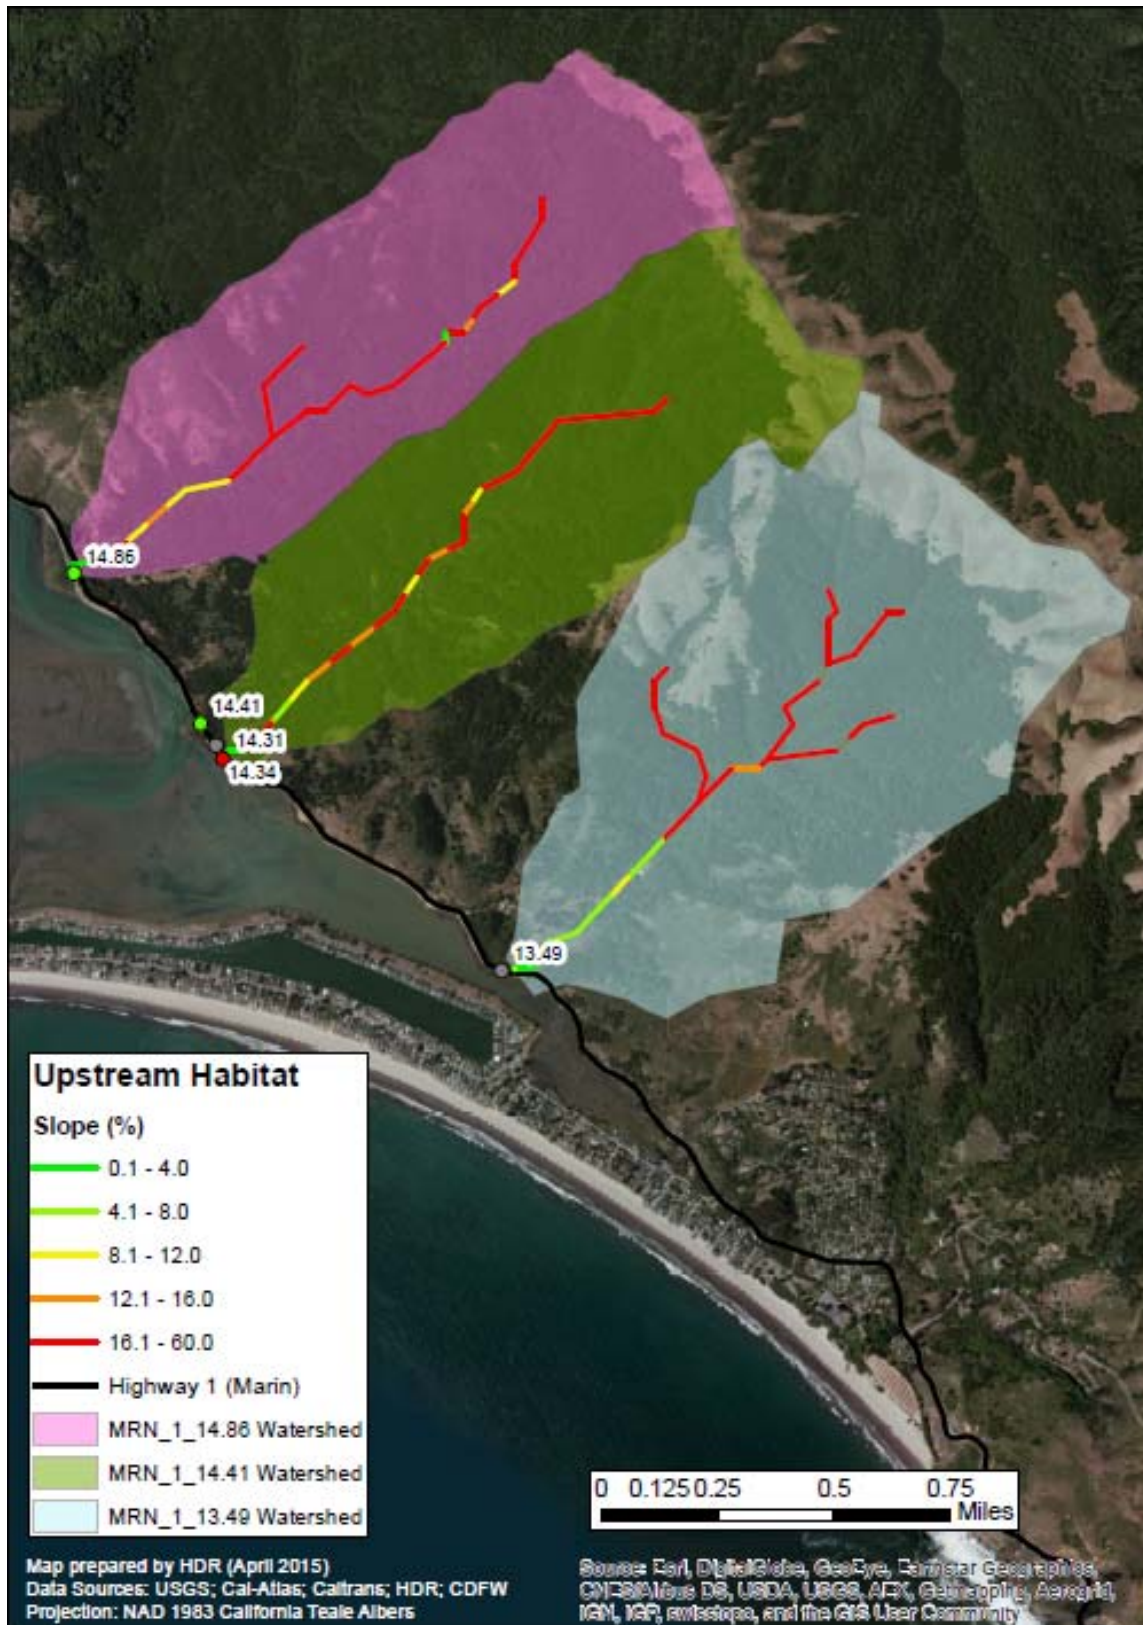
Figure 21. Stream gradient upstream of MRN 1 14.86, 14.41/14.34/14.31 and 13.49.

This crossing was identified as “green” by the CDFW Passage Evaluation Filter, however, this classification was discarded because the culvert was nearly full with sediment. It is recommended that this site be re-surveyed after the excess sediment is removed from the site. The estimated potential habitat upstream of the crossing was approximately 0.4 miles before the stream gradient increased above 12% over more than 100 m in stream length (Figure 21). Due to discrepancies between the stream channel and the stream network representation, initial high gradient segments just upstream of the crossing were ignored. Fong (2002) estimated the length of potential habitat in Wilkins Gulch as approximately 1 km (.6 miles), with the upstream extent an 8 m tall waterfall.

This site was identified as “gray” by the CDFW Passage Evaluation Filter. The estimated potential habitat upstream of the crossing was approximately 0.6 miles before the stream gradient increased above 12% over more than 100 m in stream length (Figure 21, above). Due to discrepancies between the existing stream channel and the stream network representation, initial high gradient segments just upstream of the crossing were ignored. Fong (2002) estimated the length of potential habitat in Stinson Gulch as greater than 1 km (.6 miles), with an unknown upstream extent.

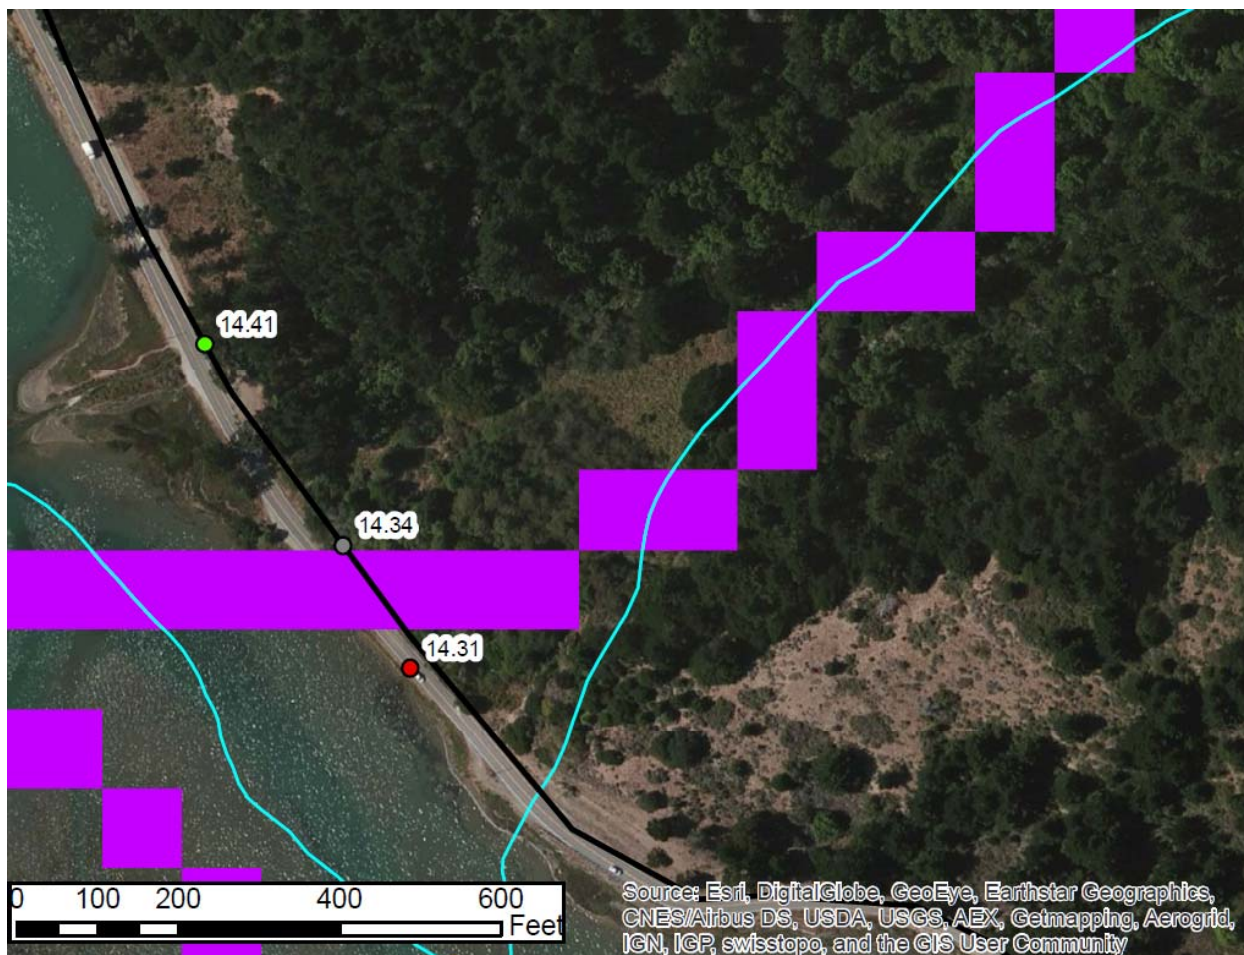
As previously described, the historical and current channel of McKinnon Gulch has been altered, resulting in the current channel passing through postmile 14.41, but with the historical outlet occurring in the vicinity of postmiles 14.31 and 14.34. This is corroborated by hydrologic GIS analysis, which suggests water would have flowed to the south of postmile 14.41 (**Figure 22**). Fong (2002) reported that the sites south of postmile 14.41 were not connected to the current main channel, and that the water passing through these sites was from an emergent wetland. Fong (2002) also reported that although the crossing at postmile 14.41 represents the outlet of the existing discharge location of McKinnon Gulch, it is now generally dry upstream of the crossing during most of the year.

**Figure 22. Crossings draining the McKinnon Gulch Watershed (purple highlighting indicates the natural pathway of the stream relative to the existing stream channel discharging at PM 14.41).**

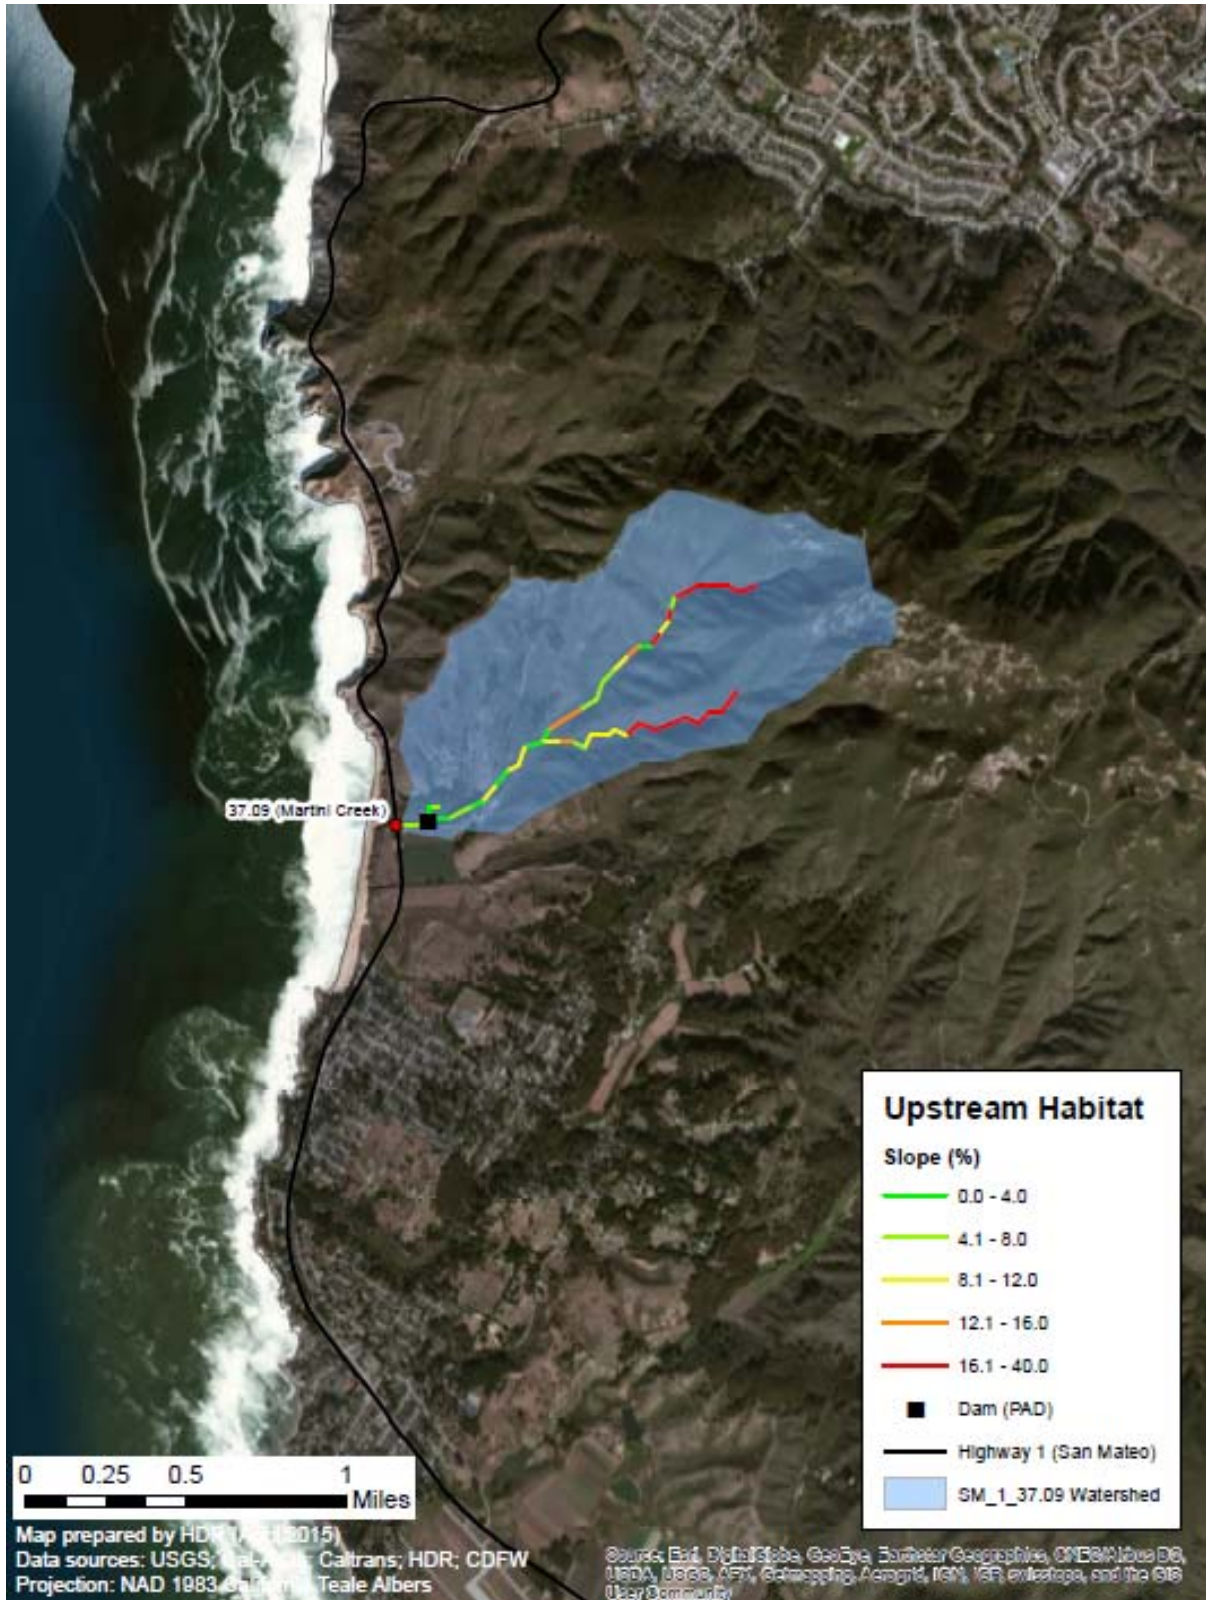
Figure 23. Stream gradient and potential barrier upstream of SM 1 37.09 (Martini Creek).

This site was identified as “red” by the CDFW Passage Evaluation Filter. In a 1976 memo regarding Martini Creek, CDFG staff noted that the creek is in a 100 foot long culvert under Highway 1 (CEMAR 2008). The culvert was suspected to be a barrier to upstream passage of steelhead (DFG 1976a, as cited in CEMAR 2008).

The estimated potential habitat upstream of the crossing was approximately 0.7 miles before the stream gradient increased above 12% over more than 100 m in stream length (**Figure 23**). CEMAR (2008) reported that an undated CDFW creek inventory states, “The Highway 1 culvert, which has a four foot drop at both ends, represents an impassable barrier to any migratory fish. Additionally, an instream impoundment blocks the flow approximately 100 yards upstream from highway 1” (DFG ca 1994, as cited in CEMAR 2008). This dam is identified in the PAD and appears to be approximately 0.1 miles upstream from the highway 1 crossing, but its presence could not be confirmed with aerial imagery.

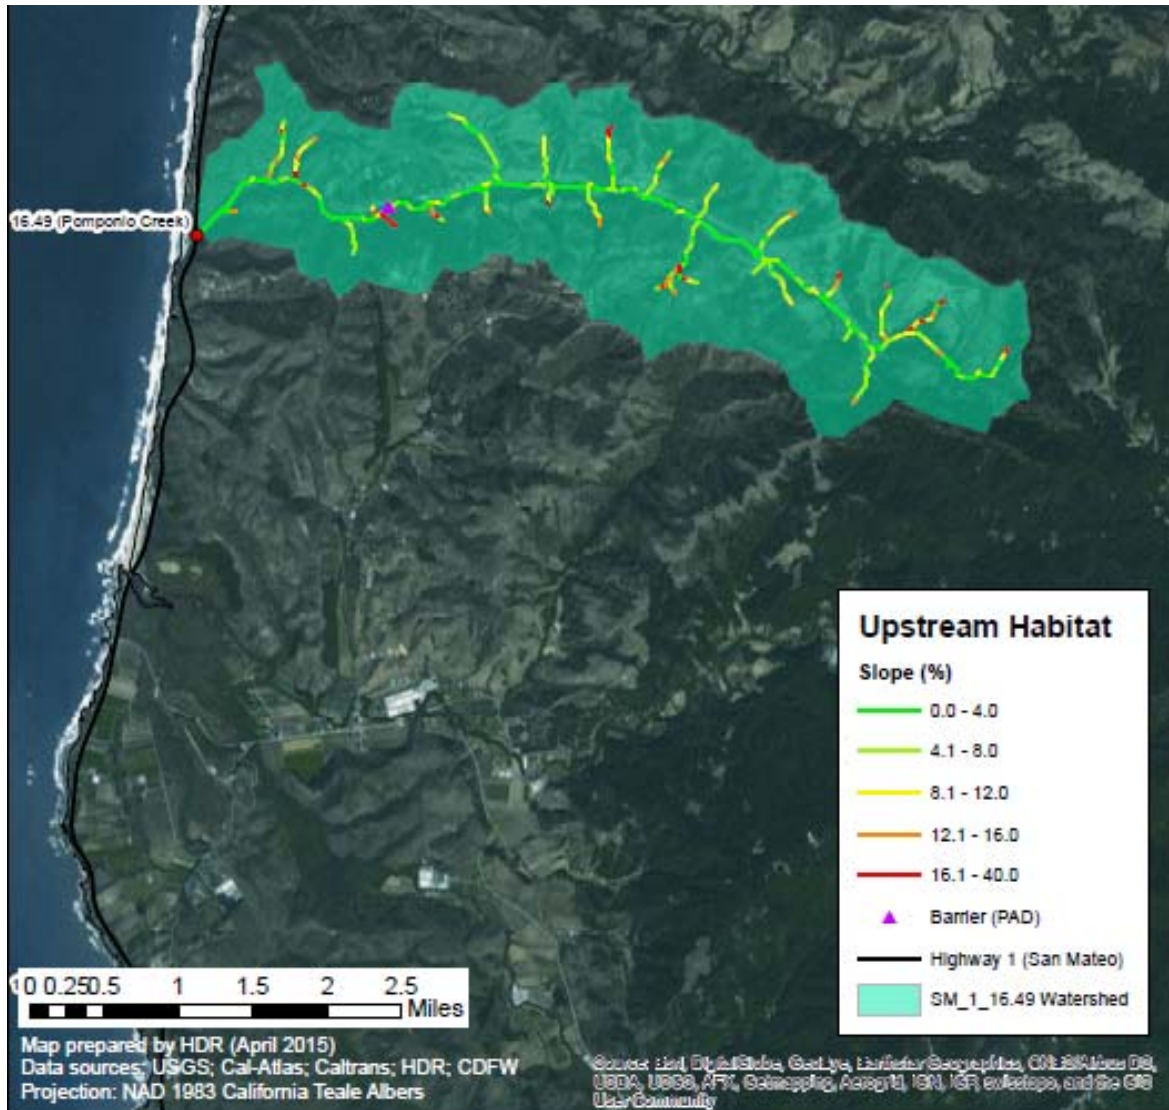
Figure 25. Stream gradient and known barrier upstream of SM 1 16.49 (Pomponio Creek).

This site was identified as “red” by the CDFW Passage Evaluation Filter. However, as previously discussed, this determination is not necessarily appropriate due to tidal hydrodynamics and the filling of the lagoon just downstream of this crossing (**Figure 24**). Additional surveying of the site, including the lagoon downstream of the crossing, and taking additional measurements not required by the Caltrans survey protocols (e.g. water depth through the crossing at different outflows and tidal conditions) during the steelhead upstream migration season and when sufficient flow is present to allow access to the site by adult salmonids, is suggested prior to conducting hydraulic modeling and making a fish passage determination at this site.

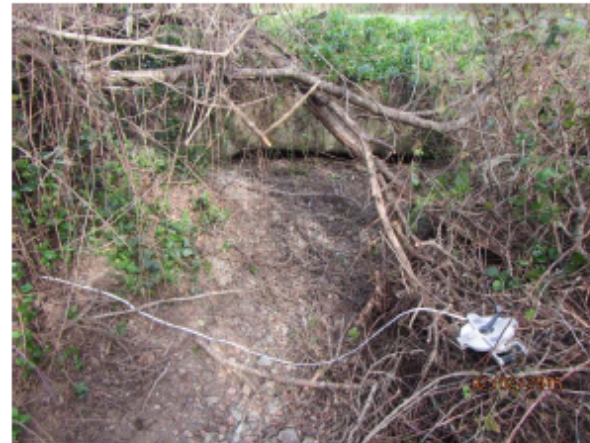
Postmile: 14.86

**MRN 1 14.86** – Although this site ranked as “green”, unimpeded fish passage is not provided due to the concrete box culvert being nearly full with sediment (**Figure 10**). Sediment excavation is recommended prior to re-surveying the site and making a fish passage determination.

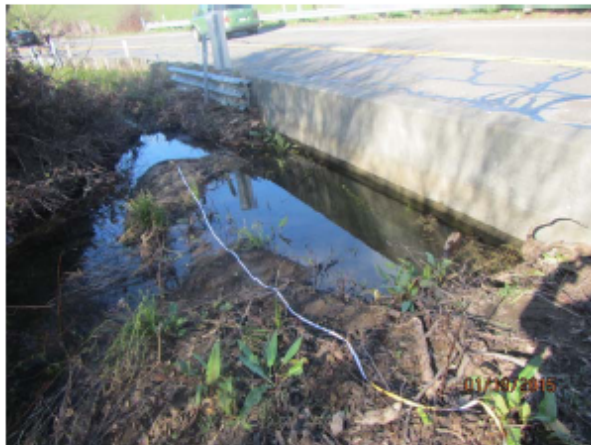
Postmile: 27.92

**MRN 1 27.92** – Although this site ranked as “green”, unimpeded fish passage is not provided due to the concrete box culvert outlet being nearly full with sediment (**Figure 11**). Sediment excavation is recommended prior to re-surveying the site. In addition, the channel enters the culvert at a 90 degree angle.

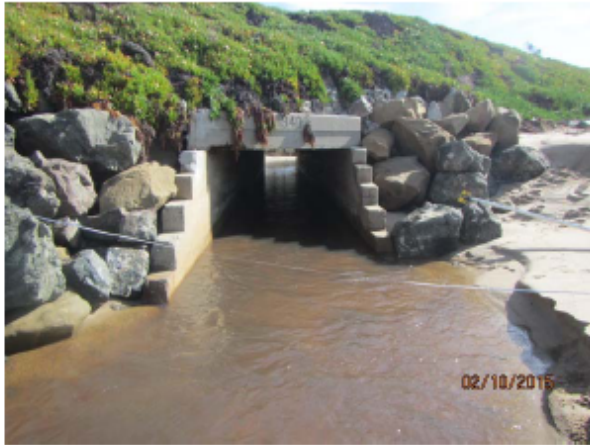
Postmile: 11.07

**SM 1 11.07** – While this site ranked as “gray” due to insufficient inlet width and insufficient residual outlet depth, due to the highly variable sediment dynamics at the crossing, the residual outlet depth is highly variable depending on freshwater outflow and potentially tidal conditions. Although there is currently no spawning habitat upstream of the crossing (further described below), if an adult fish passage

This site was identified as “gray” by the CDFW Passage Evaluation Filter. However, as previously discussed, this determination was due to insufficient inlet width and insufficient residual outlet depth. As shown in **Figure 26**, due to the highly variable sediment dynamics at the crossing, the residual outlet depth is highly variable depending on freshwater outflow and potentially tidal conditions. Therefore, it is recommended that this site be surveyed during the upstream migration season and when hydrologic conditions allow for adult salmonid access to the site, and take additional measurements not required by the Caltrans survey protocols (e.g. water depth through the crossing at different outflows and tidal conditions), prior to conducting hydraulic modeling for the site and making a fish passage determination.
