# 2014–2015 Detailed Fish Passage Assessment Evaluations

District 4 – Marin and San Mateo Counties | Highway 1

April 2015

California Department of Transportation  
Division of Environmental Analysis  
Office of Biology and Technical Assistance  
Sacramento, CA USA

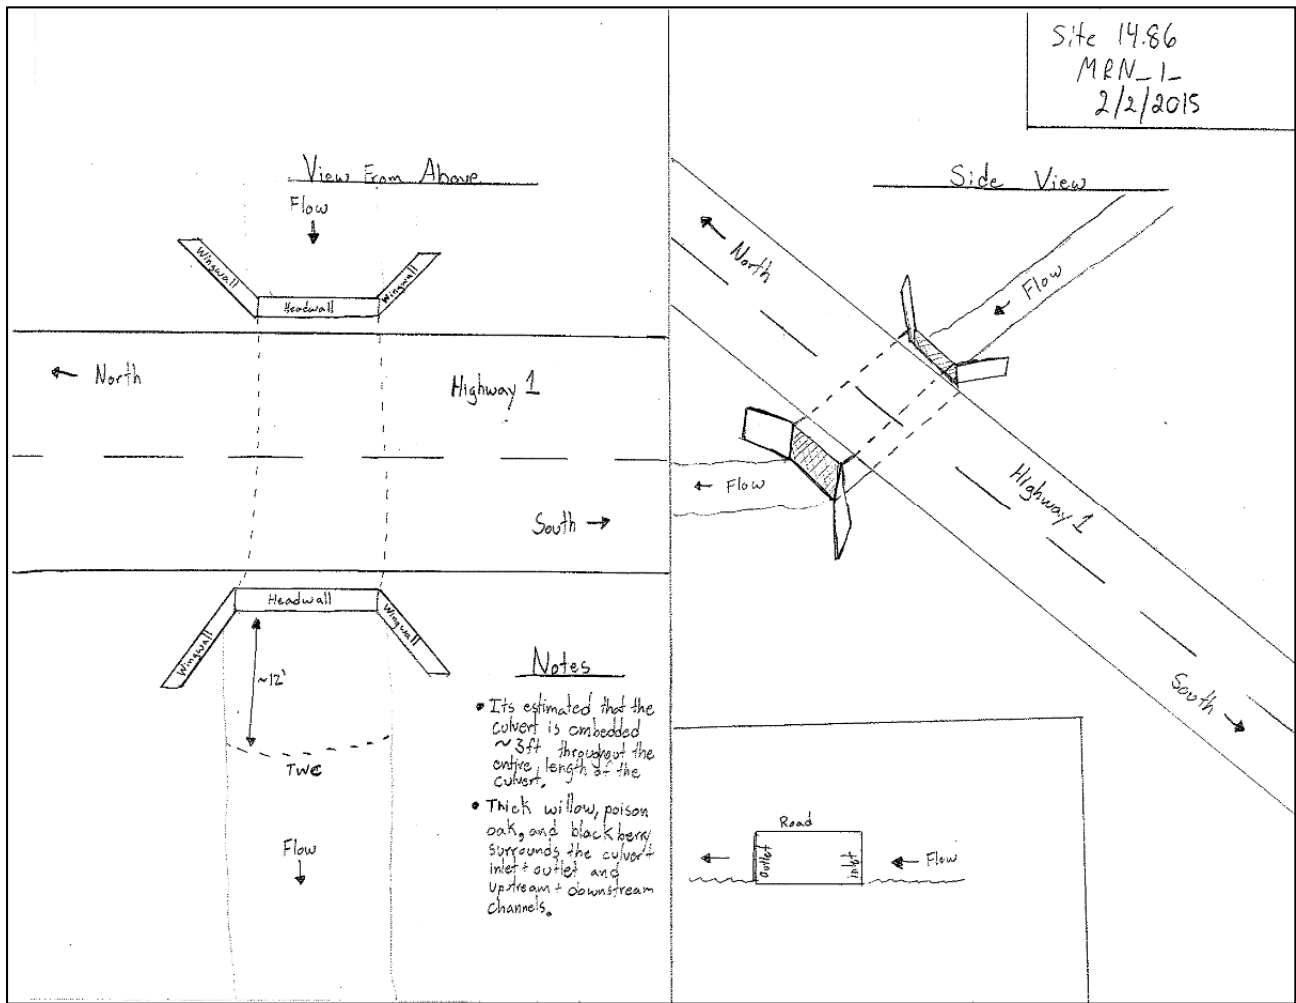
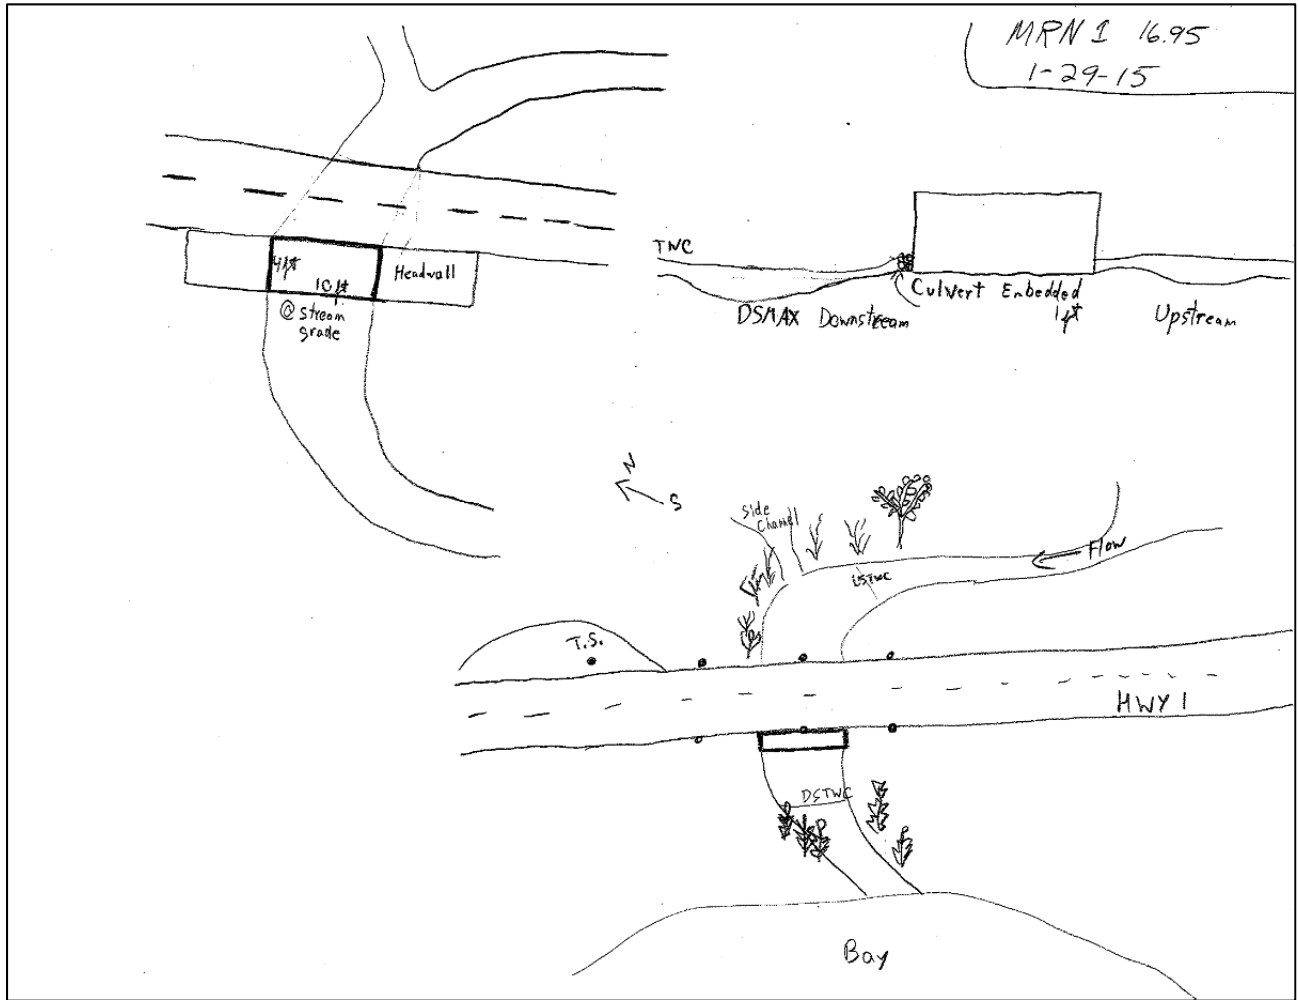
Figure B-9. Site sketch for MRN-1-14.86

**MRN 1 14.86** – Although this site ranked as “green”, unimpeded fish passage is not provided due to the concrete box culvert being nearly full with sediment (**Figure 10**). Sediment excavation is recommended prior to re-surveying the site and making a fish passage determination.

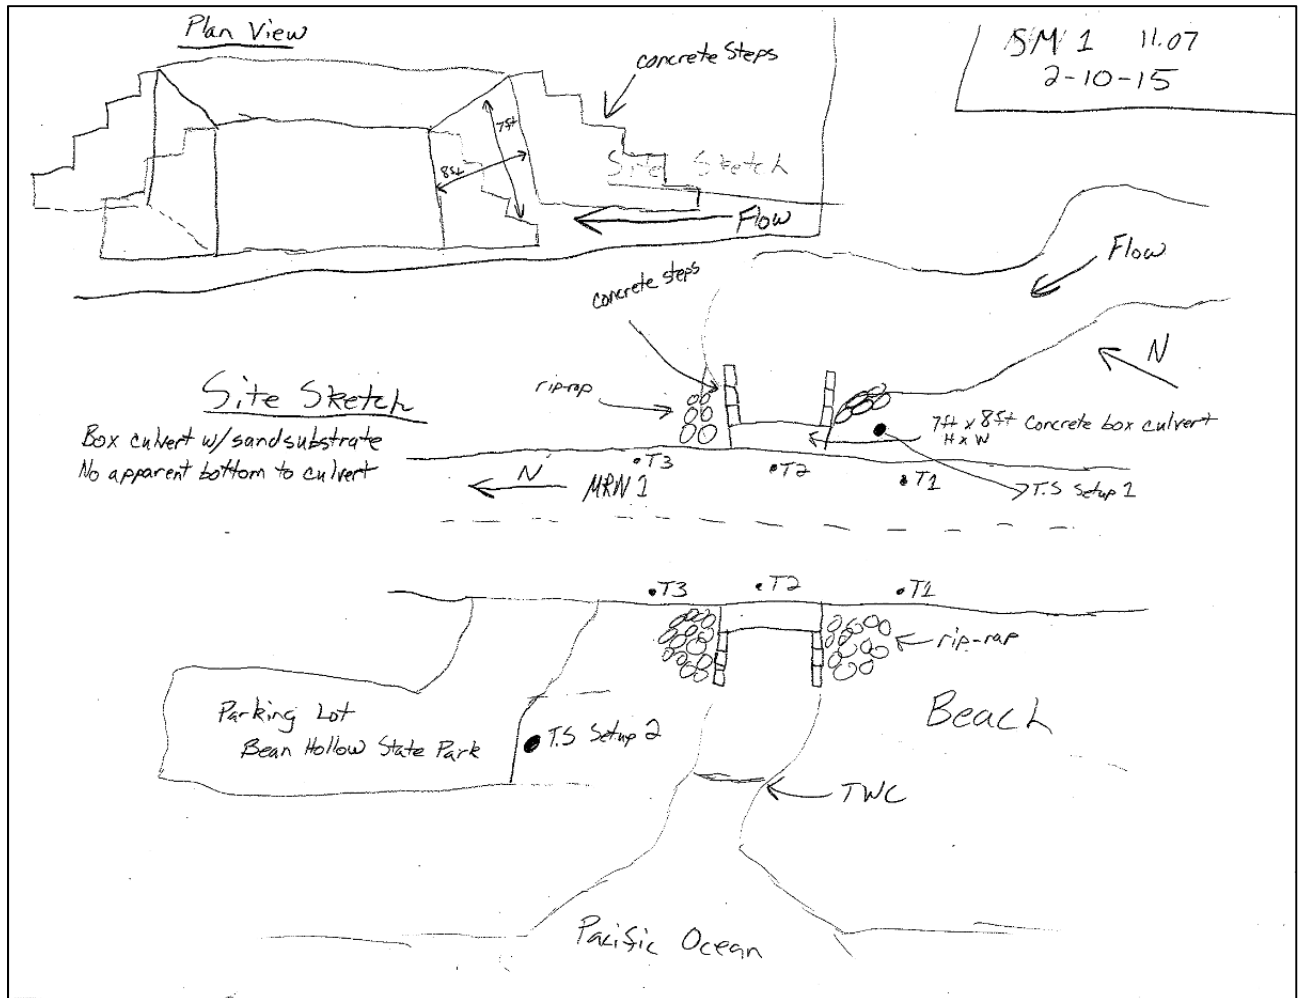
Figure B-35. Site sketch for SM-1-11.07

This site was identified as “gray” by the CDFW Passage Evaluation Filter. However, as previously discussed, this determination was due to insufficient inlet width and insufficient residual outlet depth. As shown in **Figure 26**, due to the highly variable sediment dynamics at the crossing, the residual outlet depth is highly variable depending on freshwater outflow and potentially tidal conditions. Therefore, it is recommended that this site be surveyed during the upstream migration season and when hydrologic conditions allow for adult salmonid access to the site, and take additional measurements not required by the Caltrans survey protocols (e.g. water depth through the crossing at different outflows and tidal conditions), prior to conducting hydraulic modeling for the site and making a fish passage determination.
