2017 Reconnaissance and Detailed Fish Passage Assessment Evaluations

Highway 101 – Santa Barbara County

Highway 192 – Santa Barbara County

July 2017

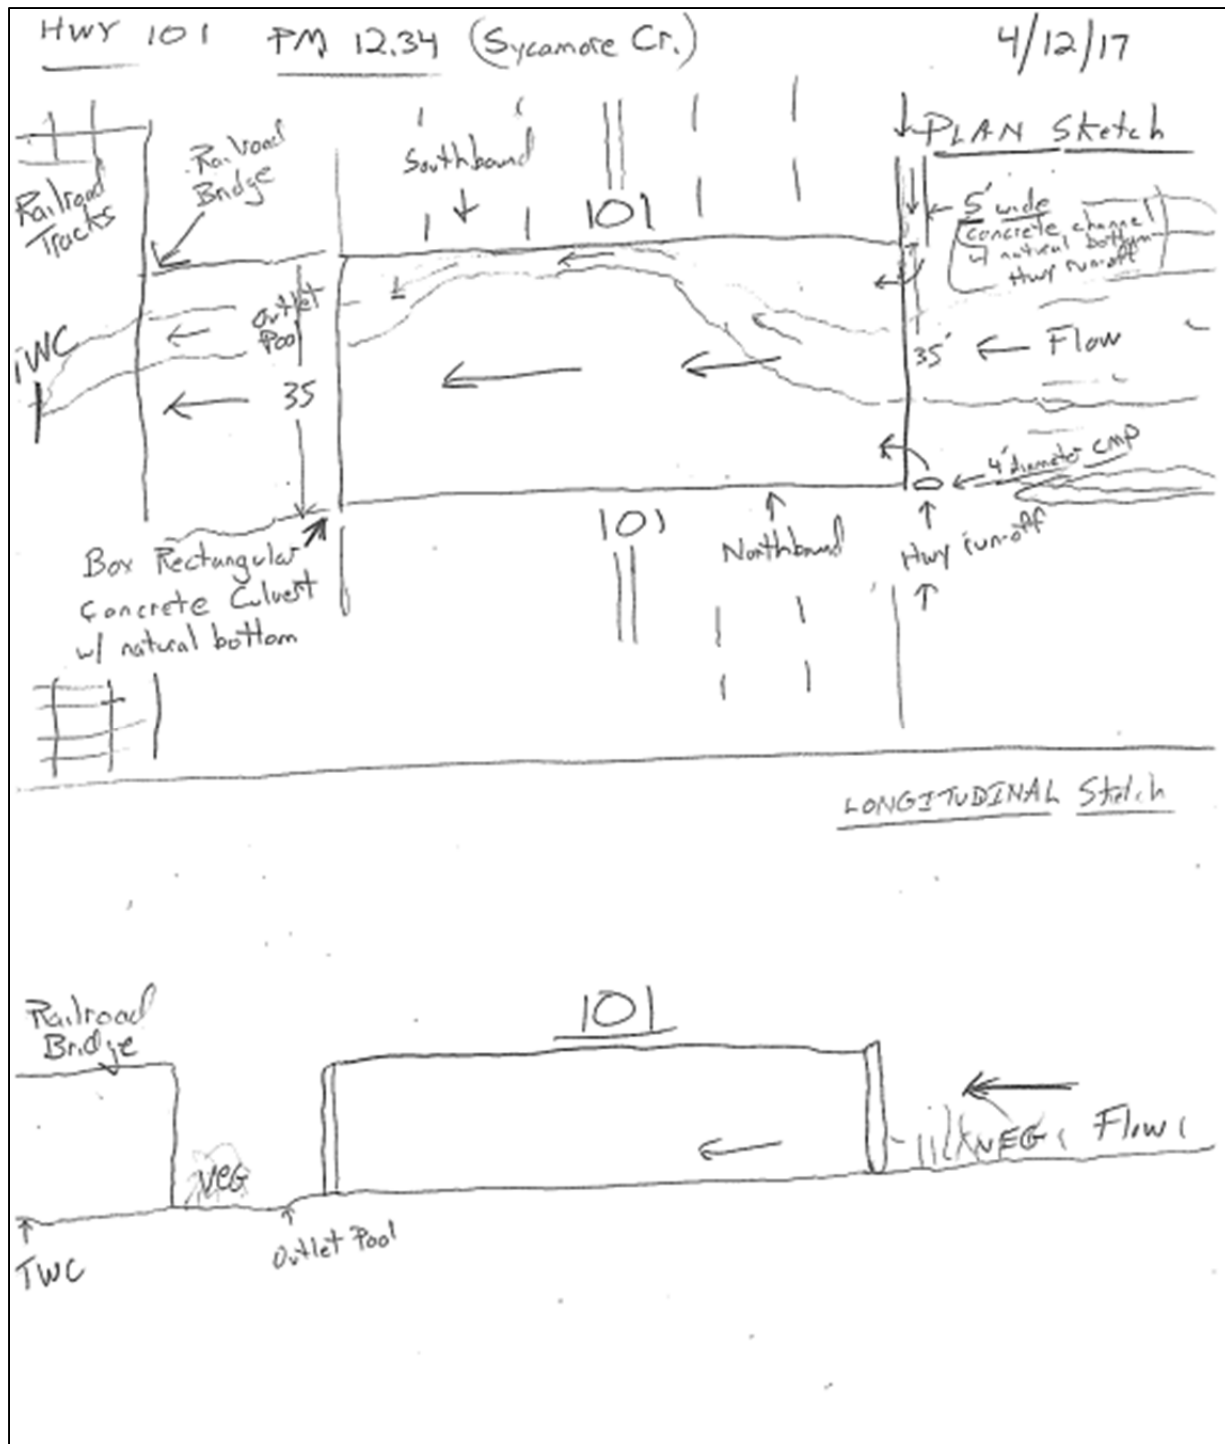
Figure D-1. Site sketch for Santa Barbara County, Route 101, PM 12.34.

SB 101 12.34 – This site ranked as “green” because the inlet to the crossing was greater in width than the active channel and the active channel substrate was natural streambed (**Photo 1**).

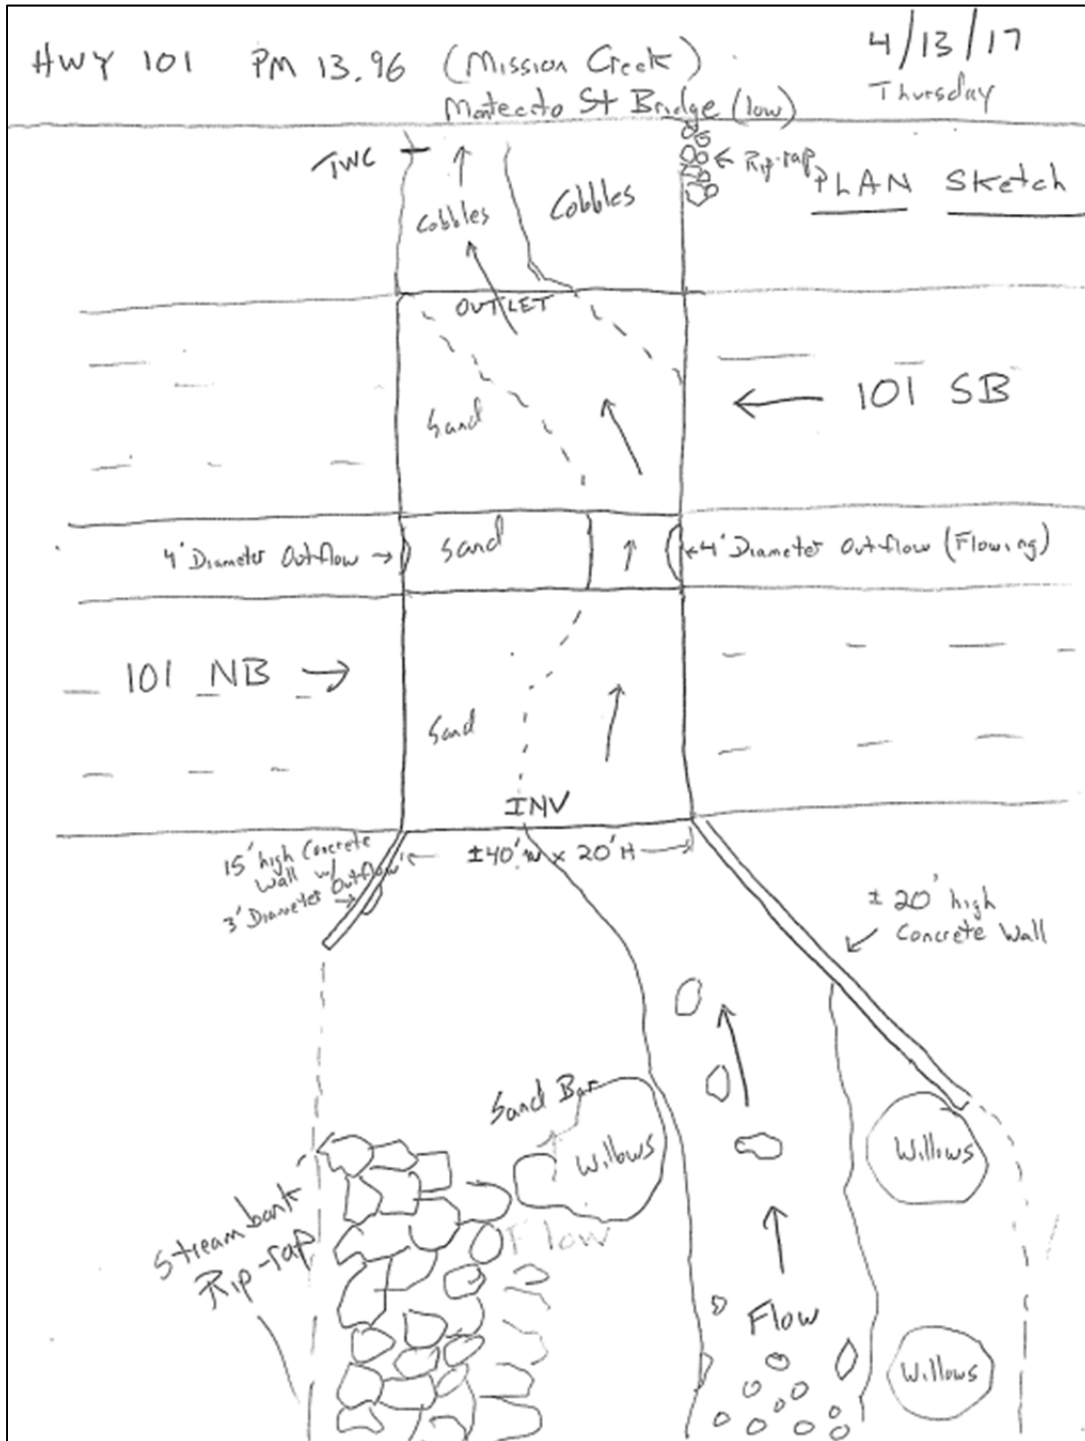
Figure D-2. Site sketch for Santa Barbara County, Route 101, PM 13.96.

SB 101 13.96 - This site ranked as “green” because the inlet to the crossing was greater in width than the active channel and the active channel substrate was natural streambed; there was an additional crossing downstream of the survey site which was constricting the active channel width (**Photo 2**).

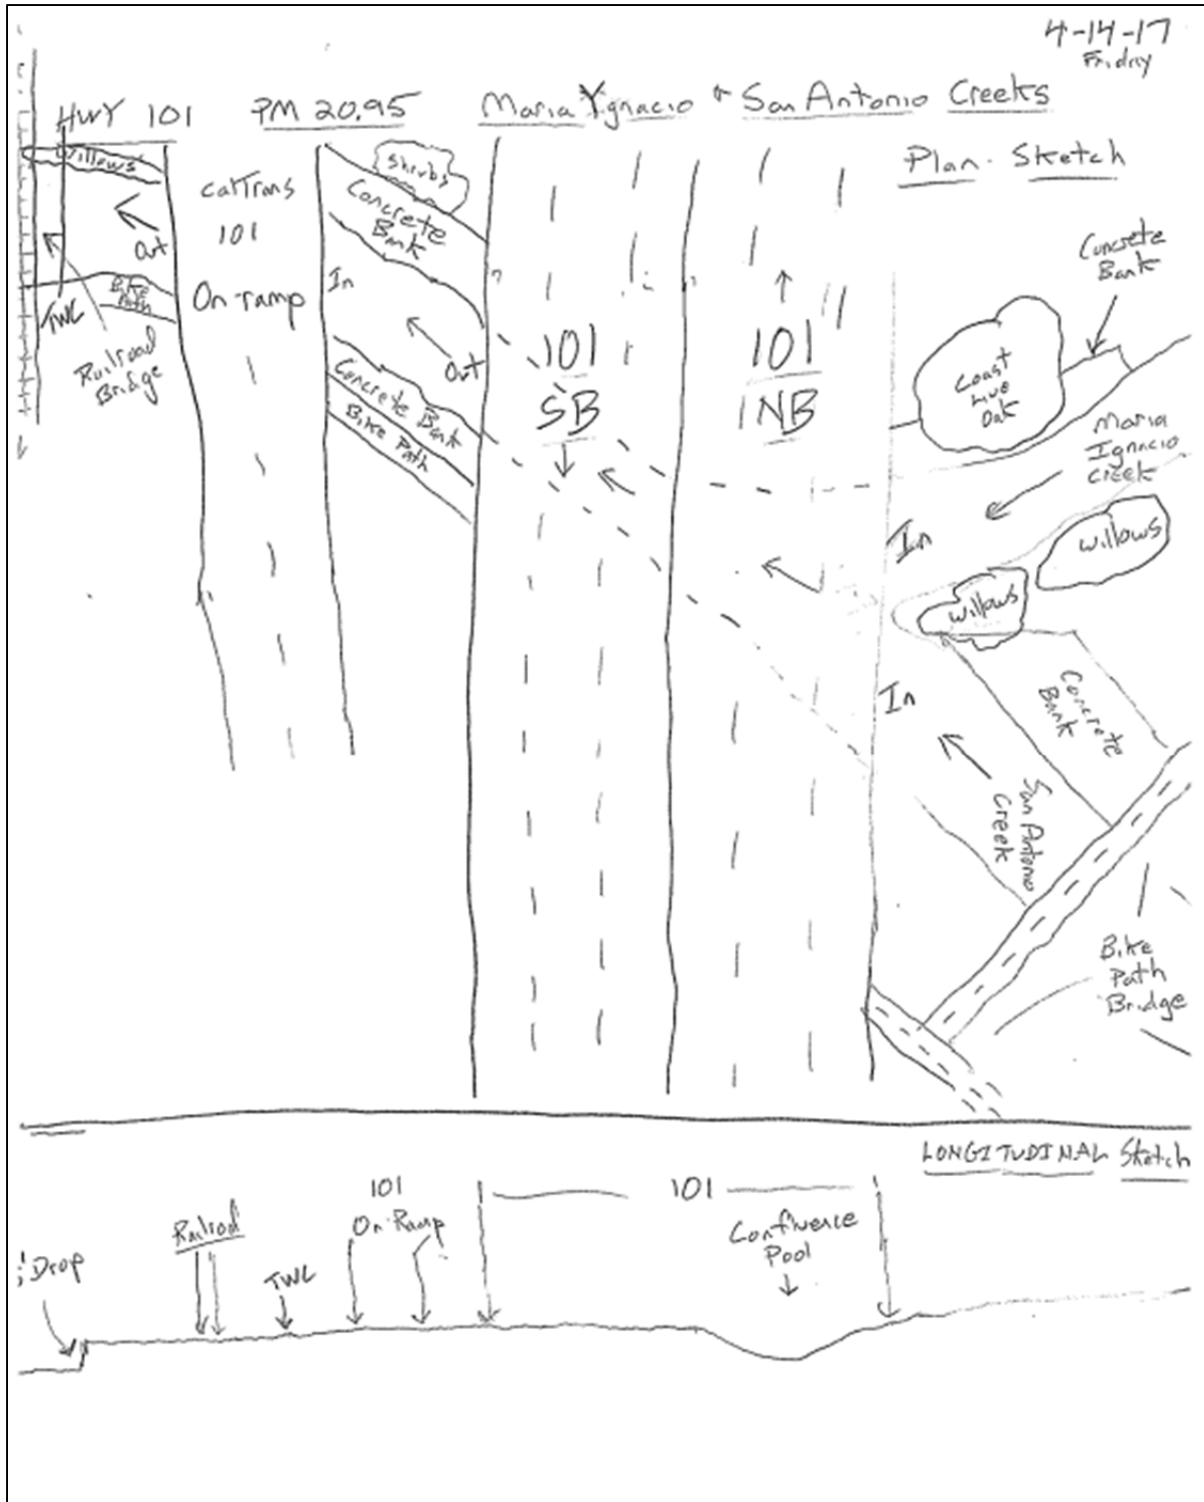
Figure D-4. Site sketch for Santa Barbara County, Route 101, PM 20.95.

SB 101 20.95 – This site ranked as “green” because the inlet to the crossing was greater in width than the active channel, however, the crossing is directly downstream of the Maria Ygnacio Creek and San Antonio Creek confluence and there may be some potential constriction of the natural width of the confluence (**Photo 3**). However, the crossing does not appear to be limiting fish passage conditions. Downstream of the crossing there is an abrupt drop in elevation of approximately 7 feet which is unrelated to the crossing (**Photo 4**).
