Pacifica Pier Restoration Project: Final Programmatic Report (AMENDED)

Recipient Organization/Agency: City of Pacifica

Date Submitted: Revised July 2, 2018

Project Number: #8006.12.033220/33220

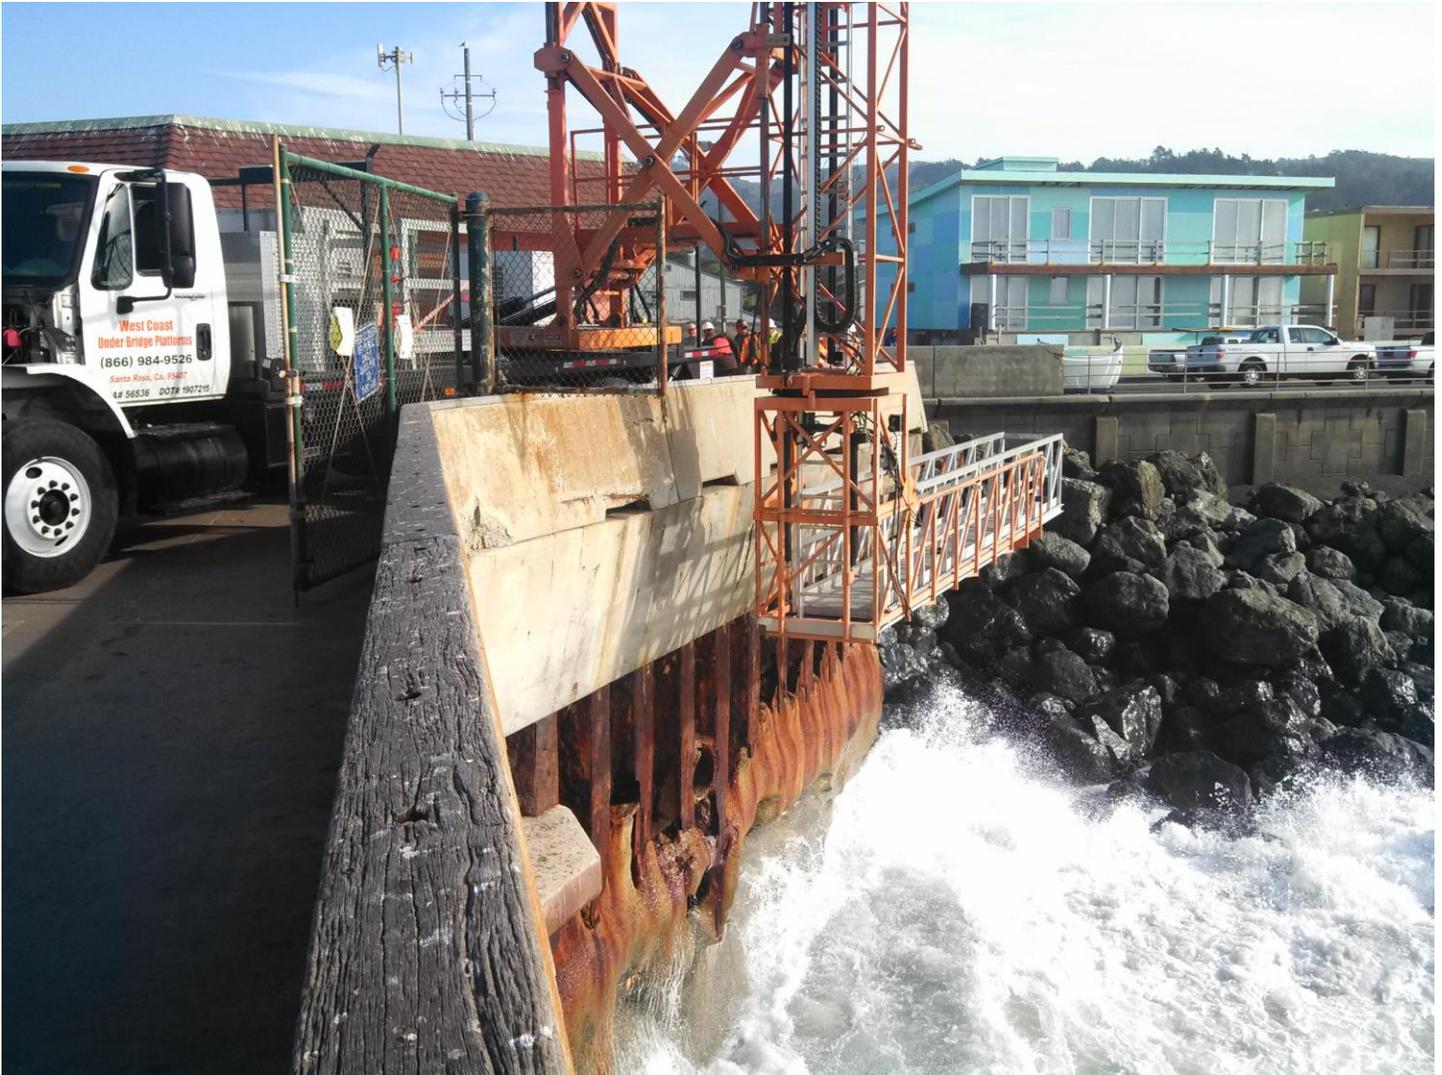
Figure 1: Upon delivery of the scaffold truck, and before it was driven out onto the Pier to begin the work, the scaffolding was checked-out. This machine allowed the crew to work safely on the underside of the Pier (the platform section can swing around to any angle underneath) and on the piles. A boat or barge could not have worked between the piles and in the surf zone. (Photo by Lee Panza)
