CALIFORNIA DEPARTMENT OF FISH AND WILDLIFE

STREAM INVENTORY REPORT

Coulborn Creek

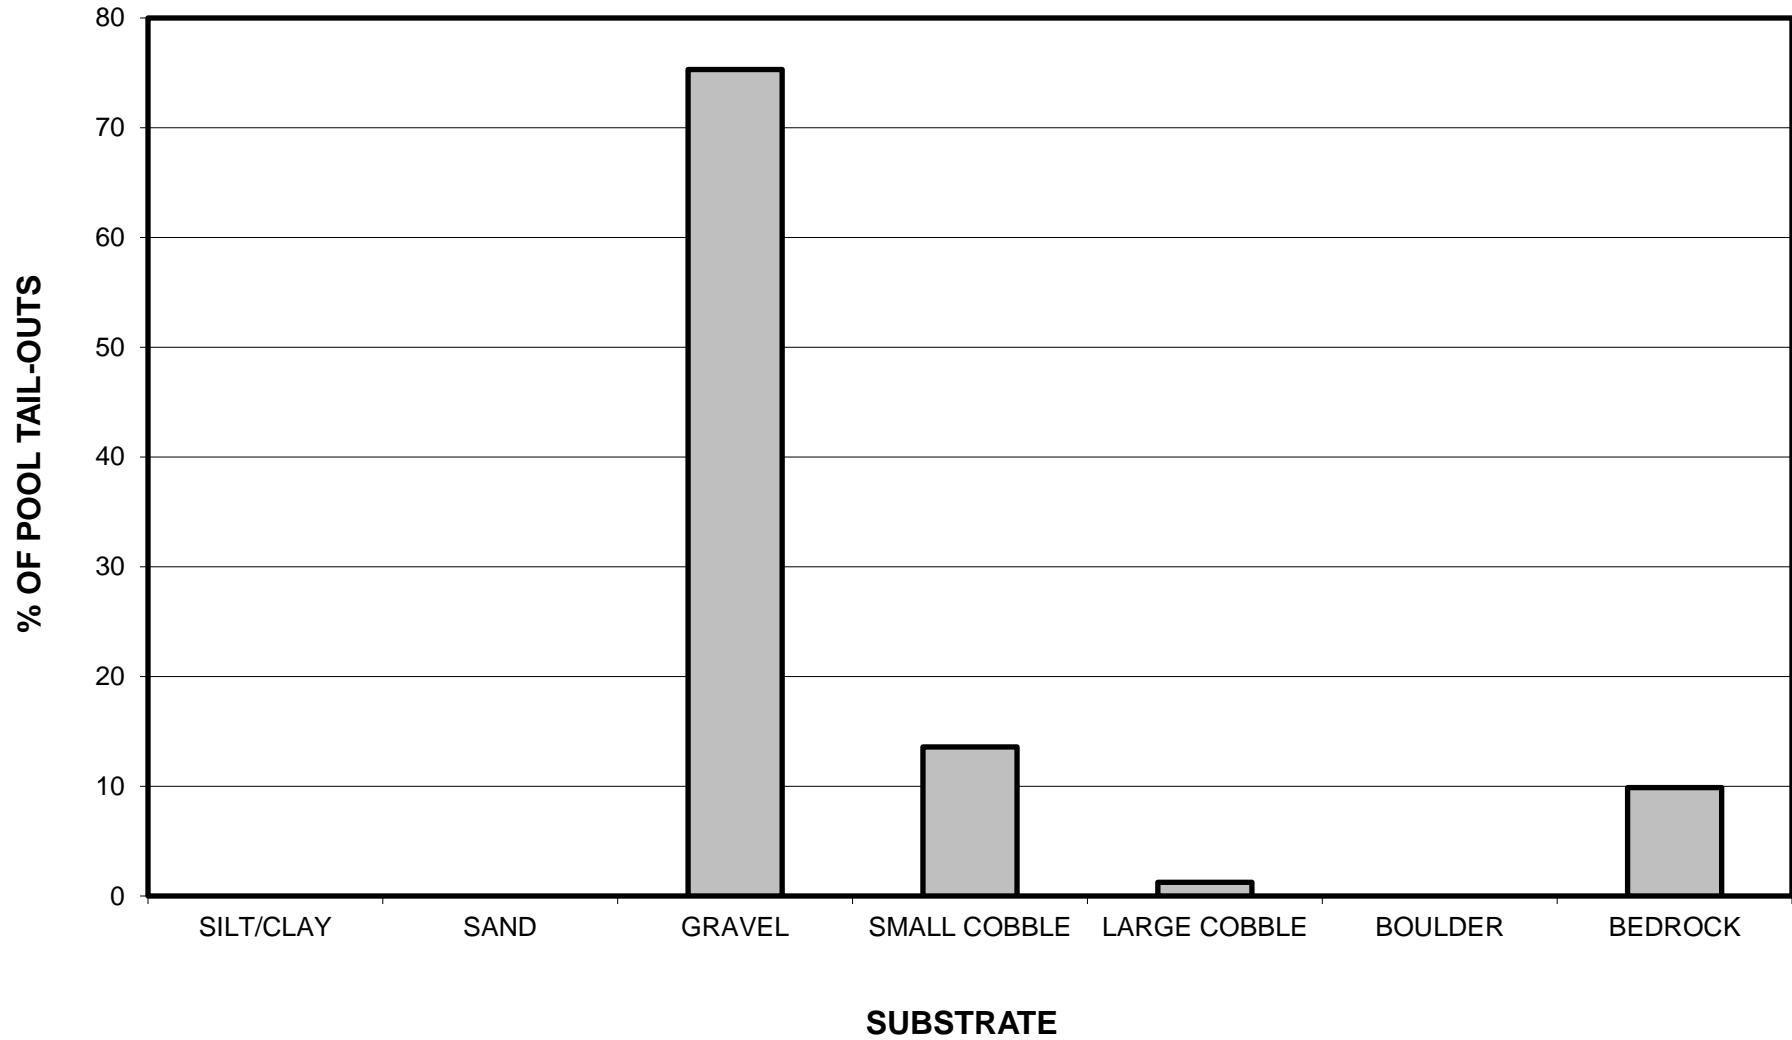
GRAPH 8

Table 6 summarizes the dominant substrate by habitat type. Graph 8 depicts the dominant substrate observed in pool tail-outs. Gravel was the dominant substrate, observed in 75% of the pool tail-outs. Small cobble was the next most frequently observed dominant substrate type and occurred in 14% of pool tail-outs.

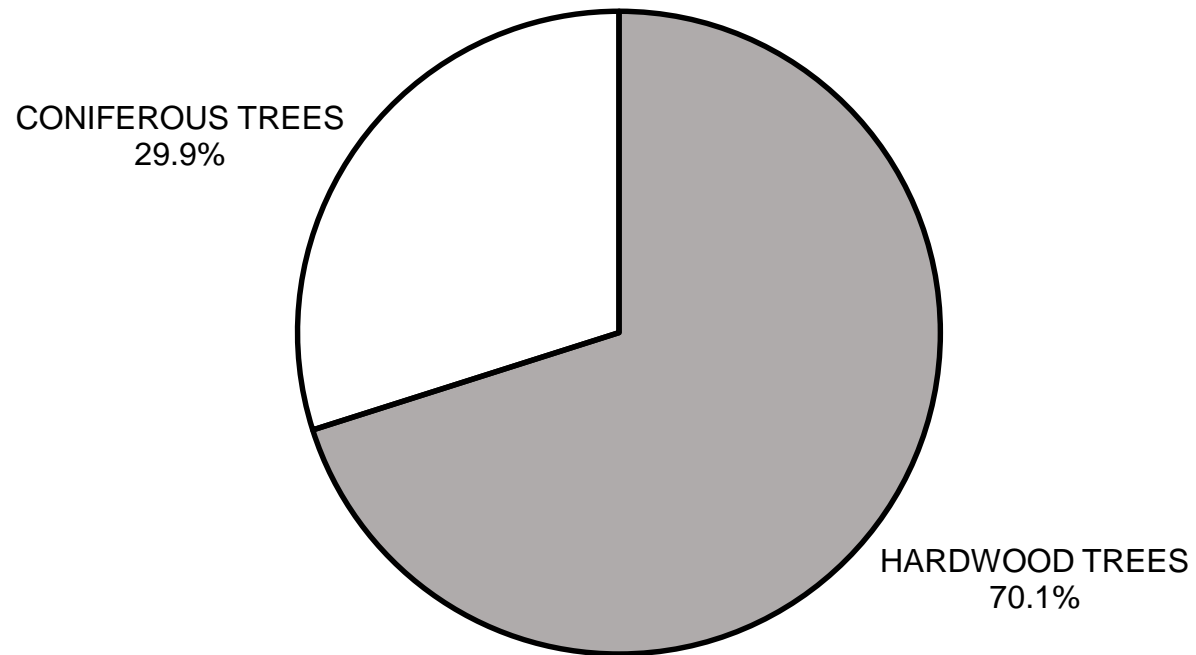
GRAPH 11

For the stream reach surveyed, the mean percent right bank vegetated was 100%. The mean percent left bank vegetated was 100%. The dominant elements composing the structure of the stream banks consisted of 65% sand/silt/clay, and 35% bedrock (Graph 10). Hardwood trees was the dominant vegetation type, observed in 70% of the units surveyed. Additionally, 30% of the units surveyed had coniferous trees as the dominant vegetation type. (Graph 11).
