CALIFORNIA DEPARTMENT OF FISH AND WILDLIFE

STREAM INVENTORY REPORT

SEELY CREEK

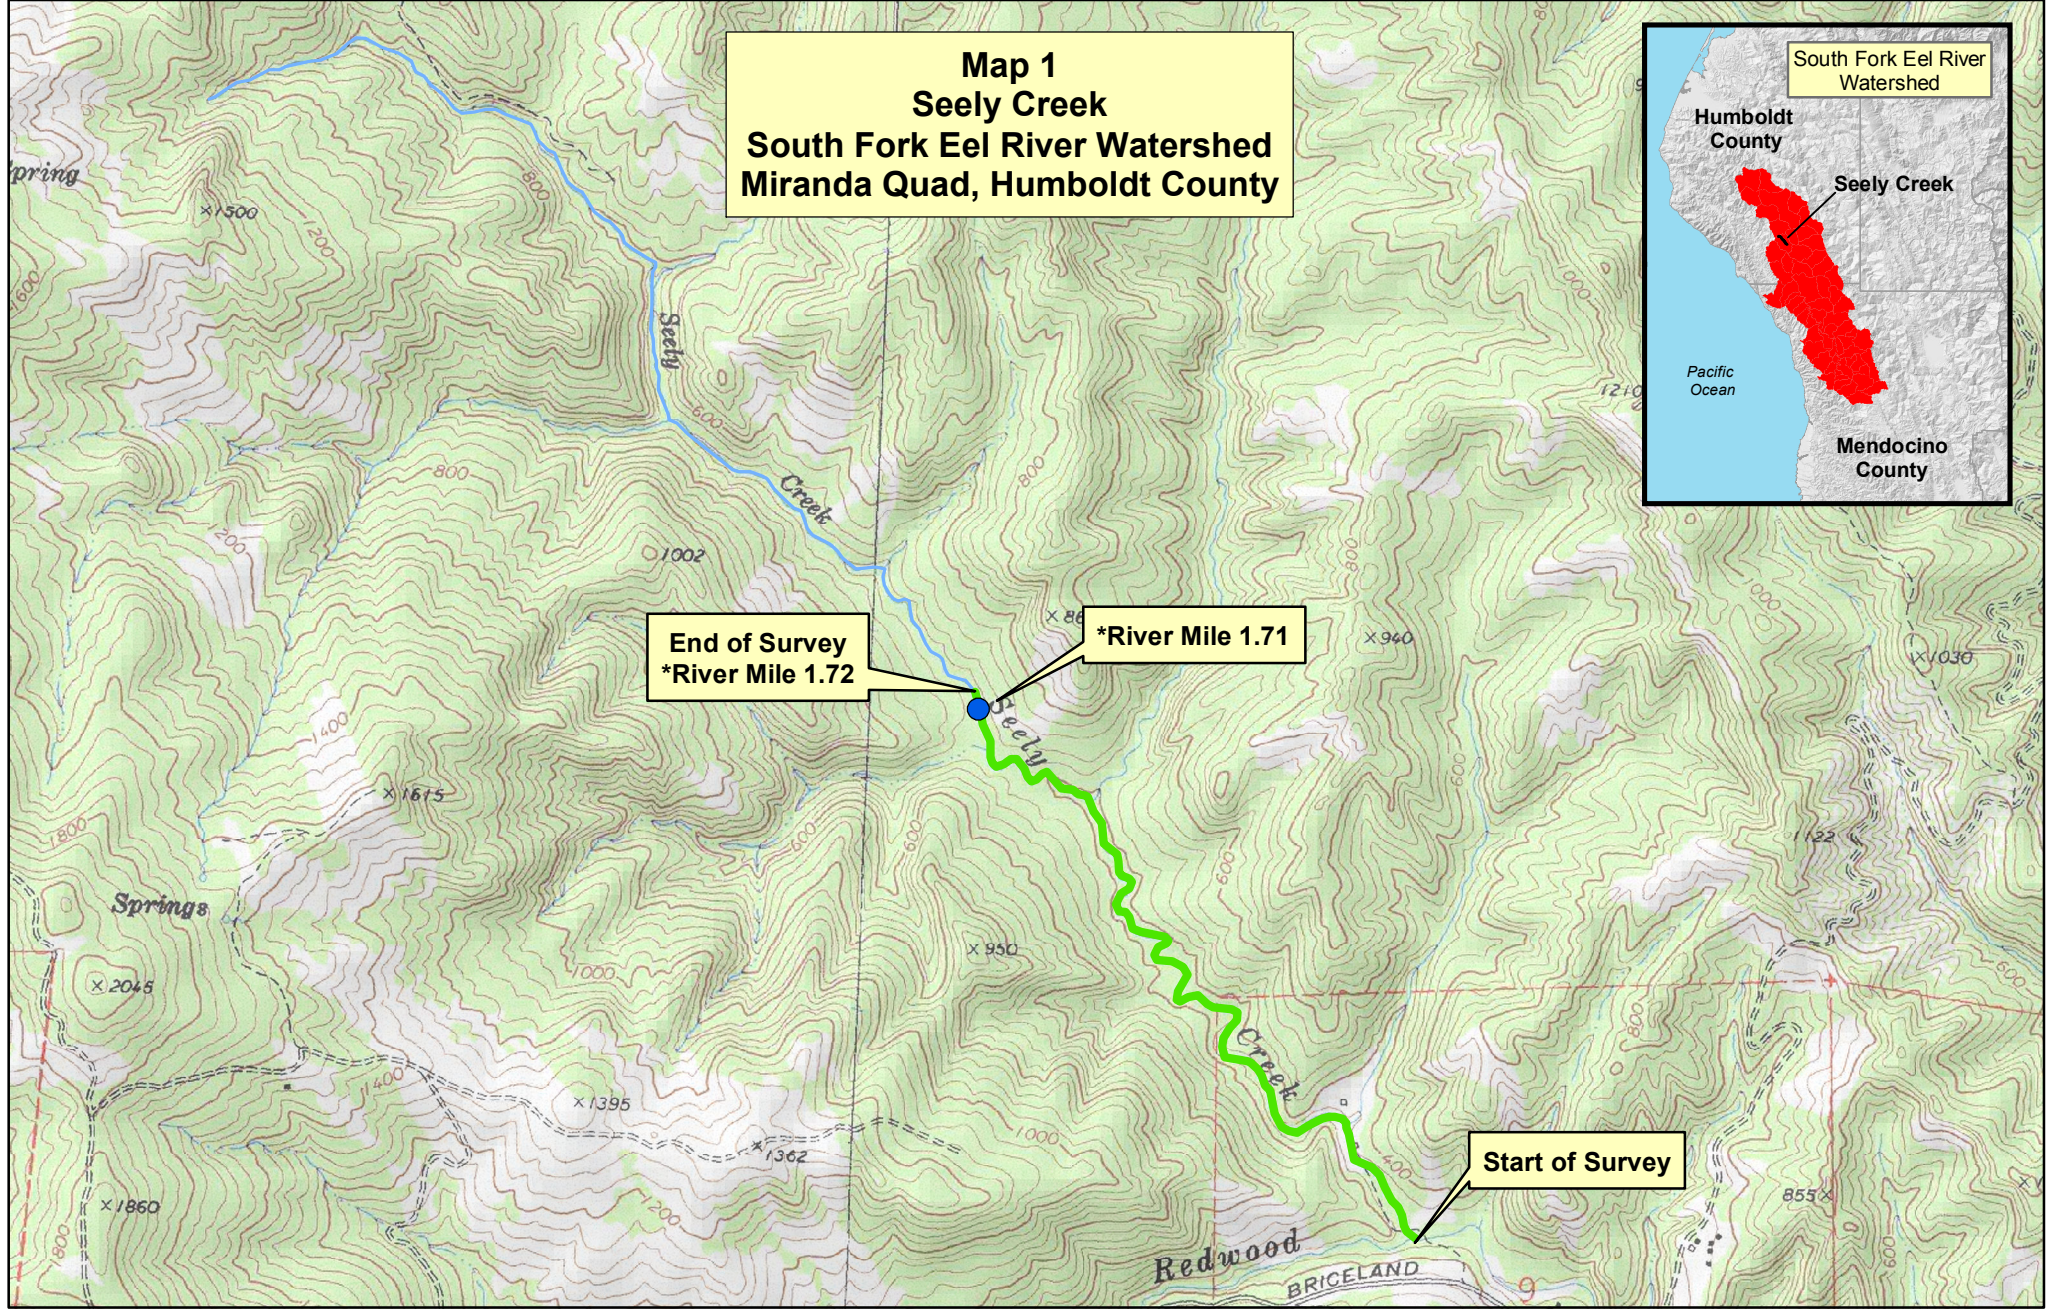
9030 0162.00 End of survey due to access. 200m short of last accessible parcel is an extensive landslide. Channel full with sediment, trees, and trash. Cut trees form LDA-like debris. Water flow is minimal through landslide. Last fish (YOY) observed in HU 161, the pool just prior to the landslide. Much of creek is comprised of bedrock and large cobble/boulders.

- Reach 1: F3 Channel Type
- Seely Creek
- Last observed juvenile steelhead trout

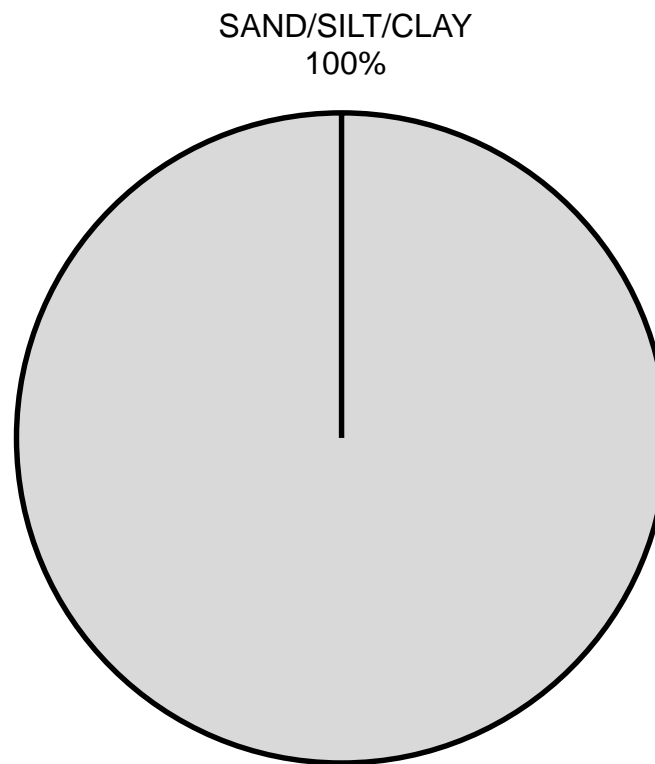
GRAPH 10

For the stream reach surveyed, the mean percent right bank vegetated was 100%. The mean percent left bank vegetated was 100%. The dominant elements composing the structure of the stream banks consisted of 100% sand/silt/clay (Graph 10). Coniferous trees were the dominant vegetation type observed in 61.7% of the units surveyed. Additionally, 38.3% of the units surveyed had hardwood tress as the dominant vegetation type (Graph 11).

SEELY CREEK 2017
DOMINANT BANK COMPOSITION IN SURVEY REACH

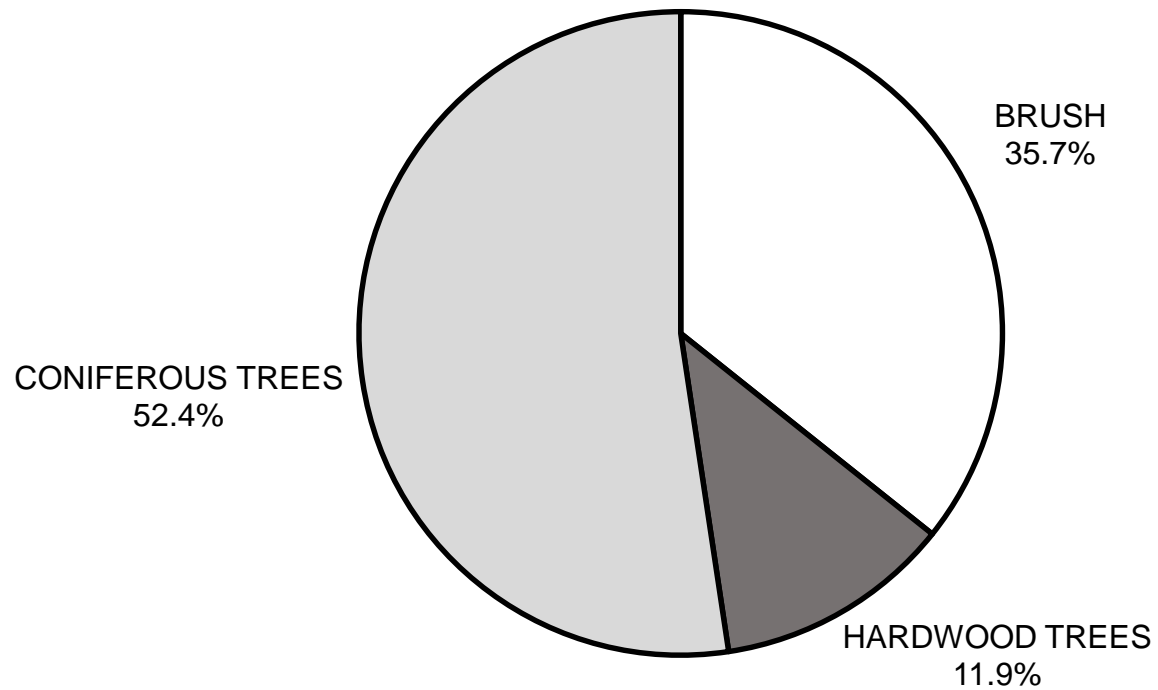
GRAPH 11

**SEELY CREEK 2017
DOMINANT BANK VEGETATION IN SURVEY REACH**
