CALIFORNIA DEPARTMENT OF FISH AND WILDLIFE

STREAM INVENTORY REPORT

Stevens Creek

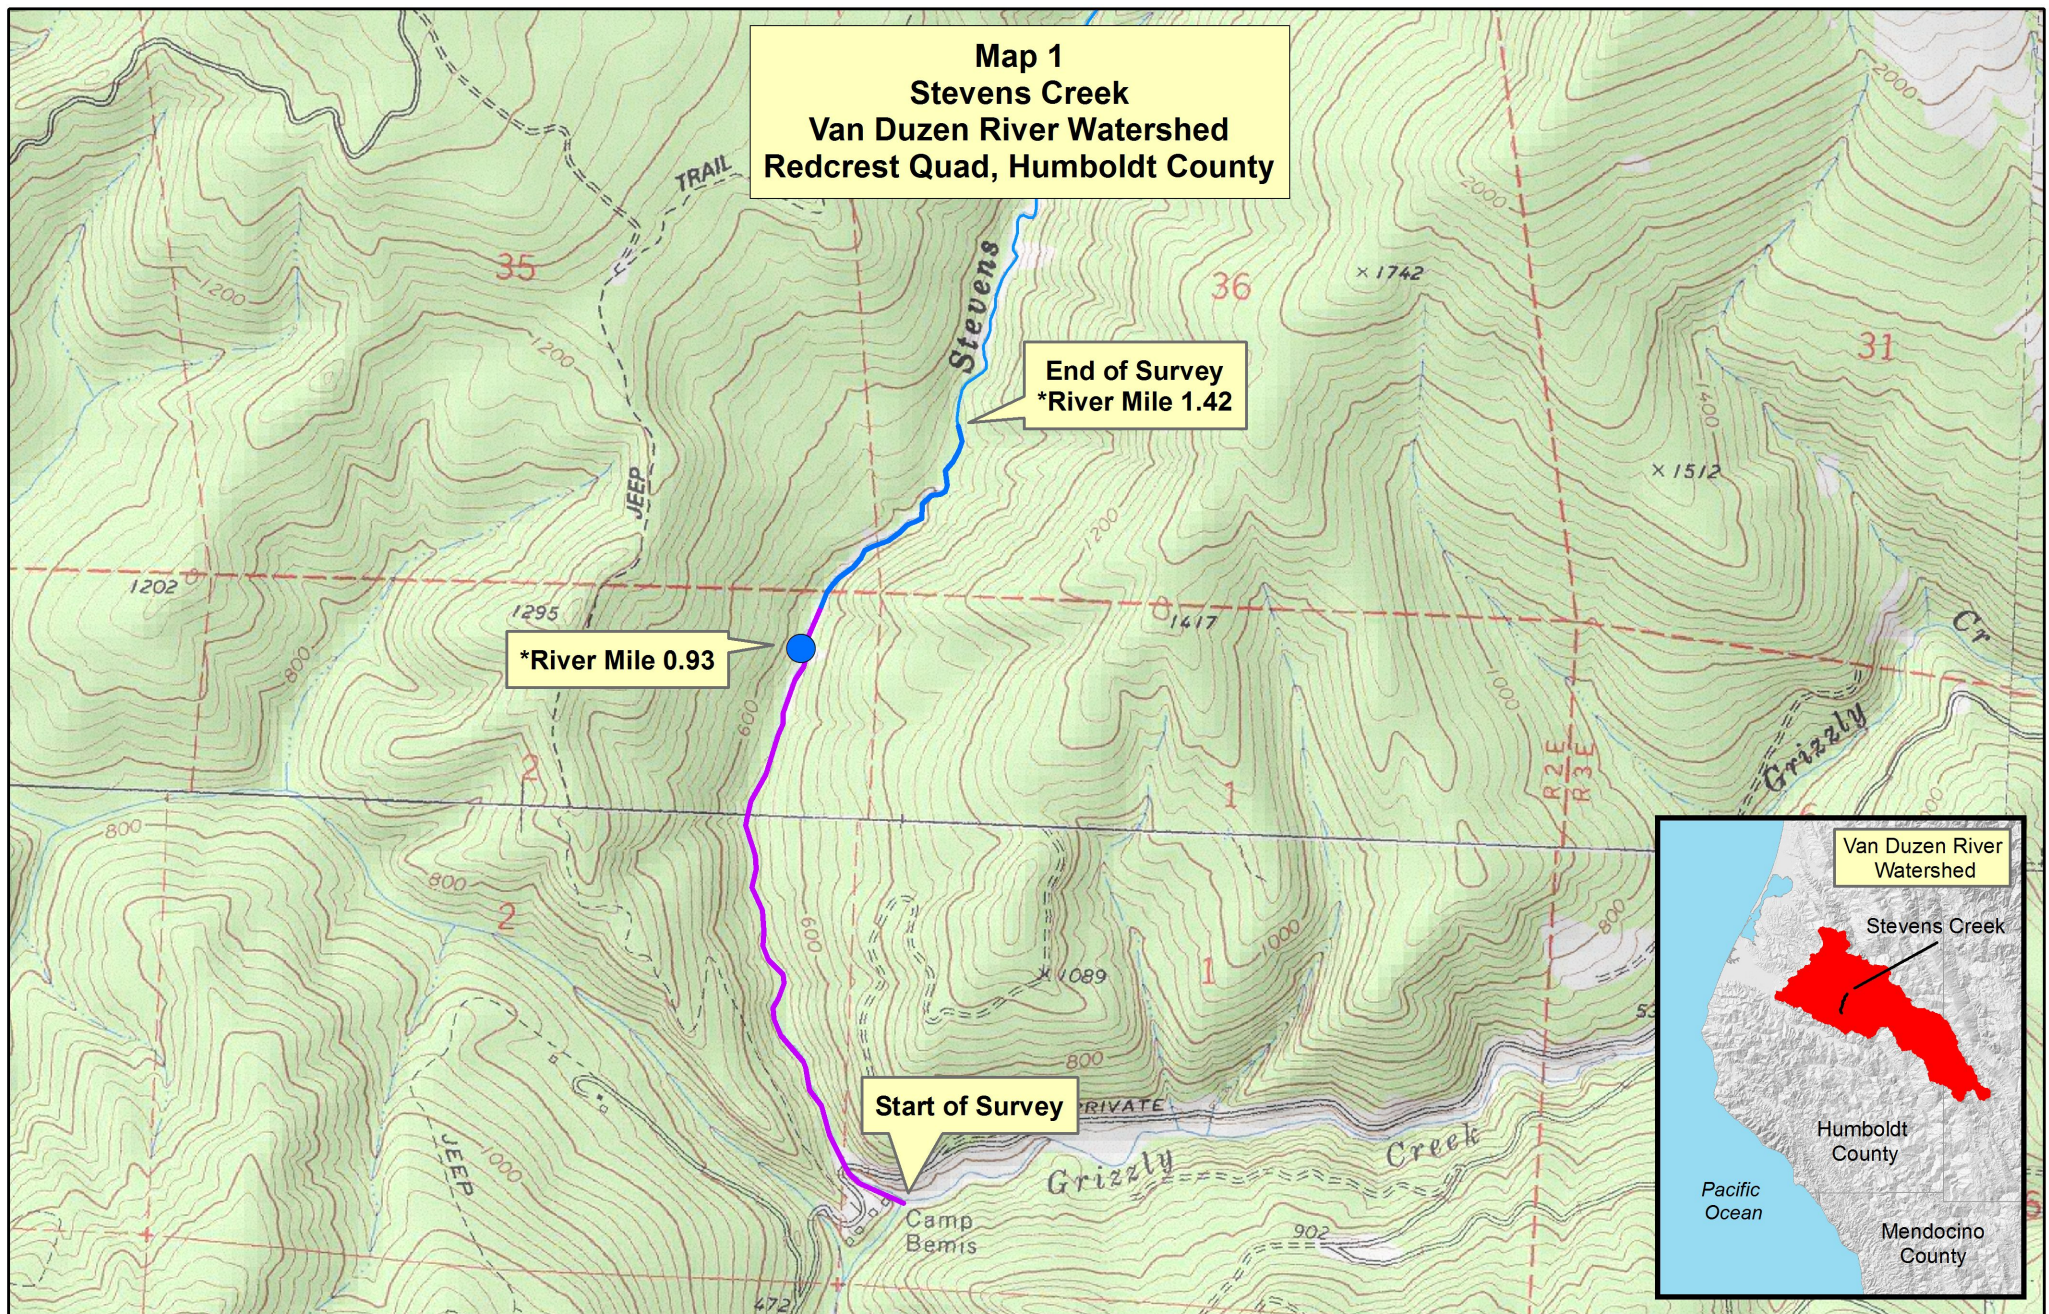
Map 1
Stevens Creek
Van Duzen River Watershed
Redcrest Quad, Humboldt County

During the survey, the upstream-most observation of juvenile steelhead trout occurred at 40.50354° north latitude, -123.91018° west longitude, approximately 4,934 feet upstream from the confluence with Grizzly Creek (Map 1). No coho salmon were observed during the biological or habitat inventory.

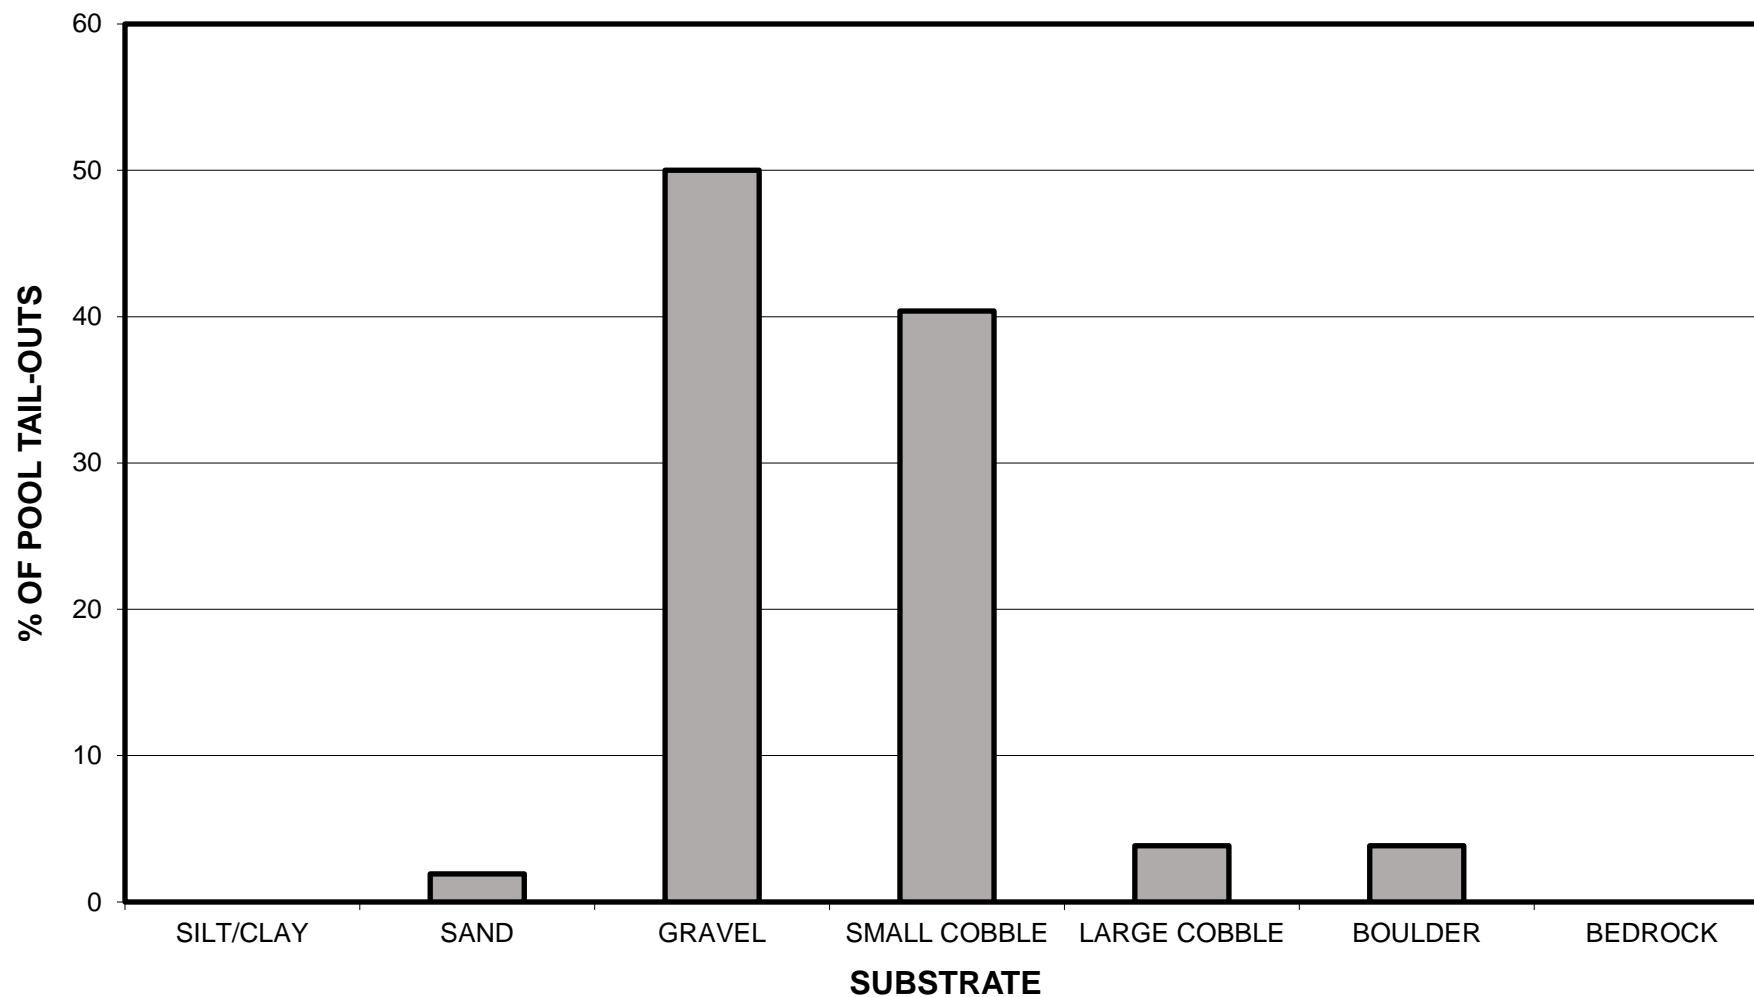
GRAPH 8

Table 6 summarizes the dominant substrate by habitat type. Graph 8 depicts the dominant substrate observed in pool tail-outs. Gravel was the dominant substrate observed in 50% of pool tail-outs. Small cobble was the next most frequently observed dominant substrate type and occurred in 40% of pool tail-outs.

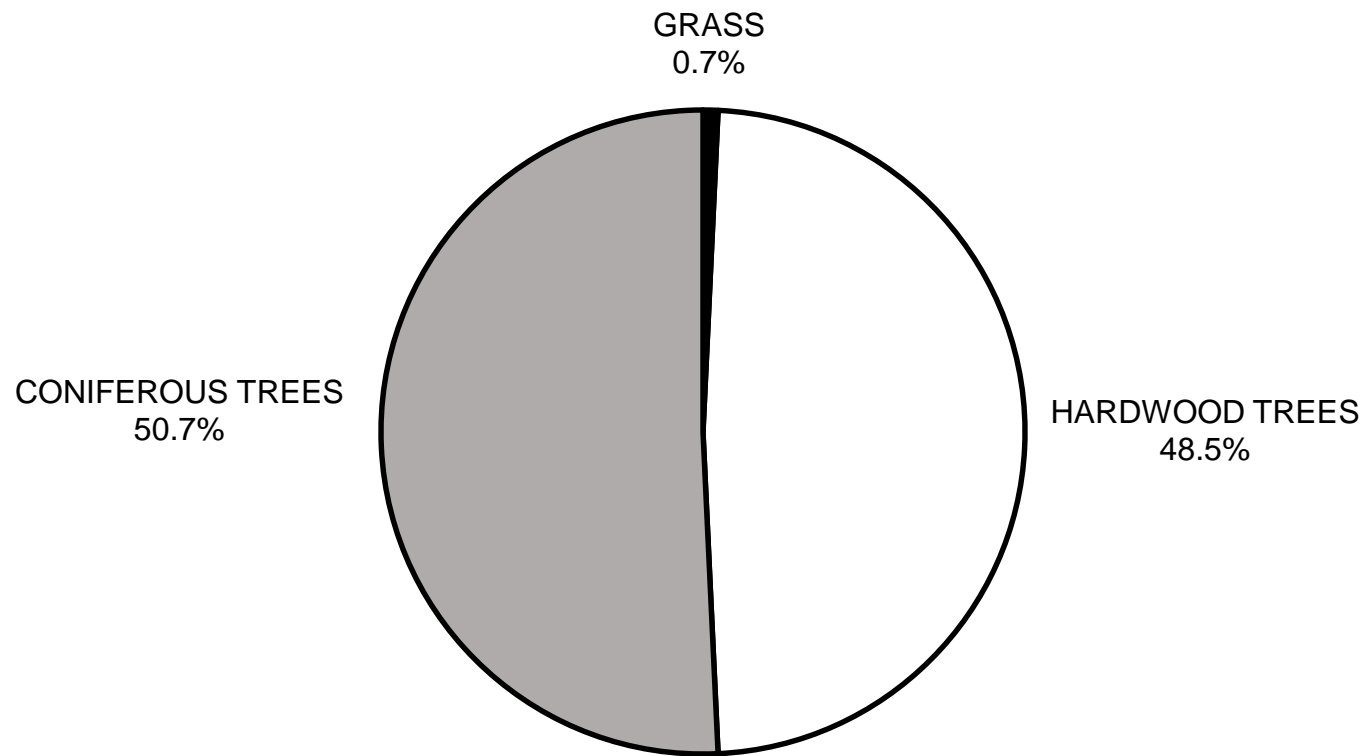
GRAPH 11

For the stream reach surveyed, the mean percent right bank vegetated was 100%. The mean percent left bank vegetated was 100%. The dominant elements composing the structure of the stream banks consisted of 82% sand/silt/clay, 12% bedrock, and 6% cobble/gravel (Graph 10). Coniferous trees were the dominant vegetation type observed in 51% of the units surveyed. Additionally, 49% of the units surveyed had deciduous as the dominant vegetation type, and 1% had grass as the dominant vegetation type (Graph 11).

The percentage of right and left bank covered with vegetation was 100% and 100%, respectively. In areas of stream bank erosion or where bank vegetation is sparse, planting endemic species of coniferous and hardwood trees, in conjunction with bank stabilization, is recommended.
