moffatt & nichol

DRAFT MEMORANDUM

Subject: Berkeley Pier Bird Habitat Field Evaluation

Job Number: 10658

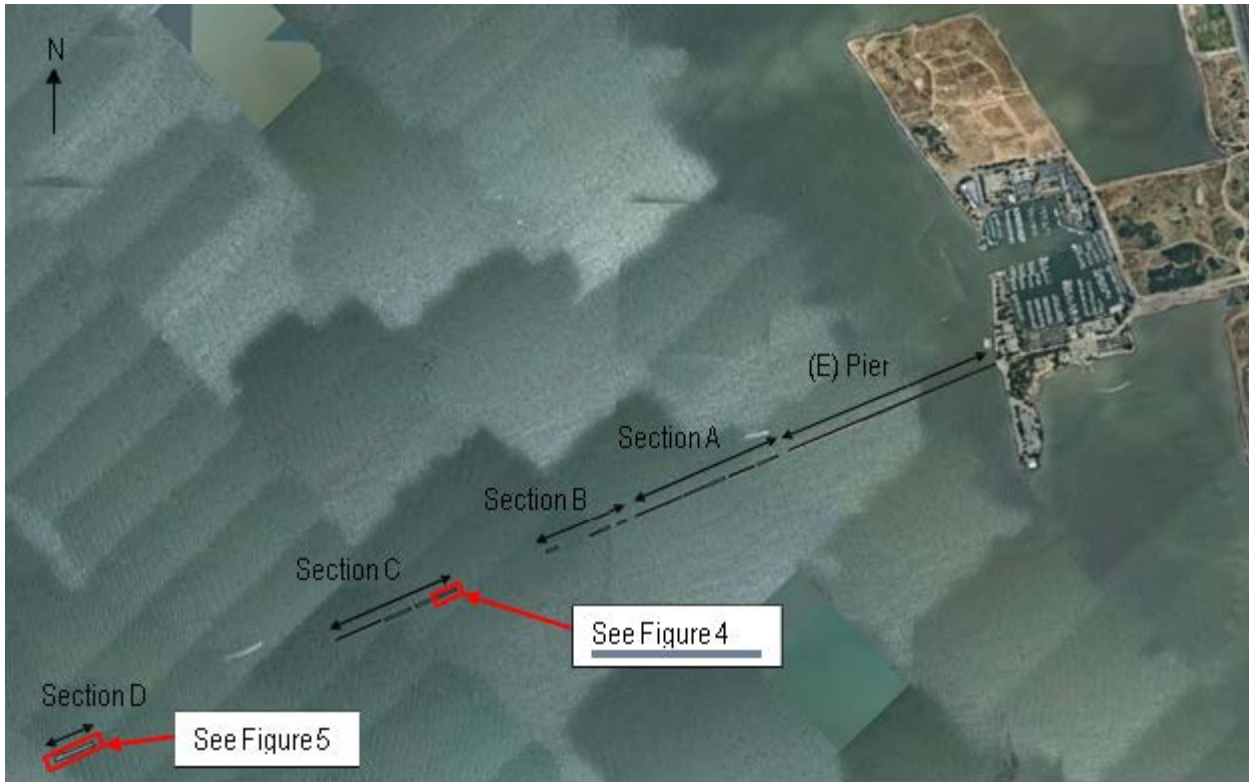
Figure 1: Layout of Berkeley Pier and Inspection Sections

The Pier was divided into 4 distinct sections for inspection (Figure 1).

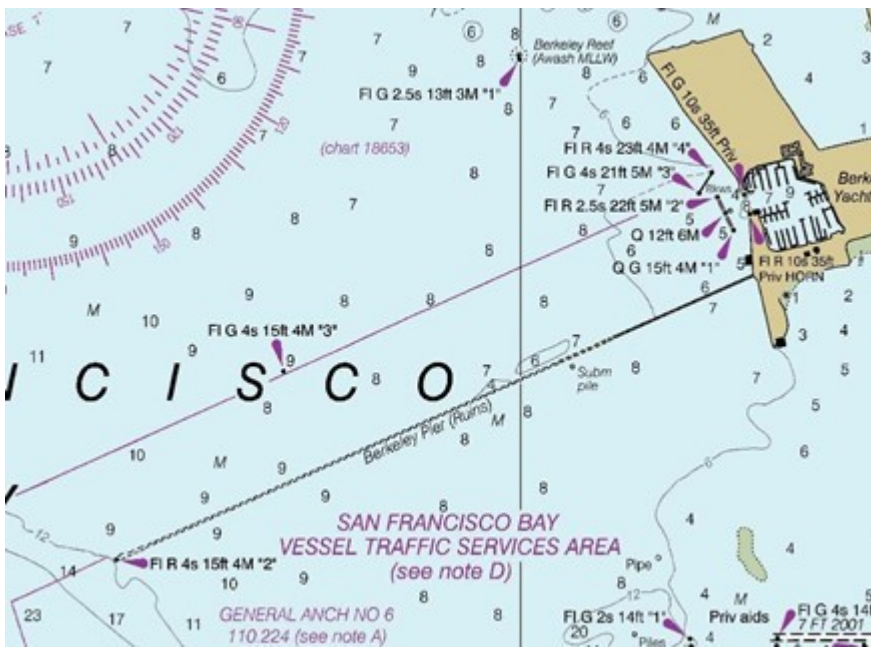
Figure 2: Taken from NOAA Chart 18650 Showing Water Depths in feet Below MLLW

At the time of inspection, no record drawings were available. Based on soundings, taken from current navigational maps, the mudline is expected to be around -9 ft (MLLW) (Figure 2).

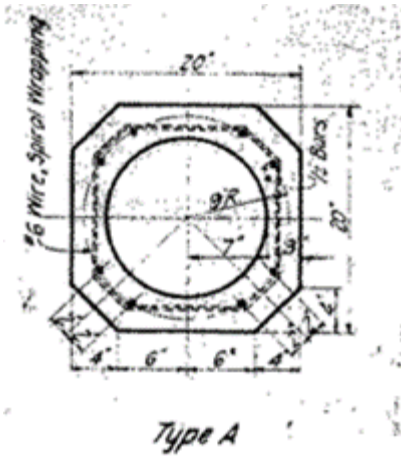
Figure 3: Design of Pile Casing at Encinal Terminals (circa 1920s)

- Plumb timber piles encased in 20 in square concrete jackets with 4 in chamfered edges. The Pier piles are similar to other Piers and Wharves constructed in the area during the period. See Figure 3 for the pile cross section of the 1924 design at Encinal Terminals, Alameda. Concrete casings are generally driven several feet below the mud line to protect the timber pile section from borers. The extent of scour around the remaining Berkeley Pier piles is unknown.
- Concrete bent caps are 15 in tall by 22 in wide. They span perpendicular to the longitudinal axis of the Pier, are spaced at approximately 16 ft O.C. and frame 3 or more piles together.
