**Mission Canyon Stream Habitat Restoration Project
Initial Study/Mitigated Negative Declaration**

Mission Canyon Stream Restoration Project

Supplemental Site Surveys and Comparative
Scoping Analysis

October 2022

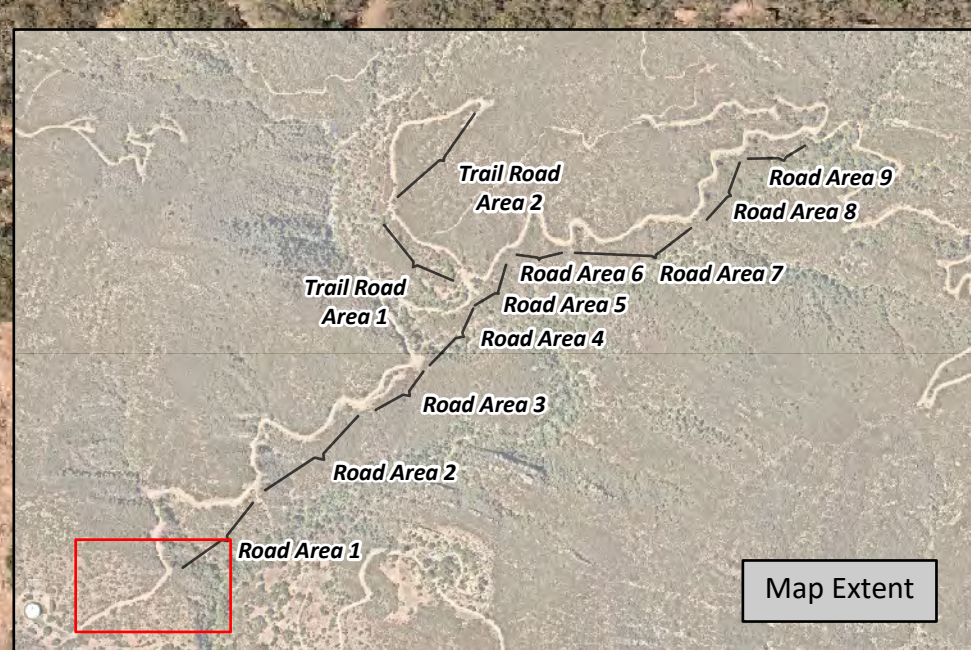
Sidecast Subarea	1.0
Sidecast Distribution	evenly distributed
Large rock >24" diameter	NA
Medium rock >12" diameter and <24" diameter	0-1%
Small rock >4" diameter and <12" diameter	>1-5%
Fines <4" diameter	>25-50%
No Sidecast Present	>50-75%
Depth of sidecast (in)	1
Percent Cover - Native Vegetation	>25-50%
Overall Slope Angle	33°
Impacted tree(s) in sidecast	NA
ESA in sidecast	NA
Notes (1)	Sidecast composition based on cover over entire mapped area. Sidecast is mostly fines. Some rocks 4-12" scattered throughout. No rocks >12" present.
Notes (2)	Mostly native vegetation

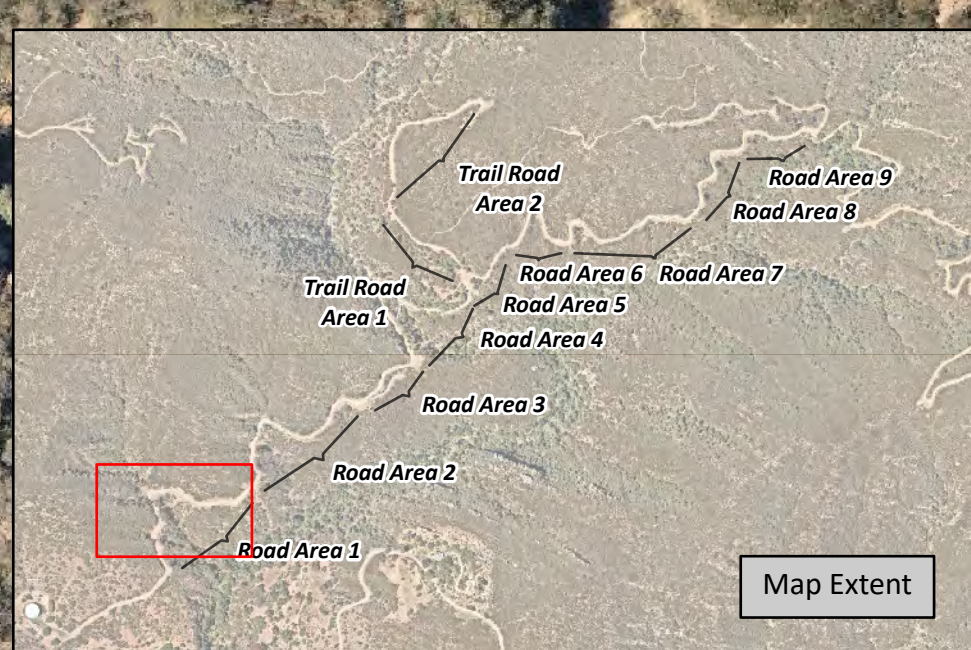
Sidecast Subarea	RA 1 creek
Sidecast Distribution	accumulated in portions
Large rock >24" diameter	>5-25%
Medium rock >12" diameter and <24" diameter	NA
Small rock >4" diameter and <12" diameter	NA
Fines <4" diameter	>25-50%
No Sidecast Present	>25-50%
Depth of sidecast (in)	3
Percent Cover - Native Vegetation	>5-25%
Overall Slope Angle	45°
Impacted tree(s) in sidecast	12
ESA in sidecast	NA
Notes (1)	Sidecast composition based on cover over entire mapped area. Most of sidecast is fines <4". Larger rocks >24" within drainage area.
Notes (2)	NA

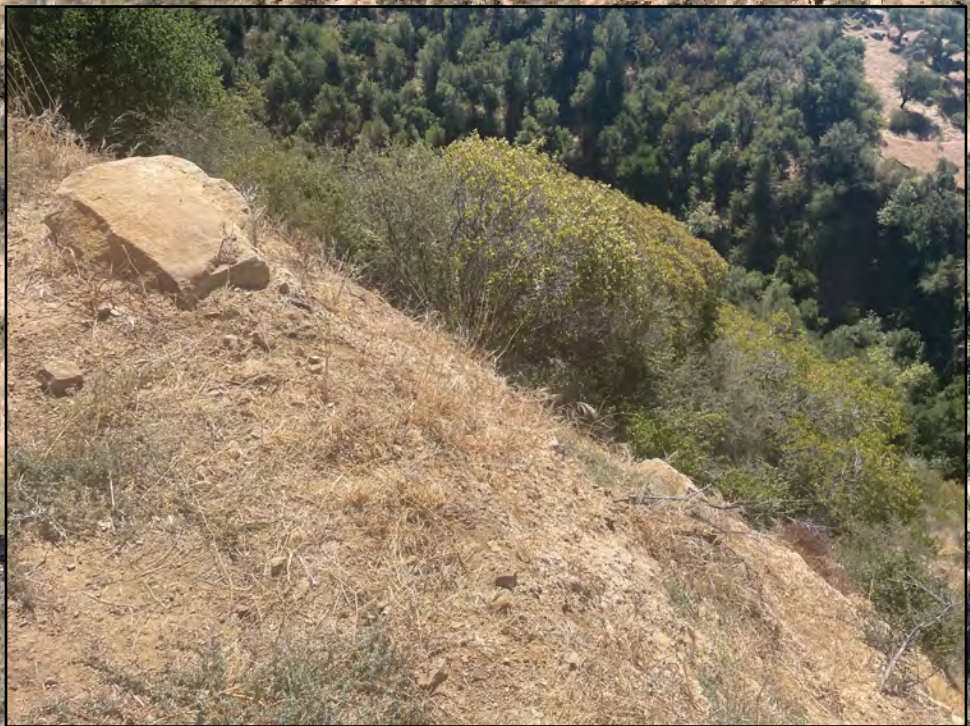
Sidecast Subarea	3.0
Sidecast Distribution	accumulated in portions
Large rock >24" diameter	>1-5%
Medium rock >12" diameter and <24" diameter	NA
Small rock >4" diameter and <12" diameter	>5-25%
Fines <4" diameter	>50-75%
No Sidecast Present	>5-25%
Depth of sidecast (in)	1
Percent Cover - Native Vegetation	>5-25%
Overall Slope Angle	40°
Impacted tree(s) in sidecast	Trees are far downslope not surveyed
ESA in sidecast	NA
Notes (1)	Sidecast composition based on cover over entire mapped area. Mostly bare ground. Most of large material appears to have fallen far downslope. Sidecast <4" throughout the area. One Peruvian pepper tree about 20 m downslope.
Notes (2)	Depth varies.

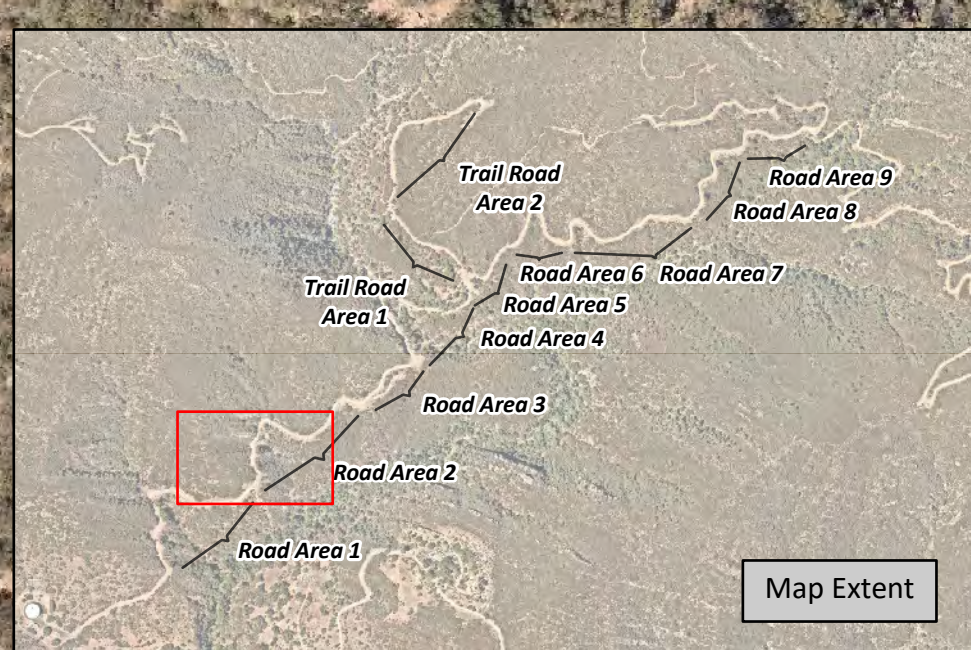
Sidecast Subarea	4.3
Sidecast Distribution	accumulated in portions
Large rock >24" diameter	NA
Medium rock >12" diameter and <24" diameter	>1-5%
Small rock >4" diameter and <12" diameter	NA
Fines <4" diameter	>5-25%
No Sidecast Present	>75%
Depth of sidecast (in)	3
Percent Cover - Native Vegetation	>5-25%
Overall Slope Angle	45°
Impacted tree(s) in sidecast	16
ESA in sidecast	NA
Notes (1)	Sidecast composition based on cover over entire mapped area. Sidecast is minimal in this area. Some rocks 4-12" scattered in around and some accumulations of small material <4" and fines present.
Notes (2)	NA

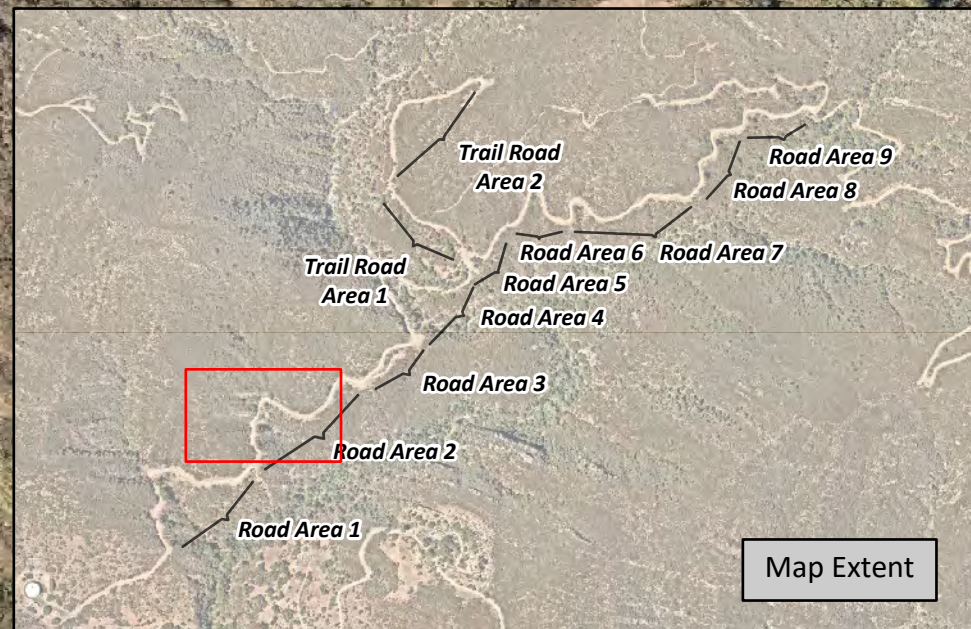
Sidecast Subarea	Road Area 2
Sidecast Distribution	evenly distributed
Large rock >24" diameter	>5-25%
Medium rock >12" diameter and <24" diameter	>25-50%
Small rock >4" diameter and <12" diameter	>25-50%
Fines <4" diameter	>5-25%
No Sidecast Present	>5-25%
Depth of sidecast (in)	NA
Percent Cover - Native Vegetation	>5-25%
Overall Slope Angle	NA
Impacted tree(s) in sidecast	17, 18, 19, 20
ESA in sidecast	NA
Notes (1)	Sidecast composition based on cover over entire mapped area. Most of sidecast is small to medium rocks with few large rocks. All sidecast is within within jurisdictional drainage area.
Notes (2)	No data collected on sidecast depth

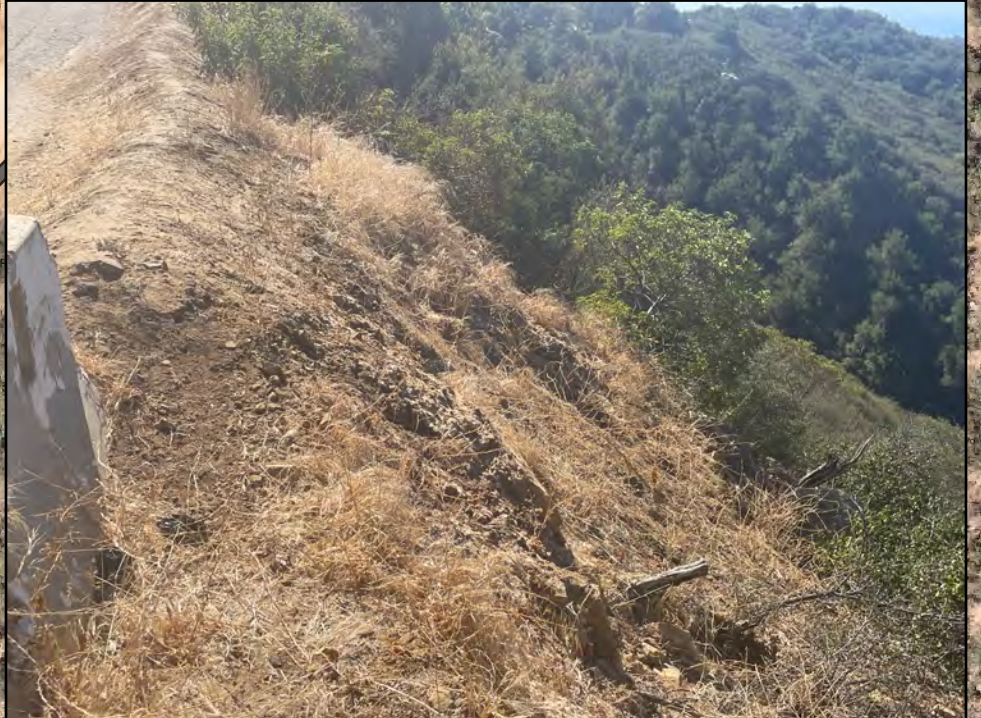
Sidecast Subarea	4.2
Sidecast Distribution	accumulated in portions
Large rock >24" diameter	>1-5%
Medium rock >12" diameter and <24" diameter	>5-25%
Small rock >4" diameter and <12" diameter	NA
Fines <4" diameter	>5-25%
No Sidecast Present	>50-75%
Depth of sidecast (in)	2.5
Percent Cover - Native Vegetation	>5-25%
Overall Slope Angle	45°
Impacted tree(s) in sidecast	NA
ESA in sidecast	NA
Notes (1)	Sidecast composition based on cover over entire mapped area. Most of area is bare ground, large accumulations of material towards the downslope side of the sidecast at the base of shrubs- about 40ft sq.
Notes (2)	NA

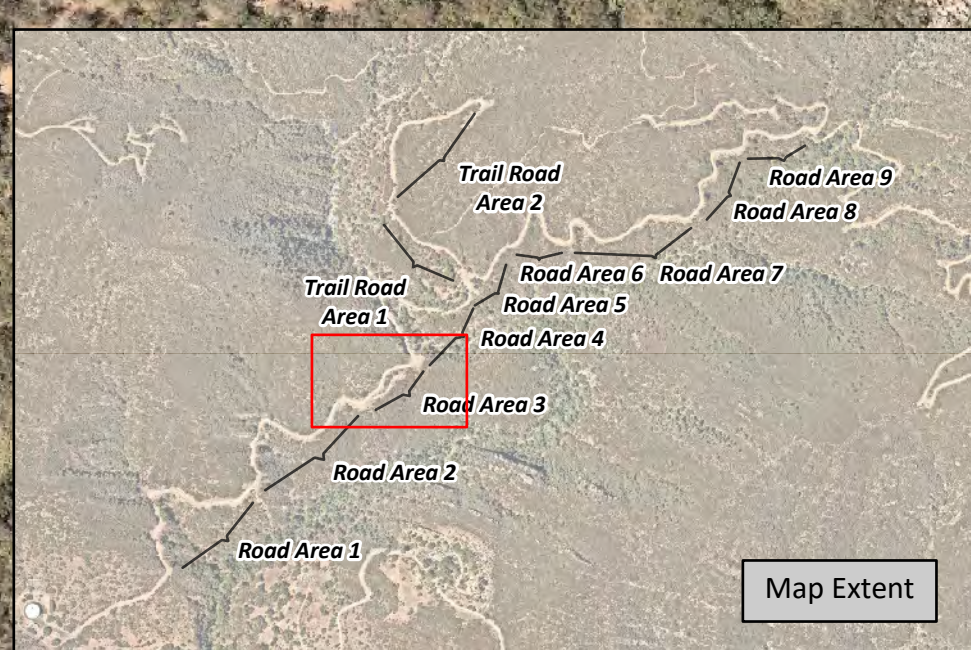
Sidecast Subarea	5.1
Sidecast Distribution	evenly distributed
Large rock >24" diameter	NA
Medium rock >12" diameter and <24" diameter	NA
Small rock >4" diameter and <12" diameter	NA
Fines <4" diameter	>50-75%
No Sidecast Present	>25-50%
Depth of sidecast (in)	4
Percent Cover - Native Vegetation	>1-5%
Overall Slope Angle	40°
Impacted tree(s) in sidecast	NA
ESA in sidecast	NA
Notes (1)	Sidecast composition based on cover over entire mapped area. Most of sidecast is fines and <4". One ceanothus m. And one malosma in northern sidecast, less than 5 percent of total area.
Notes (2)	NA

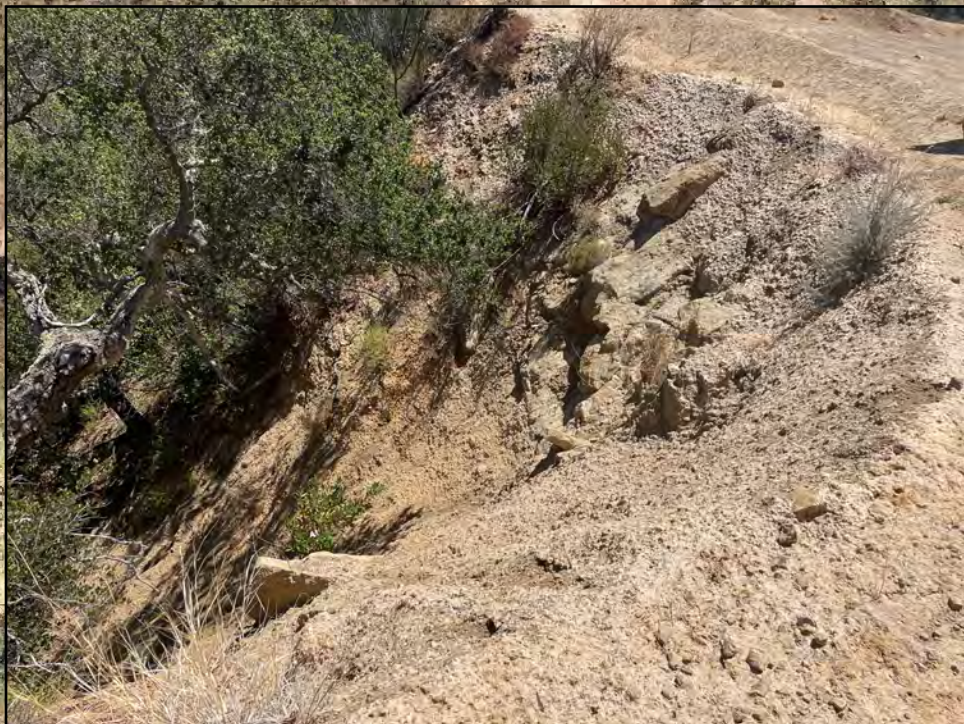
Sidecast Subarea	CRSite4
Sidecast Distribution	accumulated in portions
Large rock >24" diameter	NA
Medium rock >12" diameter and <24" diameter	0-1%
Small rock >4" diameter and <12" diameter	NA
Fines <4" diameter	>5-25%
No Sidecast Present	>75%
Depth of sidecast (in)	NA
Percent Cover - Native Vegetation	>1-5%
Overall Slope Angle	NA
Impacted tree(s) in sidecast	NA
ESA in sidecast	NA
Notes (1)	Sidecast composition based on cover over entire mapped area. Area is mostly bare with very steep slopes. Some sidecast accumulated at base of shrubs closer to the road by most of area looks too steep to accumulate sidecast. No slope data collected because area is too steep.
Notes (2)	NA

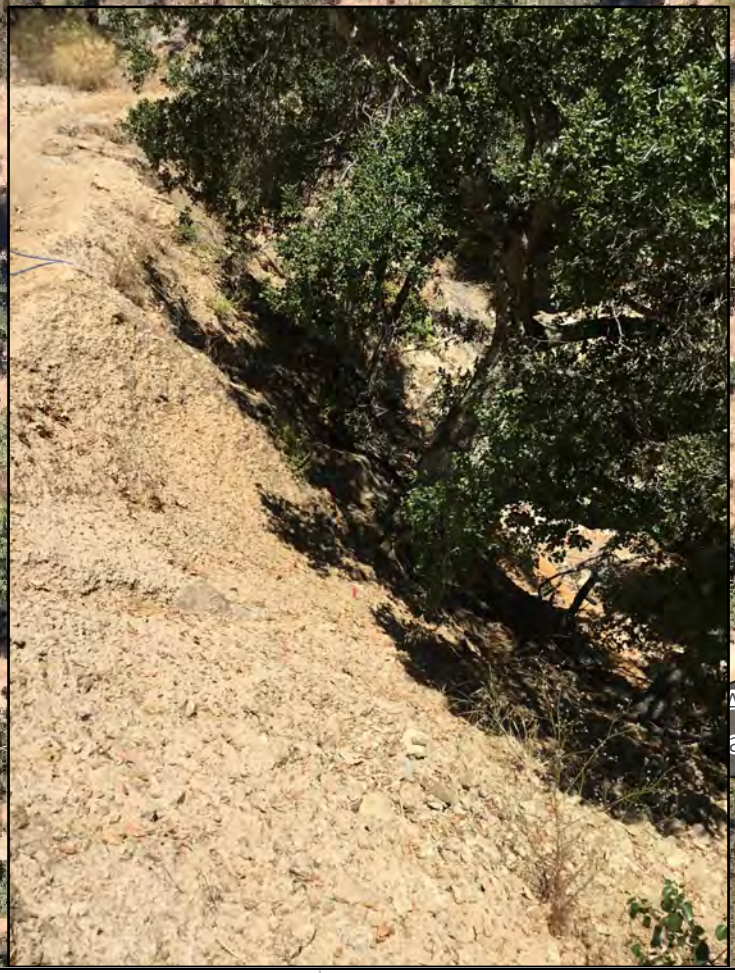
Sidecast Subarea	CRSite2
Sidecast Distribution	evenly distributed
Large rock >24" diameter	>5-25%
Medium rock >12" diameter and <24" diameter	>25-50%
Small rock >4" diameter and <12" diameter	>5-25%
Fines <4" diameter	>1-5%
No Sidecast Present	>25-50%
Depth of sidecast (in)	3
Percent Cover - Native Vegetation	>5-25%
Overall Slope Angle	45°
Impacted tree(s) in sidecast	57, 58, 59, 60, 61, 62
ESA in sidecast	NA
Notes (1)	Sidecast composition based on cover over entire mapped area. Smaller sized rock composition is upslope w/ larger rock size collecting in and above creek. ~4-5 Plummer baccharis within.
Notes (2)	Depth varies.

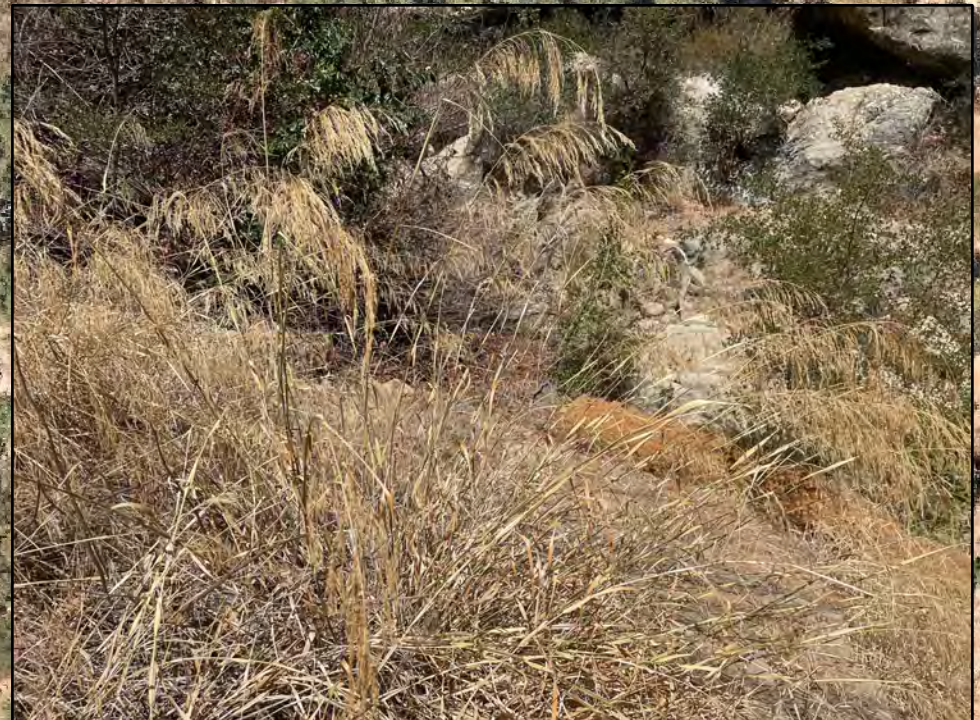
Creek Site 1

Sidecast Subarea	CRSite1
Sidecast Distribution	evenly distributed
Large rock >24" diameter	>25-50%
Medium rock >12" diameter and <24" diameter	NA
Small rock >4" diameter and <12" diameter	NA
Fines <4" diameter	NA
No Sidecast Present	>50-75%
Depth of sidecast (in)	NA
Percent Cover - Native Vegetation	>25-50%
Overall Slope Angle	NA
Impacted tree(s) in sidecast	NA
ESA in sidecast	NA
Notes (1)	Sidecast composition based on cover over entire mapped area. Most sidecast appears to be large boulders, covered with netting. No soil data collected because area is mostly large boulders with some fines in between.
Notes (2)	NA

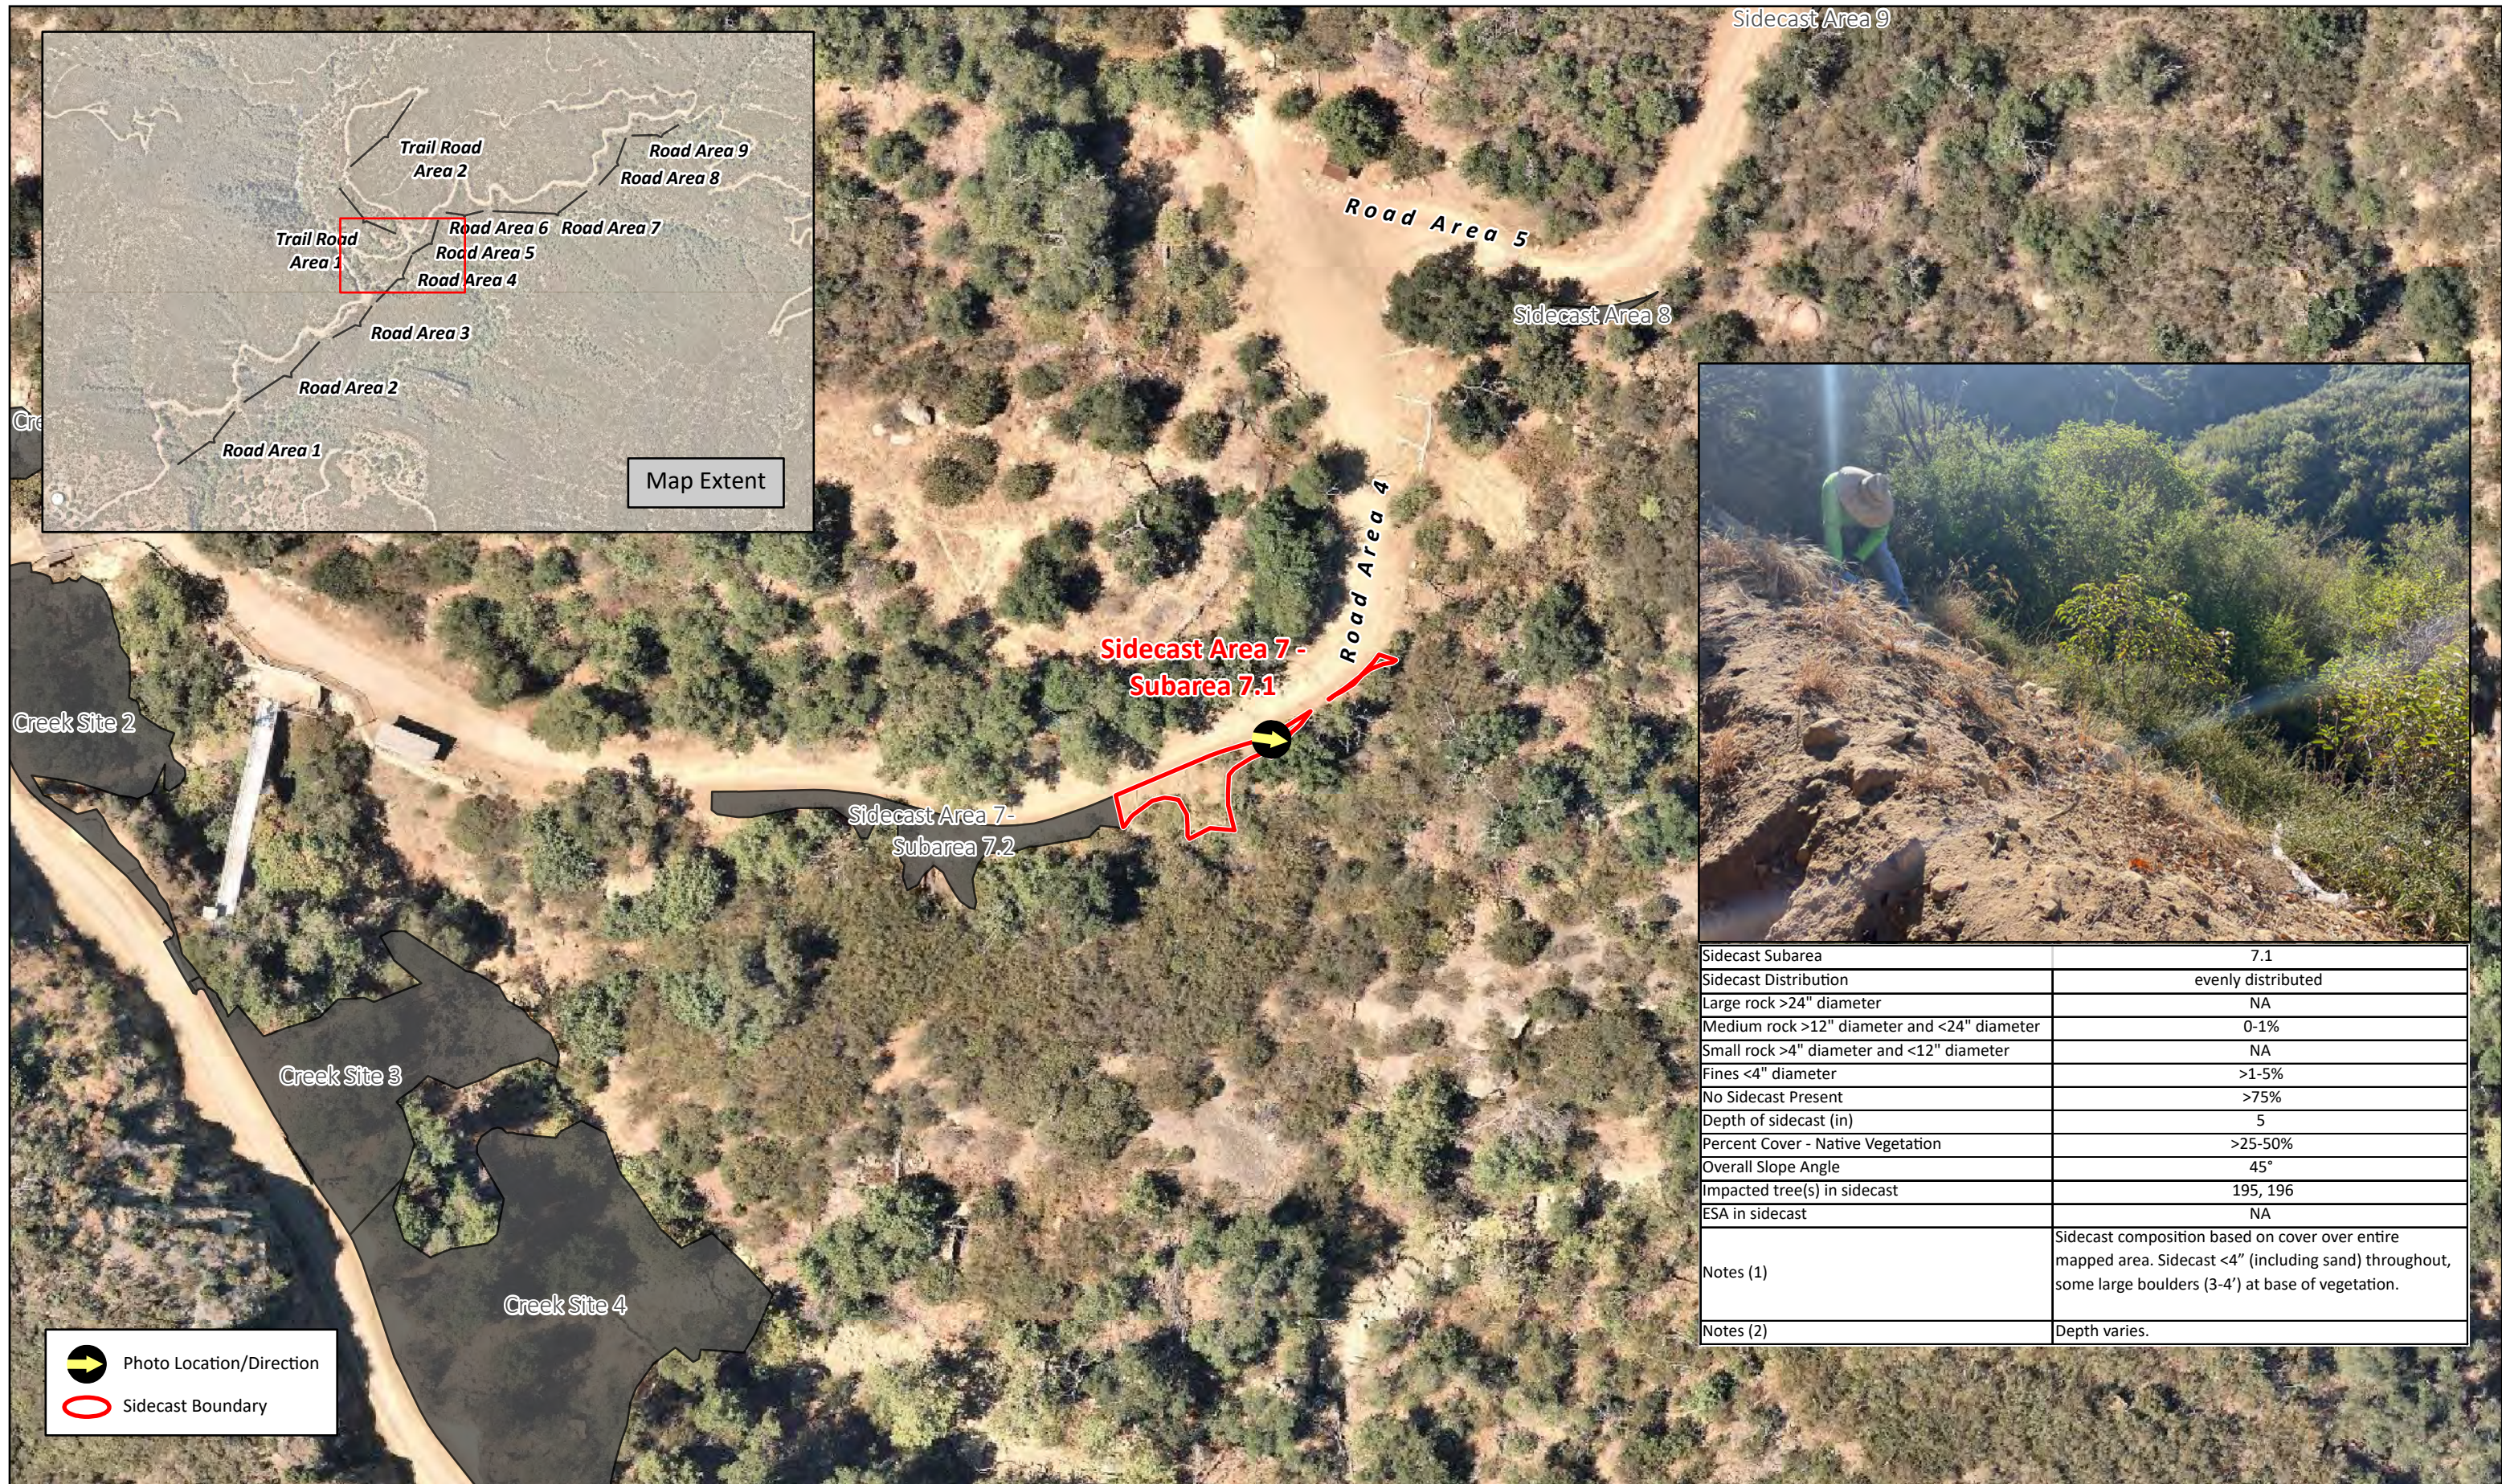
Sidecast Subarea	7.1
Sidecast Distribution	evenly distributed
Large rock >24" diameter	NA
Medium rock >12" diameter and <24" diameter	0-1%
Small rock >4" diameter and <12" diameter	NA
Fines <4" diameter	>1-5%
No Sidecast Present	>75%
Depth of sidecast (in)	5
Percent Cover - Native Vegetation	>25-50%
Overall Slope Angle	45°
Impacted tree(s) in sidecast	195, 196
ESA in sidecast	NA
Notes (1)	Sidecast composition based on cover over entire mapped area. Sidecast <4" (including sand) throughout, some large boulders (3-4') at base of vegetation.
Notes (2)	Depth varies.

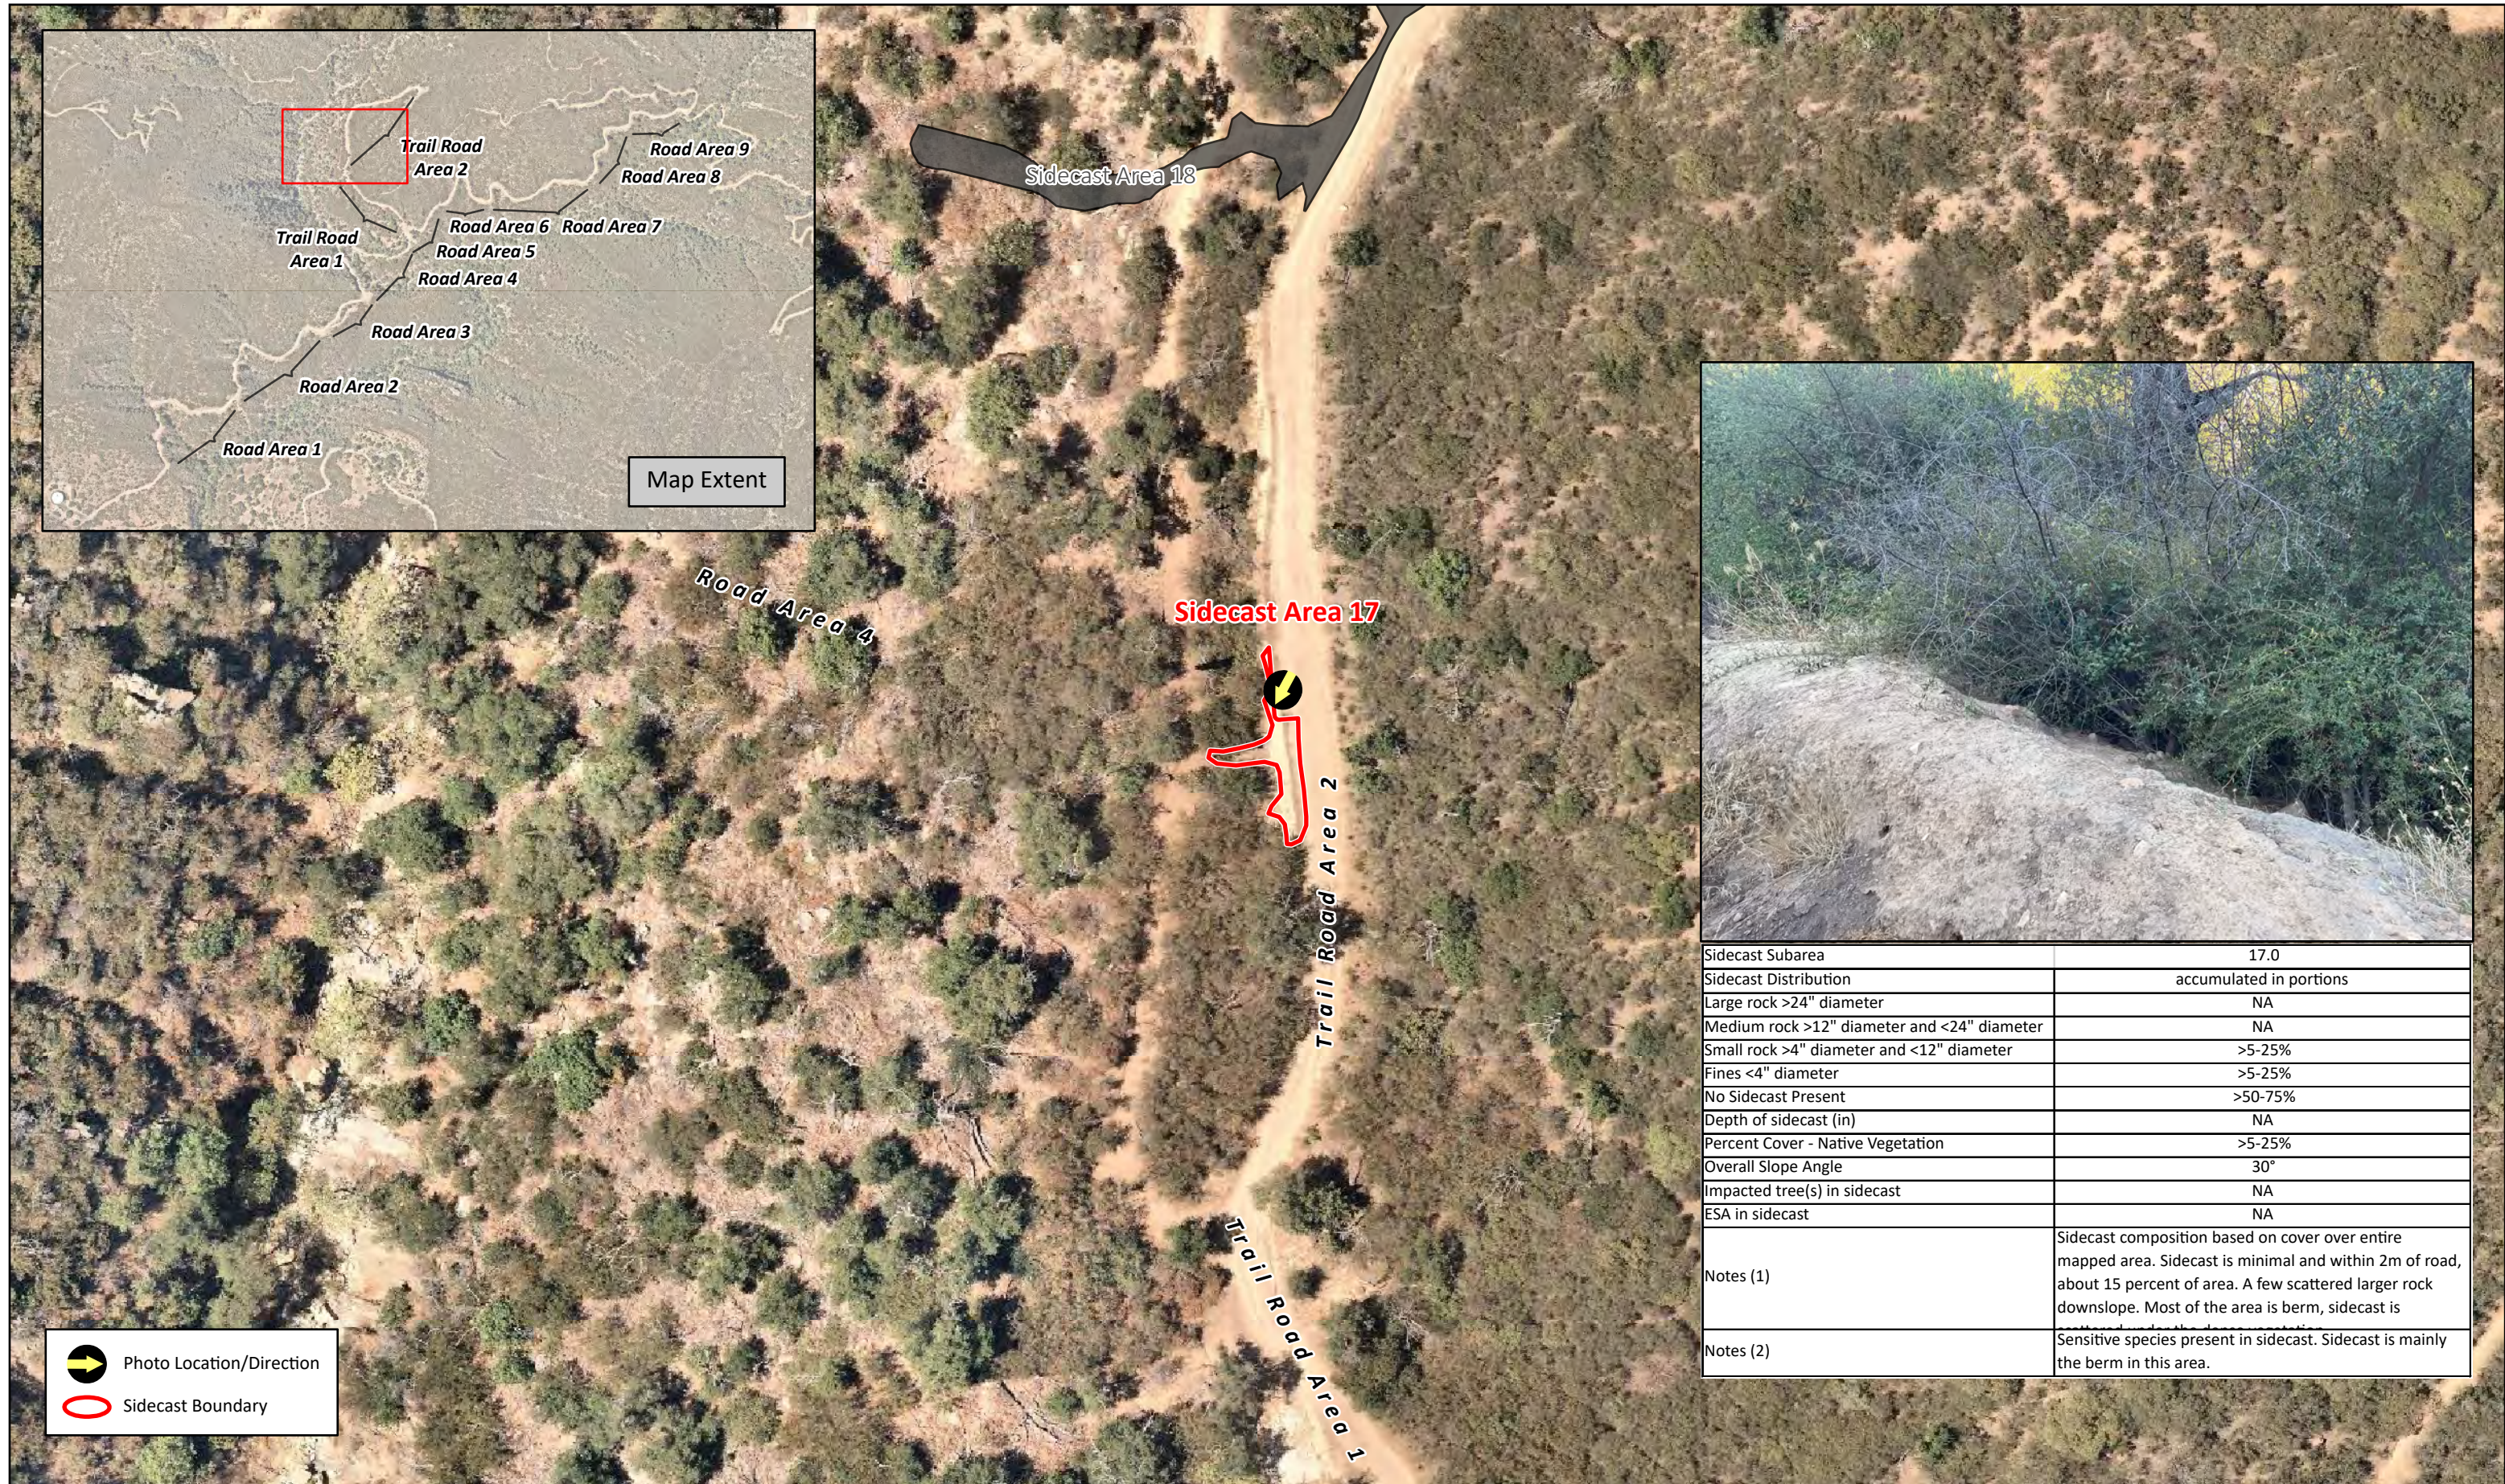
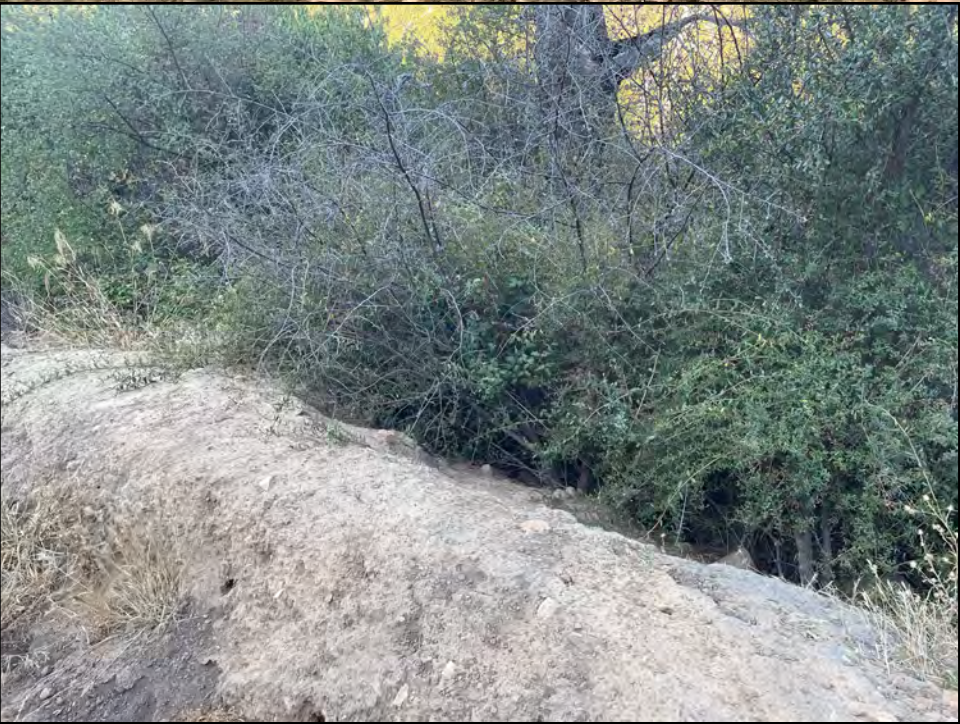
Sidecast Subarea	17.0
Sidecast Distribution	accumulated in portions
Large rock >24" diameter	NA
Medium rock >12" diameter and <24" diameter	NA
Small rock >4" diameter and <12" diameter	>5-25%
Fines <4" diameter	>5-25%
No Sidecast Present	>50-75%
Depth of sidecast (in)	NA
Percent Cover - Native Vegetation	>5-25%
Overall Slope Angle	30°
Impacted tree(s) in sidecast	NA
ESA in sidecast	NA
Notes (1)	Sidecast composition based on cover over entire mapped area. Sidecast is minimal and within 2m of road, about 15 percent of area. A few scattered larger rock downslope. Most of the area is berm, sidecast is
Notes (2)	Sensitive species present in sidecast. Sidecast is mainly the berm in this area.

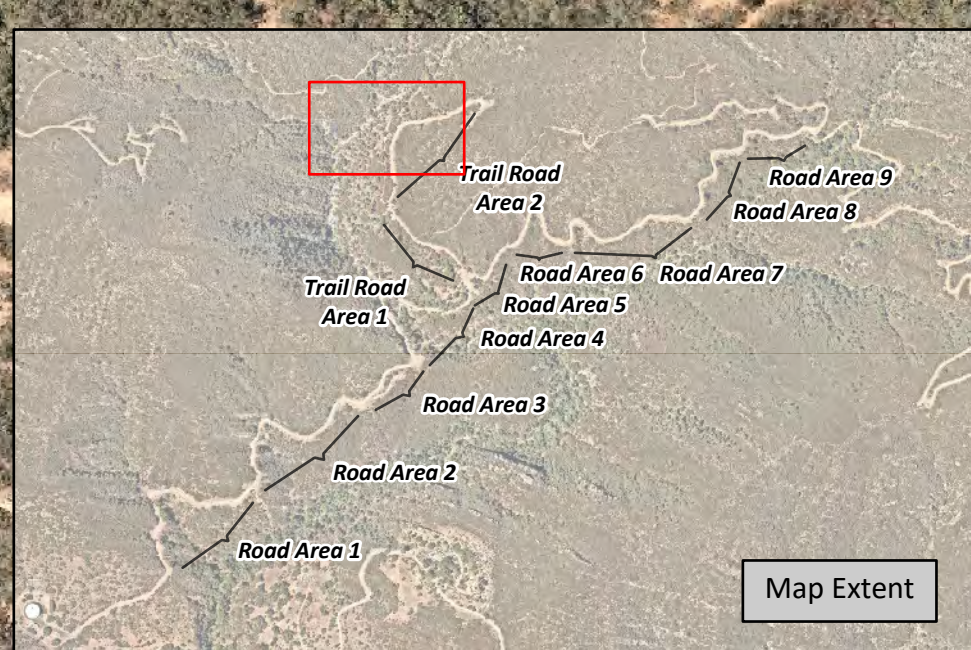
Sidecast Subarea	18.0
Sidecast Distribution	evenly distributed
Large rock >24" diameter	>1-5%
Medium rock >12" diameter and <24" diameter	NA
Small rock >4" diameter and <12" diameter	>25-50%
Fines <4" diameter	>5-25%
No Sidecast Present	>50-75%
Depth of sidecast (in)	2
Percent Cover - Native Vegetation	>5-25%
Overall Slope Angle	35°
Impacted tree(s) in sidecast	109
ESA in sidecast	NA
Notes (1)	Sidecast composition based on cover over entire mapped area. Sidecast is minimal and within 2m of road with a few scattered larger rock downslope. Baccharis plummarae near tree #109. Sidecast fines <4" throughout. Some scattered boulders (2' or greater) present.
Notes (2)	Sensitive species present in sidecast. Sidecast is mainly the berm in this area.

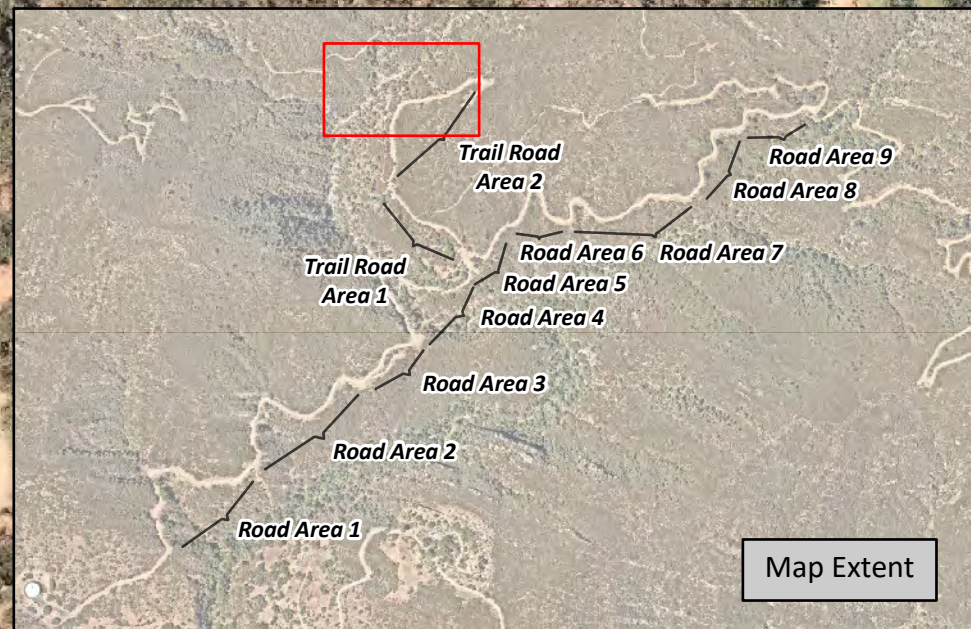
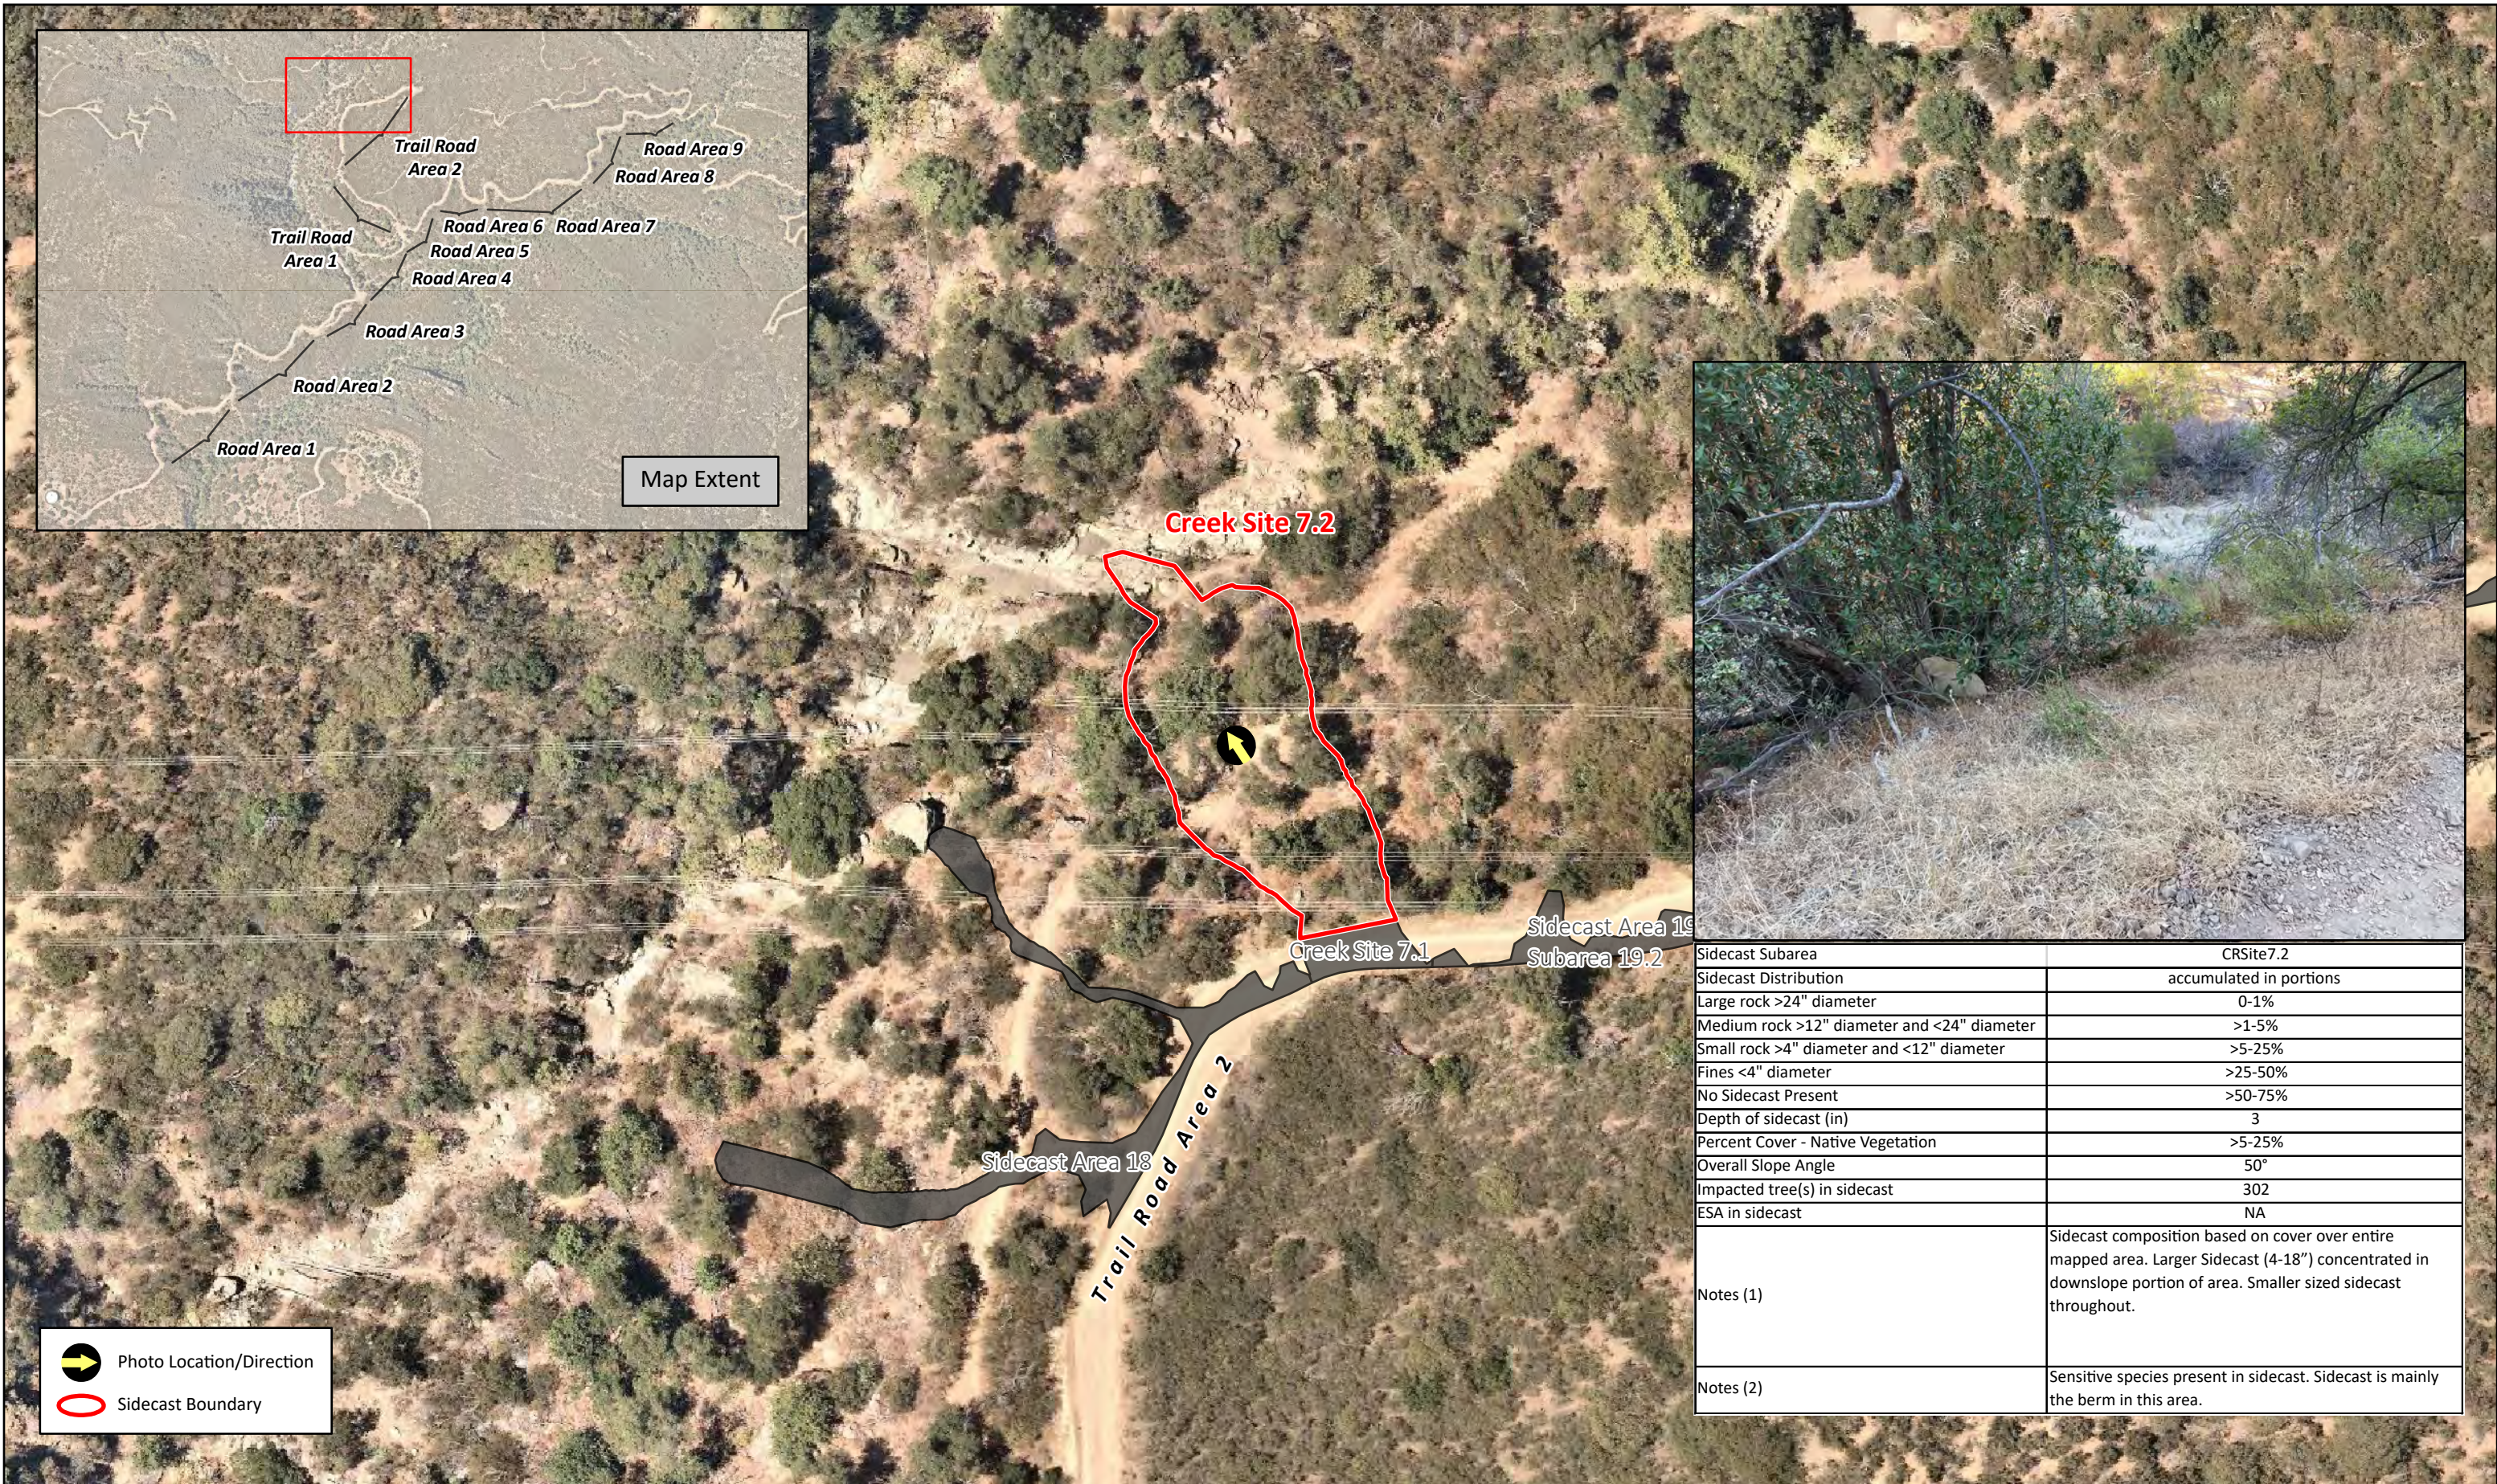
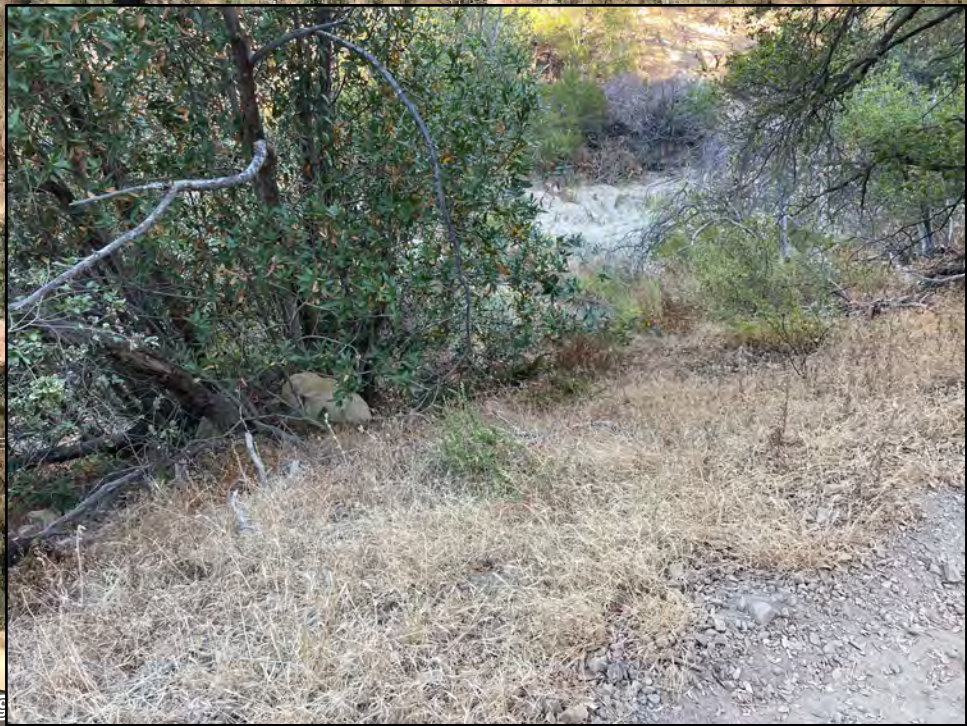
Sidecast Subarea	CRSite7.2
Sidecast Distribution	accumulated in portions
Large rock >24" diameter	0-1%
Medium rock >12" diameter and <24" diameter	>1-5%
Small rock >4" diameter and <12" diameter	>5-25%
Fines <4" diameter	>25-50%
No Sidecast Present	>50-75%
Depth of sidecast (in)	3
Percent Cover - Native Vegetation	>5-25%
Overall Slope Angle	50°
Impacted tree(s) in sidecast	302
ESA in sidecast	NA
Notes (1)	Sidecast composition based on cover over entire mapped area. Larger Sidecast (4-18") concentrated in downslope portion of area. Smaller sized sidecast throughout.
Notes (2)	Sensitive species present in sidecast. Sidecast is mainly the berm in this area.
