**Mission Canyon Stream Habitat Restoration Project
Initial Study/Mitigated Negative Declaration**

Mission Canyon Stream Restoration Project

Supplemental Site Surveys and Comparative
Scoping Analysis

October 2022

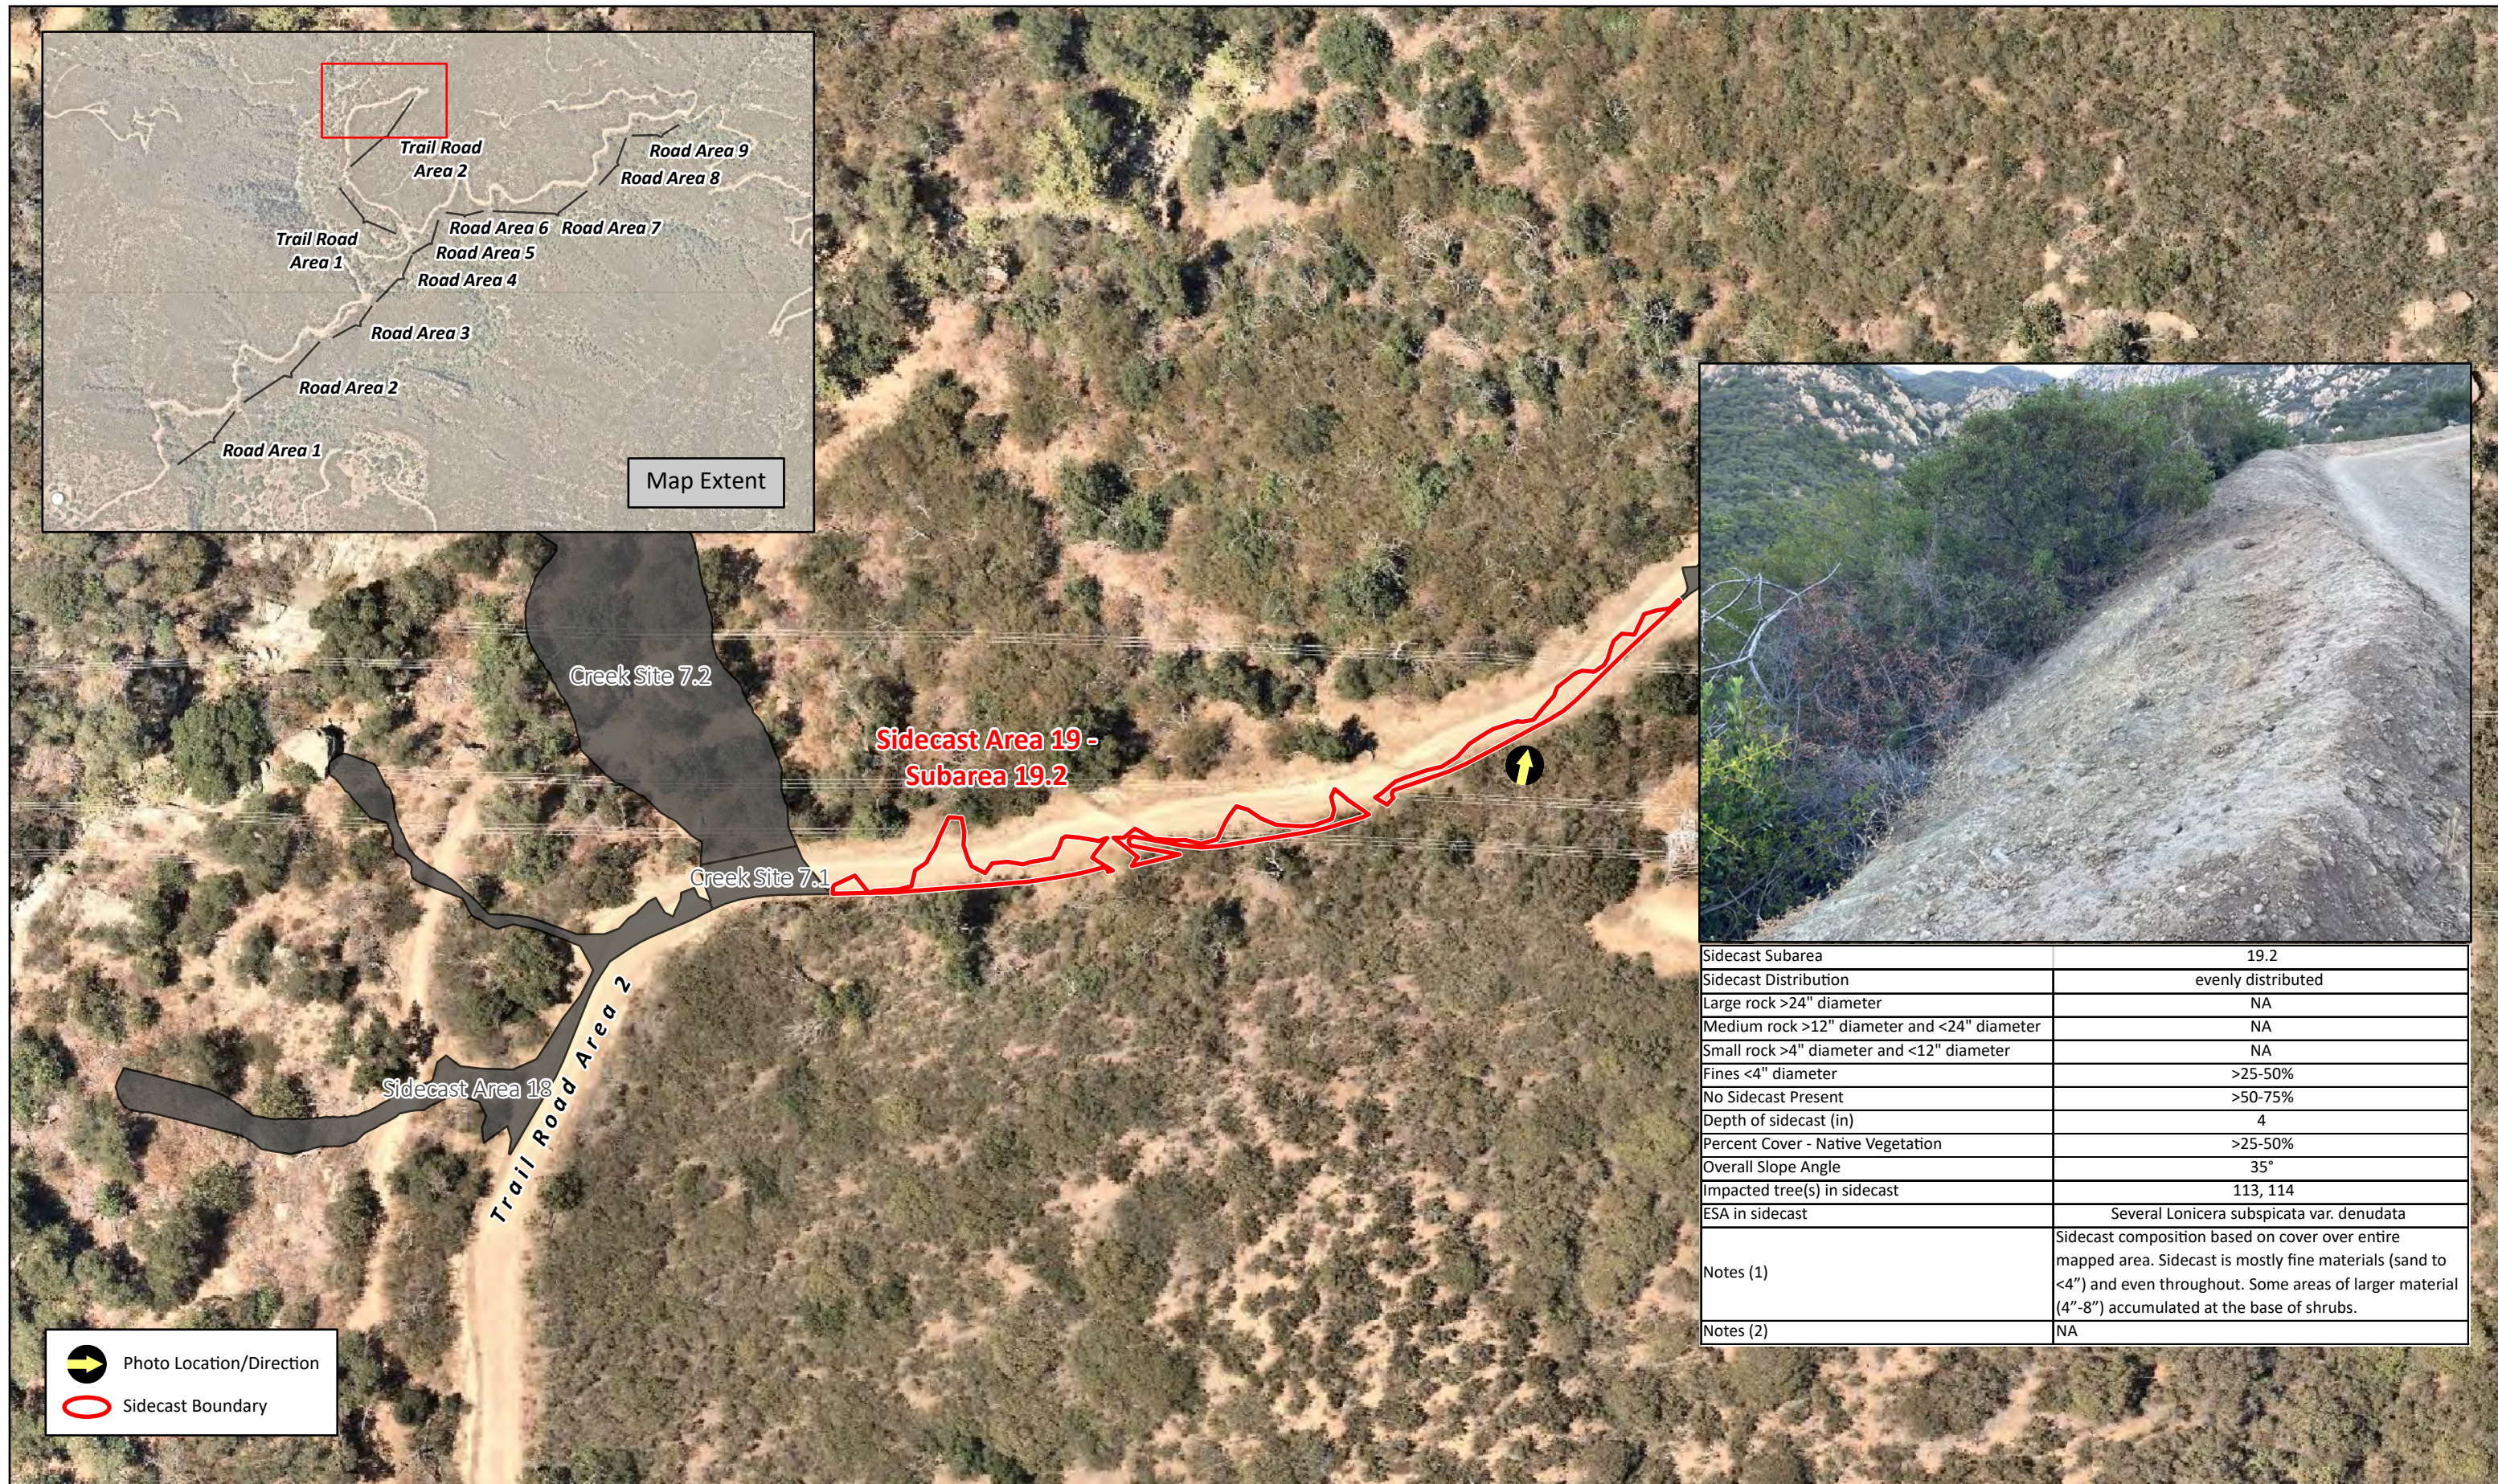
Sidecast Subarea	19.2
Sidecast Distribution	evenly distributed
Large rock >24" diameter	NA
Medium rock >12" diameter and <24" diameter	NA
Small rock >4" diameter and <12" diameter	NA
Fines <4" diameter	>25-50%
No Sidecast Present	>50-75%
Depth of sidecast (in)	4
Percent Cover - Native Vegetation	>25-50%
Overall Slope Angle	35°
Impacted tree(s) in sidecast	113, 114
ESA in sidecast	Several <i>Lonicera subspicata</i> var. <i>denudata</i>
Notes (1)	Sidecast composition based on cover over entire mapped area. Sidecast is mostly fine materials (sand to <4") and even throughout. Some areas of larger material (4"-8") accumulated at the base of shrubs.
Notes (2)	NA

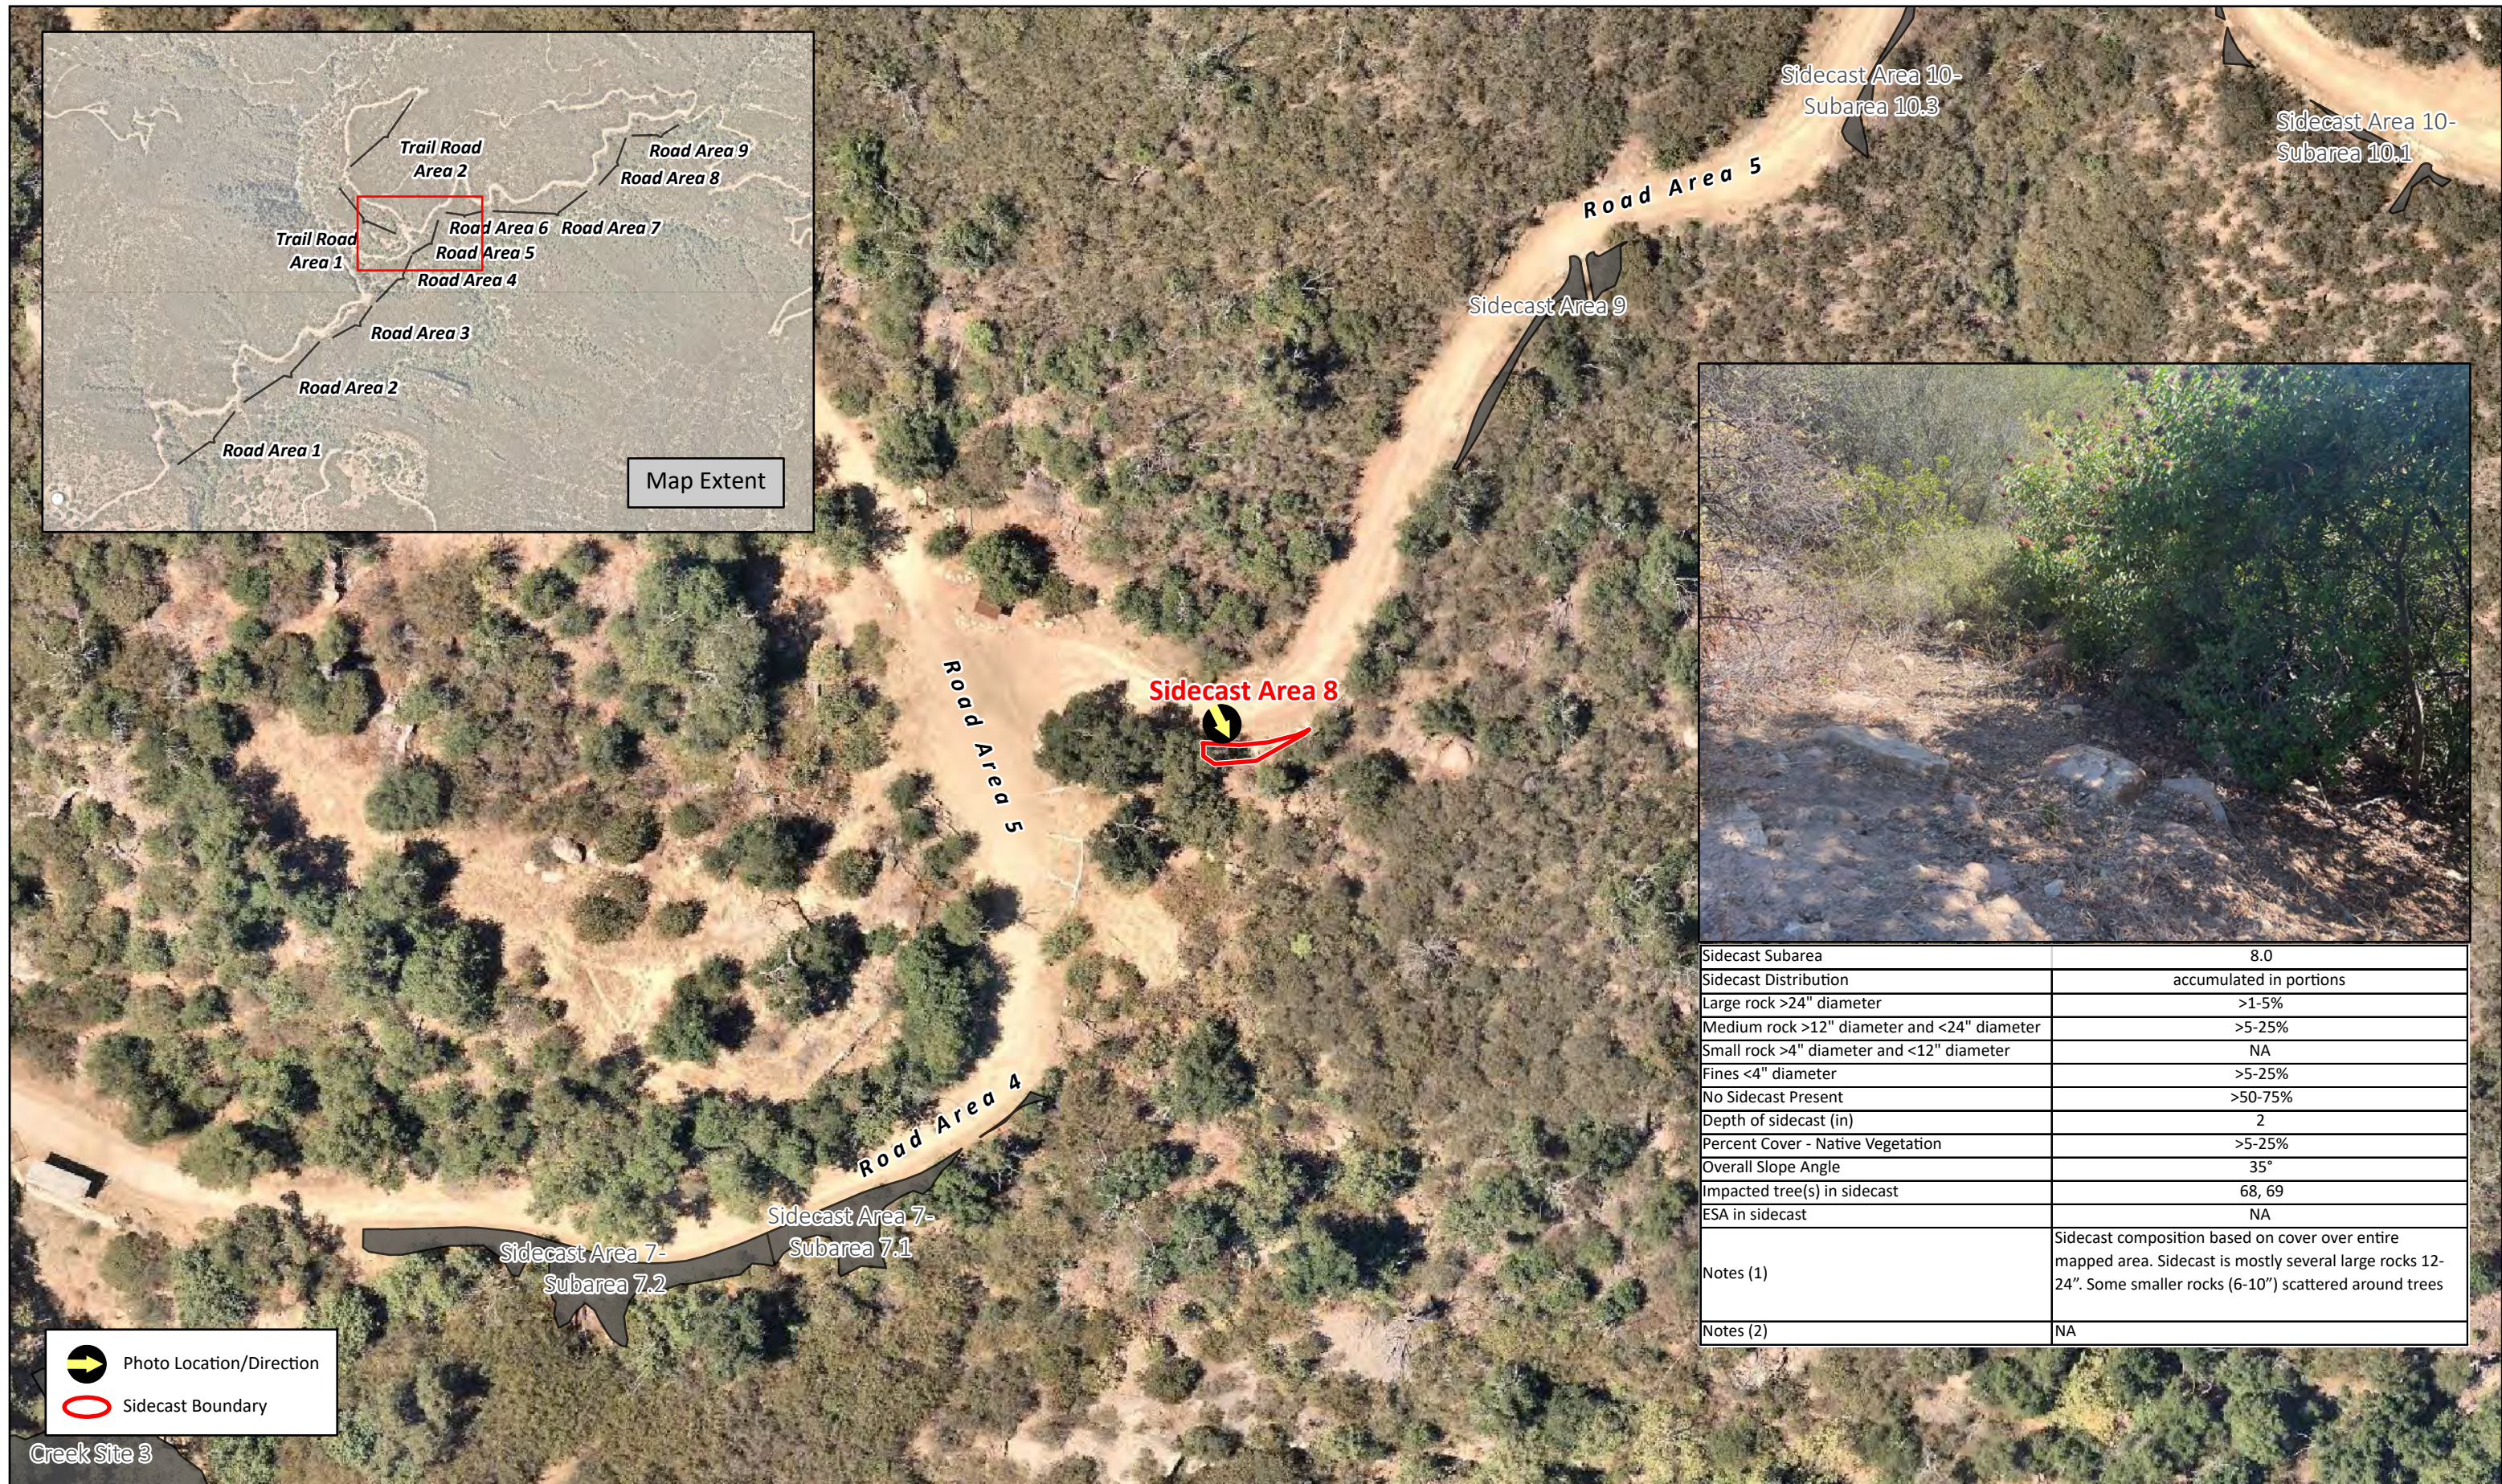
Sidecast Subarea	8.0
Sidecast Distribution	accumulated in portions
Large rock >24" diameter	>1-5%
Medium rock >12" diameter and <24" diameter	>5-25%
Small rock >4" diameter and <12" diameter	NA
Fines <4" diameter	>5-25%
No Sidecast Present	>50-75%
Depth of sidecast (in)	2
Percent Cover - Native Vegetation	>5-25%
Overall Slope Angle	35°
Impacted tree(s) in sidecast	68, 69
ESA in sidecast	NA
Notes (1)	Sidecast composition based on cover over entire mapped area. Sidecast is mostly several large rocks 12-24". Some smaller rocks (6-10") scattered around trees
Notes (2)	NA

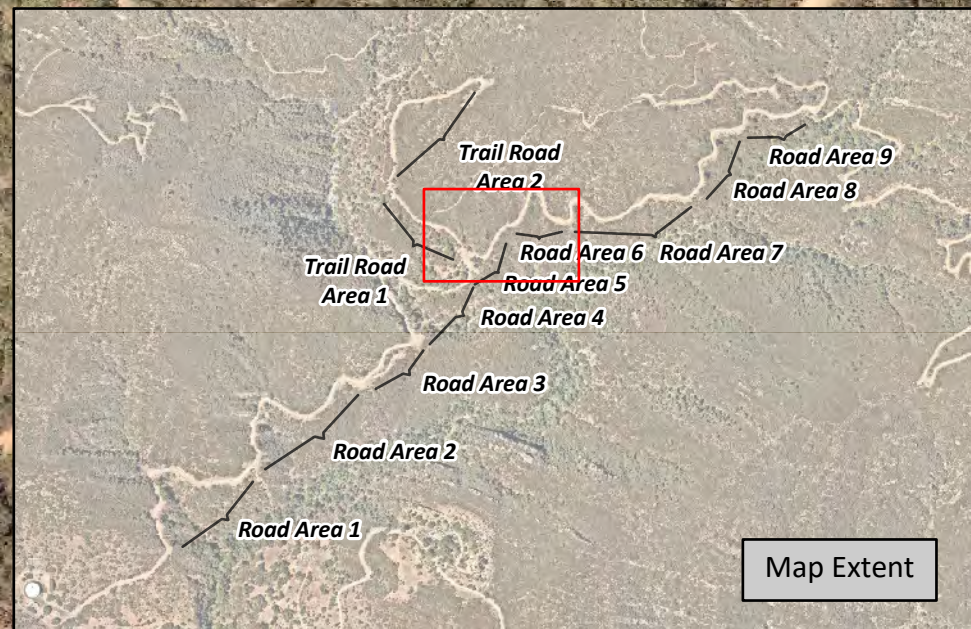
Sidecast Subarea	9.0
Sidecast Distribution	accumulated in portions
Large rock >24" diameter	NA
Medium rock >12" diameter and <24" diameter	NA
Small rock >4" diameter and <12" diameter	>1-5%
Fines <4" diameter	>1-5%
No Sidecast Present	>75%
Depth of sidecast (in)	NA
Percent Cover - Native Vegetation	>5-25%
Overall Slope Angle	9°
Impacted tree(s) in sidecast	194
ESA in sidecast	NA
Notes (1)	Sidecast composition based on cover over entire mapped area. Very little sidecast in this area, mostly limited to area around the berm. Slope is not steep. Very dense vegetation.
Notes (2)	Most of sidecast for this subarea is located at this point, which is minimal.

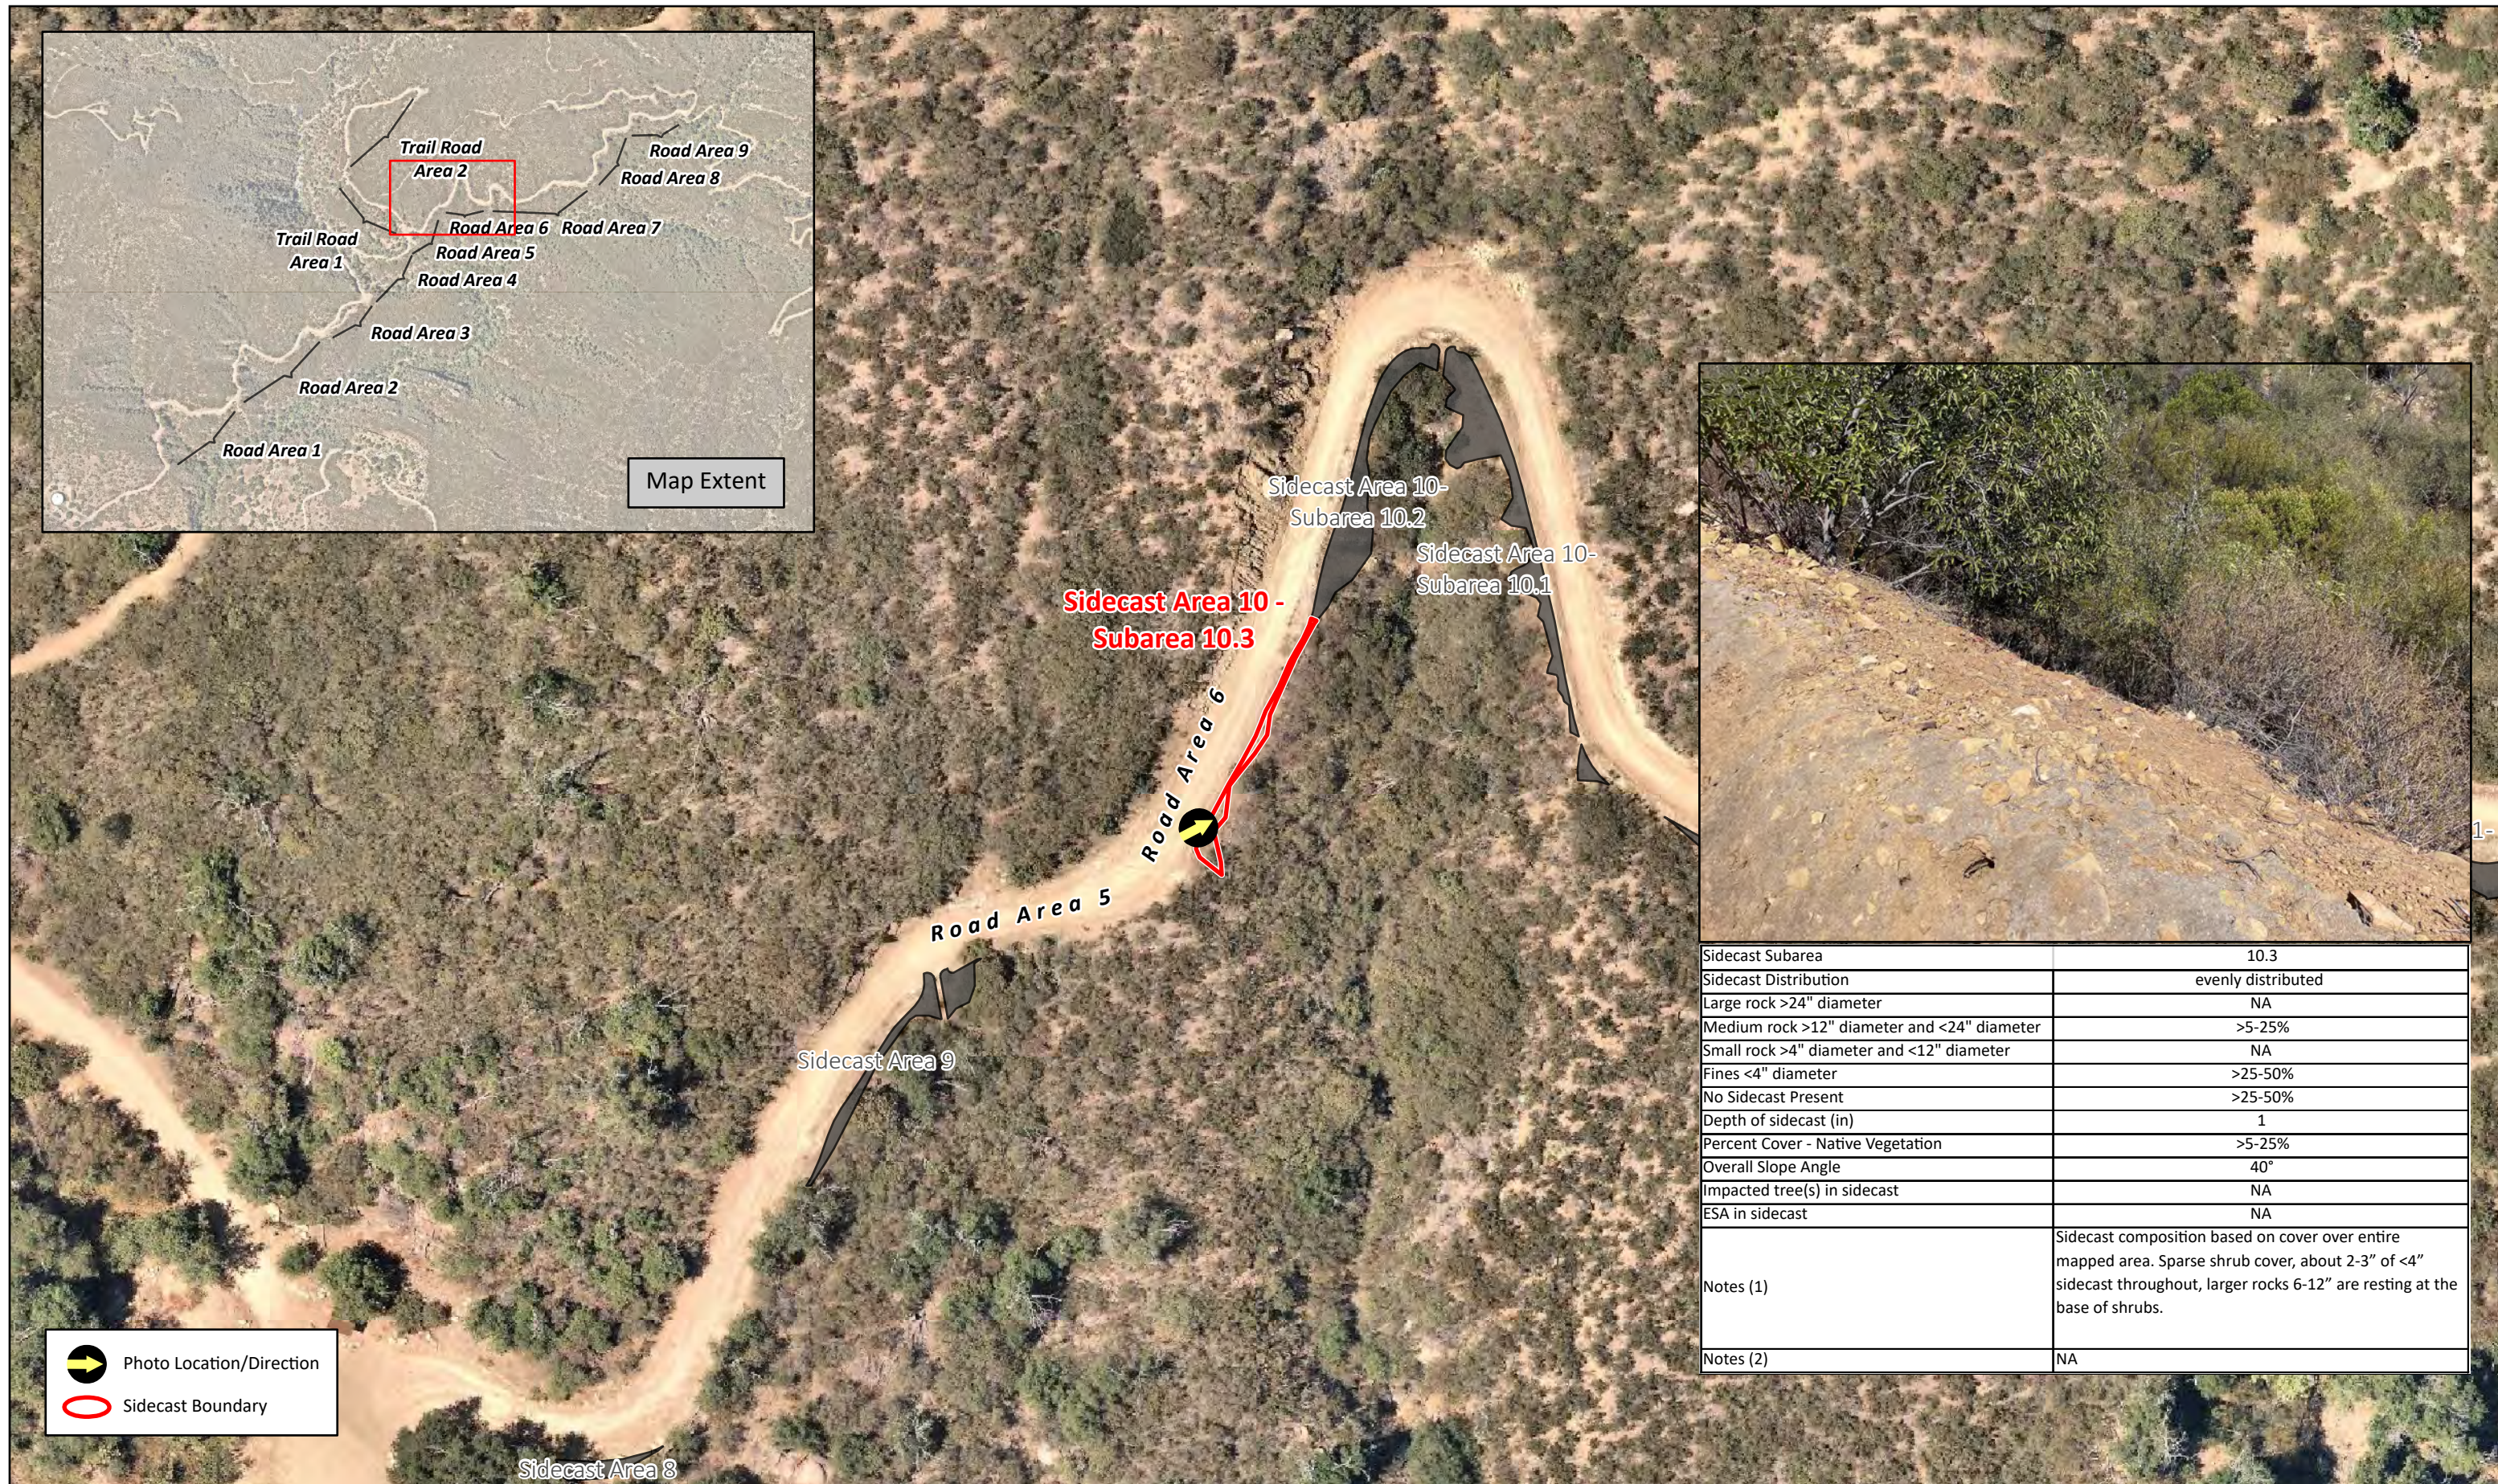
Sidecast Subarea	10.3
Sidecast Distribution	evenly distributed
Large rock >24" diameter	NA
Medium rock >12" diameter and <24" diameter	>5-25%
Small rock >4" diameter and <12" diameter	NA
Fines <4" diameter	>25-50%
No Sidecast Present	>25-50%
Depth of sidecast (in)	1
Percent Cover - Native Vegetation	>5-25%
Overall Slope Angle	40°
Impacted tree(s) in sidecast	NA
ESA in sidecast	NA
Notes (1)	Sidecast composition based on cover over entire mapped area. Sparse shrub cover, about 2-3" of <4" sidecast throughout, larger rocks 6-12" are resting at the base of shrubs.
Notes (2)	NA

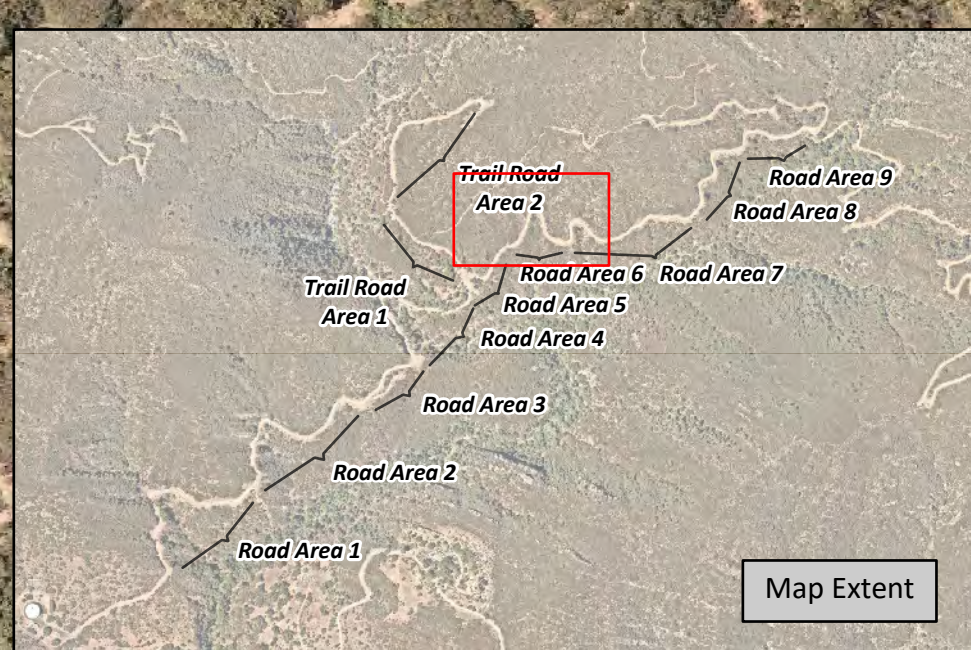
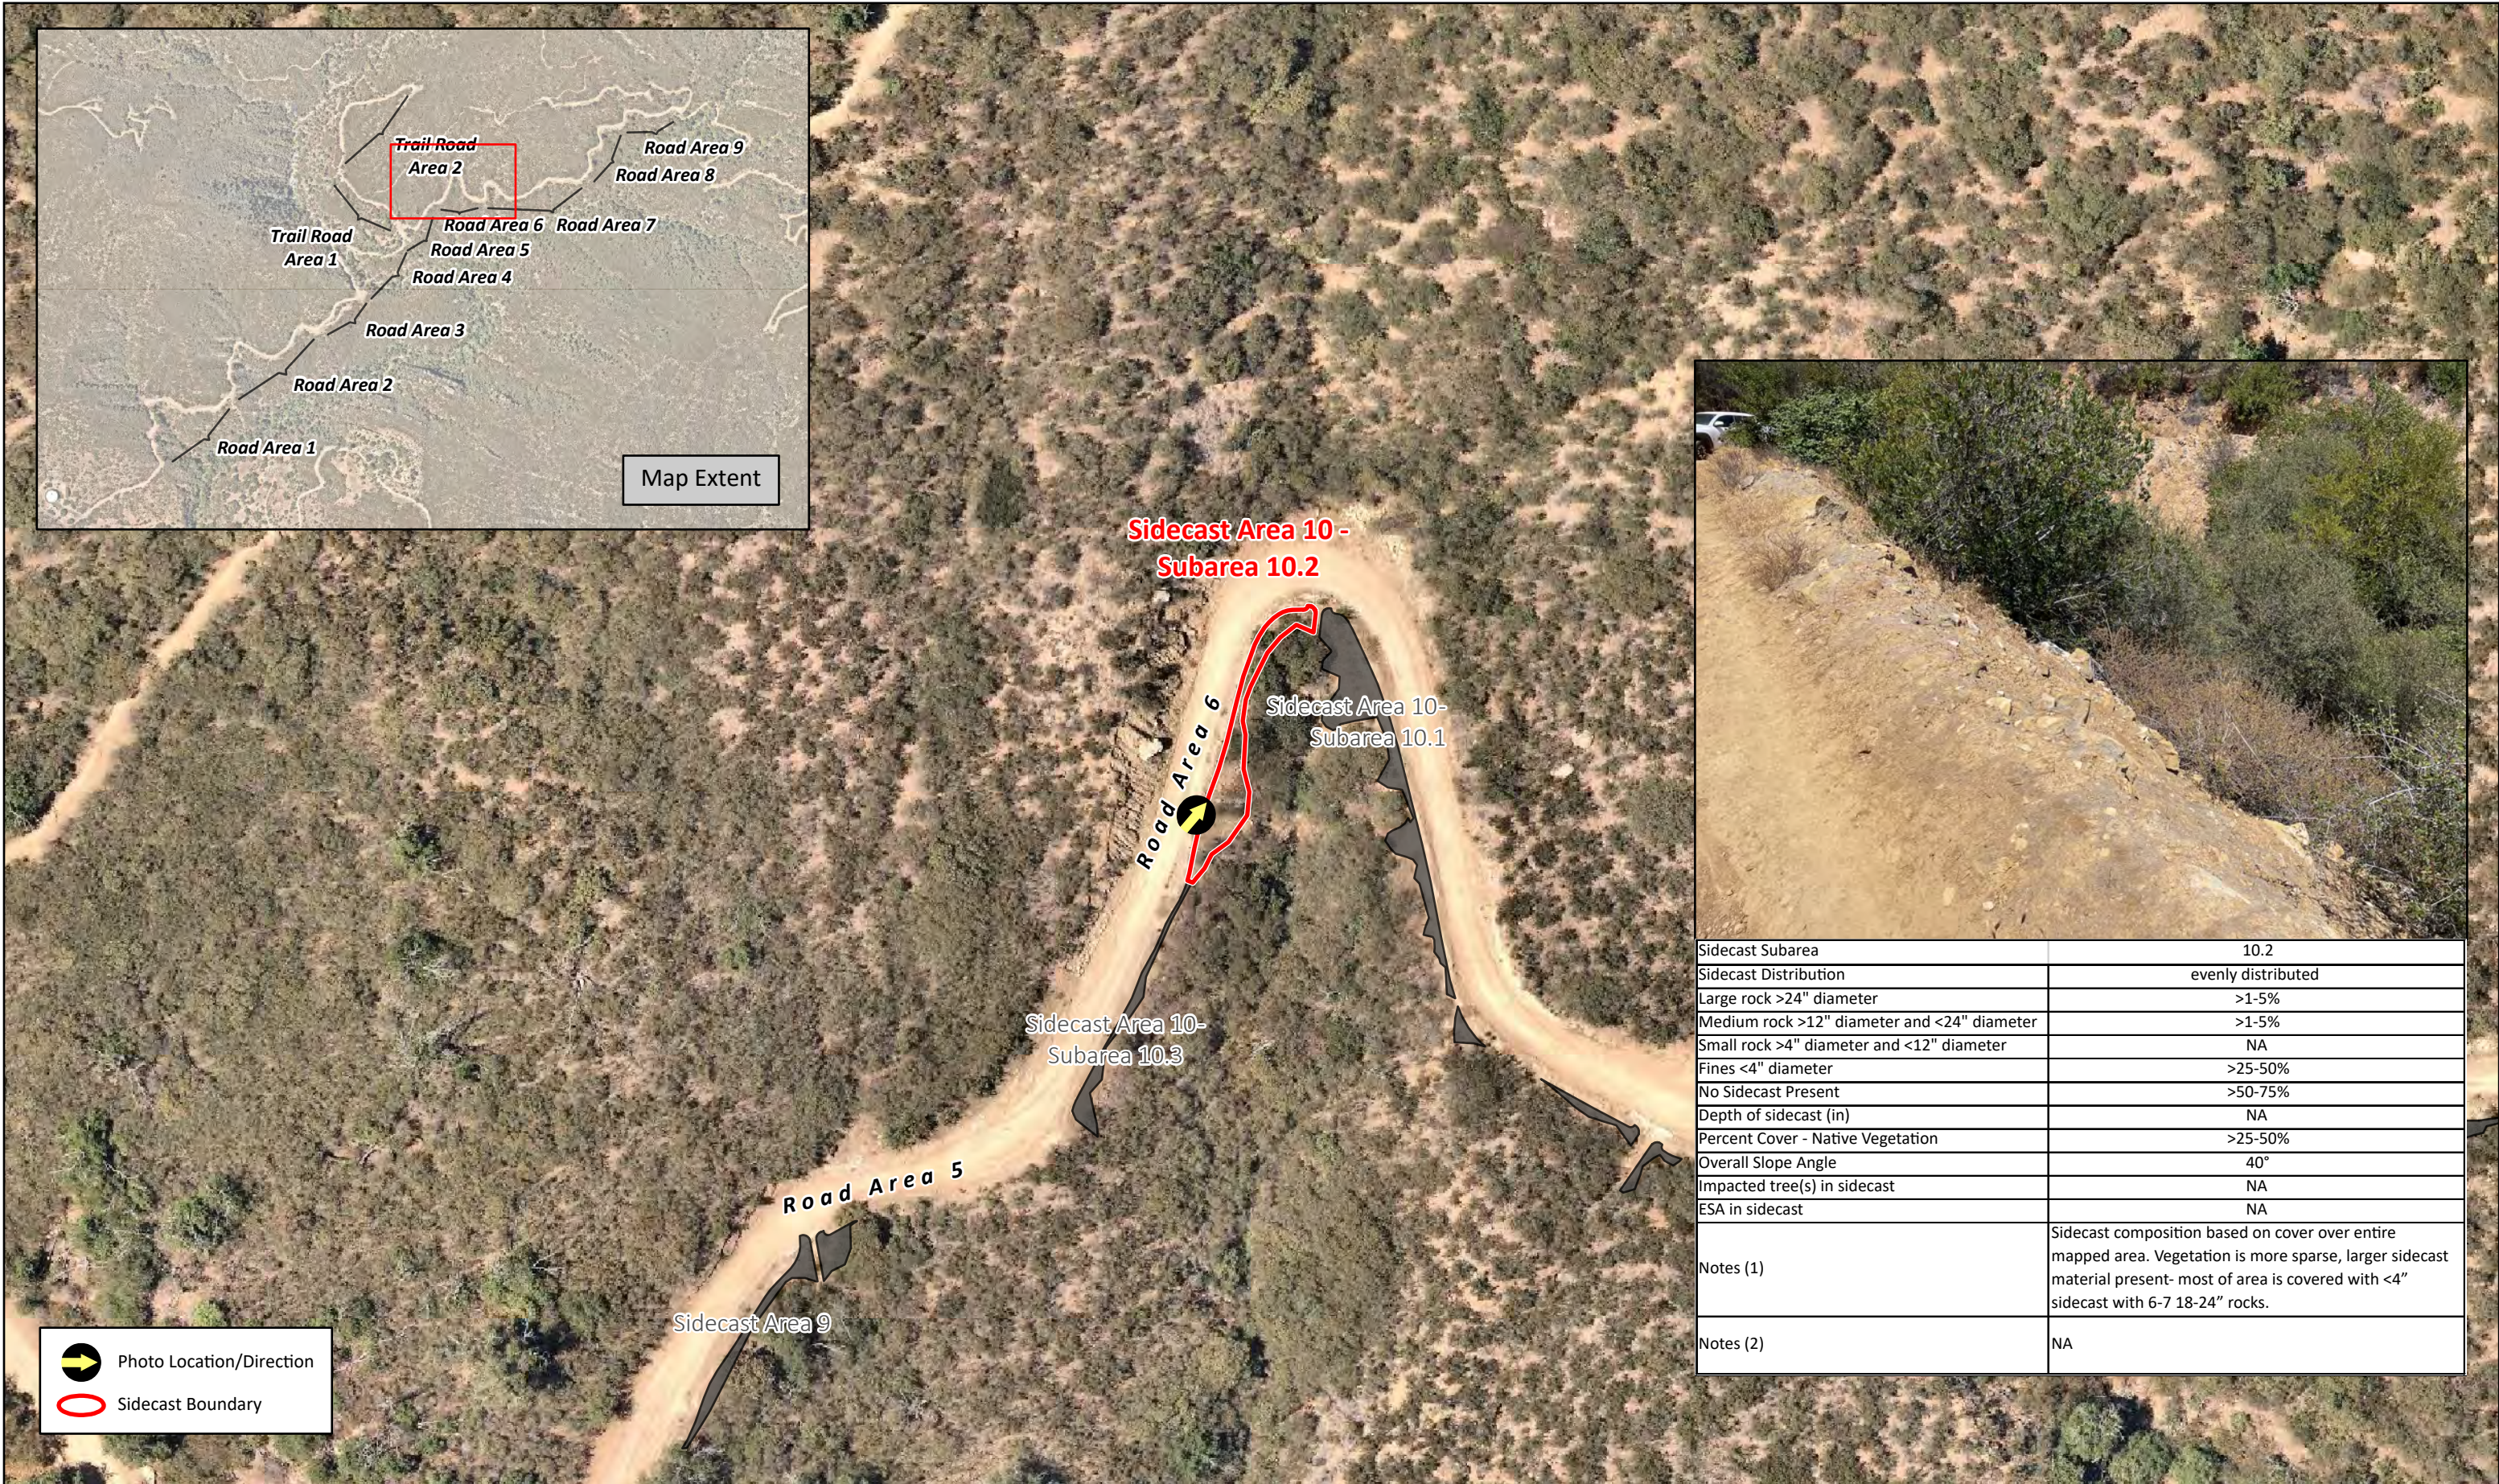
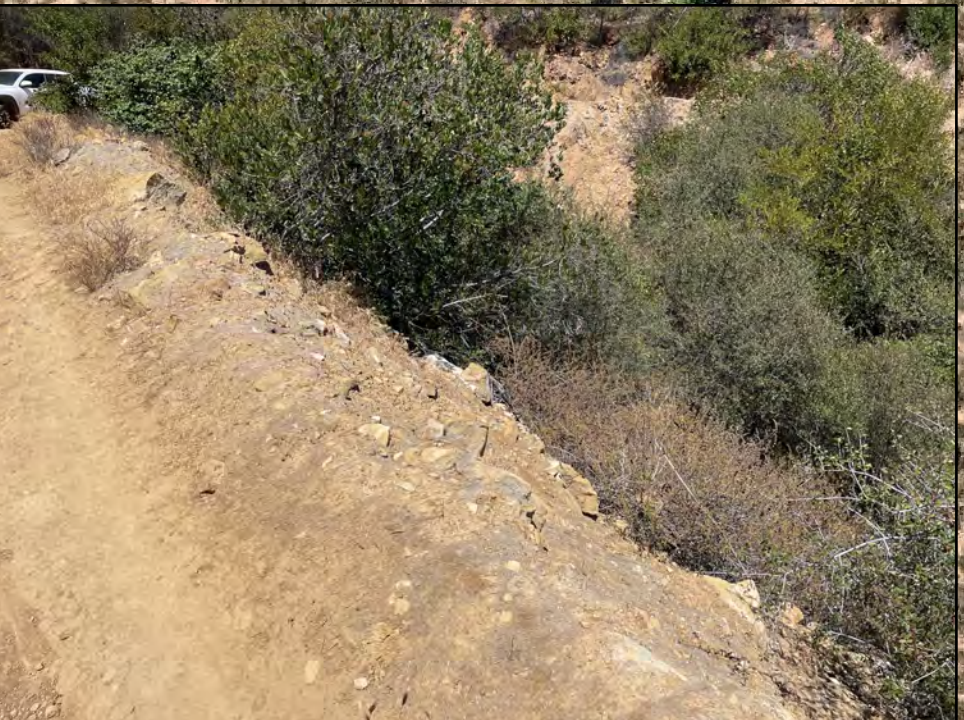
Sidecast Subarea	10.2
Sidecast Distribution	evenly distributed
Large rock >24" diameter	>1-5%
Medium rock >12" diameter and <24" diameter	>1-5%
Small rock >4" diameter and <12" diameter	NA
Fines <4" diameter	>25-50%
No Sidecast Present	>50-75%
Depth of sidecast (in)	NA
Percent Cover - Native Vegetation	>25-50%
Overall Slope Angle	40°
Impacted tree(s) in sidecast	NA
ESA in sidecast	NA
Notes (1)	Sidecast composition based on cover over entire mapped area. Vegetation is more sparse, larger sidecast material present- most of area is covered with <4" sidecast with 6-7 18-24" rocks.
Notes (2)	NA

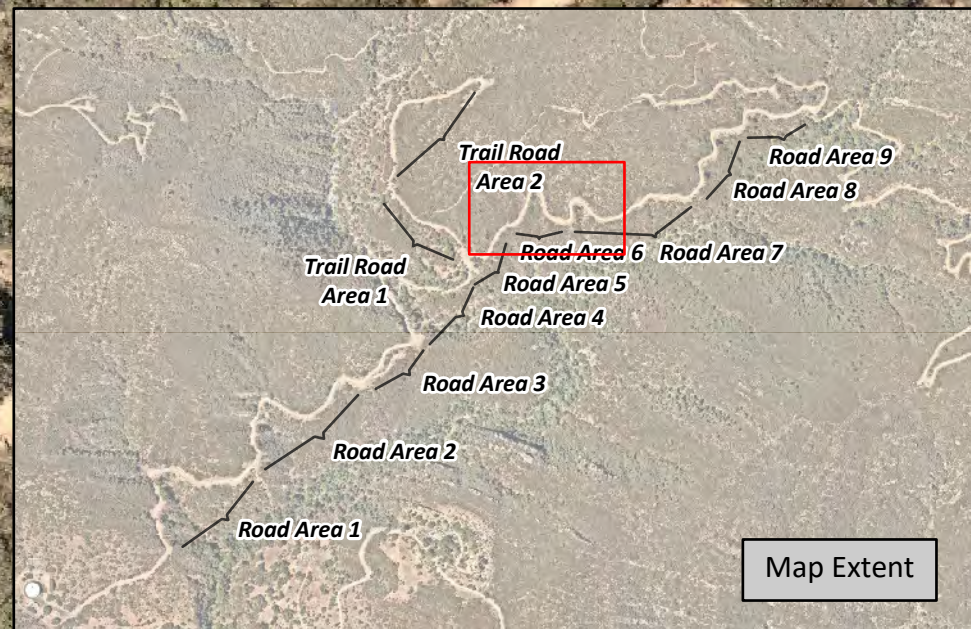
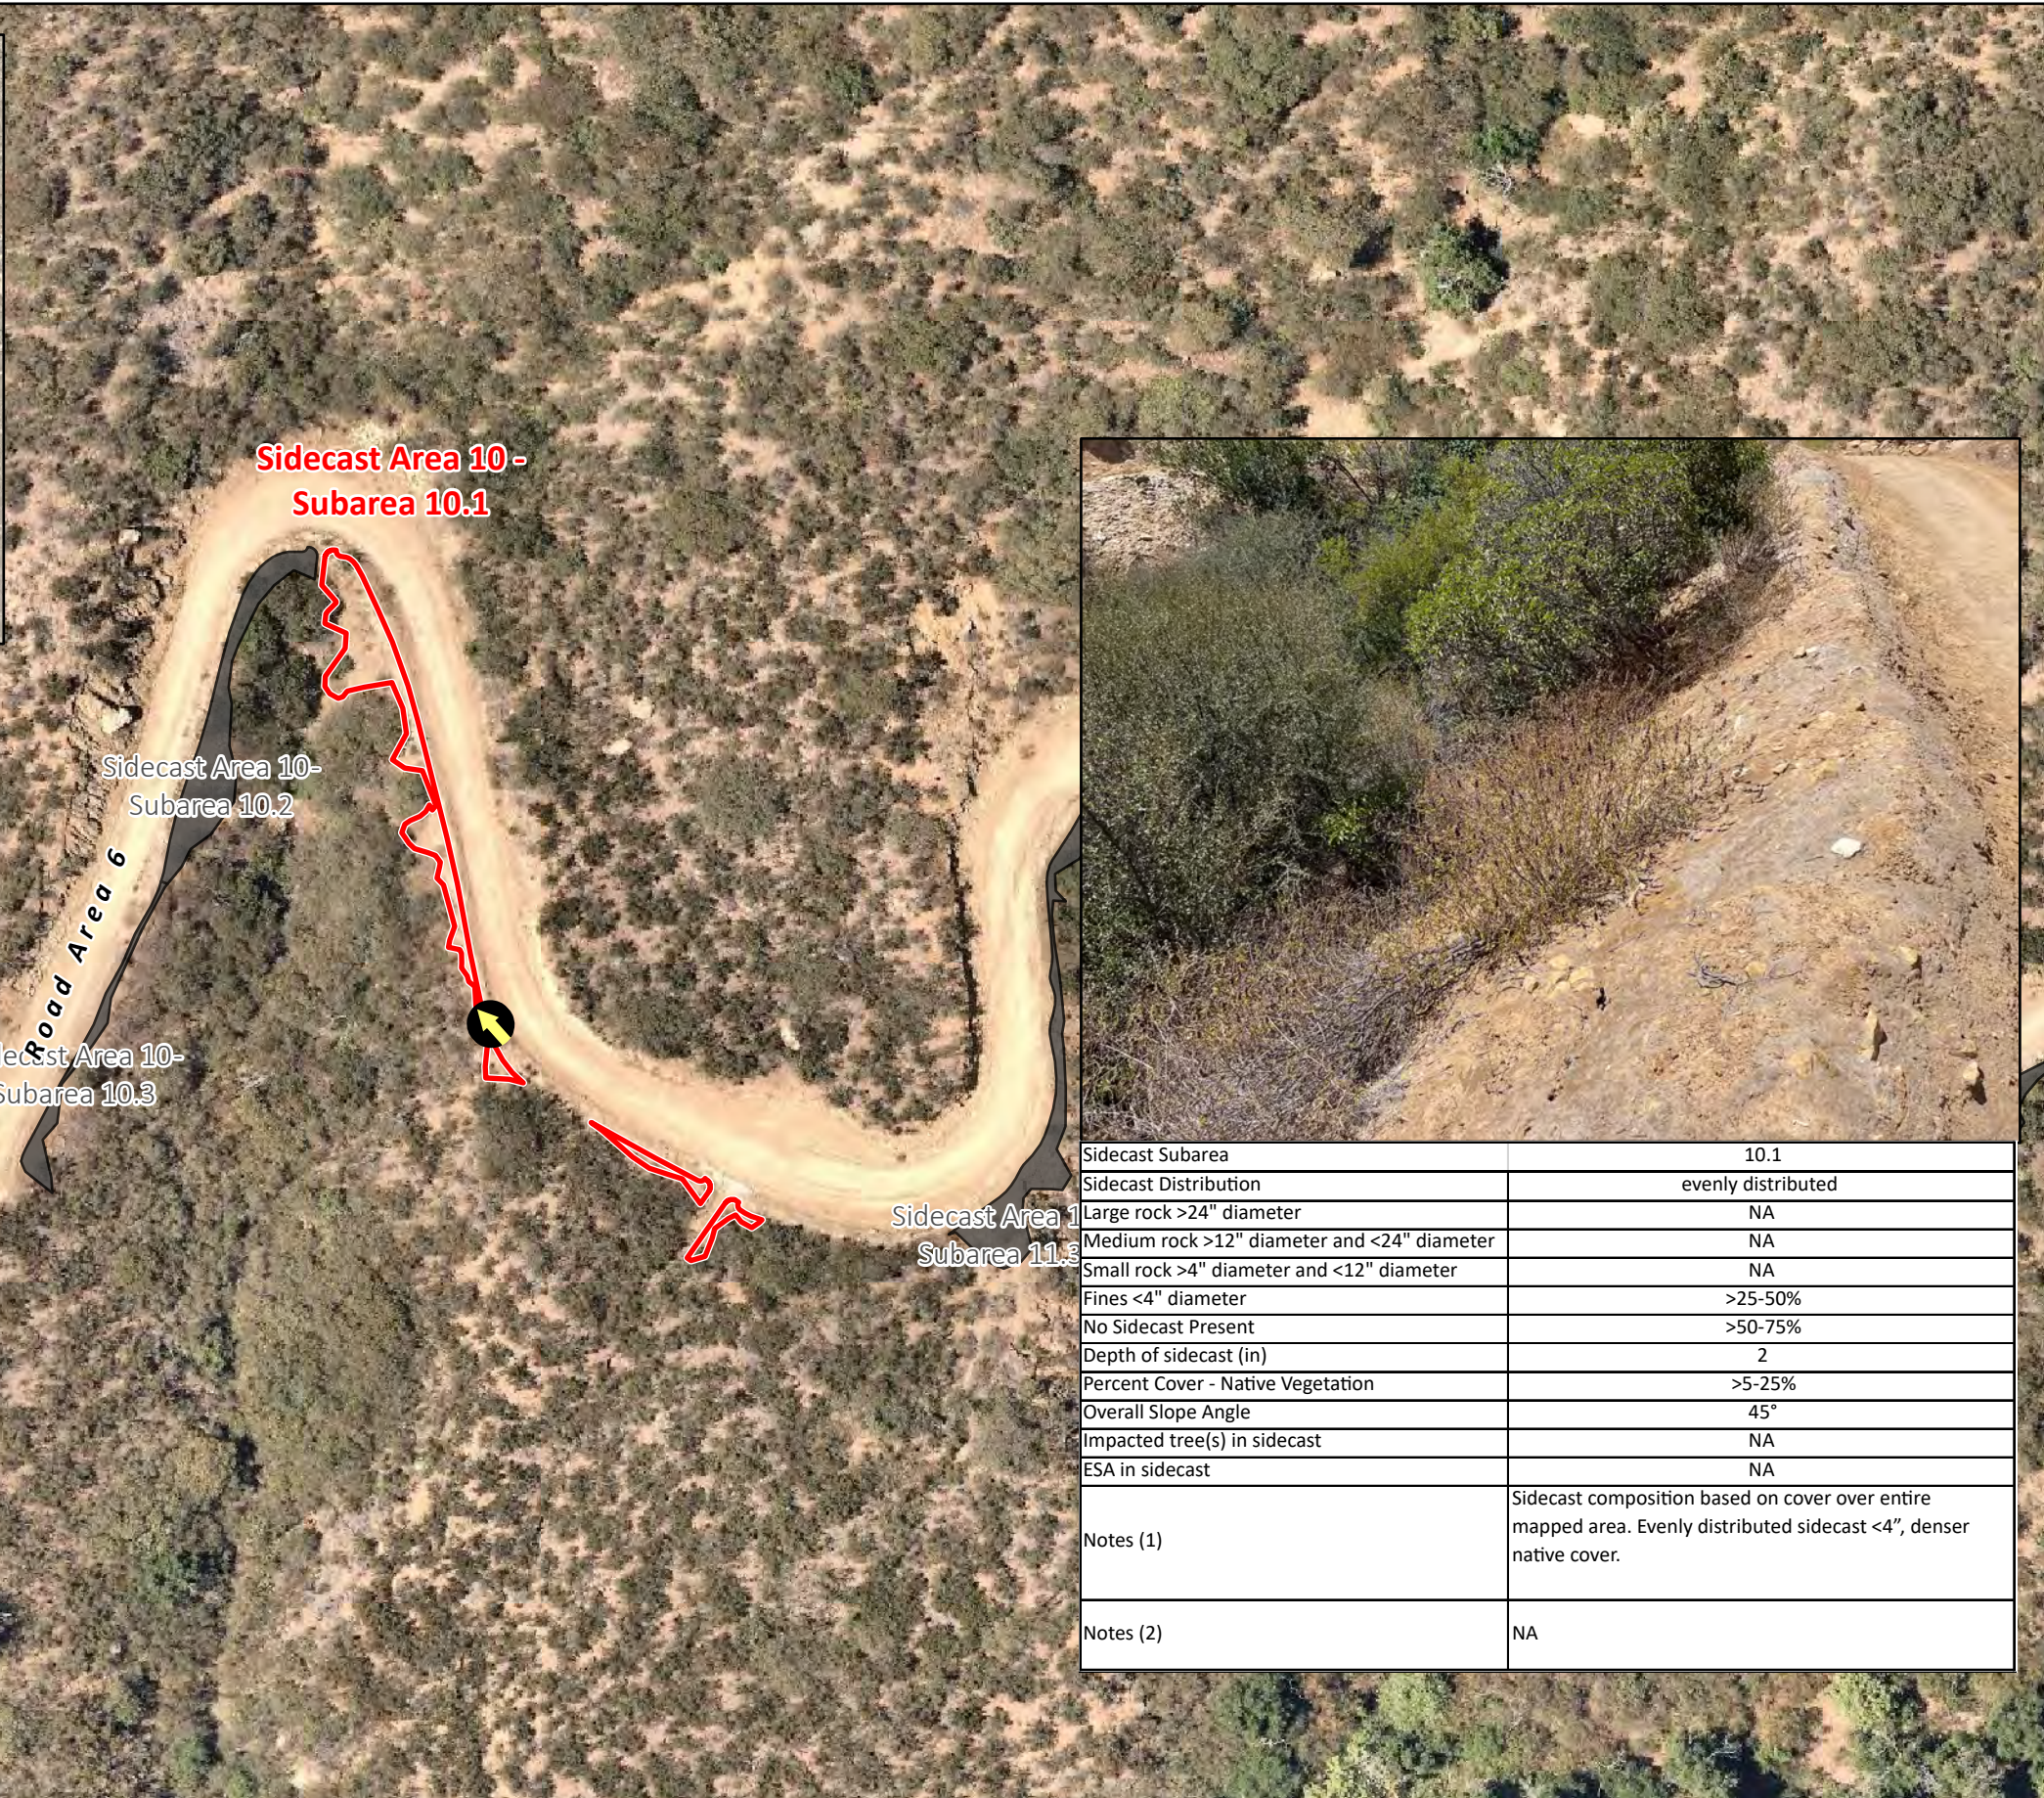
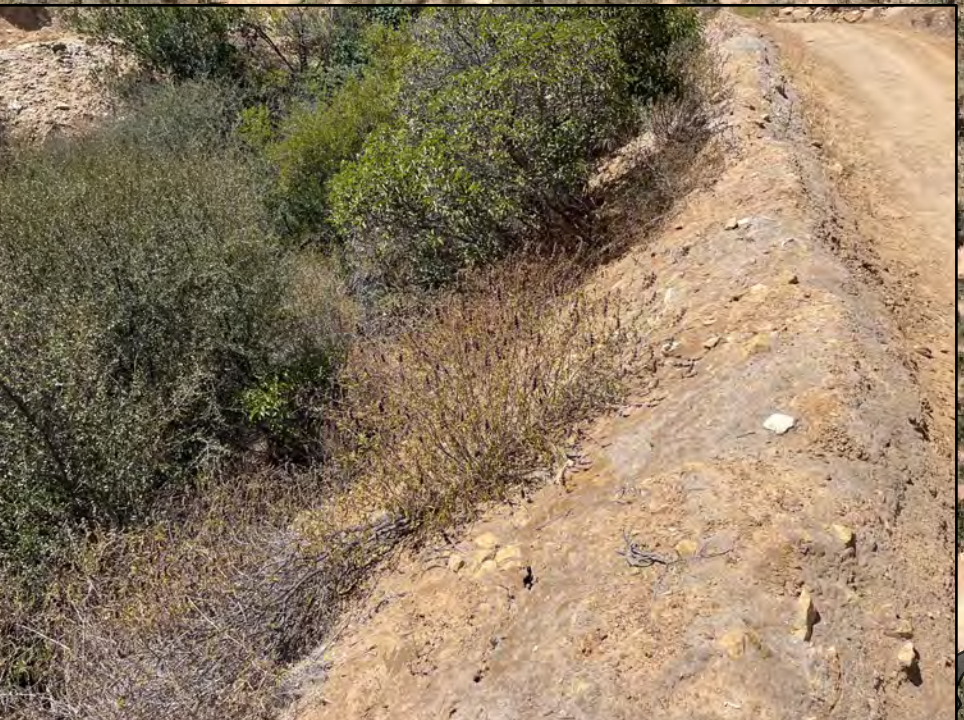
Sidecast Subarea	10.1
Sidecast Distribution	evenly distributed
Large rock >24" diameter	NA
Medium rock >12" diameter and <24" diameter	NA
Small rock >4" diameter and <12" diameter	NA
Fines <4" diameter	>25-50%
No Sidecast Present	>50-75%
Depth of sidecast (in)	2
Percent Cover - Native Vegetation	>5-25%
Overall Slope Angle	45°
Impacted tree(s) in sidecast	NA
ESA in sidecast	NA
Notes (1)	Sidecast composition based on cover over entire mapped area. Evenly distributed sidecast <4", denser native cover.
Notes (2)	NA
