**Mission Canyon Stream Habitat Restoration Project
Initial Study/Mitigated Negative Declaration**

Mission Canyon Stream Restoration Project

Supplemental Site Surveys and Comparative
Scoping Analysis

October 2022

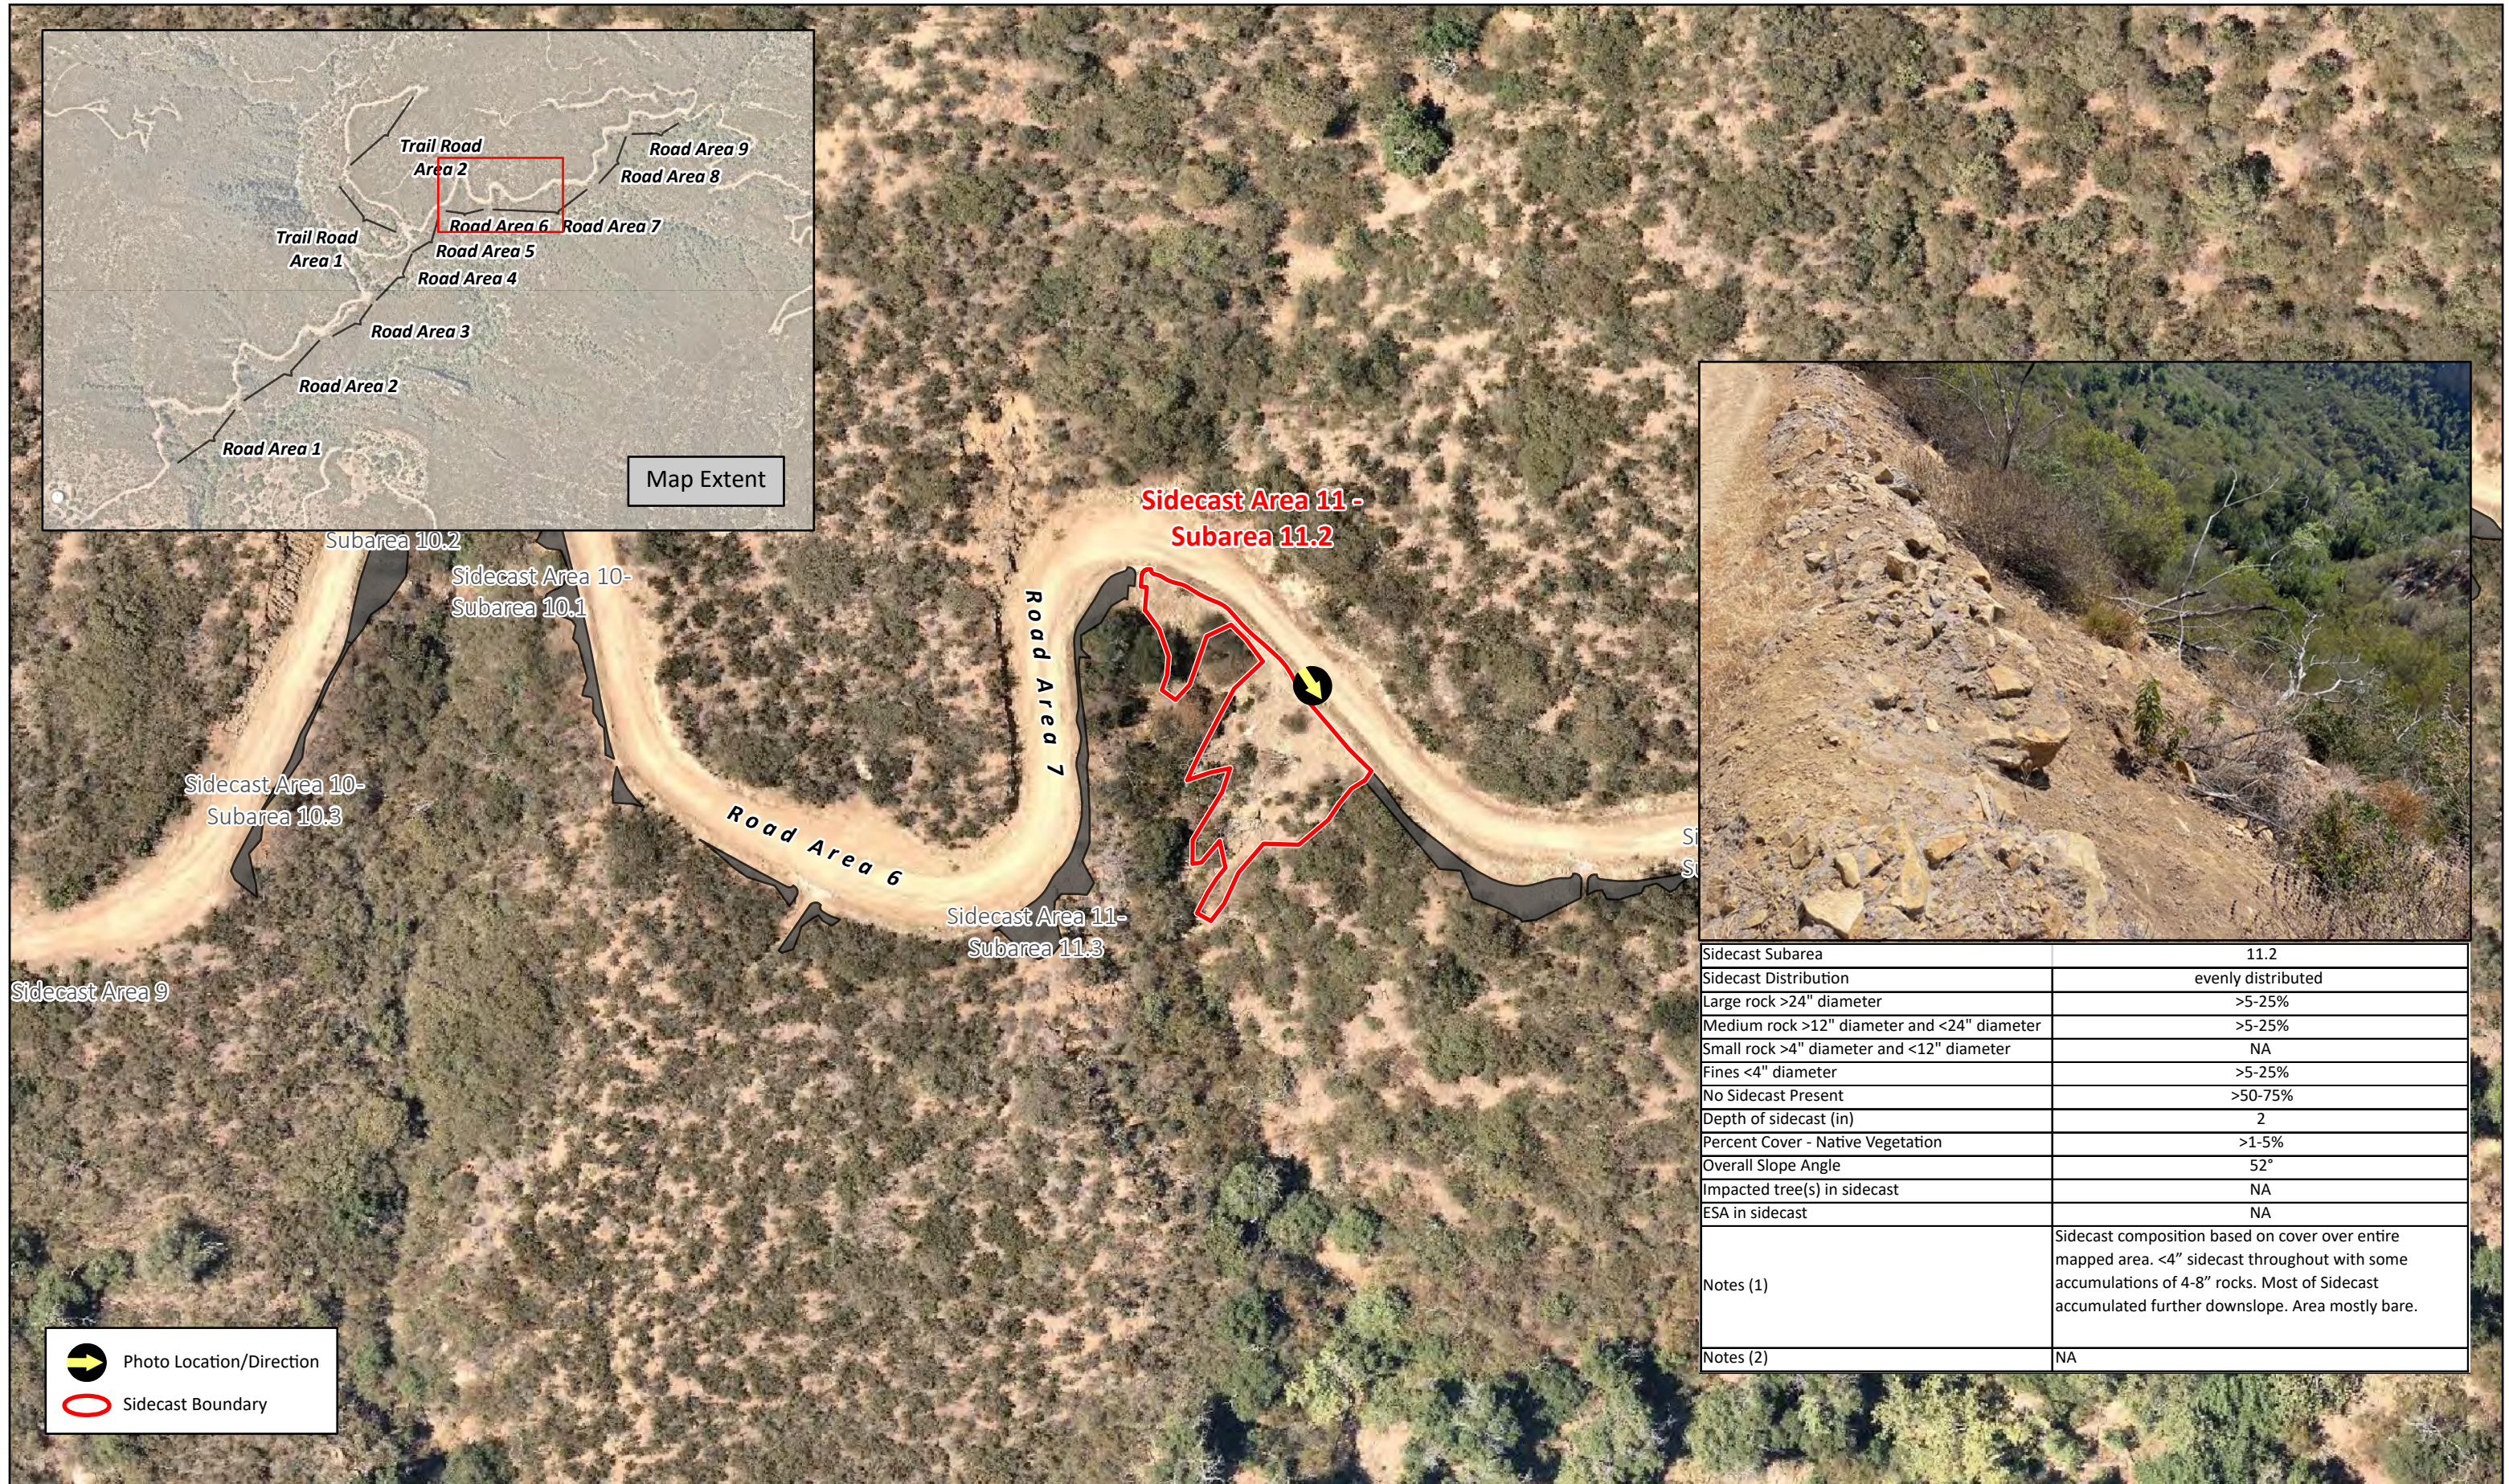
Sidecast Subarea	11.2
Sidecast Distribution	evenly distributed
Large rock >24" diameter	>5-25%
Medium rock >12" diameter and <24" diameter	>5-25%
Small rock >4" diameter and <12" diameter	NA
Fines <4" diameter	>5-25%
No Sidecast Present	>50-75%
Depth of sidecast (in)	2
Percent Cover - Native Vegetation	>1-5%
Overall Slope Angle	52°
Impacted tree(s) in sidecast	NA
ESA in sidecast	NA
Notes (1)	Sidecast composition based on cover over entire mapped area. <4" sidecast throughout with some accumulations of 4-8" rocks. Most of Sidecast accumulated further downslope. Area mostly bare.
Notes (2)	NA

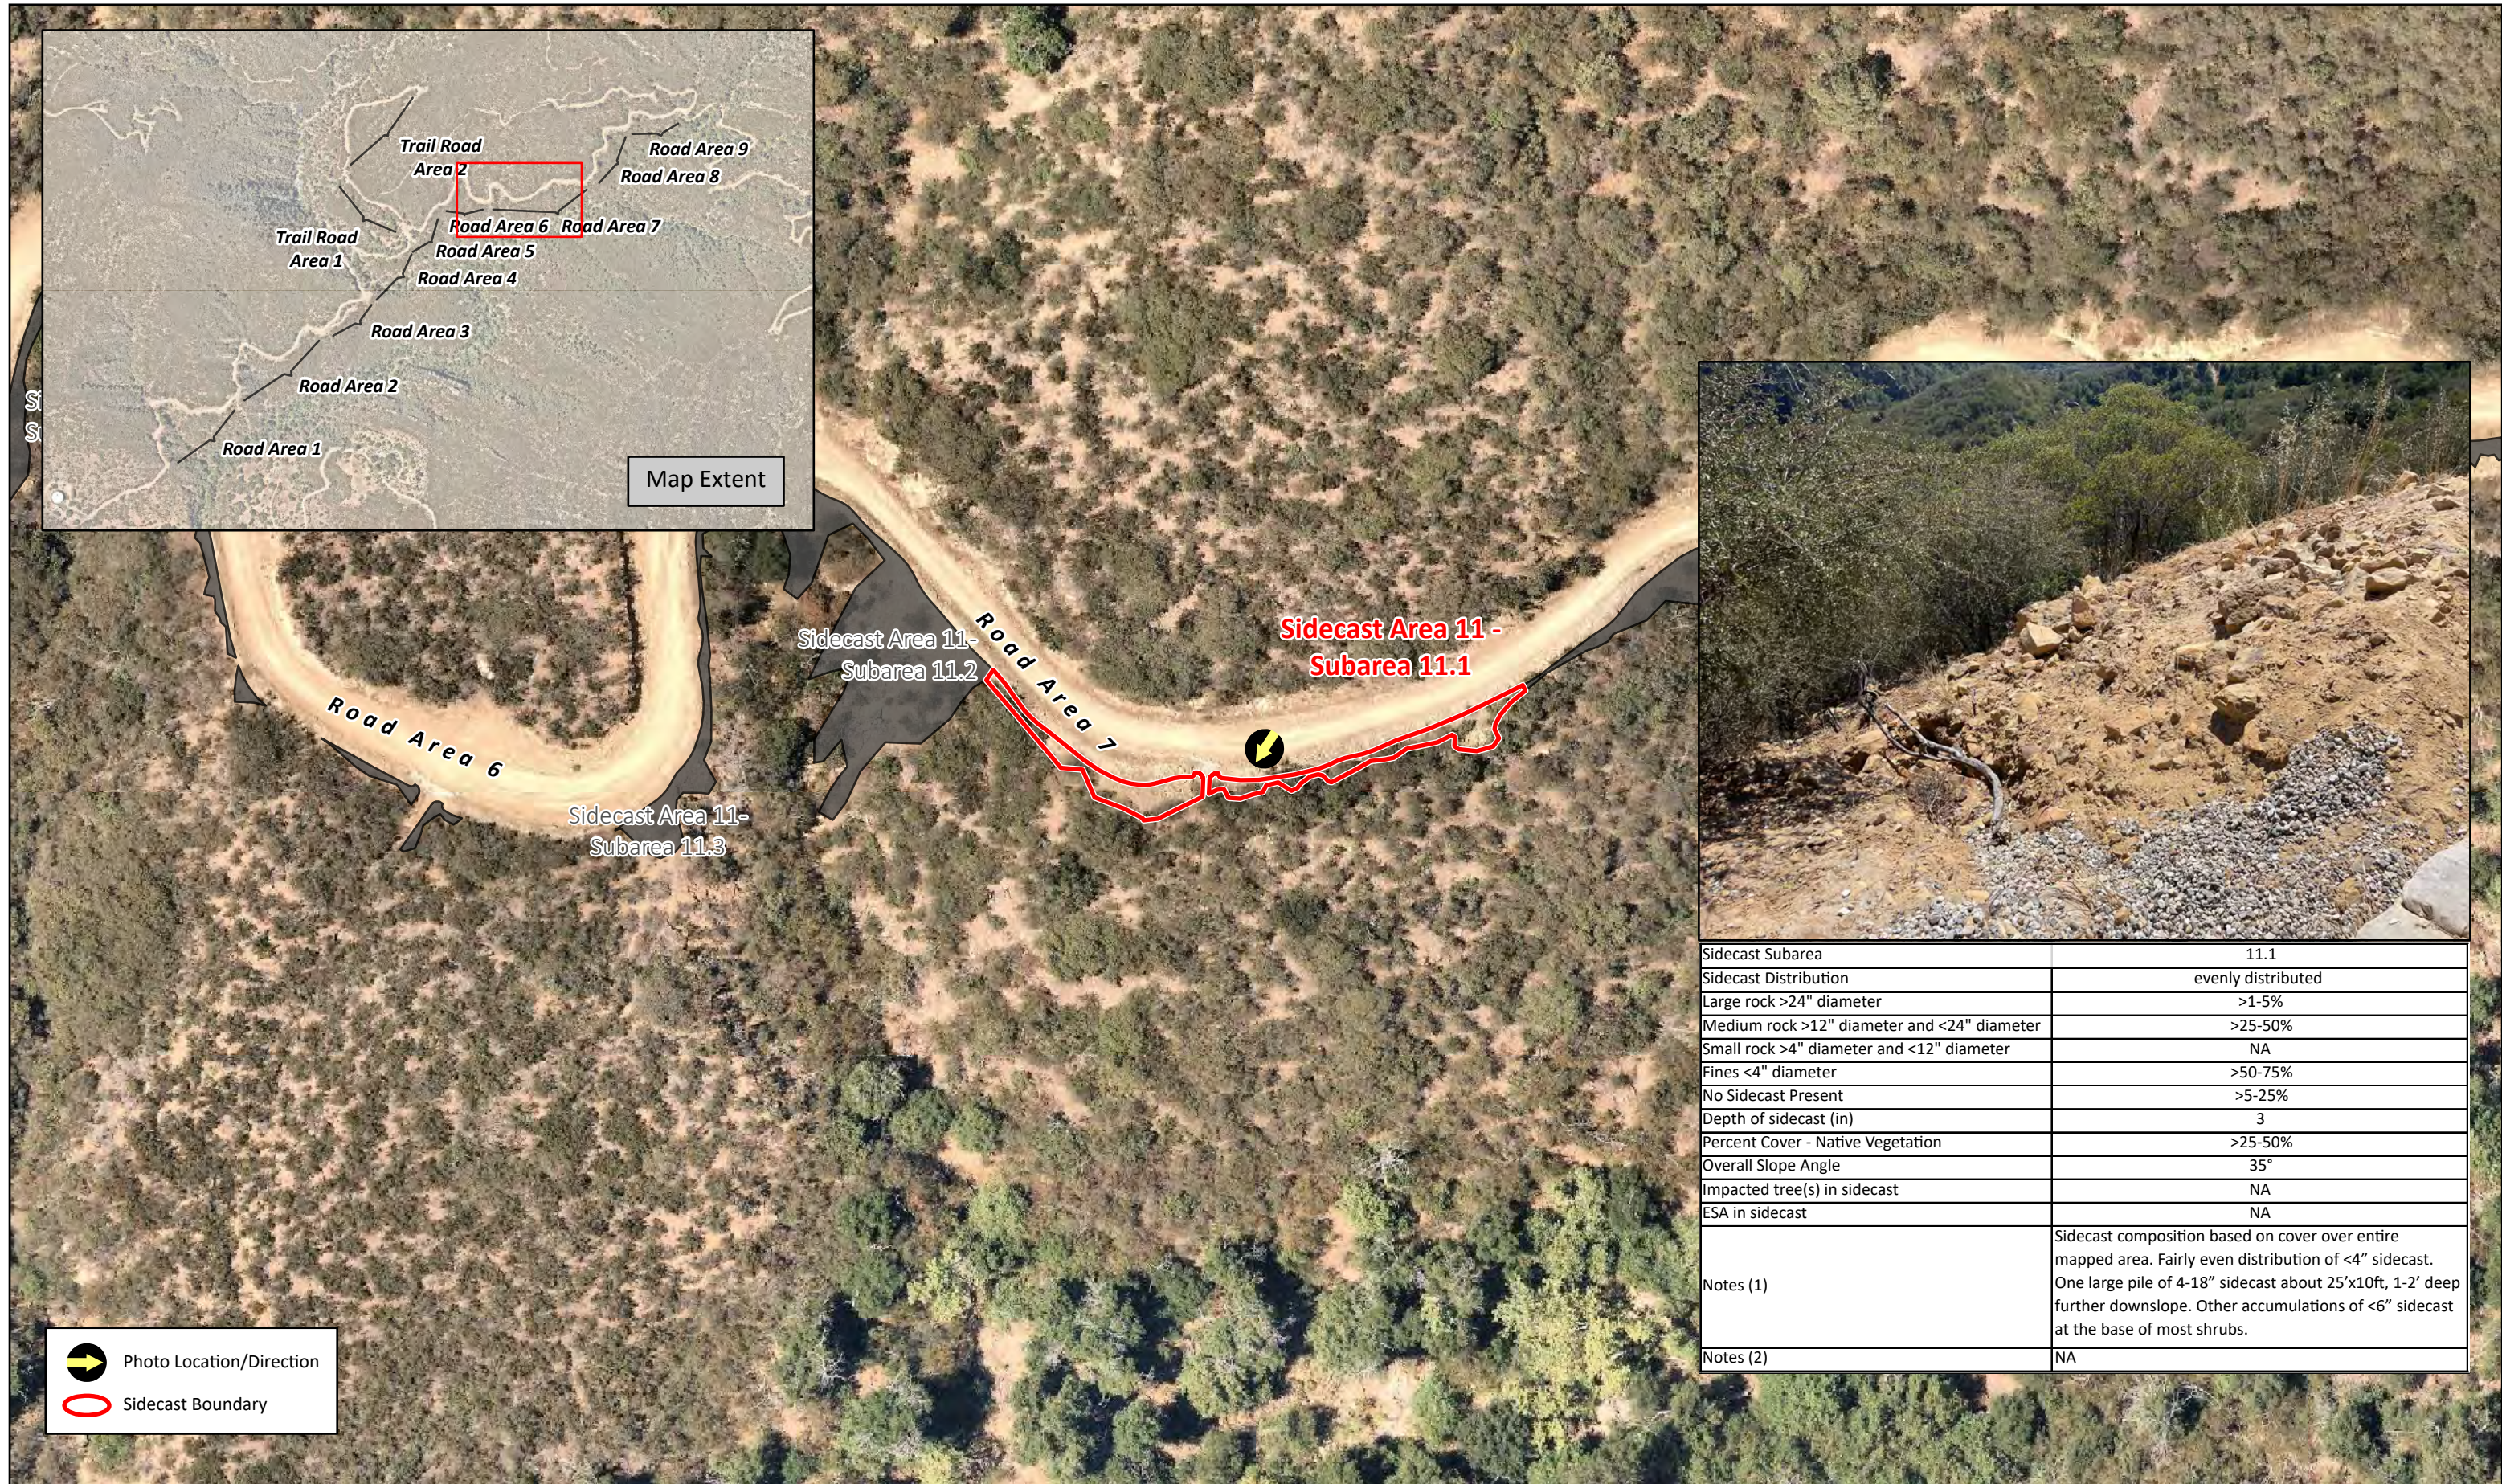
Sidecast Subarea	11.1
Sidecast Distribution	evenly distributed
Large rock >24" diameter	>1-5%
Medium rock >12" diameter and <24" diameter	>25-50%
Small rock >4" diameter and <12" diameter	NA
Fines <4" diameter	>50-75%
No Sidecast Present	>5-25%
Depth of sidecast (in)	3
Percent Cover - Native Vegetation	>25-50%
Overall Slope Angle	35°
Impacted tree(s) in sidecast	NA
ESA in sidecast	NA
Notes (1)	Sidecast composition based on cover over entire mapped area. Fairly even distribution of <4" sidecast. One large pile of 4-18" sidecast about 25'x10ft, 1-2' deep further downslope. Other accumulations of <6" sidecast at the base of most shrubs.
Notes (2)	NA

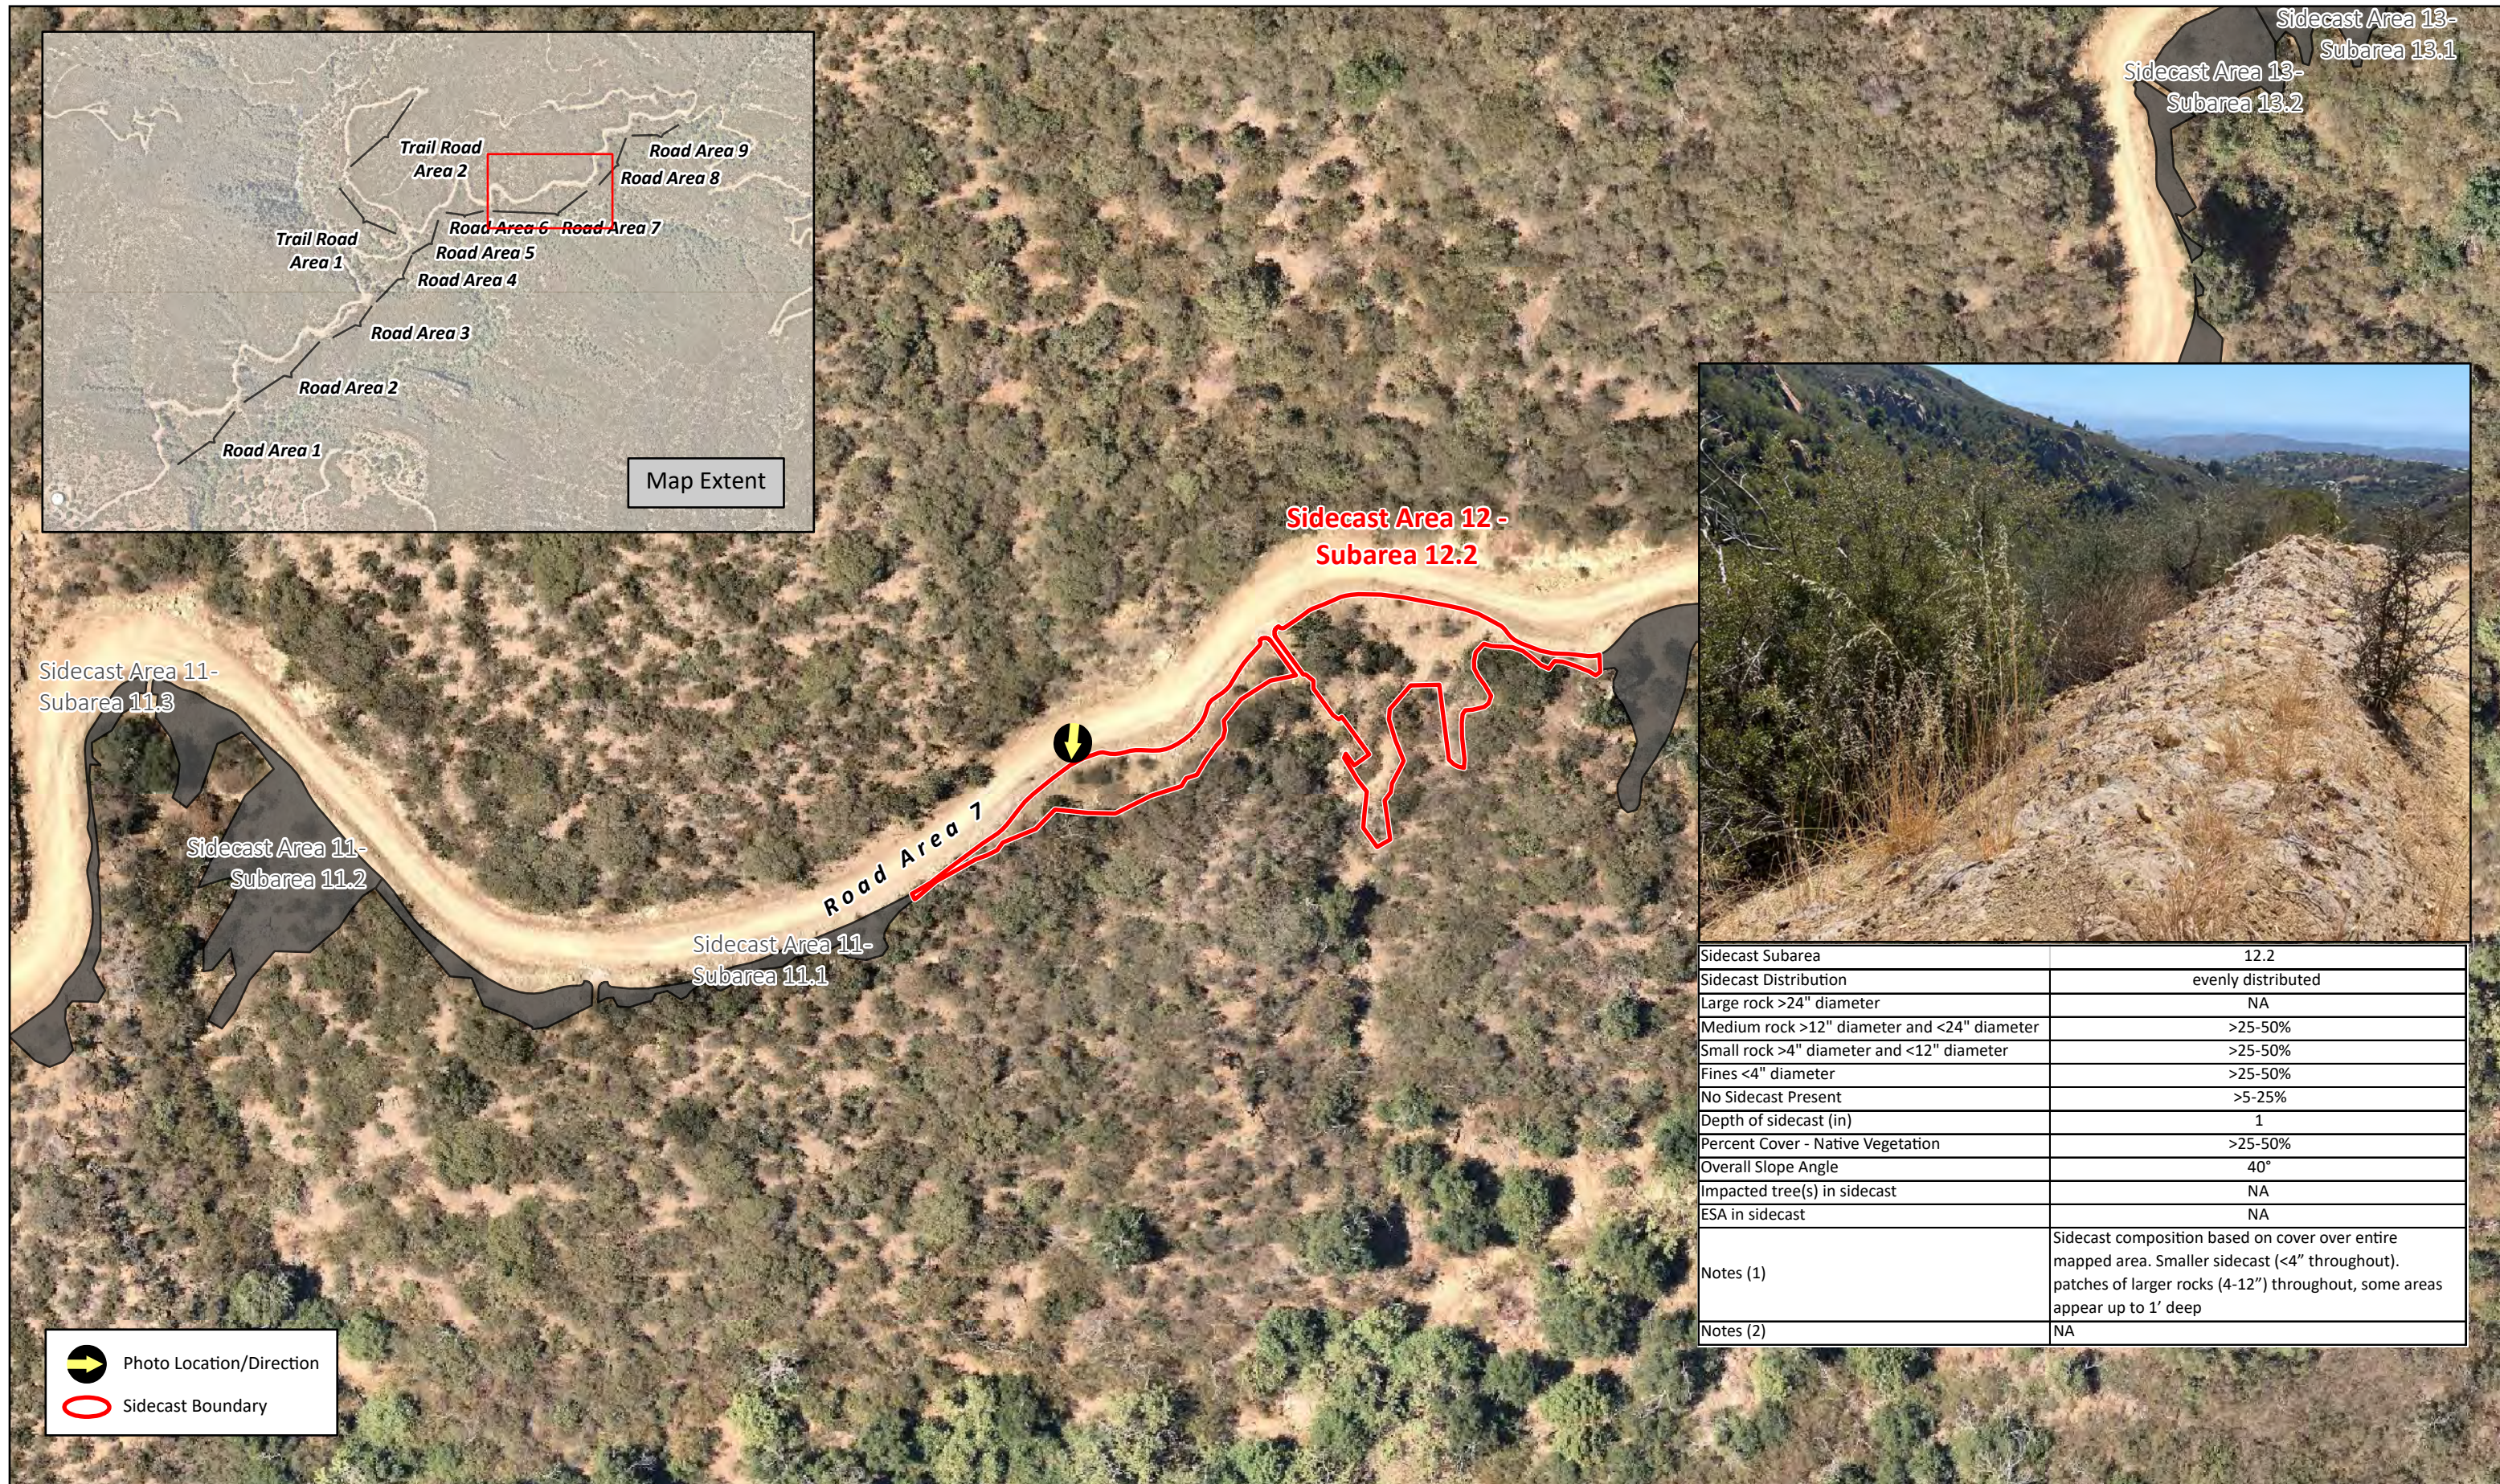
Sidecast Subarea	12.2
Sidecast Distribution	evenly distributed
Large rock >24" diameter	NA
Medium rock >12" diameter and <24" diameter	>25-50%
Small rock >4" diameter and <12" diameter	>25-50%
Fines <4" diameter	>25-50%
No Sidecast Present	>5-25%
Depth of sidecast (in)	1
Percent Cover - Native Vegetation	>25-50%
Overall Slope Angle	40°
Impacted tree(s) in sidecast	NA
ESA in sidecast	NA
Notes (1)	Sidecast composition based on cover over entire mapped area. Smaller sidecast (<4" throughout). patches of larger rocks (4-12") throughout, some areas appear up to 1' deep
Notes (2)	NA

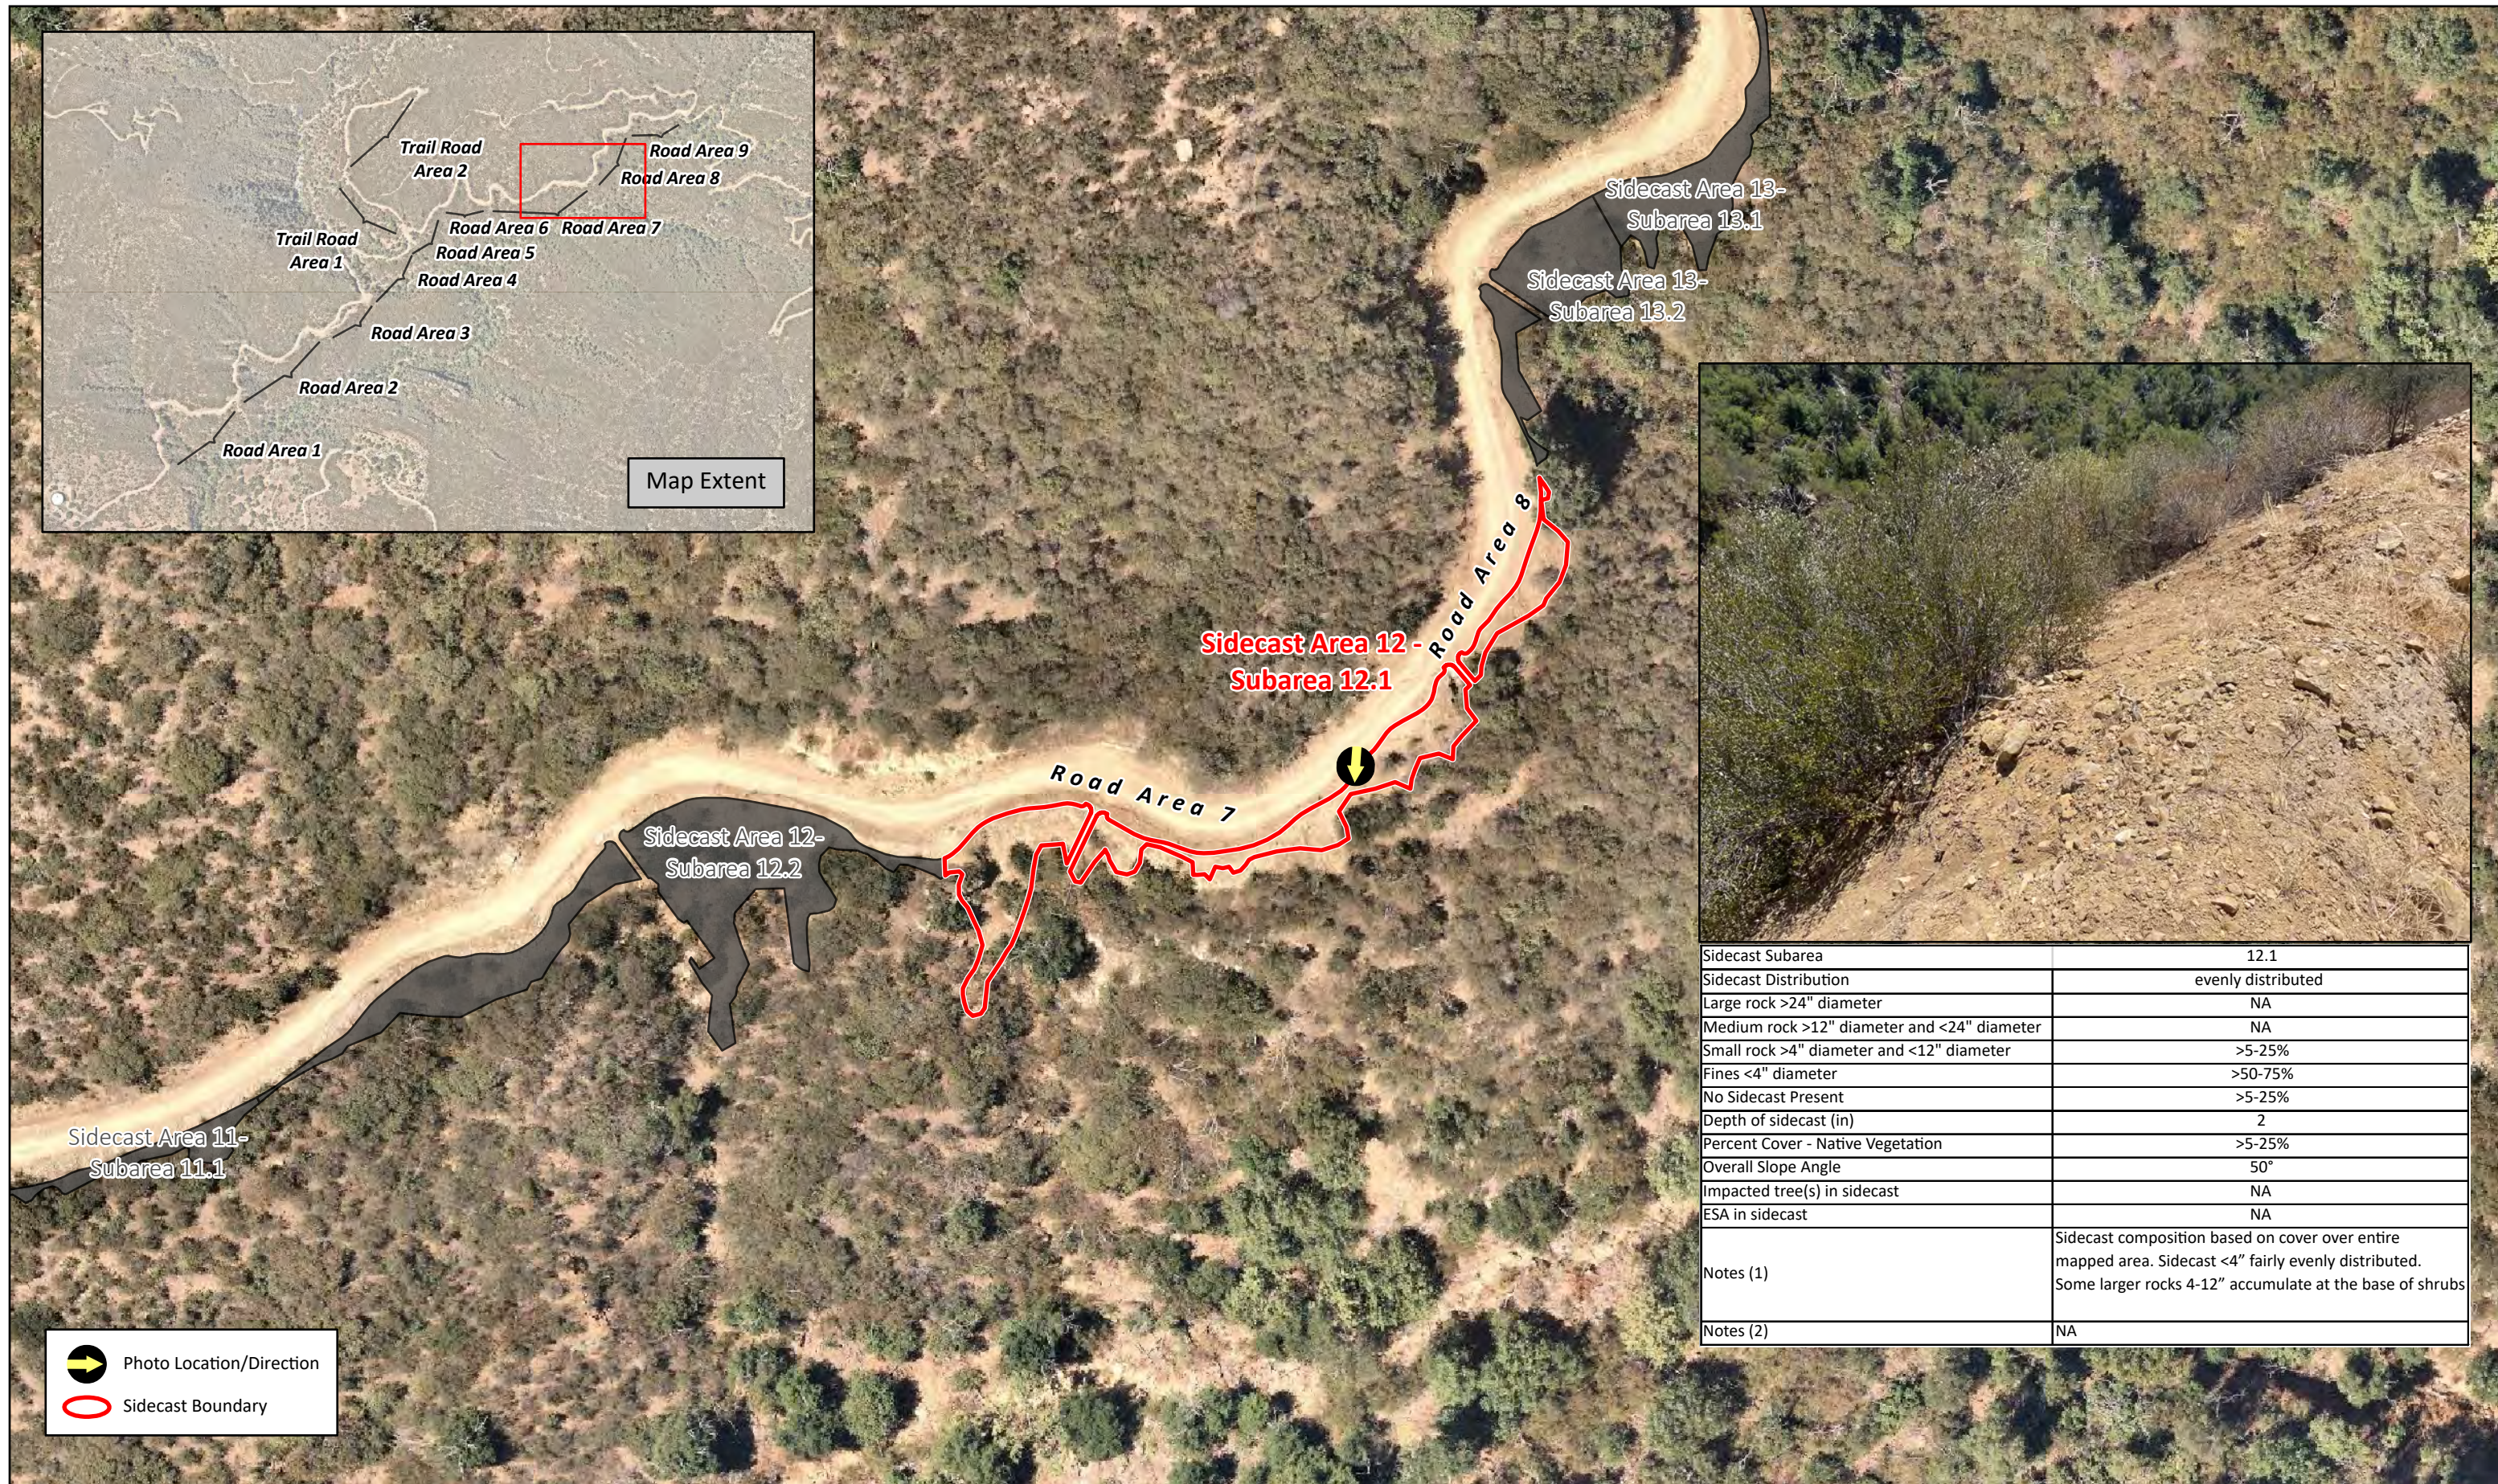
Sidecast Subarea	12.1
Sidecast Distribution	evenly distributed
Large rock >24" diameter	NA
Medium rock >12" diameter and <24" diameter	NA
Small rock >4" diameter and <12" diameter	>5-25%
Fines <4" diameter	>50-75%
No Sidecast Present	>5-25%
Depth of sidecast (in)	2
Percent Cover - Native Vegetation	>5-25%
Overall Slope Angle	50°
Impacted tree(s) in sidecast	NA
ESA in sidecast	NA
Notes (1)	Sidecast composition based on cover over entire mapped area. Sidecast <4" fairly evenly distributed. Some larger rocks 4-12" accumulate at the base of shrubs
Notes (2)	NA

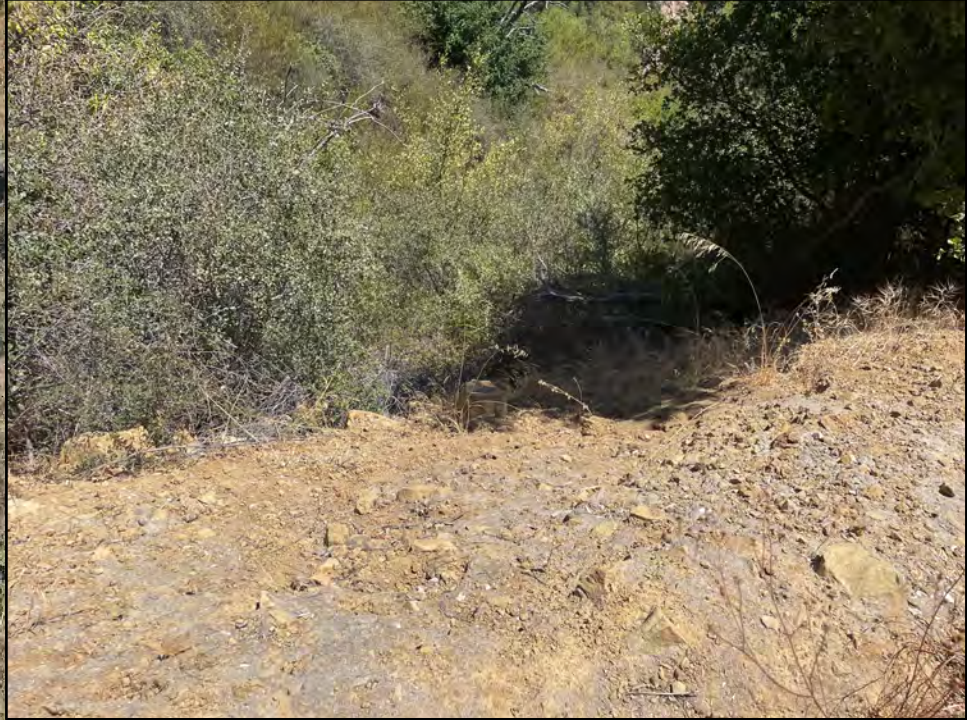
Sidecast Subarea	13.2
Sidecast Distribution	accumulated in portions
Large rock >24" diameter	>1-5%
Medium rock >12" diameter and <24" diameter	>5-25%
Small rock >4" diameter and <12" diameter	NA
Fines <4" diameter	NA
No Sidecast Present	>75%
Depth of sidecast (in)	3
Percent Cover - Native Vegetation	>5-25%
Overall Slope Angle	48°
Impacted tree(s) in sidecast	75, 76
ESA in sidecast	NA
Notes (1)	Sidecast composition based on cover over entire mapped area. One area 15'x4' of rocks 4"-12", about 8-12" deep. Some sidecast at the base of shrubs.
Notes (2)	NA

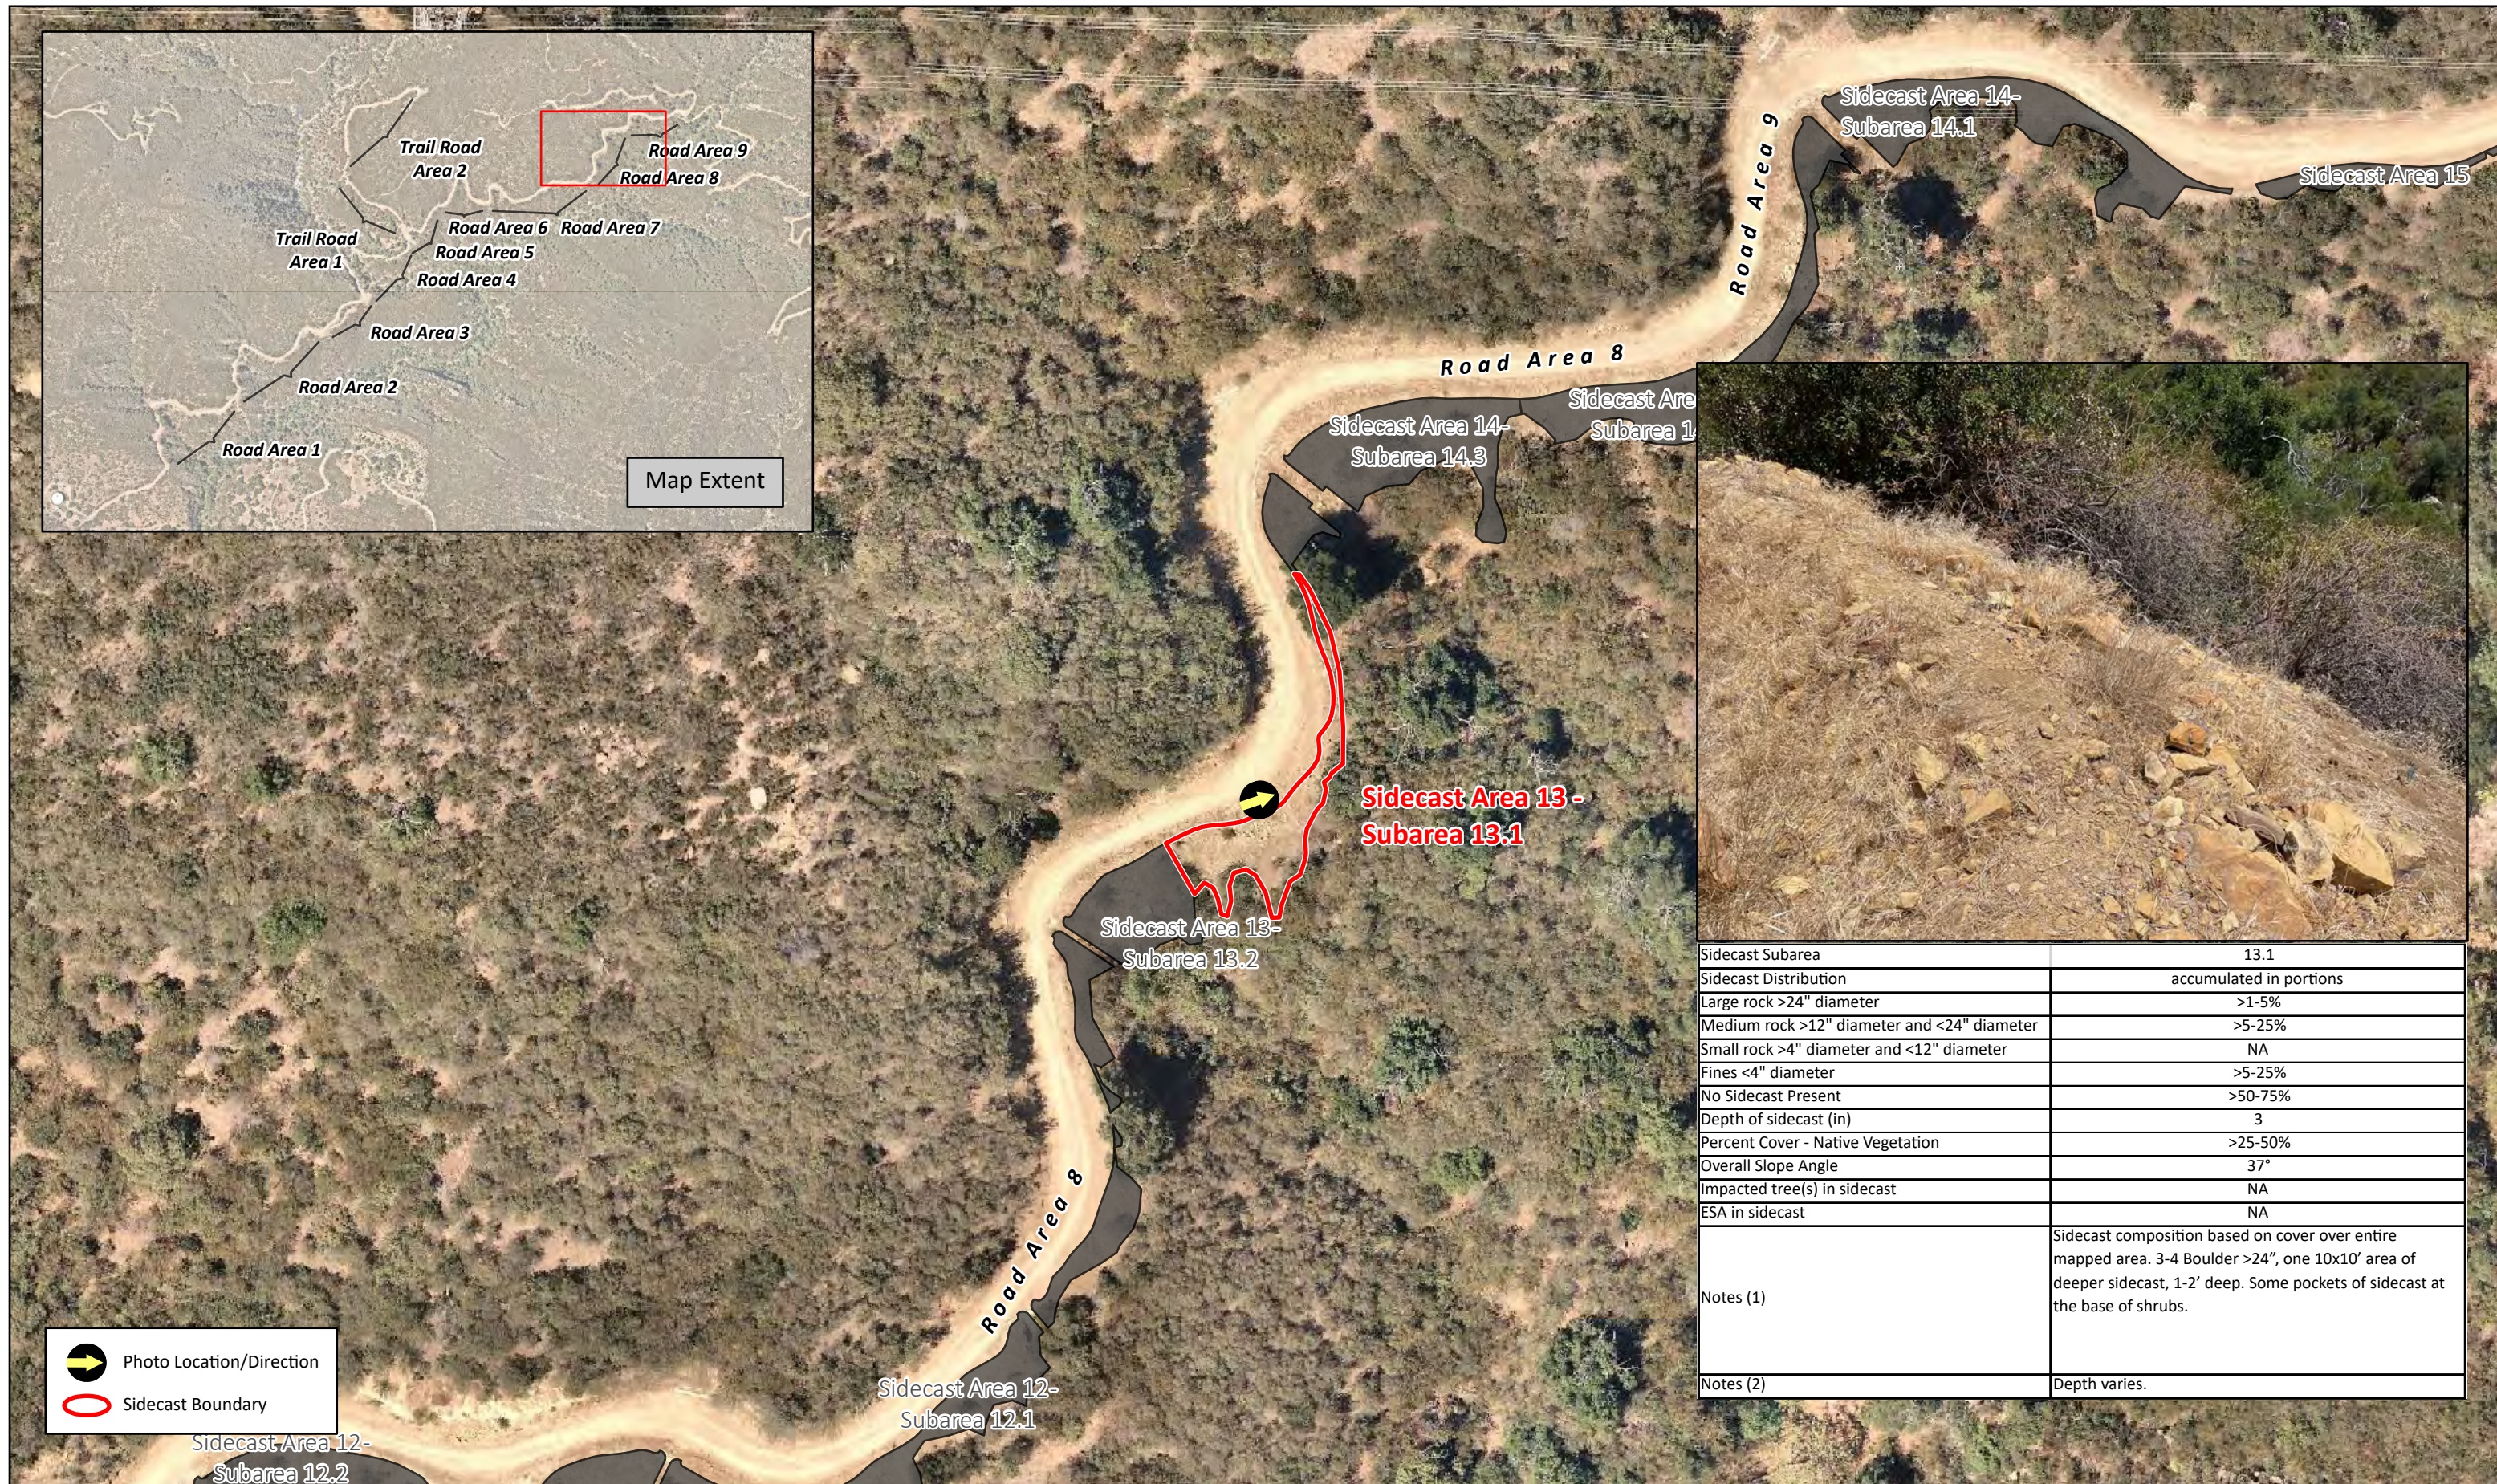
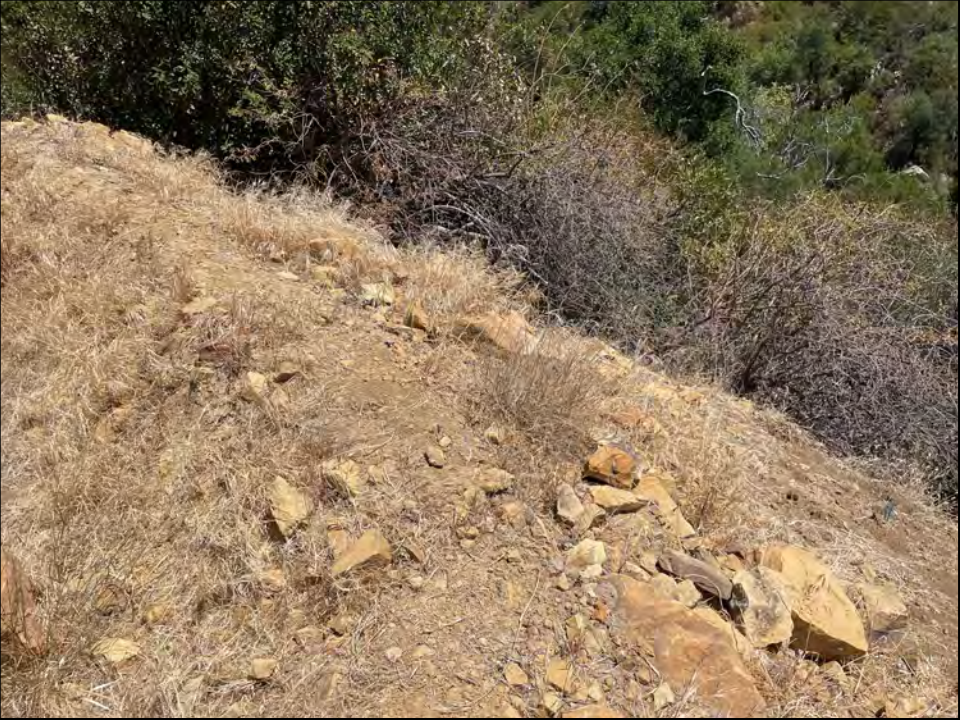
Sidecast Subarea	13.1
Sidecast Distribution	accumulated in portions
Large rock >24" diameter	>1-5%
Medium rock >12" diameter and <24" diameter	>5-25%
Small rock >4" diameter and <12" diameter	NA
Fines <4" diameter	>5-25%
No Sidecast Present	>50-75%
Depth of sidecast (in)	3
Percent Cover - Native Vegetation	>25-50%
Overall Slope Angle	37°
Impacted tree(s) in sidecast	NA
ESA in sidecast	NA
Notes (1)	Sidecast composition based on cover over entire mapped area. 3-4 Boulder >24", one 10x10' area of deeper sidecast, 1-2' deep. Some pockets of sidecast at the base of shrubs.
Notes (2)	Depth varies.

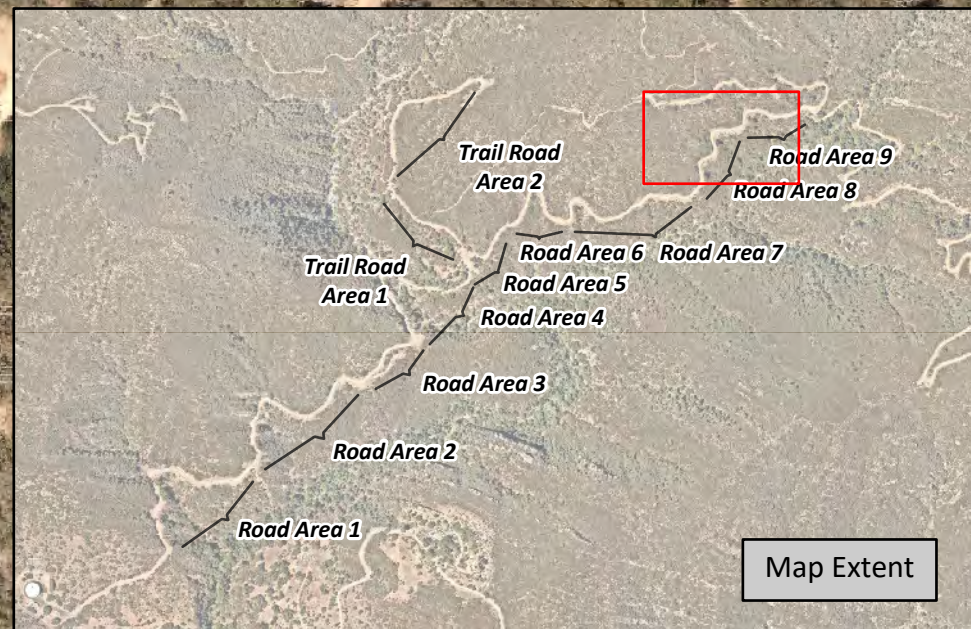
Sidecast Subarea	14.3
Sidecast Distribution	accumulated in portions
Large rock >24" diameter	0-1%
Medium rock >12" diameter and <24" diameter	>1-5%
Small rock >4" diameter and <12" diameter	>5-25%
Fines <4" diameter	>25-50%
No Sidecast Present	>25-50%
Depth of sidecast (in)	2
Percent Cover - Native Vegetation	>1-5%
Overall Slope Angle	35°
Impacted tree(s) in sidecast	78
ESA in sidecast	Tree at the edge 78
Notes (1)	Sidecast composition based on cover over entire mapped area. Some accumulation of sidecast under tree, 6'x6', 6-8" deep of 4-12" rocks. Some patches are smaller sidecast closer to road
Notes (2)	NA

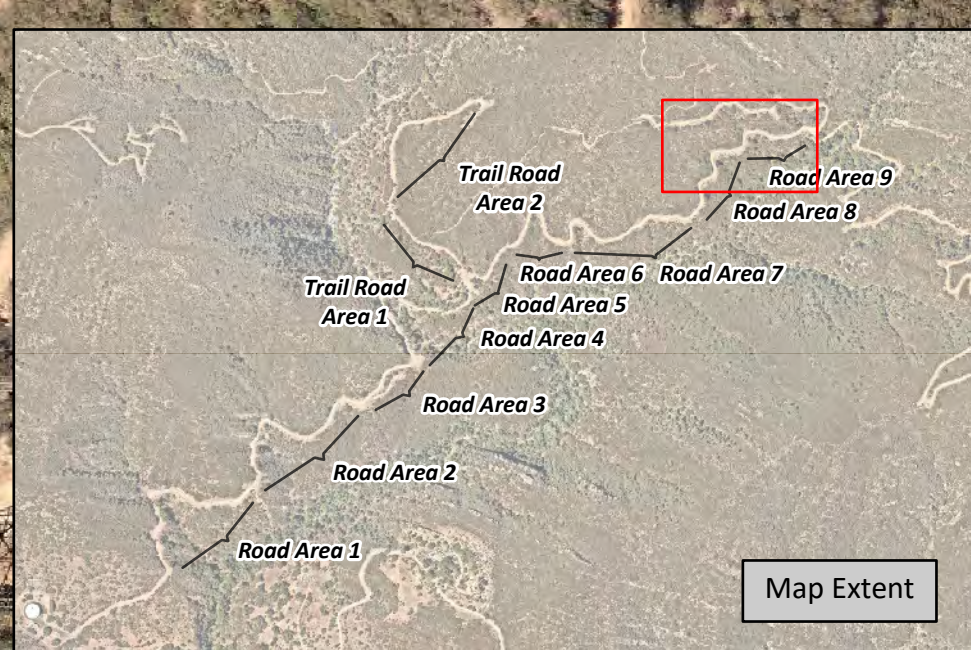
Sidecast Subarea	14.2
Sidecast Distribution	accumulated in portions
Large rock >24" diameter	>1-5%
Medium rock >12" diameter and <24" diameter	>5-25%
Small rock >4" diameter and <12" diameter	>5-25%
Fines <4" diameter	NA
No Sidecast Present	>50-75%
Depth of sidecast (in)	4
Percent Cover - Native Vegetation	>5-25%
Overall Slope Angle	43°
Impacted tree(s) in sidecast	NA
ESA in sidecast	NA
Notes (1)	Sidecast composition based on cover over entire mapped area. Larger sidecast (rocks 4-12") accumulated at base of shrubs, 100' long X 3' wide, 6-8" deep, about 5-6 boulders 2-3' long, 1-2' wide.
Notes (2)	Depth varies.
