**Mission Canyon Stream Habitat Restoration Project
Initial Study/Mitigated Negative Declaration**

Mission Canyon Stream Restoration Project

Supplemental Site Surveys and Comparative
Scoping Analysis

October 2022

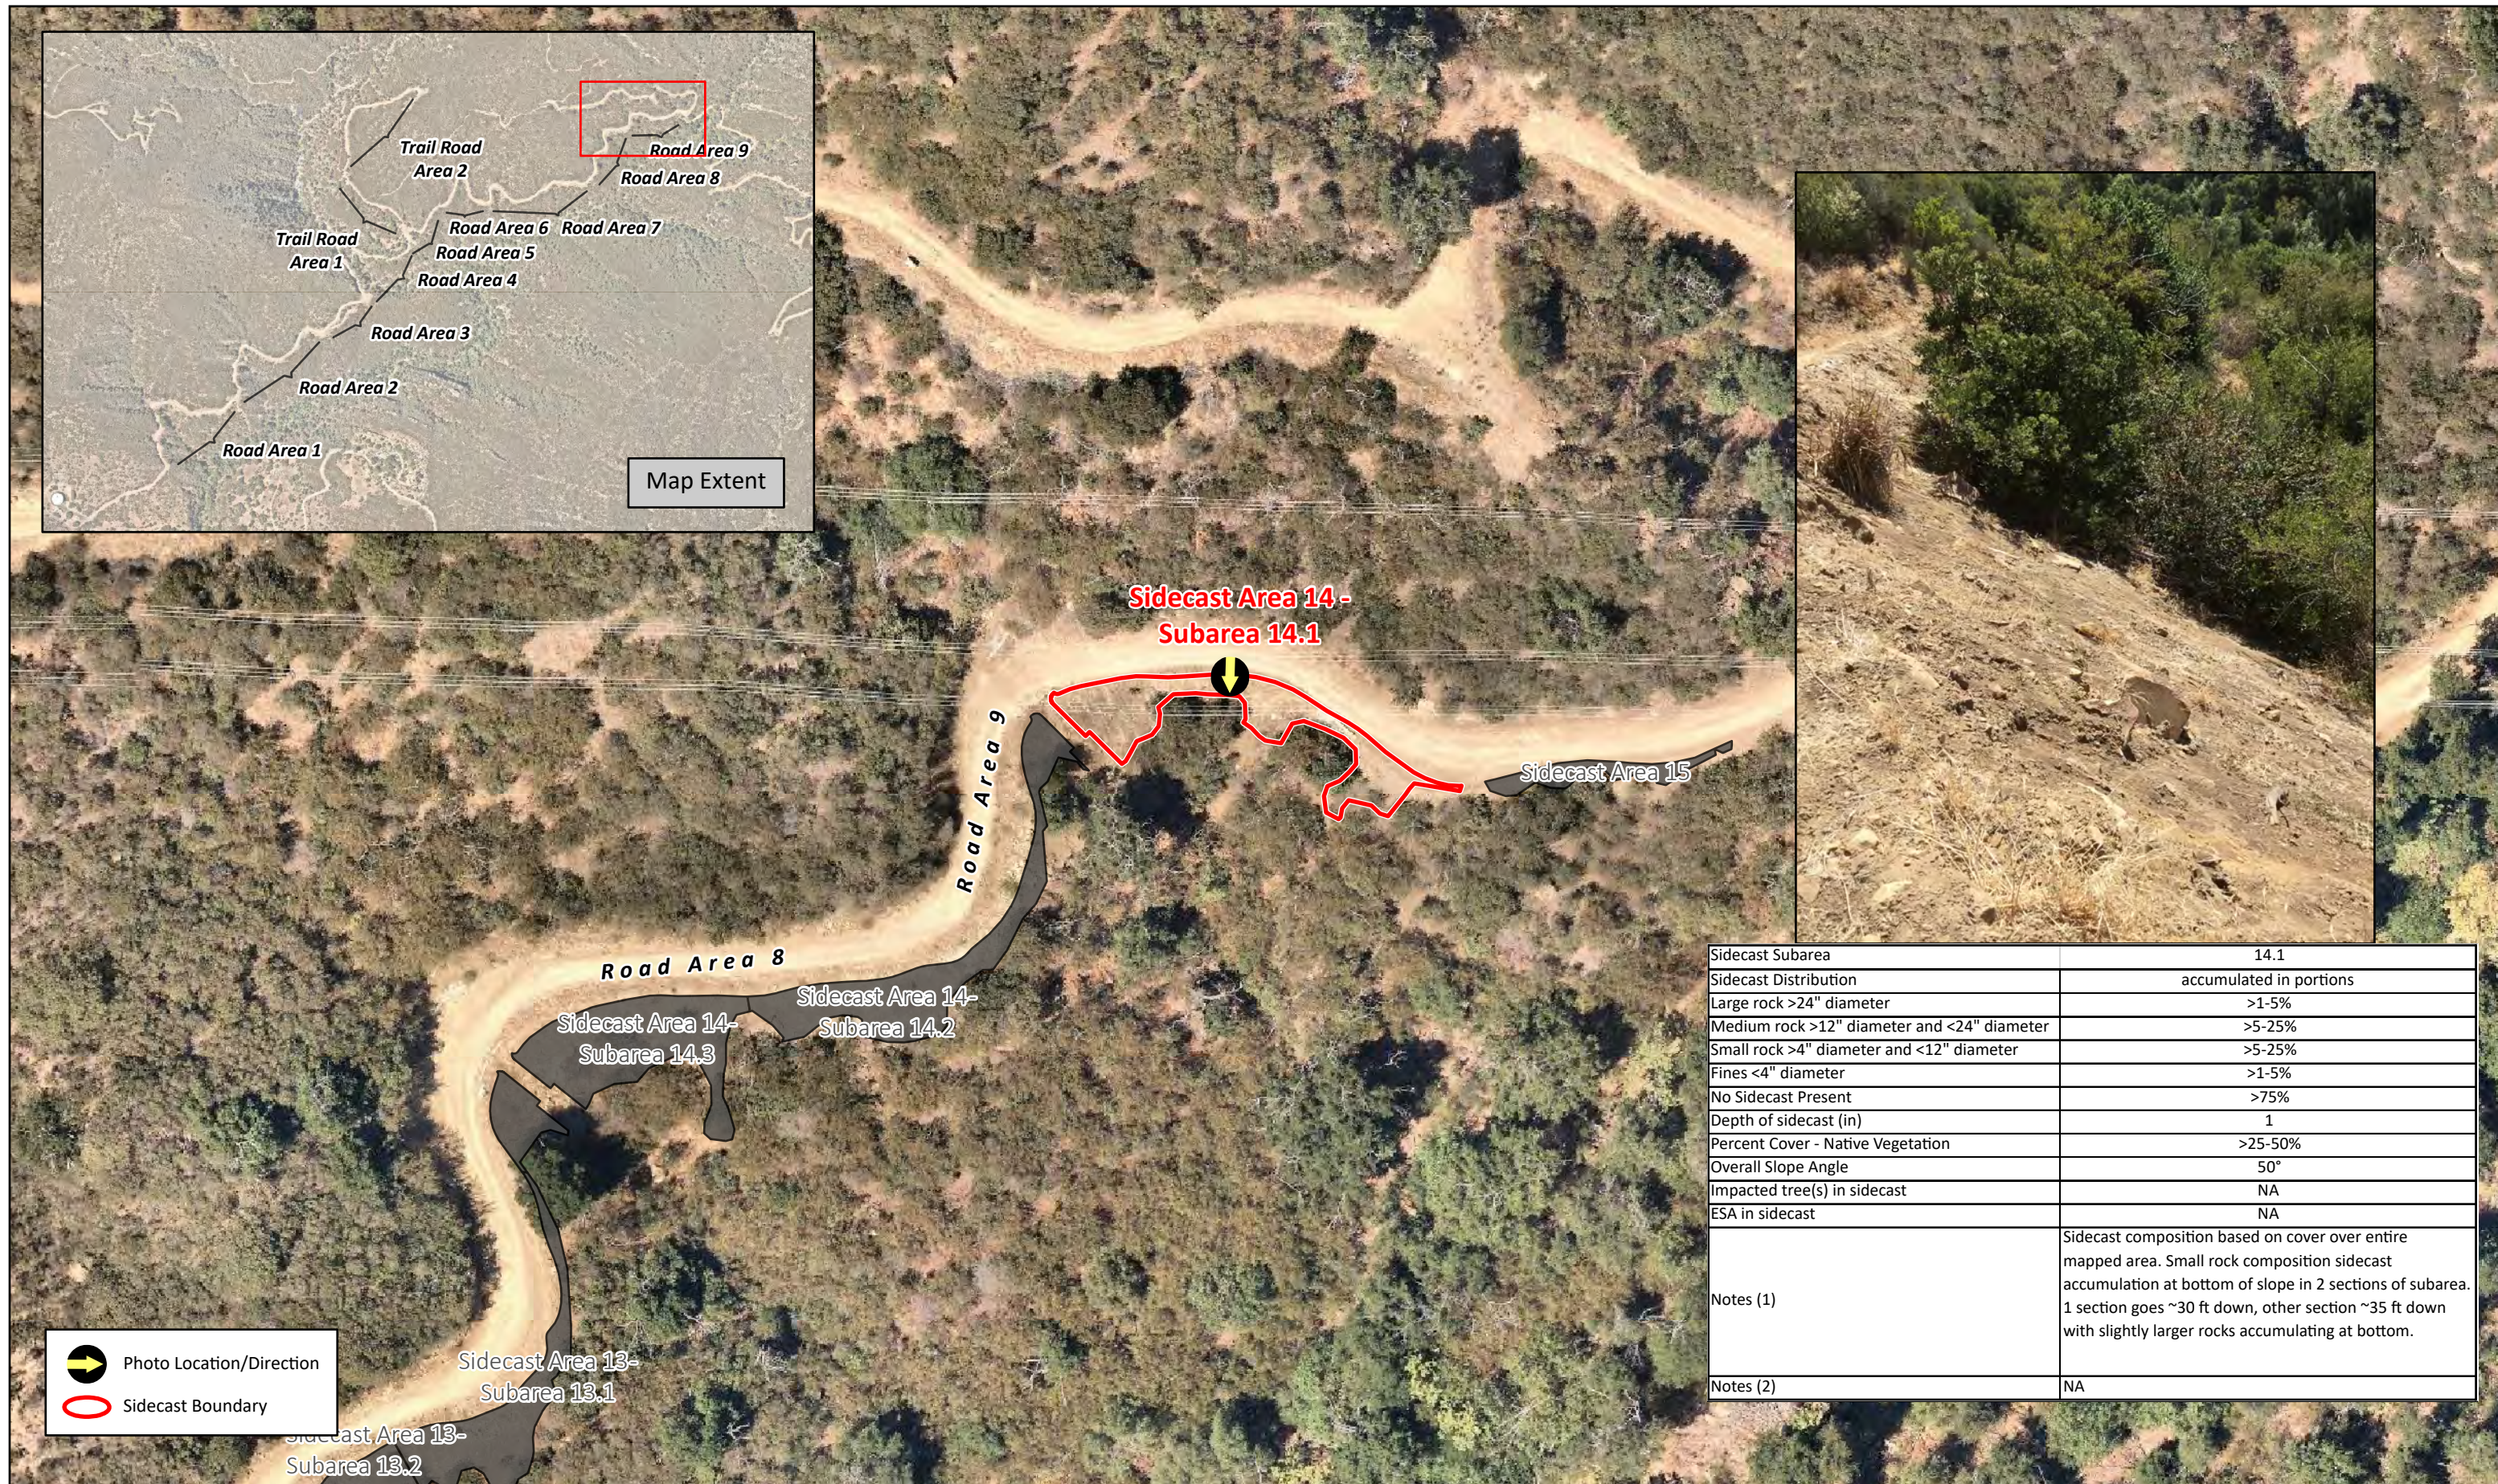
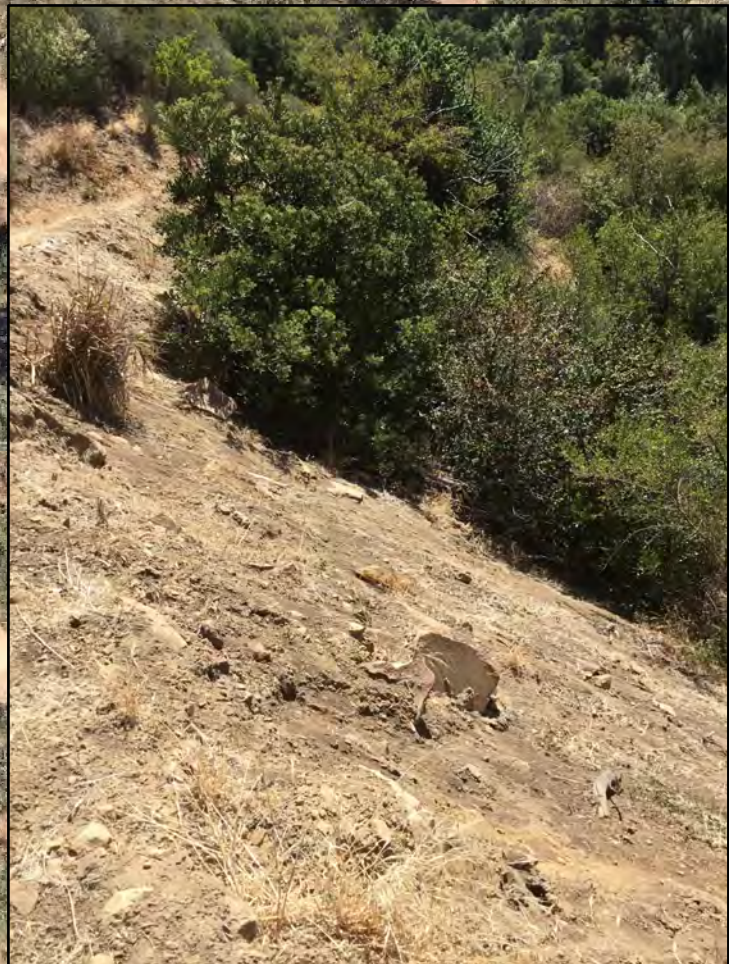
Sidecast Subarea	14.1
Sidecast Distribution	accumulated in portions
Large rock >24" diameter	>1-5%
Medium rock >12" diameter and <24" diameter	>5-25%
Small rock >4" diameter and <12" diameter	>5-25%
Fines <4" diameter	>1-5%
No Sidecast Present	>75%
Depth of sidecast (in)	1
Percent Cover - Native Vegetation	>25-50%
Overall Slope Angle	50°
Impacted tree(s) in sidecast	NA
ESA in sidecast	NA
Notes (1)	Sidecast composition based on cover over entire mapped area. Small rock composition sidecast accumulation at bottom of slope in 2 sections of subarea. 1 section goes ~30 ft down, other section ~35 ft down with slightly larger rocks accumulating at bottom.
Notes (2)	NA

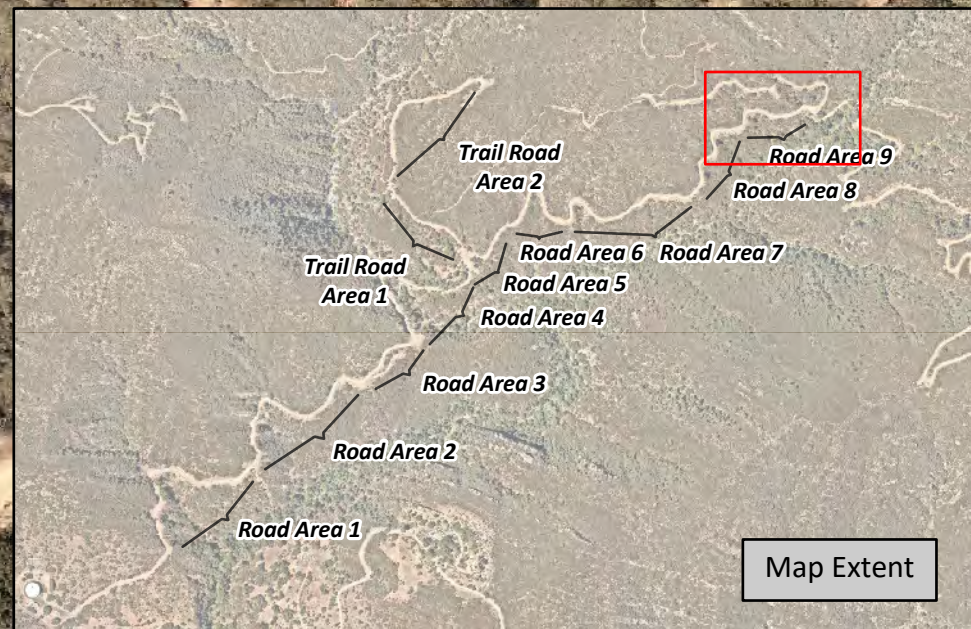
Sidecast Subarea	15.0
Sidecast Distribution	accumulated in portions
Large rock >24" diameter	0-1%
Medium rock >12" diameter and <24" diameter	NA
Small rock >4" diameter and <12" diameter	>5-25%
Fines <4" diameter	>5-25%
No Sidecast Present	>50-75%
Depth of sidecast (in)	3
Percent Cover - Native Vegetation	>25-50%
Overall Slope Angle	5°
Impacted tree(s) in sidecast	NA
ESA in sidecast	NA
Notes (1)	Sidecast composition based on cover over entire mapped area. 2 ft large boulders outside majority of Sidecast. 3'x10' area consisting of smaller Sidecast.
Notes (2)	NA

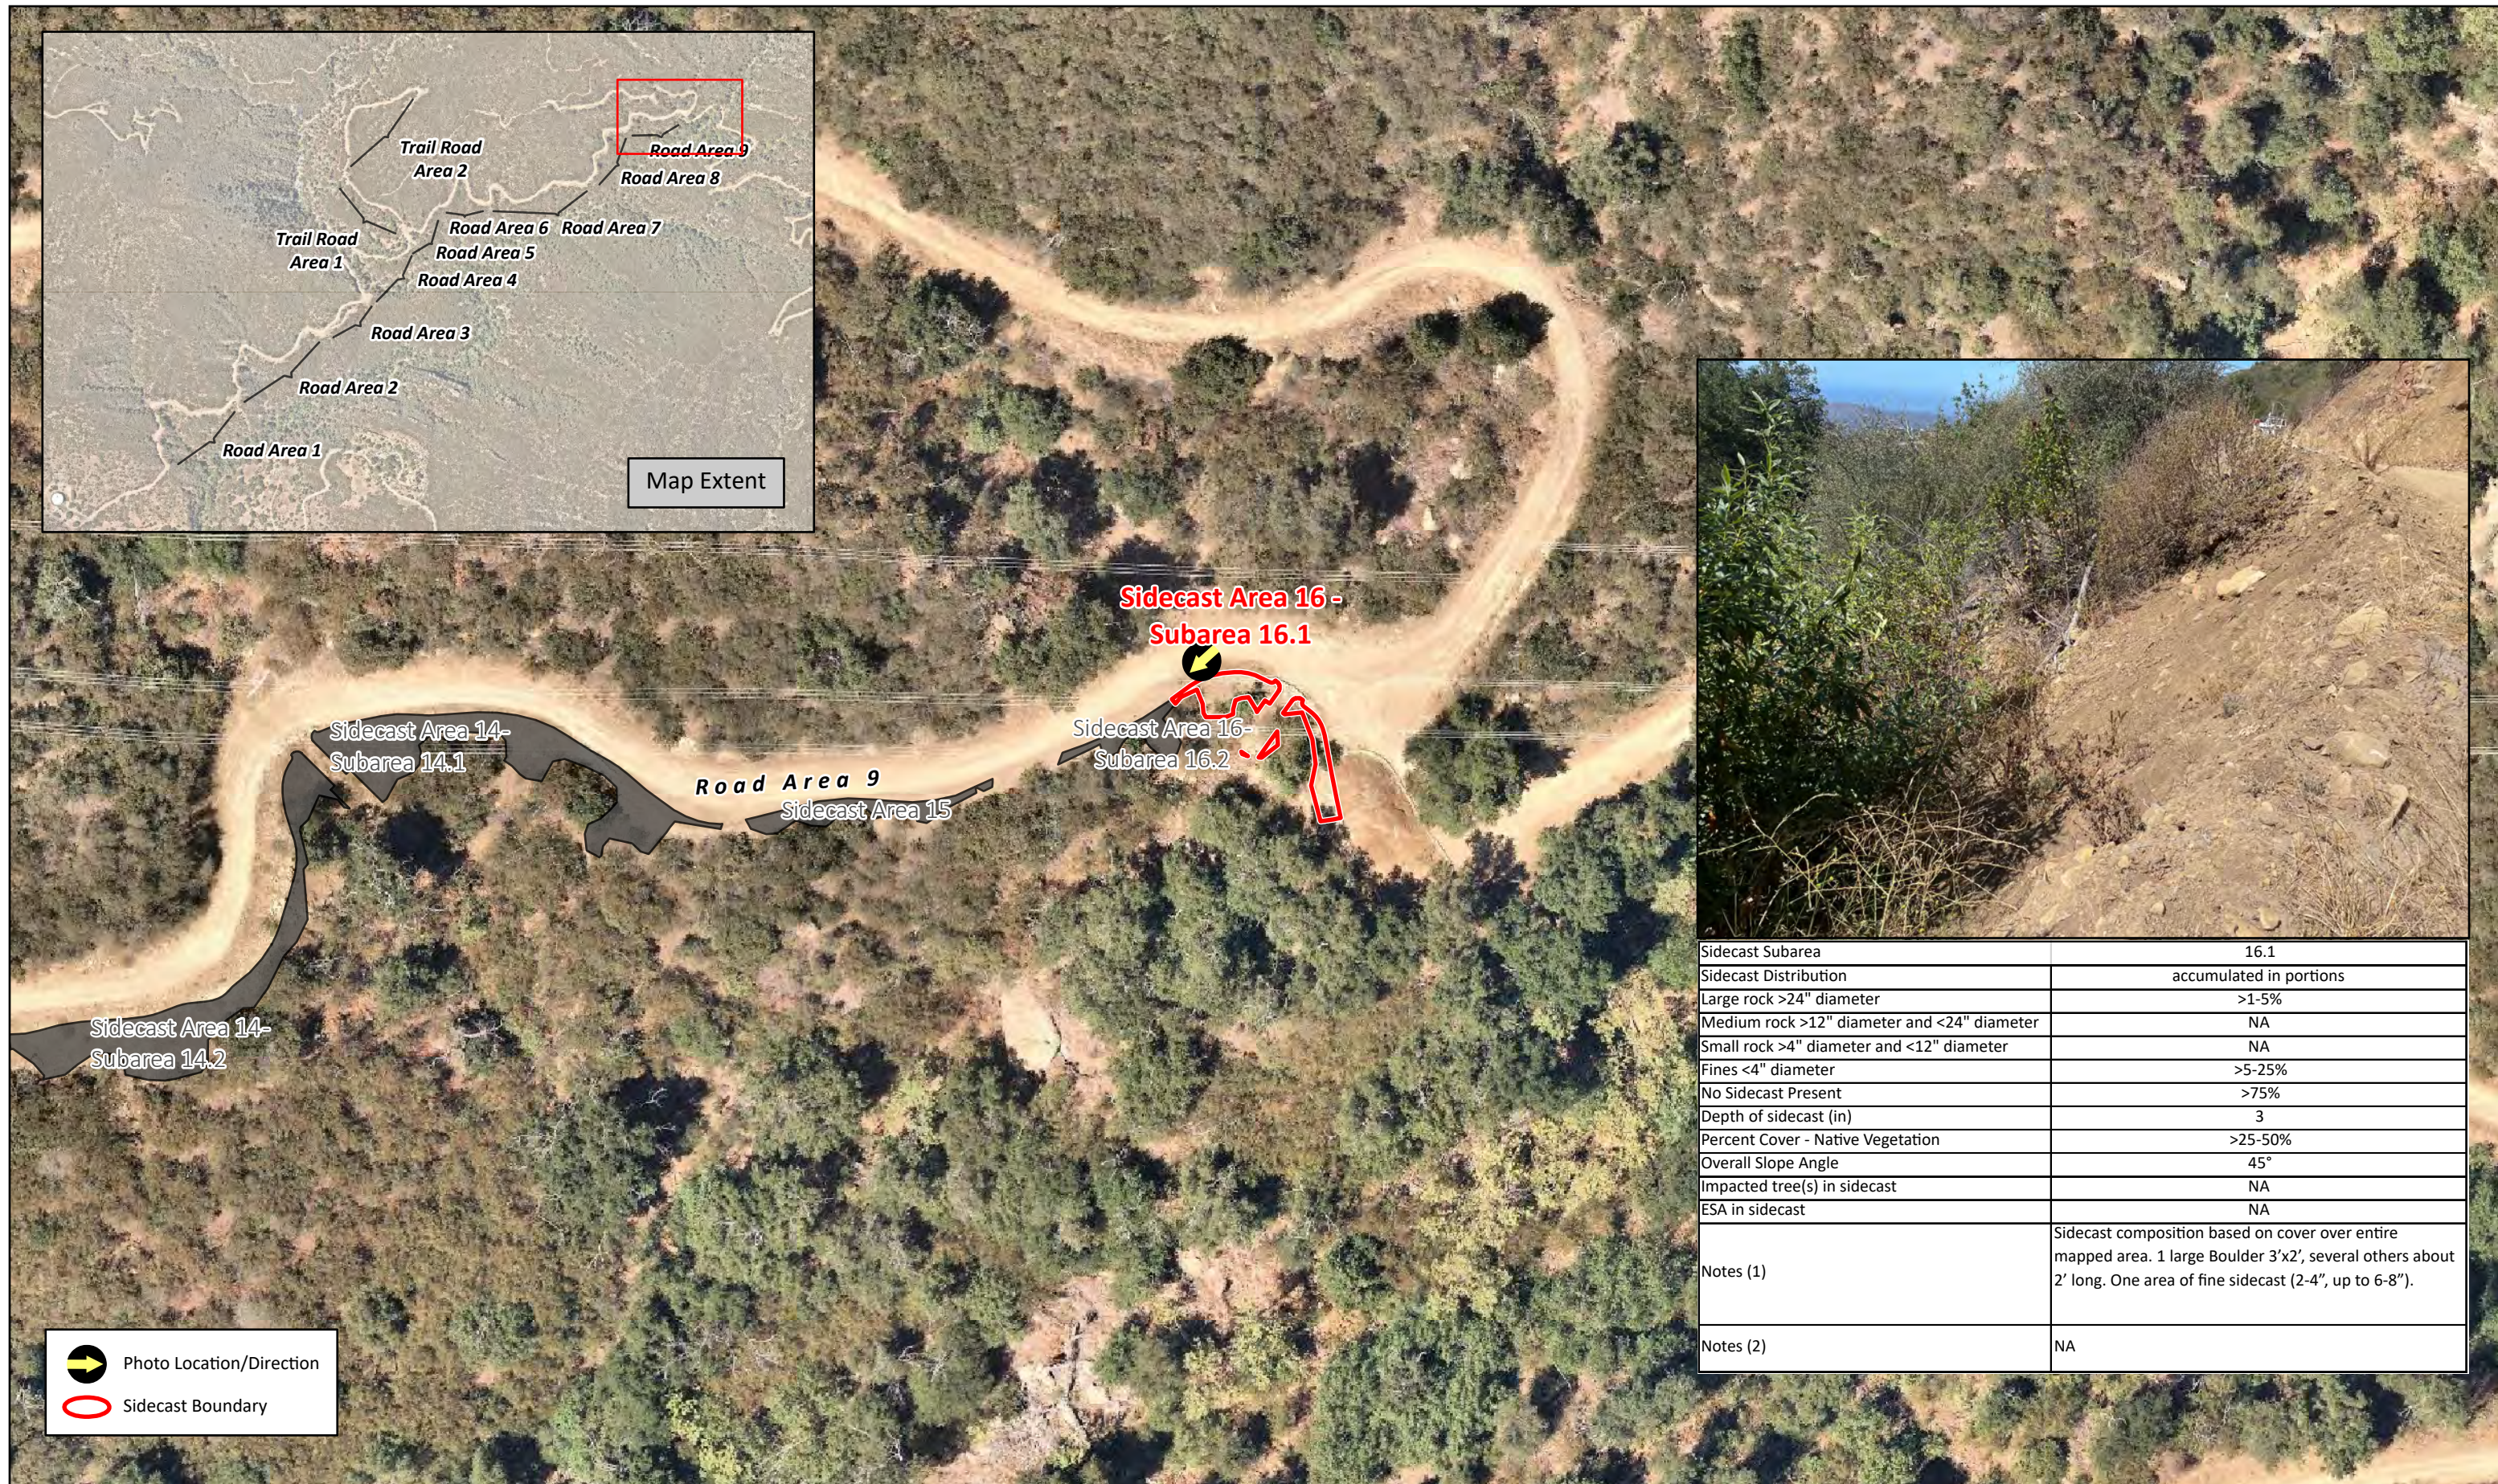
Sidecast Subarea	16.1
Sidecast Distribution	accumulated in portions
Large rock >24" diameter	>1-5%
Medium rock >12" diameter and <24" diameter	NA
Small rock >4" diameter and <12" diameter	NA
Fines <4" diameter	>5-25%
No Sidecast Present	>75%
Depth of sidecast (in)	3
Percent Cover - Native Vegetation	>25-50%
Overall Slope Angle	45°
Impacted tree(s) in sidecast	NA
ESA in sidecast	NA
Notes (1)	Sidecast composition based on cover over entire mapped area. 1 large Boulder 3'x2', several others about 2' long. One area of fine sidecast (2-4", up to 6-8").
Notes (2)	NA
