The Nipomo Creek Watershed Program

Watershed Characterization Report

The Guadalupe-Nipomo Dunes
Restoration Subcommittee

The Land Conservancy of
San Luis Obispo County

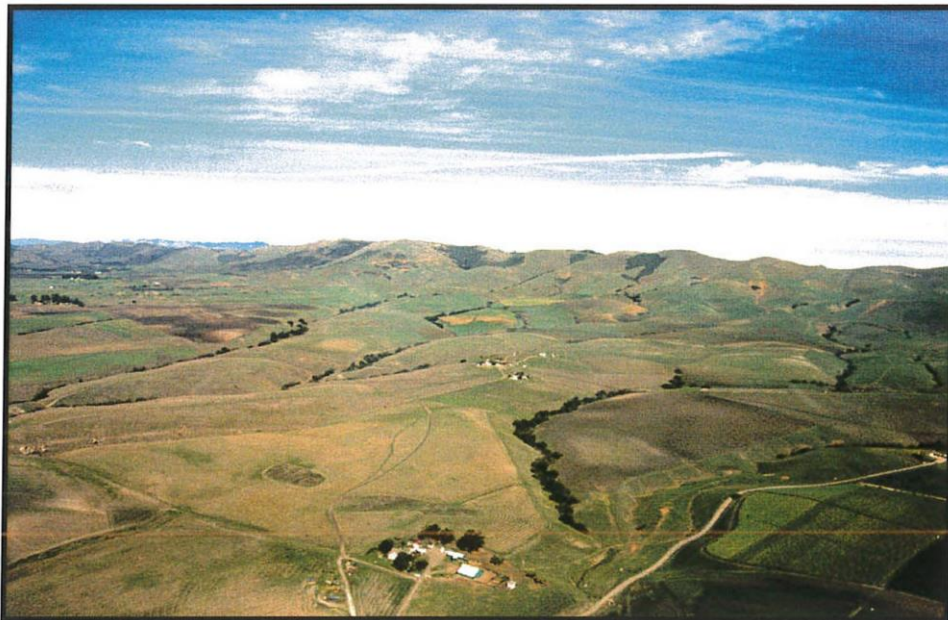
WC - 3: This final reach collects the north fork, middle fork, and south fork of Wineman Creek. Surprisingly, it appears as a relatively minor section of creek. There are a few trees and some riparian vegetation present. This reach is primarily incised to a depth of about two feet. The channel is about three feet across and the banks are vertical. There are several dirt roads crossing over the creek.

Rocky Creek, D111111 Creek, a11d Wil1ema11 Creek (from left to right)
