Monitoring and Evaluation of Salmonid Habitat Restoration  
Program

Contract P2196001

Final Report

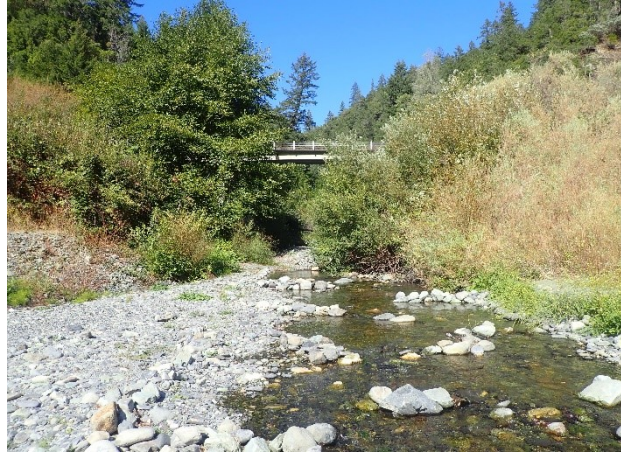
Photo\_2\_Mid-Klamath\_Slate  
Creek\_HB\_Post

File Name	Date	Subject/Site Name	Description	Standing	Facing
Photo_2_Mid-Klamath_Slate_Creek_HB_Post.jpg	10/5/2022	Mid-Klamath Tributary Fish Passage Improvement Project, HB Project, Post-treatment/ Slate Creek.	Modified channel to concentrate flow towards left bank for fish passage.	At the confluence with the Klamath River.	Upstream
Photo_3_Alpine_Creek_FP_Pre.jpg	5/16/2019	Alpine Creek Fish Passage Project, FP Project, Pre-treatment/ Alpine Creek	Left bank fish ladder and failing concrete apron.	20 feet downstream of culvert outlet.	Upstream at culvert outlet
Photo_4_Alpine_Creek_FP_Post.jpg	6/7/2022	Alpine Creek Fish Passage Project, FP Project, Post-treatment/ Alpine Creek.	Reconstructed roughened channel.	20 feet downstream of culvert outlet.	Upstream at culvert outlet.
Photo_5_Dewarren_Creek_HI_Pre.jpg	7/30/2019	North Fork Noyo River-Dewarren Creek Coho Habitat Enhancement Project, HI Project, Pre-treatment/ Dewarren Creek.	Without large wood habitat in wetted portion of channel.	Right bank gravel bar within active channel.	Downstream

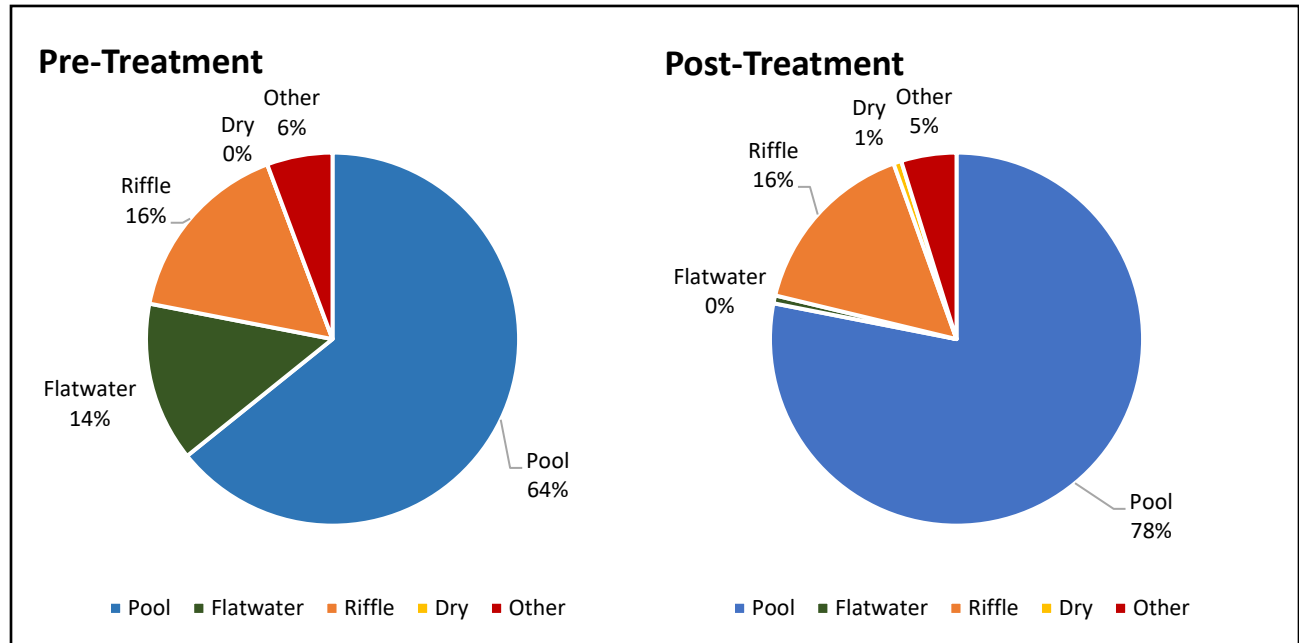
Figure 2. Level habitat type collected within the post-treatment IN checklist using pre-treatment conditions as a comparison.

The IN checklists are primarily used for HI projects where the goal of the project is to improve habitat and stream morphology. The percentage of pool habitat types evaluated using the IN checklist increased from 64% to 78% (Figure 2).

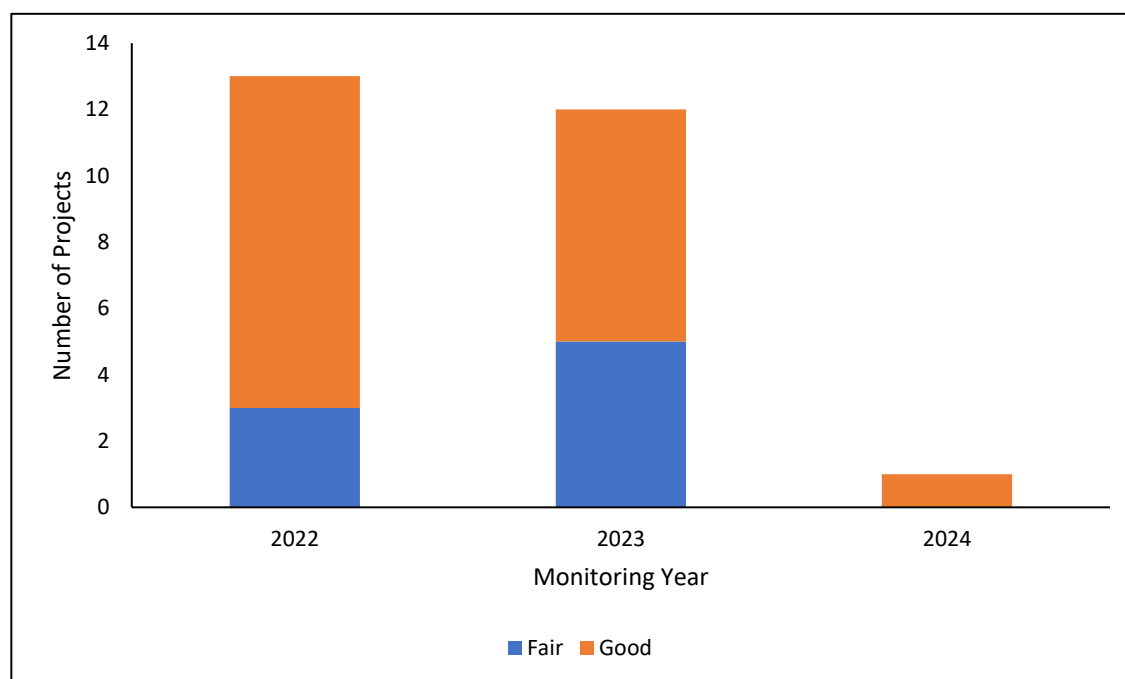
Figure 5. Overall project effectiveness ratings by year.

Twenty-six projects were monitored for post-treatment effectiveness during the contract period and received overall project effectiveness ratings. In 2022 ten projects received a good rating and three a fair rating. In 2023 seven projects received a good rating and five a fair rating. One project was monitored for post-treatment effectiveness in 2024 under this contract and received a good rating. No projects received an excellent, poor or fail rating (Figure 5).

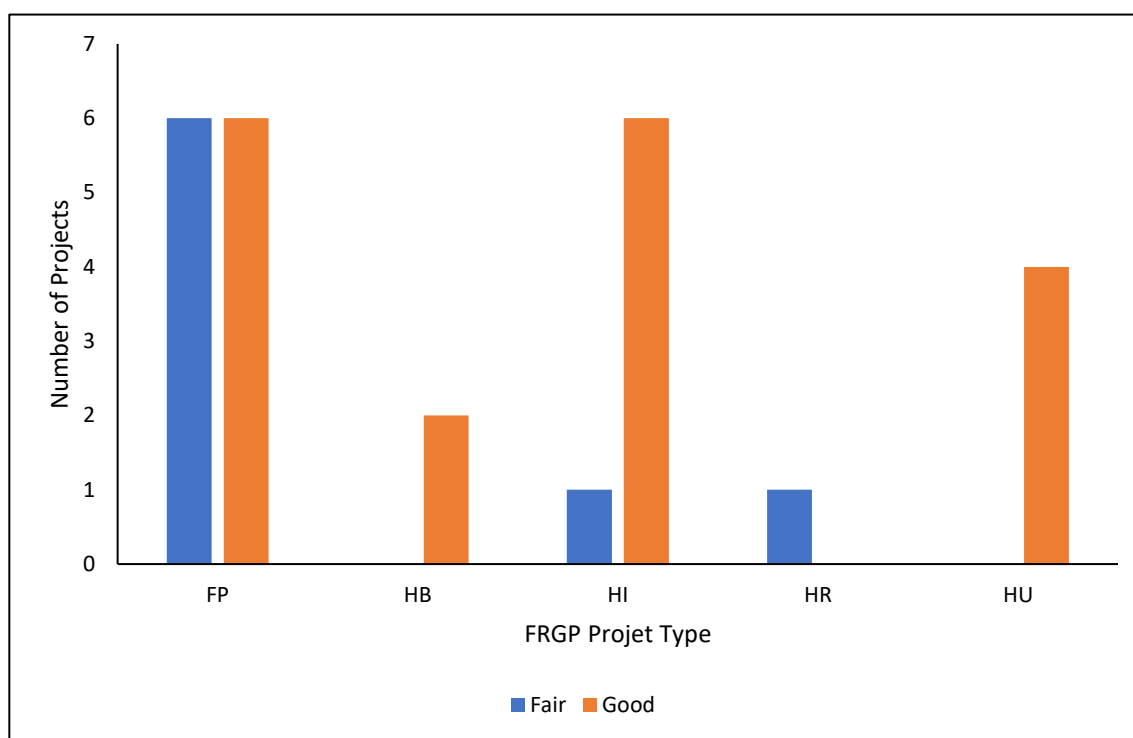
Figure 6. Overall project effectiveness ratings by project type.

All HB and HU projects received a good project rating (Figure 6). Six FP projects, one HI project, and one HR project also received fair project ratings.

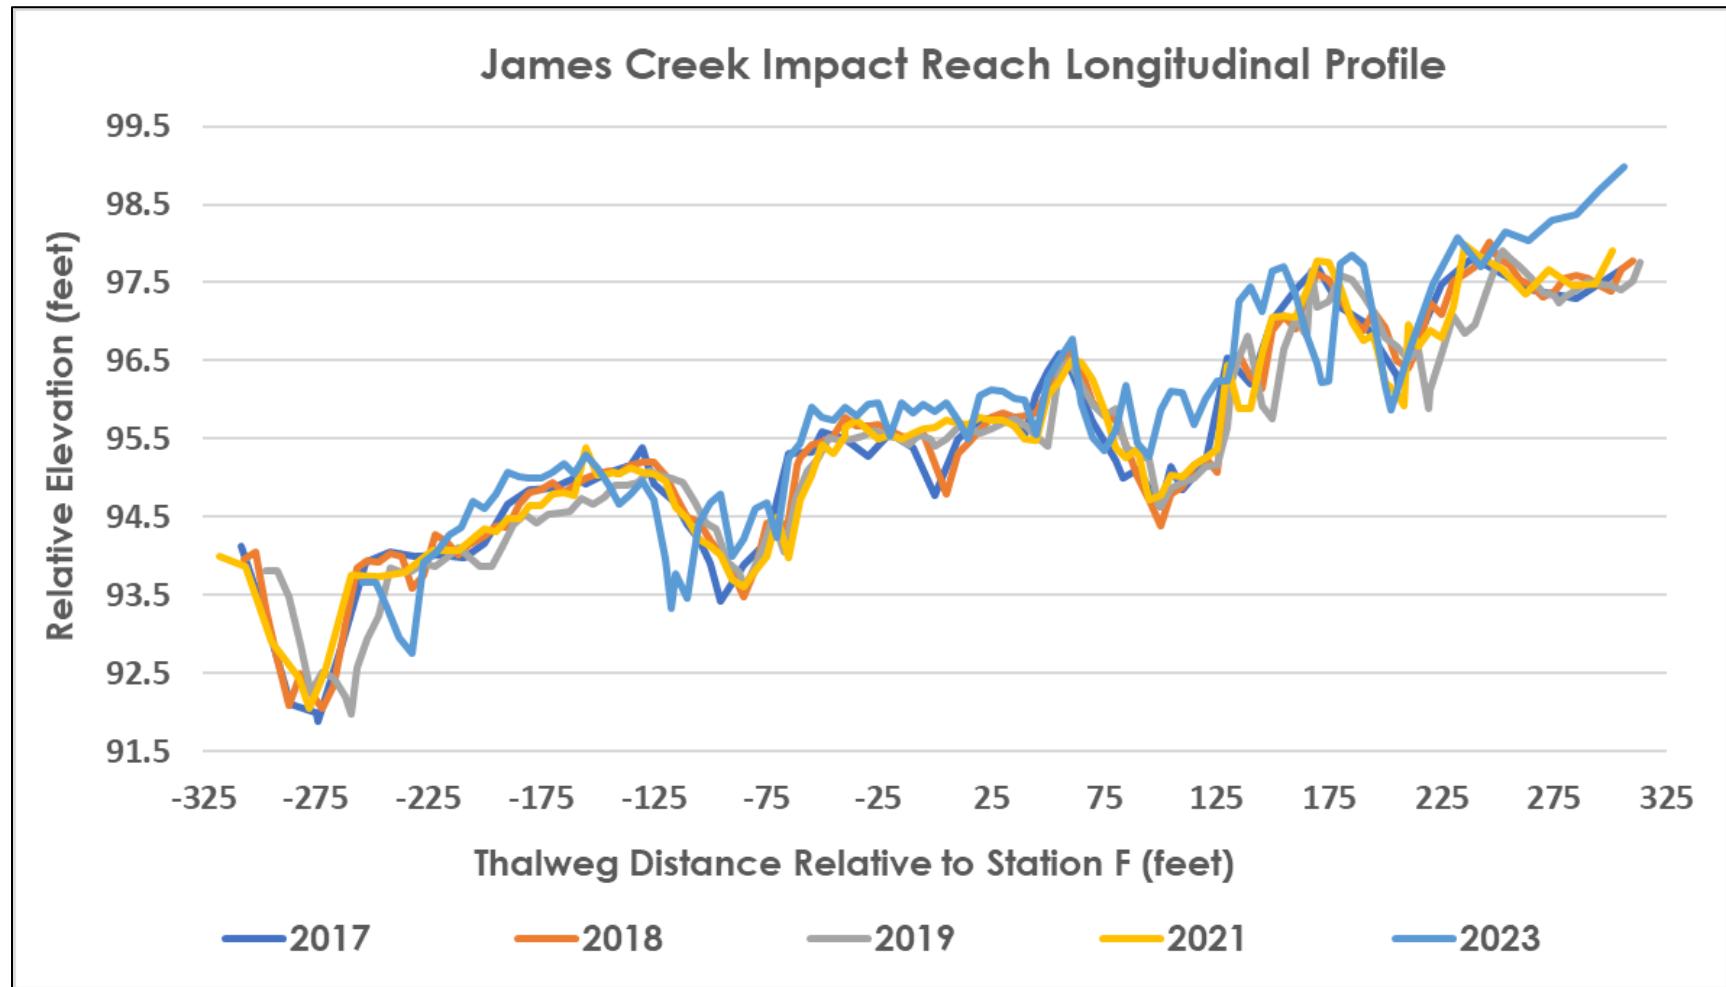
Figure 7. James Creek impact reach longitudinal profiles. Station F is the midpoint of the reach.

Longitudinal profile surveys in the James Creek Coho Stream Habitat Enhancement Project were conducted in 2017, 2018, 2019, 2021 and 2023. Large wood structures were added into the impact reach in 2020. The longitudinal profile survey results for the impact reach are presented in Figure 7 and the longitudinal profile survey results for the control reach are presented in Figure 8.

Through the first year after construction (2021) the BACI longitudinal profile survey detected no large thalweg profile changes in the James Creek impact reach, likely due to the passage of only one mild winter since implementation. However, two additional winters passed prior to the 2023 survey and changes in the longitudinal profile were more notable (Figure 9). For example, a pool formed at the lowest point within the impact reach, moving the bottom of the longitudinal profile upstream 64 ft.

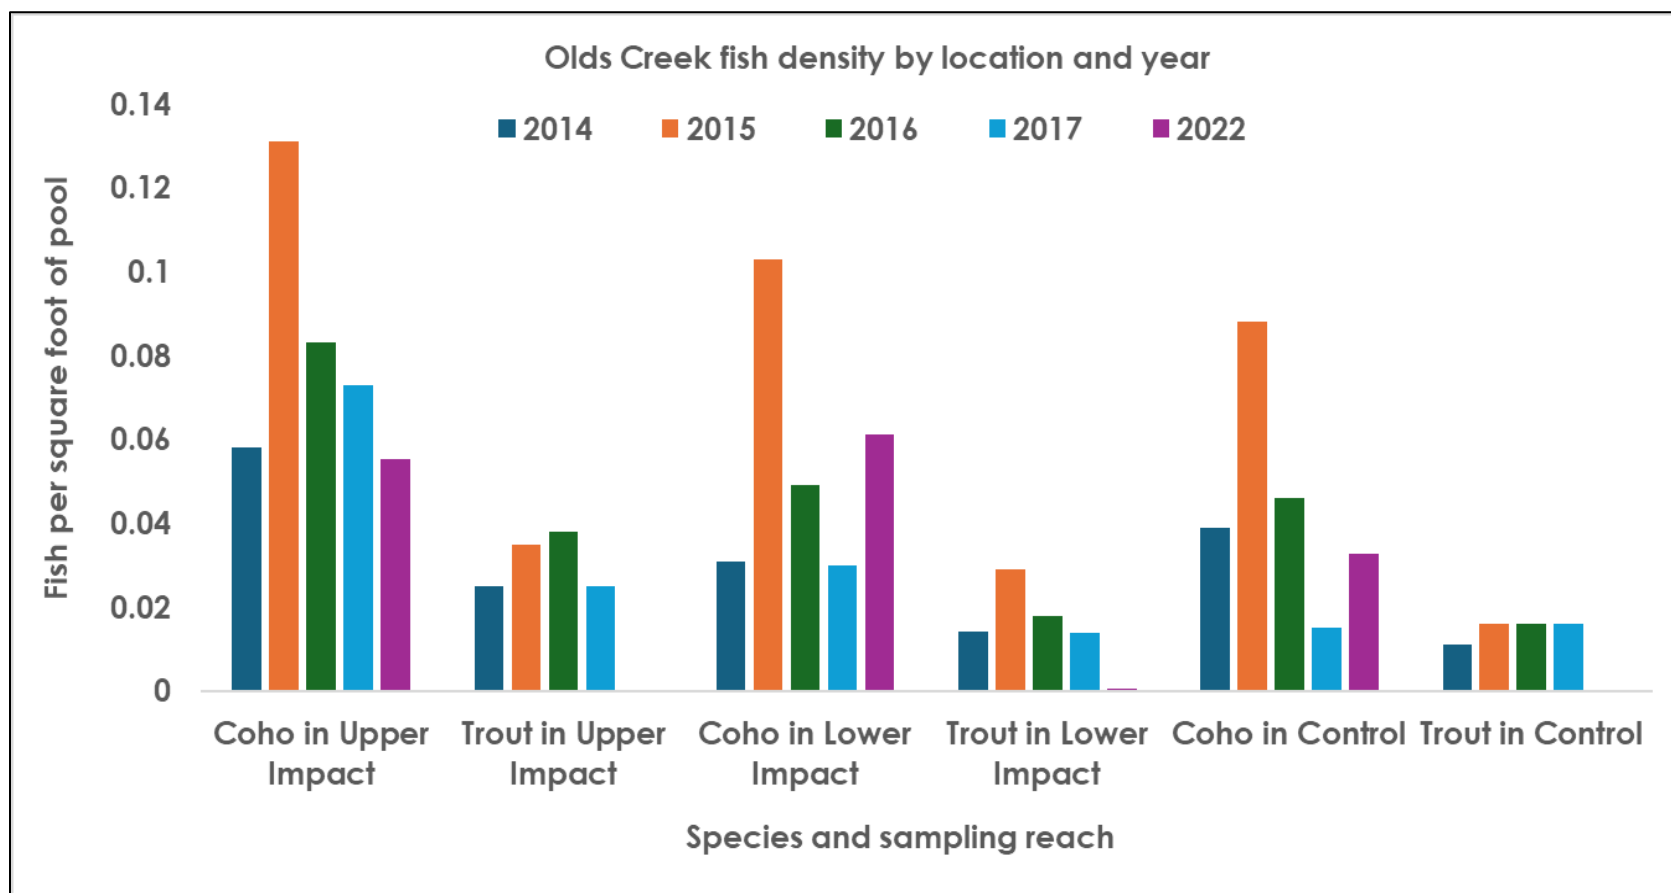
Figure 10. Olds Creek fish density by year, sorted by species and reach.

Fish density by reach, year and species is presented in Figure 10.

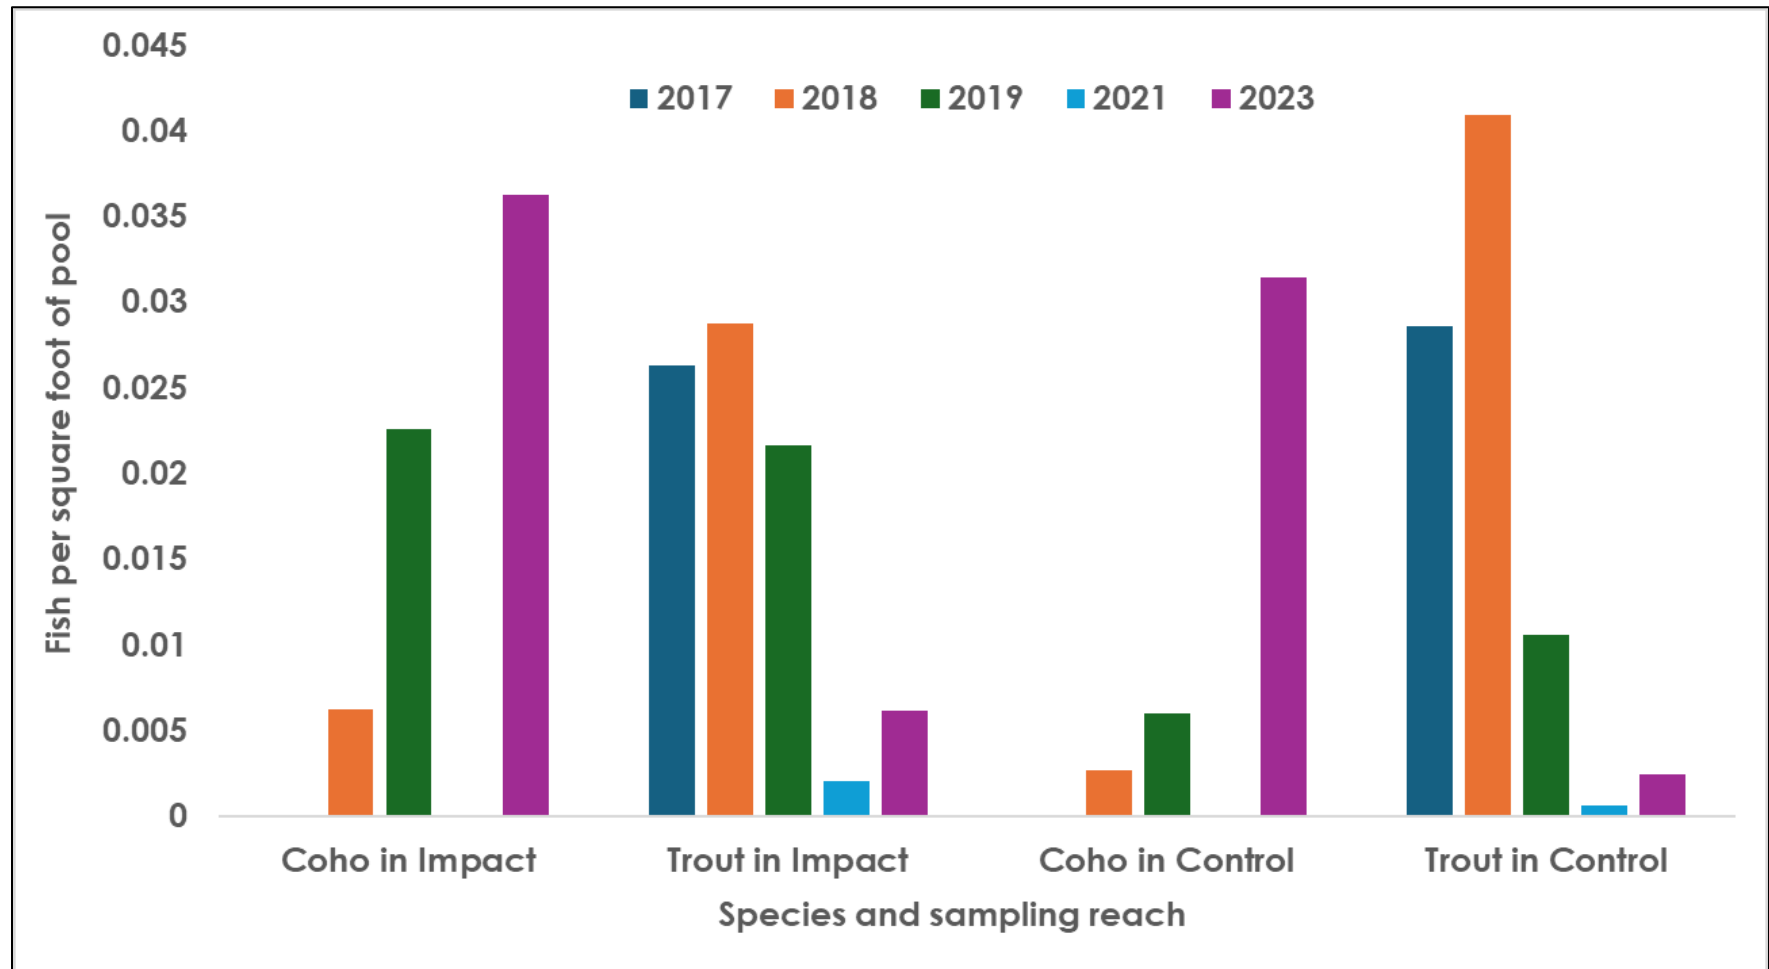
Figure 11. James Creek fish density by reach and year, sorted by species and reach.

Fish density by reach, year and species is presented in Figure 11.
