**California Department of Fish and Wildlife**  
*Fisheries Restoration Grant Program*  
Restoration Project Case Study

**P1450011 Fish Passage Improvement at Crossing 3, Quiota Creek**

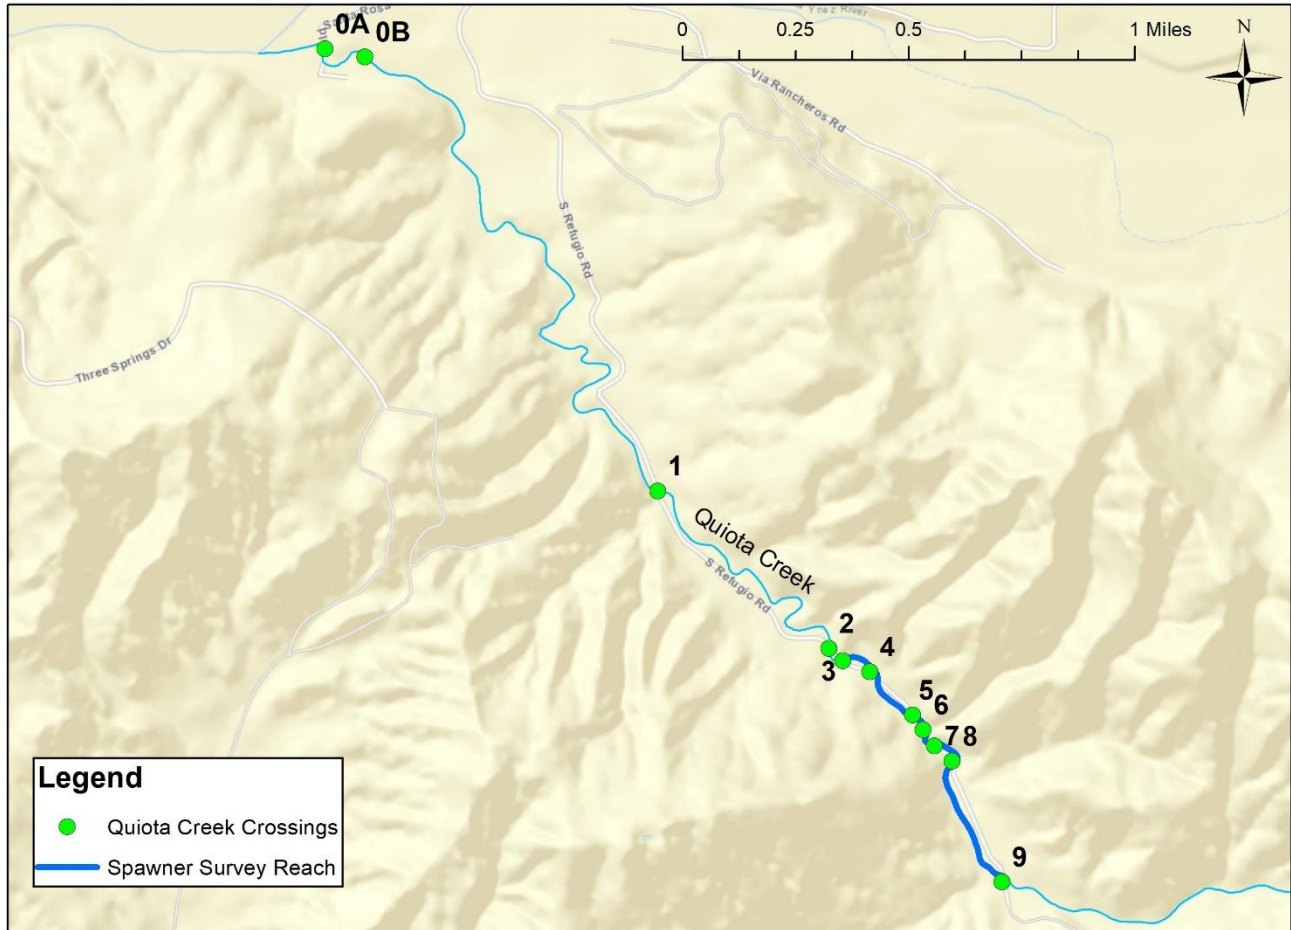
Approximately 0.78 miles of Quiota Creek were surveyed during spawner survey validation monitoring (Figure 3). This survey reach encompasses the portion of the creek from Crossing 3 through Crossing 9, the last of the stream crossings located along the creek. Much of the potential spawning habitat and summer refugia is in the upper watershed. One spawner survey was conducted by the MESHR team on April 4, 2023. Additional spawner surveys were conducted by Cachuma Operations and Maintenance Board (COMB) during the 2022-2023 spawning season. No steelhead trout were observed during these surveys. Summer snorkel surveys were conducted by COMB in June and September 2023 along a slightly longer survey reach beginning from Crossing 2 through just upstream of Crossing 9. During the June snorkel survey, 12 juvenile *O. mykiss* were observed upstream of Crossing 3. During the September snorkel survey, a total of 15 juvenile and resident adult *O. mykiss* were observed throughout the survey reach, with 5 trout observed below Crossing 3 and 10 trout observed above Crossing 3. Spawner and snorkel surveys have been conducted annually along this portion of Quiota Creek by COMB staff since 2012. No anadromous adult steelhead trout were observed during any of these surveys. One barrier to fish passage, Crossing 0B, still remains along Quiota Creek, though efforts are underway to replace this remaining Arizona crossing with a bottomless arch culvert. Combined with multiple years of severe drought conditions, this remaining barrier, which is located downstream of nine of the remediated crossings and downstream of the validation survey reach, likely contributes to a lack of steelhead observations. With the removal of Crossing 3 and the other fish passage barriers along Quiota Creek, future repopulation by steelhead can be possible when stream flow and habitat conditions allow. Future surveys are recommended to monitor long-term adult steelhead passage and repopulation in Quiota Creek.

**Figure 3.** Map of the eleven stream crossing locations along Quiota Creek. The spawner survey reach is highlighted in dark blue.

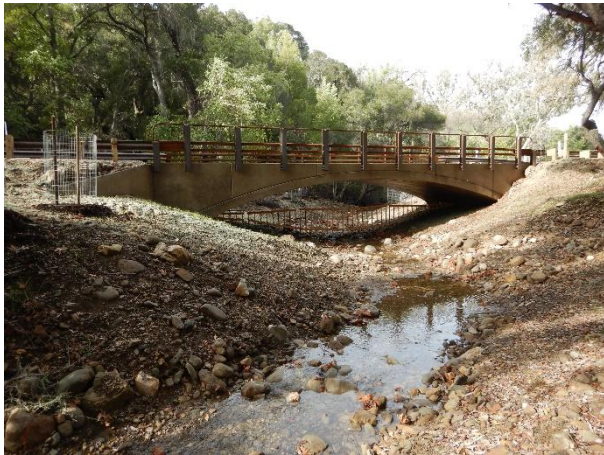
The bottomless arch culvert, channel reconstruction, rock riffle, and RSP treatments at the Quiota Crossing 5 project site were monitored for effectiveness in September of 2023, five years after implementation. The bottomless arch culvert was in good condition and functioning as intended. Channel conditions appeared ideal for passage for all steelhead life stages during passable flow conditions as the crossing replacement successfully removed the barrier to fish passage. The channel regrading and reconstruction with engineered stream material retained the intended gradient and good substrate, even after significant flow events following implementation. There was some shifting of materials in the channel, resulting in the unintended effect of aggradation of boulders and cobble within the channel upstream of and under the culvert. This has led to a reduced freeboard within the culvert. Overall, the channel feature still is passable and provides good habitat for fish. The large RSP was still in place and functioning as intended to protect crossing abutments from scour. Some of the smaller material installed as fill between the larger rocks and boulders that make up the RSP appeared to have washed out, exposing the large rock that was intended to be buried. The rock riffle that was installed at the upstream limit of the channel reconstruction was still riffle habitat and the large boulders installed appear to still be in place, but the channel had shifted to the river left side of this feature rather

**Figure 3.** View, facing downstream, of the new bottomless arch culvert and upstream channel as they appeared immediately following implementation. Photo date: 1/8/2019

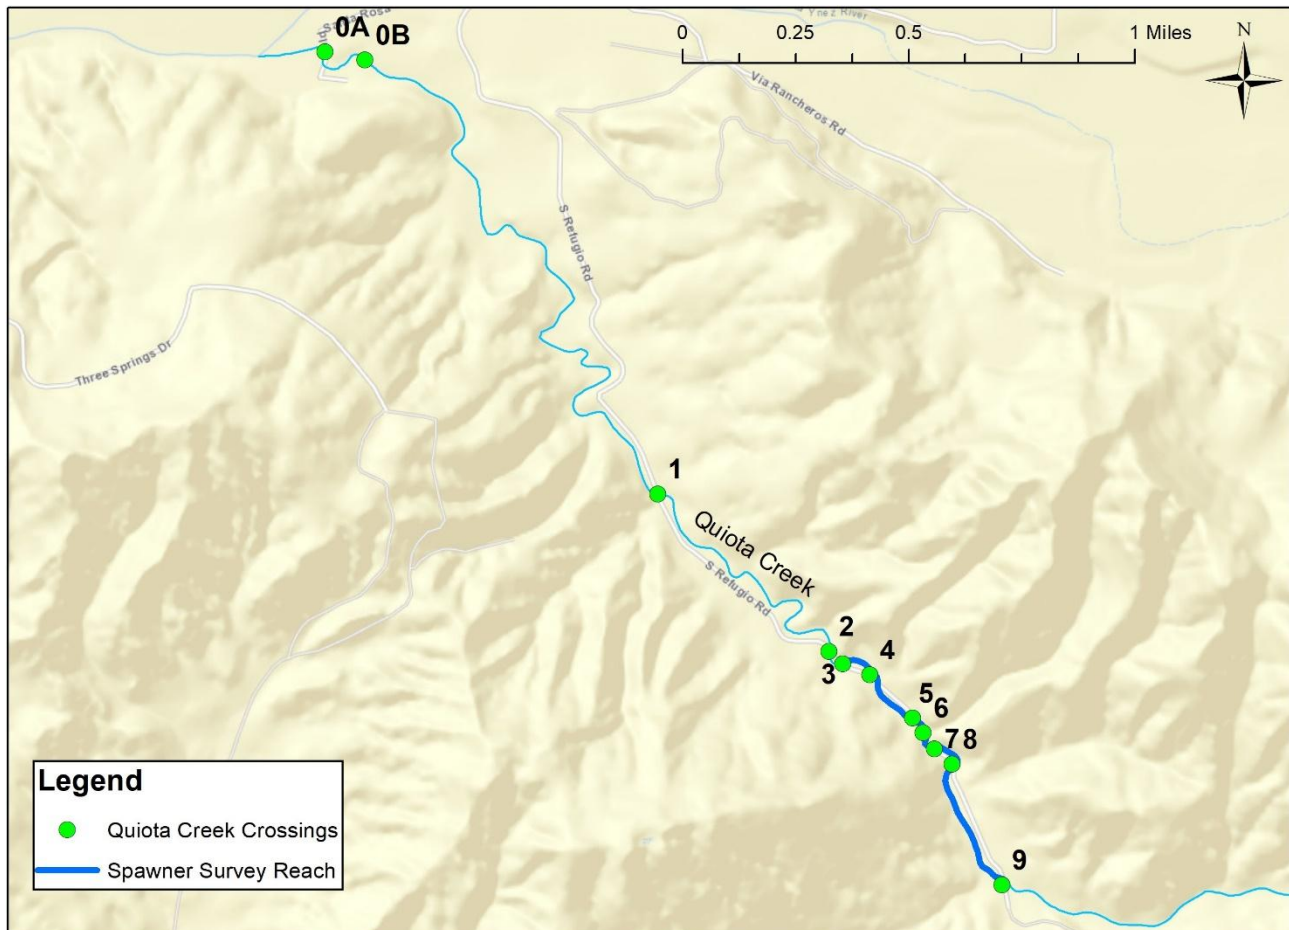
Approximately 0.78 miles of Quiota Creek were surveyed during spawner survey validation monitoring (Figure 5). This survey reach encompasses the portion of the creek from Crossing 3 through Crossing 9, the last of the stream crossings located along the creek. Much of the potential spawning habitat and summer refugia is in the upper watershed. One spawner survey was conducted by the MESHR team on April 4, 2023. Additional spawner surveys were conducted by Cachuma Operations and Maintenance Board (COMB) during the 2022-2023 spawning season. No steelhead trout were observed during these surveys. Summer snorkel surveys were conducted by COMB in June and September 2023 along a slightly longer survey reach beginning from Crossing 2 through just upstream of Crossing 9. During the June snorkel survey, 12 juvenile *O. mykiss* were observed upstream of Crossing 5. During the September snorkel survey, a total of 15 juvenile and resident adult *O. mykiss* were observed throughout the survey reach, with five trout observed below Crossing 5 and 10 trout observed above Crossing 5. Spawner and

**Figure 5.** Map of the eleven stream crossing locations along Quiota Creek. The spawner survey reach is highlighted in dark blue.

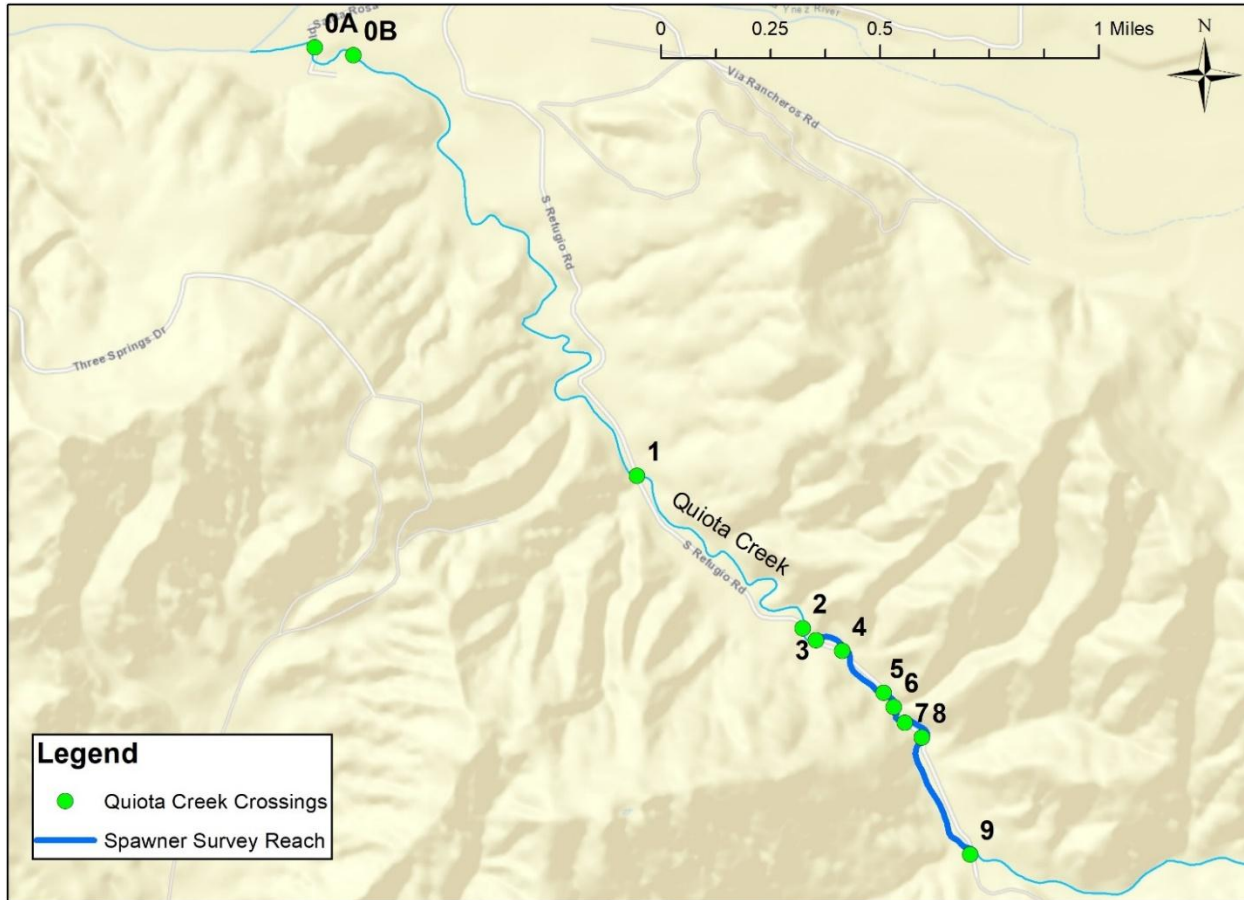
Approximately 0.78 miles of Quiota Creek were surveyed during spawner survey validation monitoring (Figure 3). This survey reach encompasses the part of the creek from Crossing 3 through Crossing 9, the last of the stream crossings located along the creek. Much of the potential spawning habitat and summer refugia is in the upper watershed. One spawner survey was conducted by the MESHR team on April 4, 2023. Additional spawner surveys were conducted by Cachuma Operations and Maintenance Board (COMB) during the 2022-2023 spawning season. No steelhead trout were observed during these surveys. Summer snorkel surveys were conducted by COMB in June and September 2023 along a slightly longer survey reach beginning from Crossing 2 through just upstream of Crossing 9. During the June snorkel survey, 12 juvenile *O. mykiss* were observed upstream of Crossing 8. During the September snorkel survey, a total of 15 juvenile and resident adult *O. mykiss* were observed throughout the survey reach, with 5 trout observed below Crossing 8 and 10 trout observed above Crossing 8. Spawner and snorkel surveys have been conducted annually along this portion of Quiota Creek by COMB staff since 2012. No adult steelhead trout were observed during any of these surveys. One barrier to fish passage, Crossing 0B, still remains along Quiota Creek, though efforts are underway to replace this remaining Arizona crossing with a bottomless arch culvert. Combined with multiple years of severe drought conditions, this remaining barrier, which is located downstream of nine of the remediated crossings and downstream of the validation survey reach, likely contributes to a lack of steelhead observations. With the removal of Crossing 8 and the other fish passage barriers along Quiota Creek, future repopulation by steelhead can be possible when stream flow and habitat conditions allow. Future surveys are recommended to monitor long-term adult steelhead passage and repopulation in Quiota Creek.

**Figure 3.** Map of the eleven stream crossing locations along Quiota Creek. The spawner survey reach is highlighted in dark blue.

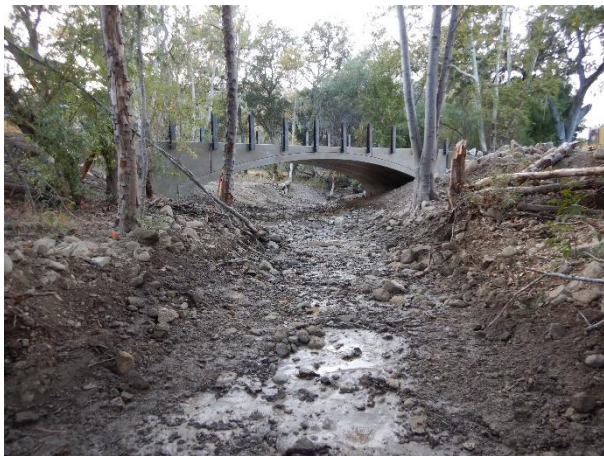
Quiota Creek experienced several severe storm and flow events during the winter prior to post-treatment monitoring which had significant effects on parts of the stream channel within this project area. The channel regrading and reconstruction with engineered stream material located upstream of and beneath the new crossing retained the intended gradient and installed ESM. Some shifting of the smaller materials might have occurred, but the larger boulders remained in place where they were installed in the channel under the culvert. Fish passage conditions through the new crossing and this section of reconstructed channel appear good. Downstream of the crossing and ESM channel section, two rock weirs consisting of large boulders that were buried under channel material were installed with the intended purpose to remain buried and maintain grade control (Figure 3). During

**Figure 3.** View, facing upstream, of the reconstructed portion of channel below the crossing with buried boulder weirs as it appeared immediately following implementation. Photo date: 10/23/2018

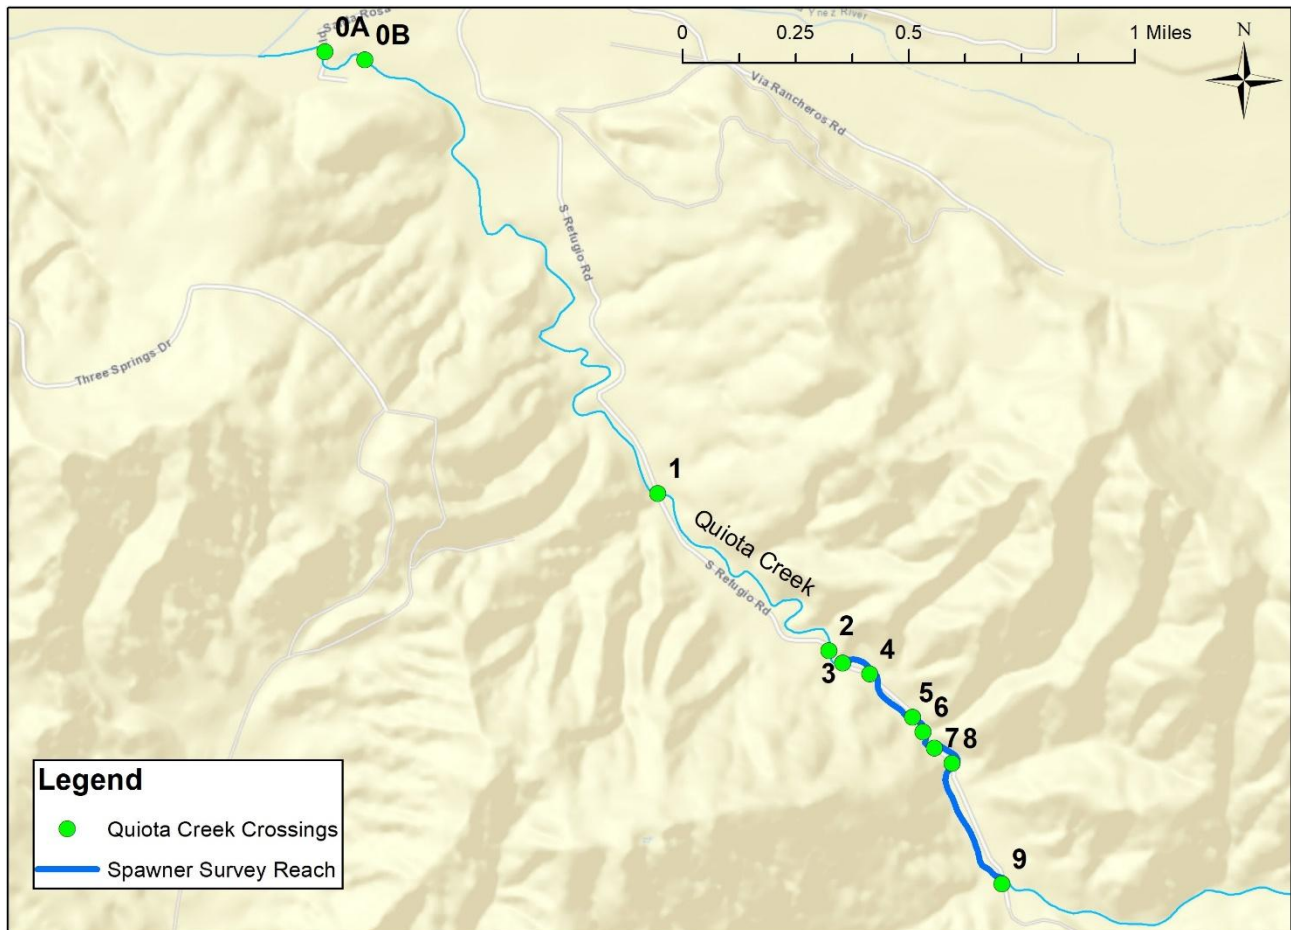
Approximately 0.78 miles of Quiota Creek were surveyed during spawner survey validation monitoring (Figure 5). This survey reach encompasses the portion of the creek from Crossing 3 through Crossing 9, the last of the stream crossings located along the creek. Much of the potential spawning habitat and summer refugia is located in the upper watershed. One spawner survey was conducted by the MESHR team on April 4, 2023. Additional spawner surveys were conducted by Cachuma Operations and Maintenance Board (COMB) during the 2022-2023 spawning season. No steelhead trout were observed during these surveys. Summer snorkel surveys were conducted by COMB in June and September 2023 along a slightly longer survey reach beginning from Crossing 2 through just upstream of Crossing 9. During the June snorkel survey, 12 juvenile *O. mykiss* were observed, with seven below and five above Crossing 9. During the September snorkel survey, a total of 15 juvenile and resident adult *O. mykiss* were observed throughout the survey reach, with 13 observed below Crossing 9 and two observed above

**Figure 5.** Map of the eleven stream crossing locations along Quiota Creek. The spawner survey reach is highlighted in dark blue.
