Site Name: Dunn Creek Culvert

Year Remediated: 2011

PAD ID: 737274

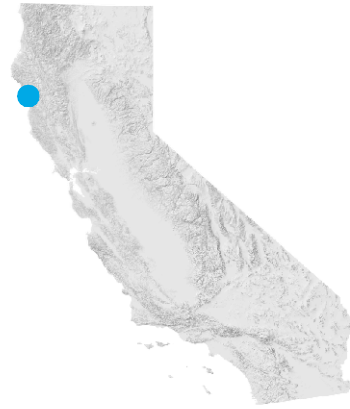
Barrier Description Prior to Remediation: Total

Notes: Culvert removed and bridge installed in 2011. New prefabricated bridge on EF Dunn Creek. BEFORE: Total barrier per FishXing. This was a 96 inch CMP culvert and a complete barrier to adult and juvenile fish passage confirmed by CDFG staff and FishXing software.
