Santa Clara River Steelhead Trout: Assessment and Recovery Opportunities

December 2005

Prepared By:

Prepared For:

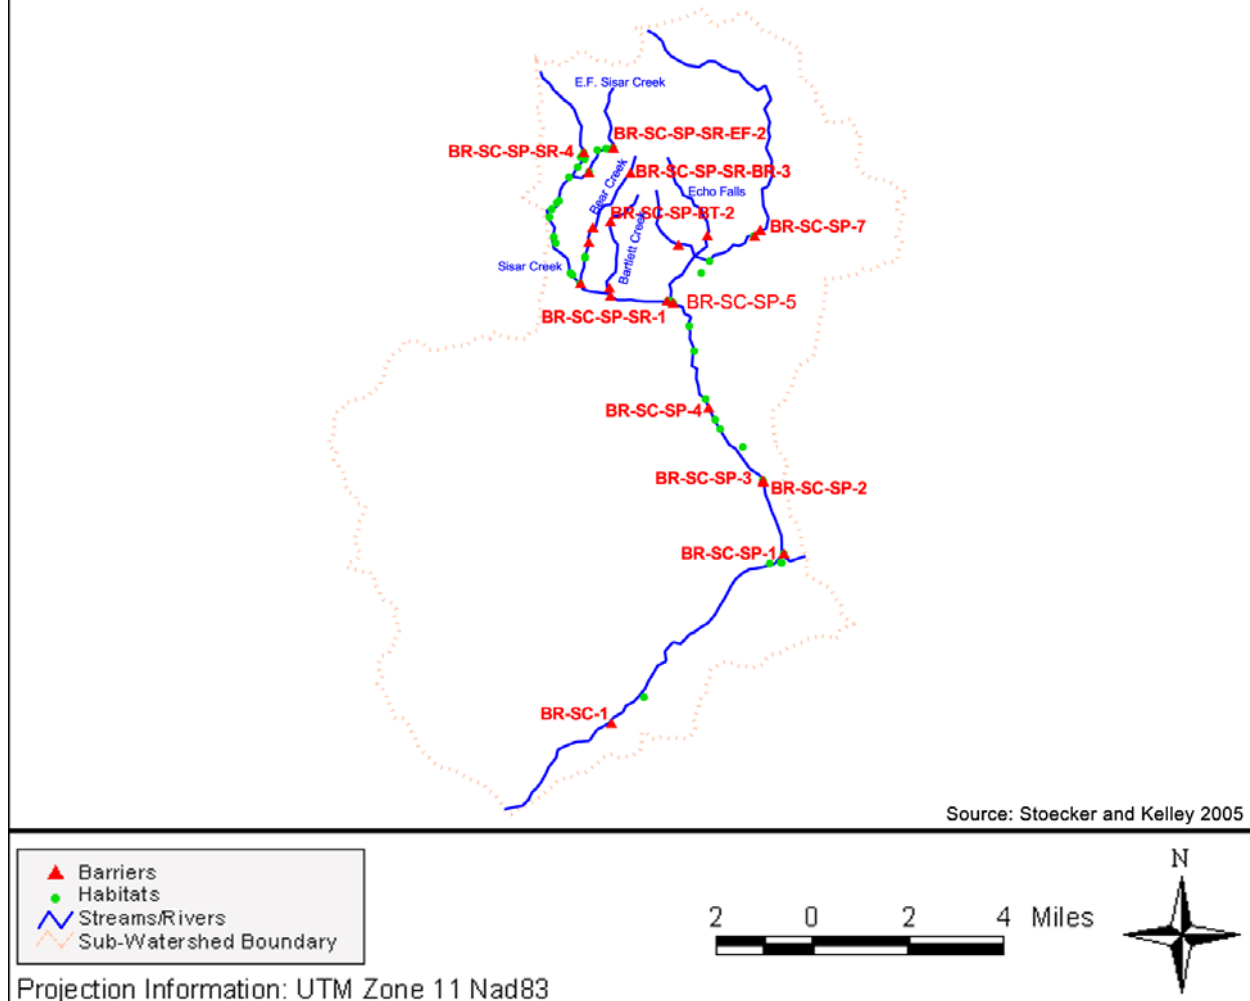
Following the high stream flows of 2004/2005 many of the barriers in Santa Paula Creek were dramatically altered. Fish ladder facilities at the Army Corp Channel near the mouth and at Harvey Dam were both damaged so severely that fish passage at those sites is no longer possible and the entire drainage is effectively inaccessible to steelhead or other upstream migrating fish. CALTRANS grade control structures under the Highway 150 bridge also failed causing another impassable fish barrier. Sesar Creek contains high quality habitat and several road-crossing barriers below the Los Padres National Forest. In general the tributaries to Sesar Creek have minimal habitat value, so the barriers on the mainstem Sesar Creek rank higher and fish passage improvement projects should focus on those barriers following effective passage on the mainstem of Santa Paula Creek.

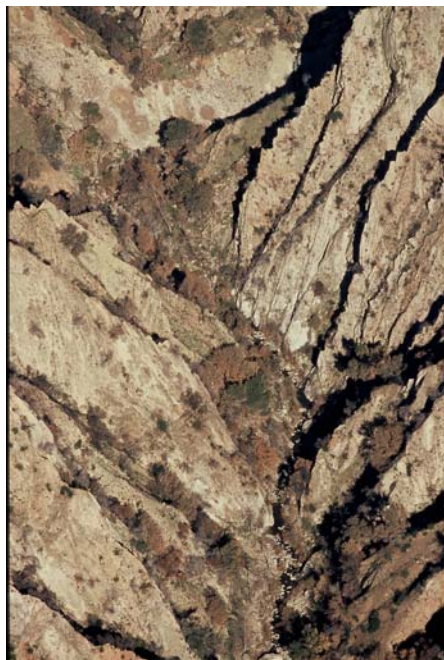
Perennial habitat downstream of impassable waterfall on Hopper Creek, post-fire

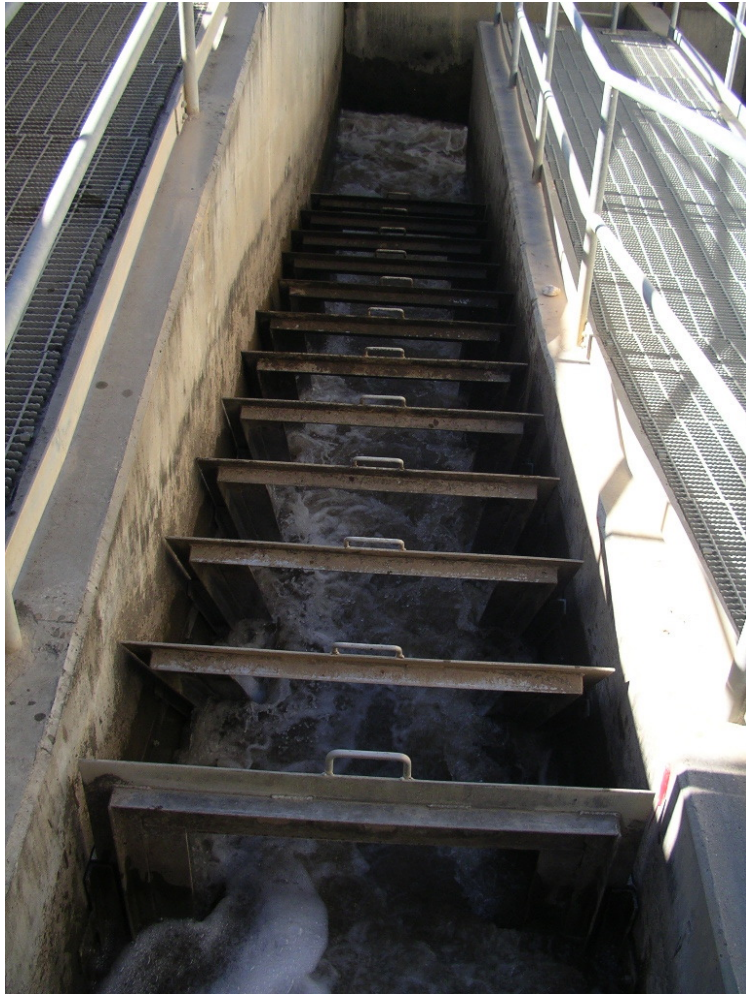
Denil Fishway at the Vern Freeman Diversion

McEachron reported that a trap set at the inlet (upstream end) of the fish ladder caught seven adult steelhead from 1994 to 2001 that apparently made it through the fish ladder and upstream into the river. No adult steelhead have been observed since the fish trap was removed, or since a fish counter/video system was installed in 2002 (pers. comm. McEachron 2005). One of the main problems with assessing the effectiveness of the fish ladder is that it is not possible to count how many steelhead are migrating into the river that may not be able to find the ladder and navigate through it successfully. Insufficient attraction flows, debris blockage, and elevated flow velocities within the ladder may also contribute to problems with the existing Denil Fishway. In addition, the fish ladder has a pipe outfall located directly above it that drops water at the entrance. This additional turbulence at the fish ladder entrance may confuse upstream migrating steelhead. The existing ladder and dam likely represent at least a partial barrier some of the time and a complete barrier when operations are not providing adequate fish ladder flows for passage, as was observed during a field visit in 2005.

The documented historic occurrence of adult steelhead and anadromous lamprey runs up the Santa Clara River prior to the construction of the current Vern Freeman Dam are well documented. Fish ladder designs such as the type at the Vern Freeman Diversion Dam are not a preferred NOAA or DFG fish passage alternative due to the many inherent problems associated with debris blockages, baffle failures, and difficulty in attracting and allowing effective fish passage. Attraction flows have been identified by NOAA personnel as a potential problem for upstream migrating steelhead trying to find a route around the dam.

Mr. McEachron reported that UWCD does not need to start operating the fish ladder until January because there are no steelhead entering the river until around that time. When steelhead are prepared to enter the Santa Clara River is in fact, unknown. There is often a lack of early winter downstream water flow connectivity which may be delaying sandbar breaching at the mouth and/or preventing early upstream migration with rains and adequate stream flow. Long-time Santa Clara River steelhead fisherman recalled how adult steelhead “were always in the surf off the mouth by late November, waiting for the first rains to break the sandbar. You would often see a group of fisherman with shovels instead of fly rods, opening the bar... The fish would storm in and all hell would break loose...” (Moore 1981). Due to the flashy flow regimes of southern California streams and the opportunistic nature of southern steelhead, the lack of fish ladder operation and potential adequate bypass flows until sometime in January may be preventing upstream access during late November and December when, like in 2004, we had several days of connectivity between the ocean and the dam.

Recommended Action: Without effective upstream adult steelhead passage at the Vern Freeman Dam that mimics the timing, duration, and magnitude of natural flow events and flow range, steelhead restoration within the Santa Clara River will not be possible. Because the principal steelhead spawning and rearing habitats within the Santa Clara River system are located in

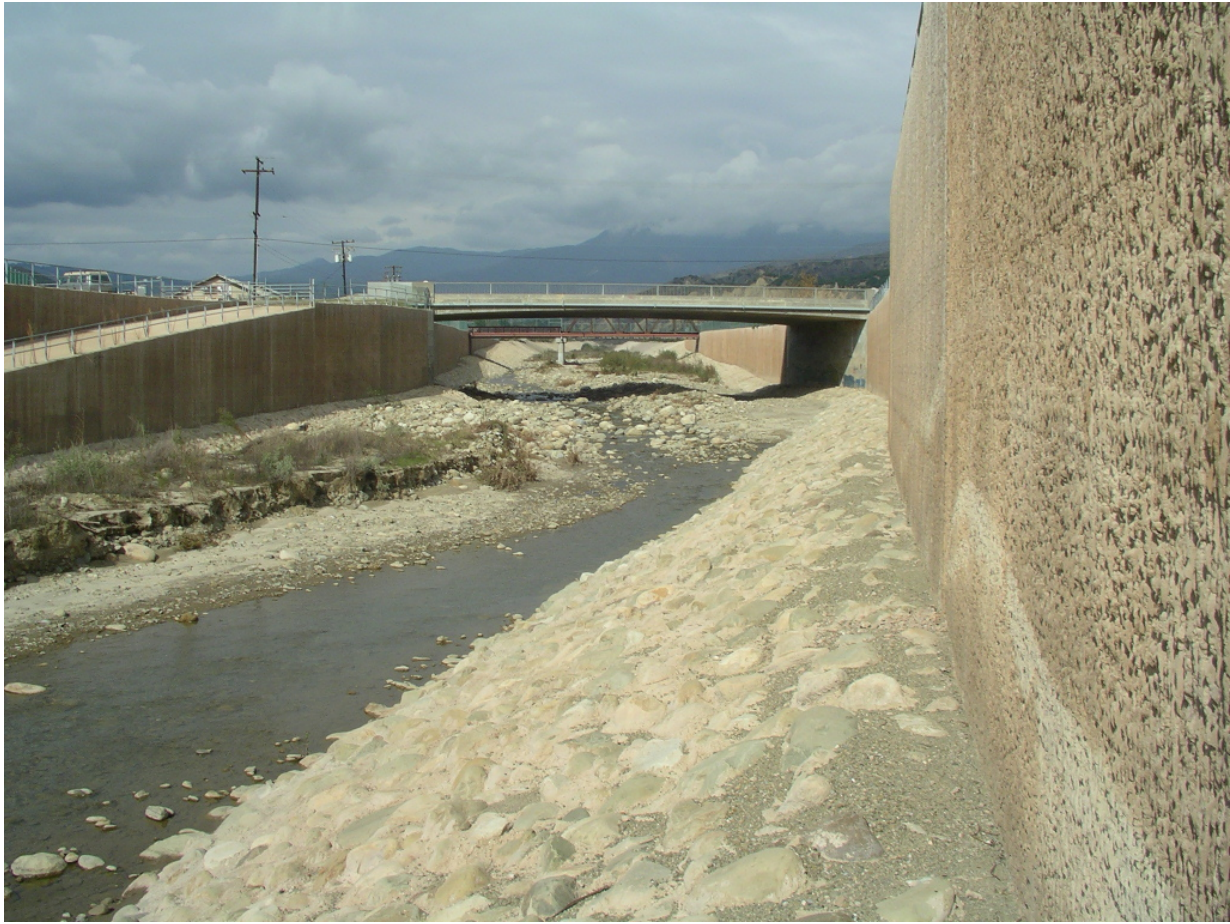
ACOE Channelization, Grade Control, and Fishway (SC_SP_1,2,3) - Santa Paula Creek

ACOE Channel adjacent to city of Santa Paula

Description: The Army Corps of Engineers built this extensive project in order to protect the City of Santa Paula from flooding. The channelized reach extends approximately 8625 feet from just upstream of the Santa Clara River to a concrete grade control structure downstream from a long fishway. The 215-foot long fishway rises 18 feet 6 inches with an overall slope of 8.6%. Following the 2005 flows the fishway and grade control were completely destroyed.

Recommended Action: A comprehensive alternatives analysis needs to be conducted and removal of the fishway and downstream grade control seriously considered. Reconstruction of similar fishway facilities will continue to have inherent failure risks, annual debris blockage, and require continual maintenance, or result in limiting or preventing upstream steelhead passage. Replacing the fishway with a roughened channel combined with channel-wide weirs tied into the existing trapezoidal concrete walls may provide the most effective steelhead passage and structural integrity with minimal maintenance. Such a design would need to extend downstream into the channelized reach to reduce the slope of the roughened channel and create a milder transition between the 18-foot 6-inch elevation difference between the current fishway inlet and outlet. The downstream channel appears to have sufficient capacity to allow for such an alternative.

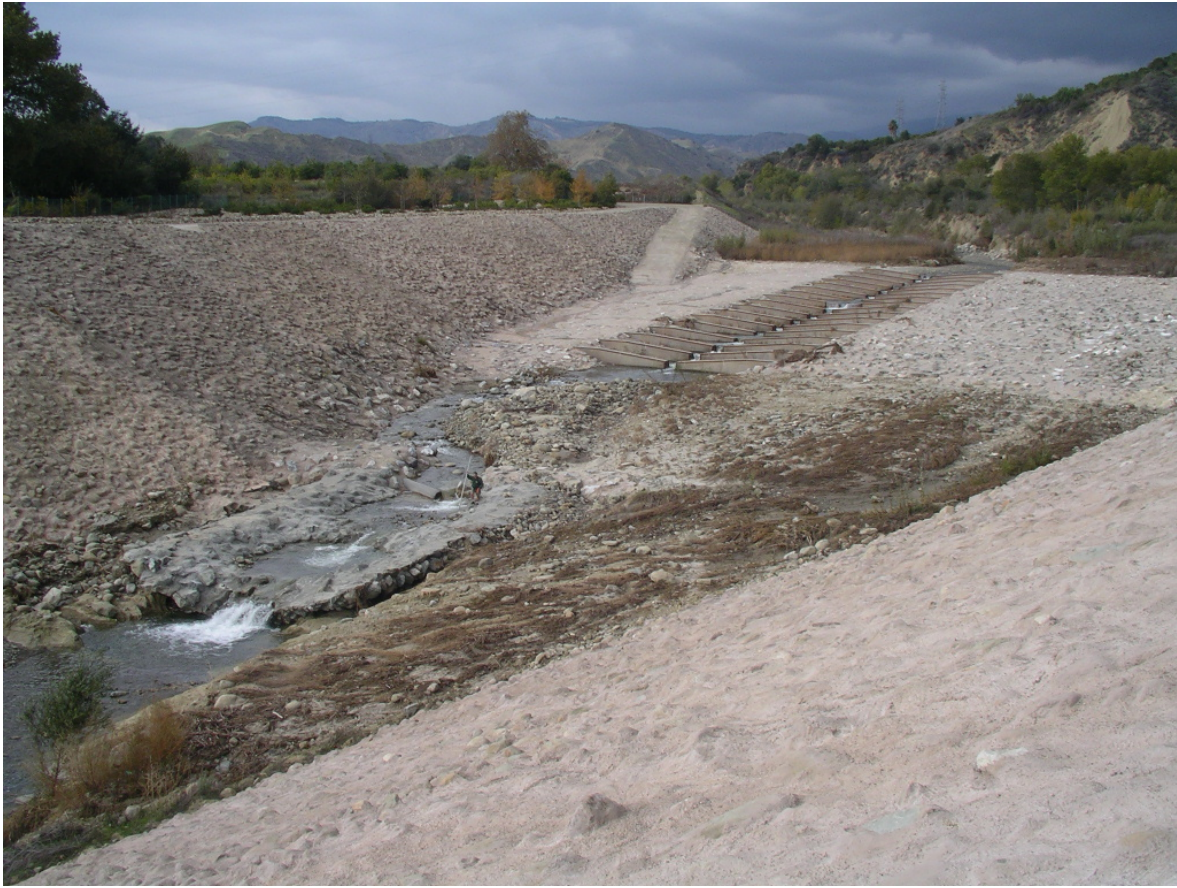
Grade control and fishway before 2005 failure

Diagnosis: The concrete channel is periodically dredged of sediments; this eliminates natural channel complexity and thus also creates unfavorable conditions for fish passage (pers. comm. Mark Capelli). Prior to the 2005 flows that destroyed the fishway and downstream grade control, this facility failed to meet DFG and NOAA fish passage criteria at all flows for strongest swimming species presumed present. The downstream grade control structure had an excessive outlet drop of 3 feet 4 inches and excessive concrete apron slope of 26%. Even the elaborate fishway failed to meet DFG and NOAA fish passage criteria at all flows due to inherent debris blockages that completely blocked the weir notches and produced drops exceeding 2 feet on 5 of the 17 weirs. In addition, many of the weirs were filled with substrate and some had large boulders located in the ideal steelhead jump location and landing zones.

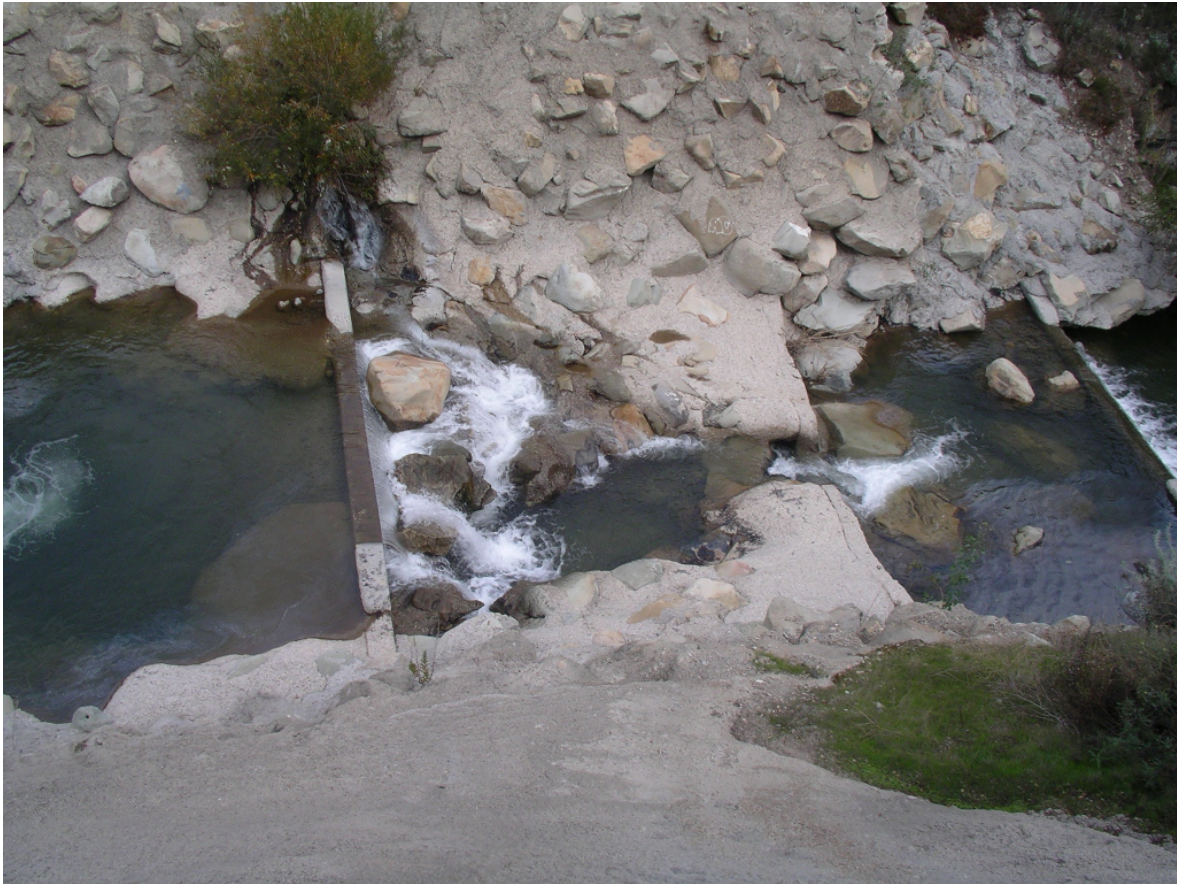
CALTRANS Highway 150 Bridge (SC_SP_5) – Santa Paula Creek

Downstream grade controls before 2005 flood

Description: Prior to the record rainfall and stream flows on Santa Paula Creek during January 2005, seven grade control structures occurred in association with the Highway 150 Bridge. These concrete curbs and associated concrete bank revetment stretched for over 400 feet from the upstream side of the Highway 150 Bridge downstream. During November 2004 surveys several of the curb drops exceeded 3 feet and the most severe drop measured 6 feet 4 inches in height. Large boulder cascades also occurred on the downstream side of several curbs and interfered with ideal steelhead jump locations. The fifth curb upstream also contained a steeply sloped apron extending 8 feet and with a slope exceeding 26%. High stream flows in January 2005 devastated much of Santa Paula Creek and dramatically changed the configuration of these Highway 150 grade control structures. The two most downstream curbs and bank revetments were completely destroyed and washed downstream.

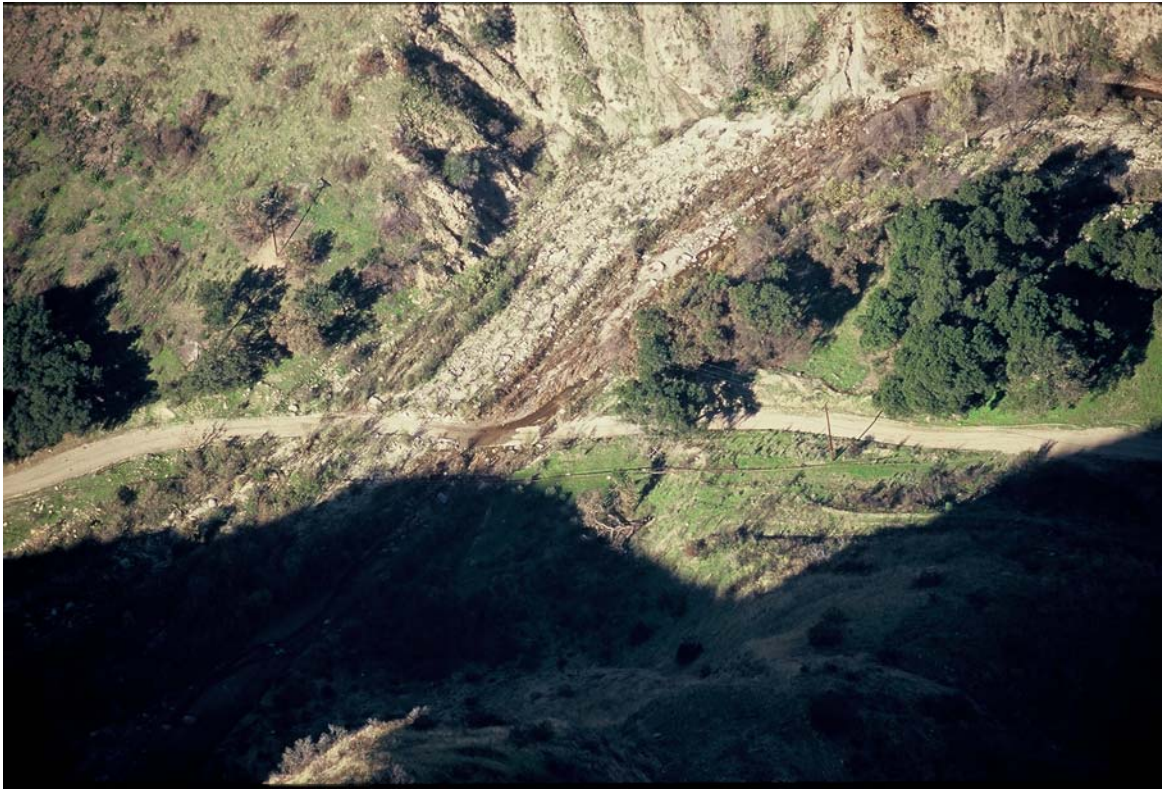
Hopper Creek barrier #2

Description: Permission to survey upper Hopper Creek was obtained, but access through locked gates on private land was never provided and observations were limited from the air and adjacent road up to the locked gate. A total of 14 private road crossings were observed on Hopper Creek upstream of Highway 126 while conducting the aerial survey. Three of the crossings appear to be constructed of concrete, while the remaining 11 appear to be in-stream fords on natural substrate that may not impede fish passage. The 3 concrete crossings were observed to have considerable outlet drops associated with them up to 4 or more feet in height. The crossings appear to service oil facilities in the canyon.

Diagnosis: Ground surveys are needed to determine the impacts of these crossings on fish passage, but aerial observations indicate that the three concrete crossings represent partial or complete barriers to upstream fish migration and limit or prevent upstream fish passage to excellent habitat located upstream. SC_HR_2 appears to have a 2-foot outlet drop while SC_HR_3 and SC_HR_4 appear to have outlet drops exceeding 4 feet in height.

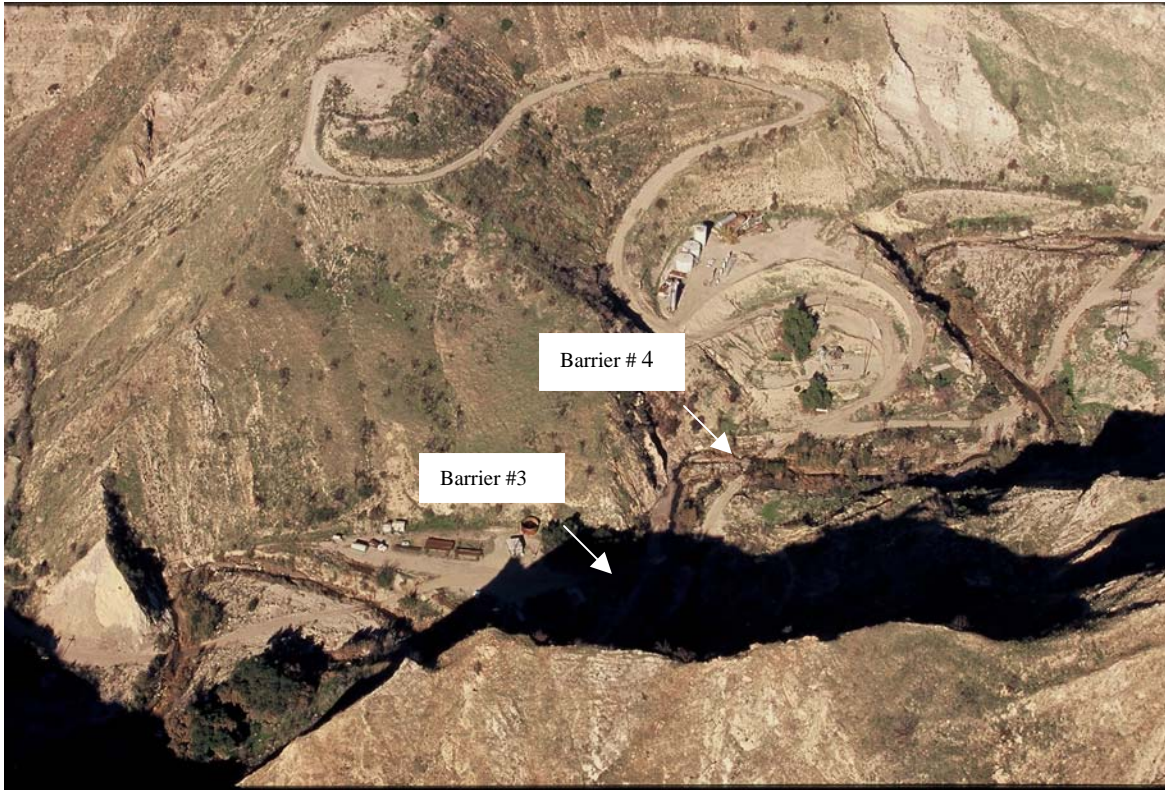
Hopper Creek Barriers #3 and #4 and other at-grade oil facility road crossings

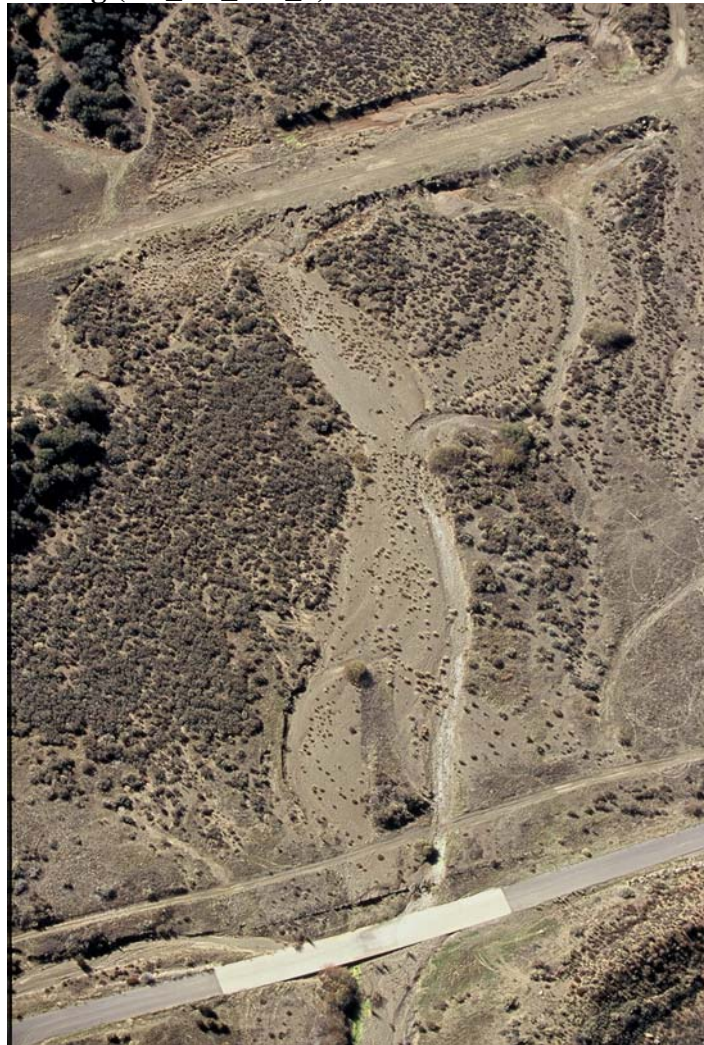
Rose Valley Road Crossing (SC_SE_HD_3) – Howard Creek

Rose Valley Road (bottom) and Airstrip (top)

Description: This concrete low-flow crossing spans 198 feet across a braided and unconfined reach of Howard Creek at the edge of a large meadow and private ranch (Rancho Grande). The crossing is 22 feet wide with a slope of 1.5 %. The outlet sill drops flows 1-foot 4 inches to the downstream substrate.

Recommended Action: See survey recommendation for the downstream culvert (SC_SE_HD_2). These culverts should be further assessed in coordination with unsurveyed upstream barriers and habitat on Rancho Grande that will influence potential alternatives at this site.

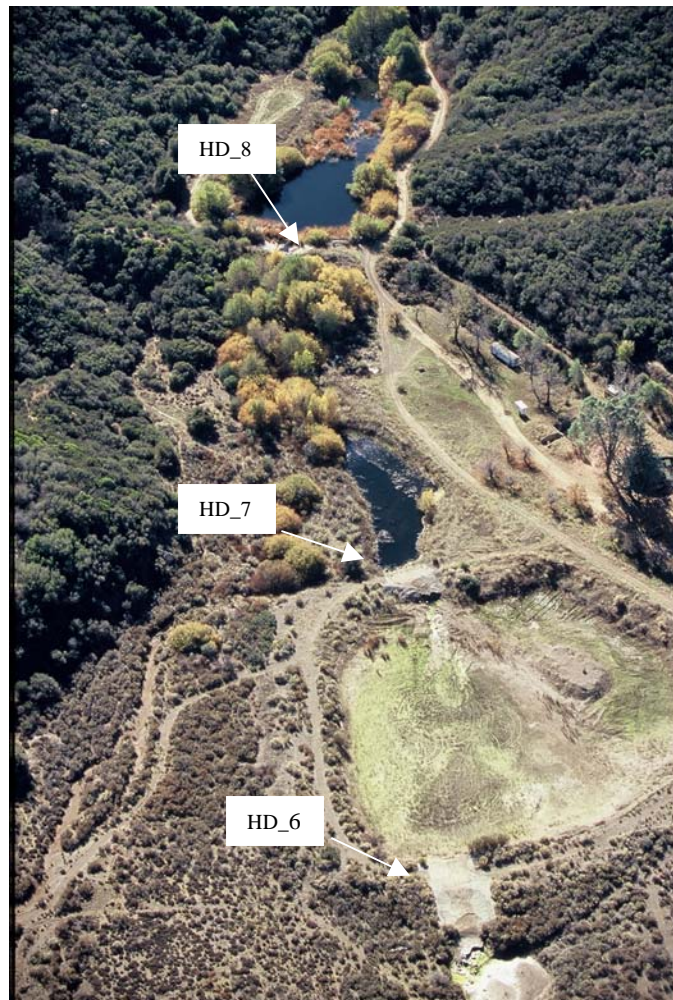
Four Dams on Rancho Grande (SC_SE_HD_5,6,7,8) – Howard Creek

Upper Three Dams and Reservoirs #6-#8 (lower dam not visible)

Description: Access to survey these four dams was not obtained and limited observations were made from the air. All dams appear to be earth filled dams with concrete spillways. The dams occur in sequence with the reservoir elevation at the next upstream dam. The concrete spillways also appear to be used for vehicle access across the dam crest.

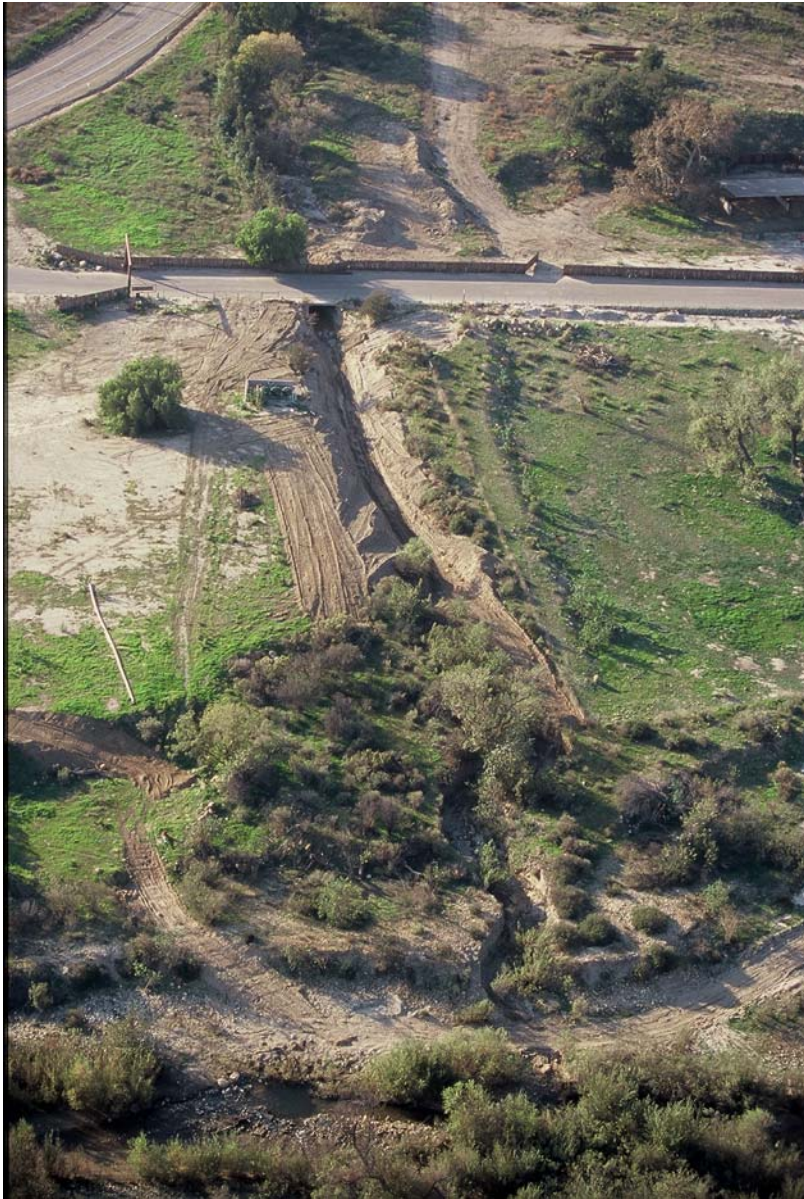
Private Box Culvert (SC_PU_LE_1) on Lime Creek

Description: Permission to survey these lower Piru Creek tributary crossings was not obtained and observations were limited from Piru Canyon Road and the air. The downstream-most box culvert on Lime Creek occurs downstream of Piru Canyon Road. Concrete box culverts occur on Modelo and Blanchard Creek under Piru Canyon Road and Lime Creek has a circular culvert. The remains of an old structure that appears to be a failed culvert crossing occur upstream of Piru Canyon Road on Lime Creek.

Recommended Action: Contact the landowners and request permission to survey the crossings and upstream habitat. Discuss the desirability of the crossings and potential grant opportunities to improve the crossings for vehicle access and fish passage. If the crossings are limiting fish passage and restoration projects are warranted, the preferred NOAA Fish Passage guideline alternatives are removal of the crossing and road realignment to avoid crossing the stream, installation of a bridge, or streambed simulation strategy (NOAA 2001).

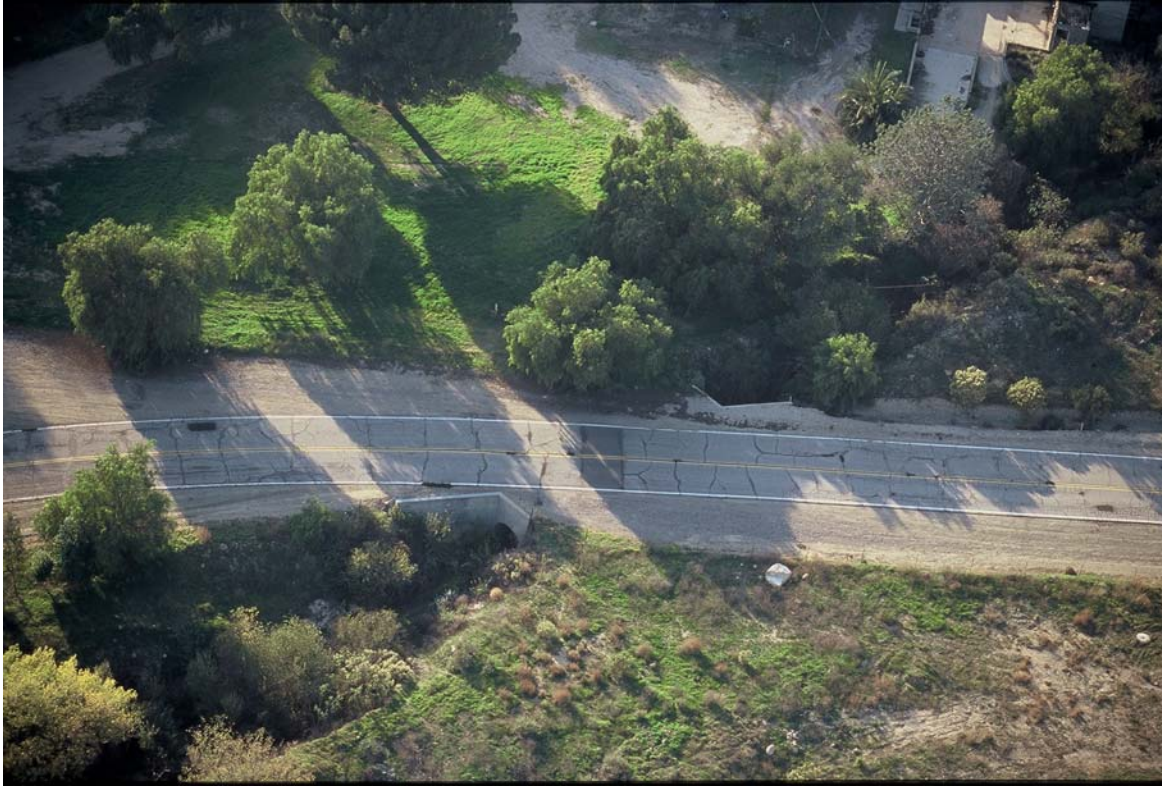
Piru Canyon Road Culvert (SC_PU_LE_2) on Lime Creek

Diagnosis: Additional assessment is needed to determine the impacts of these crossing on fish passage and ground surveying of upstream habitat conditions and summer flows is needed to determine if fish passage projects are warranted. Each culvert likely limits fish passage to some degree during various flow conditions.

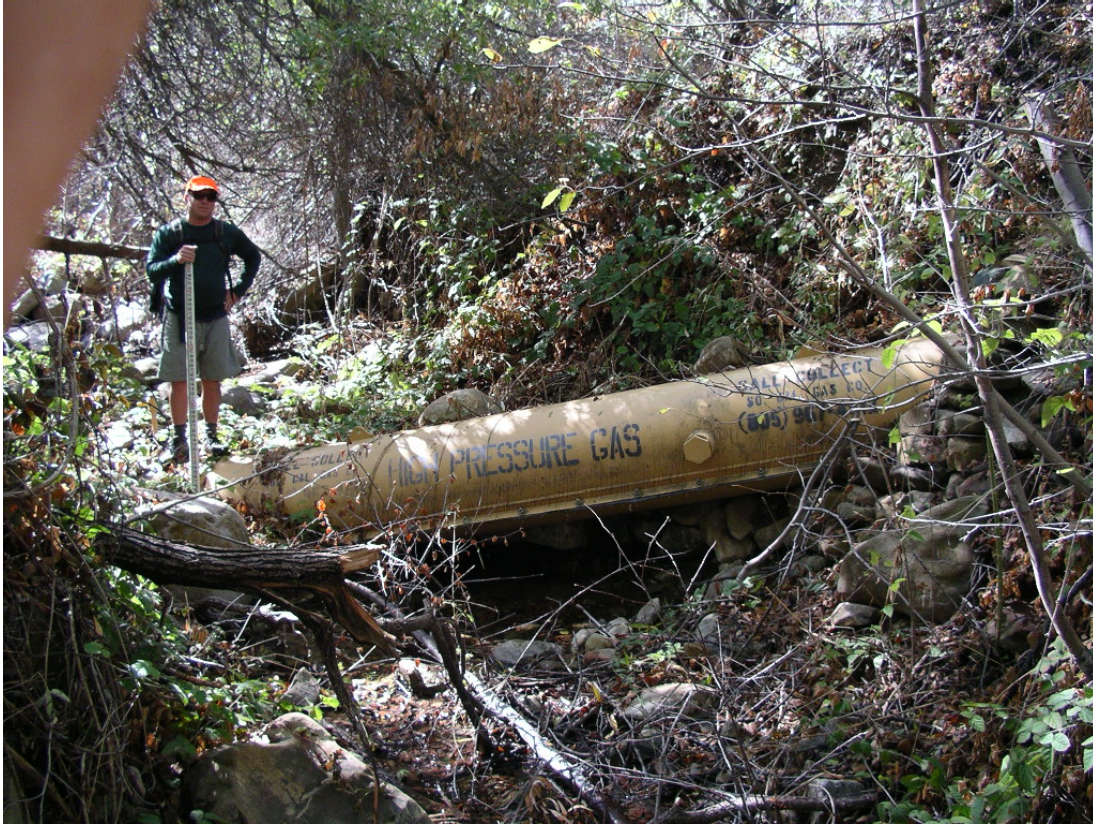
So. Cal. Gas Pipeline Crossing (SC_SE_CY_1) - Cherry Creek

Description: This high-pressure gas line is highly exposed in the stream channel and presents a partial barrier to trout migrating into Cherry Creek from Sespe Creek. The 2-foot diameter pipeline has natural substrate occurring on top of it on the far river-left side of the channel and produced a 12-inch drop to the downstream pool that measured 12 inches in depth. Spray painted on the side is “High Pressure Gas” and “So. Cal. Gas Co. (805) 967-4612”

Diagnosis: The short jump height required to clear this pipeline would likely not limit upstream fish migration during moderate and high flows, but imposes a moderate degree of difficulty during lower flows and especially for small salmonids that occur upstream in Cherry Creek.

Recommended Action: So. Cal. Gas Co. should remove this pipeline and reroute it aerially in a “gooseneck” design to allow unimpeded fish passage and eliminate damage from the stream channel. A small population of *O. mykiss* were observed in Cherry Creek upstream of this pipeline this partial barrier and potential pollution hazard should be rerouted out of the active stream channel.

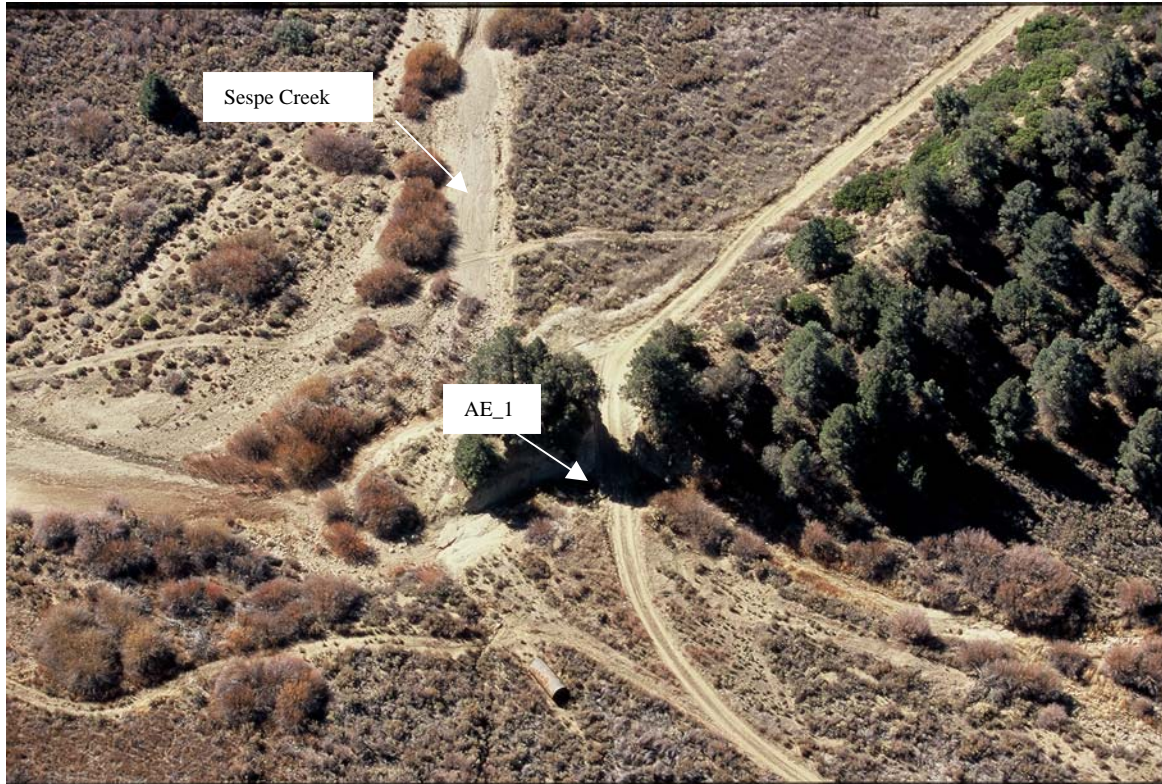
Private culvert crossing on Adobe Creek just upstream of Sespe Creek

Description: Permission to survey these crossings was not obtained and observations were limited from the air. The most downstream crossing appears to be a culvert pipe and dirt road crossing that occurs immediately upstream from the Sespe Creek confluence. The upstream crossing occurs upstream of the Highway 33 Bridge and observations could not determine the configuration of the crossing due to excessive vegetation cover.

Recommended Action: Contact the landowners and request permission to survey the crossings and discuss the desirability crossings and potential grant opportunities to improve the crossings for vehicle access and provide fish passage. If the crossings are limiting fish passage and habitat conditions warrant restoration projects, the preferred NOAA Fish Passage guideline alternatives are removal of the crossing and road realignment to avoid crossing the stream, installation of a bridge, or streambed simulation strategy (NOAA 2001).

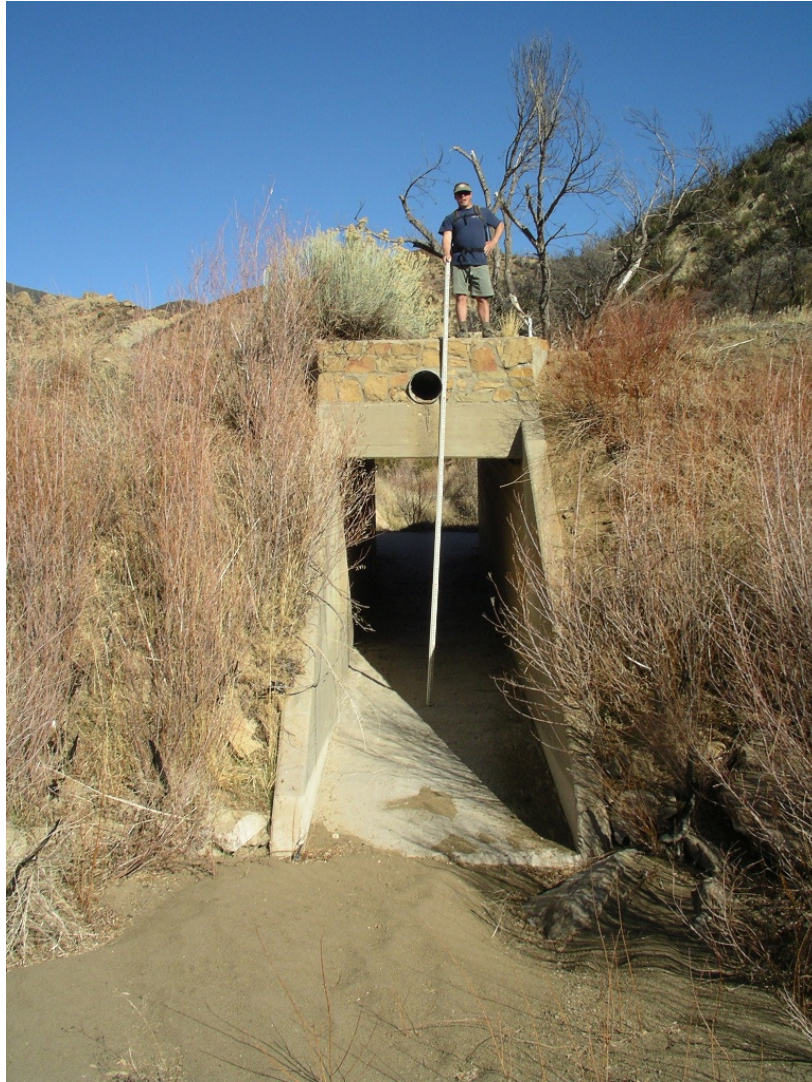
Burro Creek #2 Highway 33 Box Culvert

Description: Two Highway 33 concrete box culverts occur on Burro Creek and the adjacent (unnamed) Burro Creek #2. The Burro Creek #2 box culvert measured 56 feet long and 6 feet wide by 8 feet tall. The steep slope of the culvert measured 11.8% with a total rise of 6 feet 7 inches from the inlet to the outlet at substrate level. The culvert bottom is damaged with exposed metal re-bar and worn concrete. No access was obtained to survey the Burro Creek culvert, but observations from the road reveal a similarly steep slope and approximately 2-foot outlet drop.

Diagnosis: Due to the steep slope of these culverts, the structures fail to meet DFG and NOAA passage criteria at all flows for strongest swimming species presumed present. During low flow conditions encountered in late November only 214 feet of habitat with surface was observed upstream of the Burro Creek #2 culvert and below an impassable 19-foot tall waterfall. However, much of the habitat observed was step-pool habitat with pools over 2 feet deep and one large plunge pool over 6 feet deep. This limited habitat may be able to support a small number of trout and provide one large over-summering pool. In accessible private lands occur upstream of Burro Creek #1 and habitat conditions were not surveyed upstream from the ground.

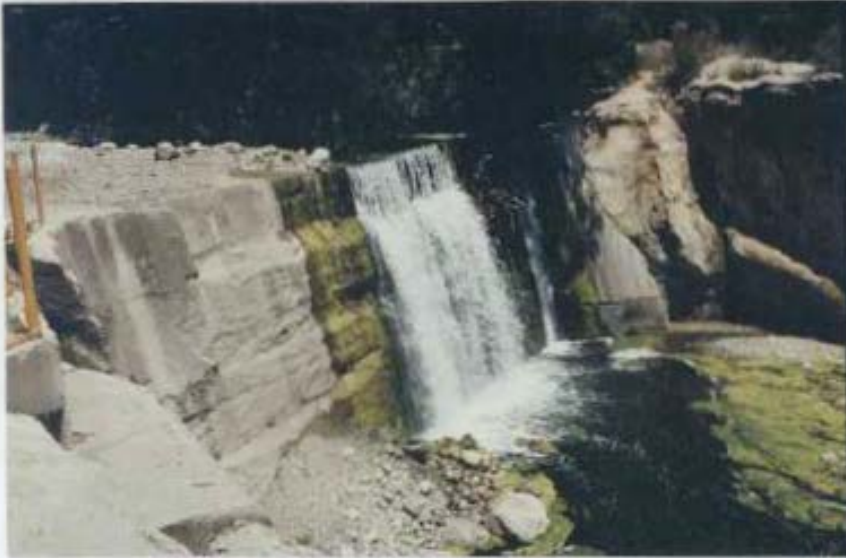
Photo #7
Santa Paula Creek

Photos 7 & 8: Pool immediately above Santa Paula Falls; this also sig. barrier. Stream runs through short, steep gorge, along uplifted "slab of bedrock" stream elevation approx. 1700'. Much more exposed bedrock → Alders 20'-25' recovering and stable on east bank. Stream appears smaller, approx. 6 CFS, 0+ fry seen. gradient steeper, stream tight among large boulders or across slab rock with small pockets. Canyon walls steeper, better shade potential. 1st Tributary from west bank to Santa Paula Creek up from E. Fork Main Fork confluence has 0 flow entering Santa Paula Creek, but approx. ¼" hose flow about 100 yds. upstream from Santa Paula Creek. See Photo 9. Elevation 1760'. Many small pools, boulder strewn, partially shaded stream, few riffles. A number of potential low flow barriers for upstream migrating resident trout in vicinity of Cross Camp, but resident population exists upstream. Water temp. 60, Air 66 @1500' in Santa Paula Creek. 100 yds. upstream from Cross Camp, elev. 1800'. Temp. of small trib. (.5 CFS) entering .5 miles upstream from East Fork Main Fork confluence = 63° Falls approximately 150 yds. upstream from Santa Paula Creek on tributary.

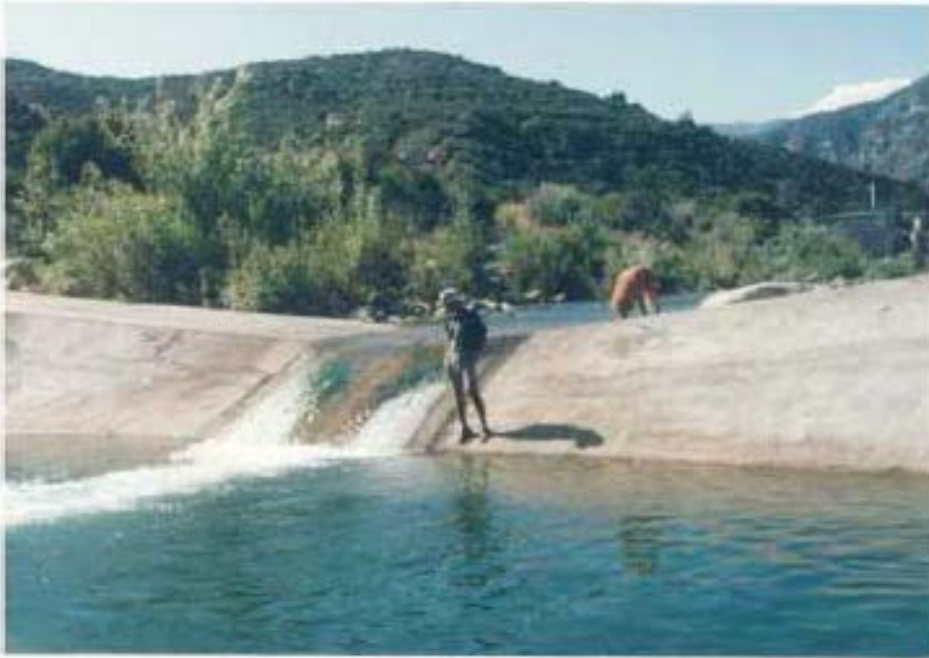
Photo # 13 Ventura River

An artificial barrier is present at a road crossing 150 meters downstream of the diversion dam (photo 13). Here, the stream flows over a concrete road and drops down a 1.5-2 meter slide into a large pool. This barrier may be passable during periods of high flows.

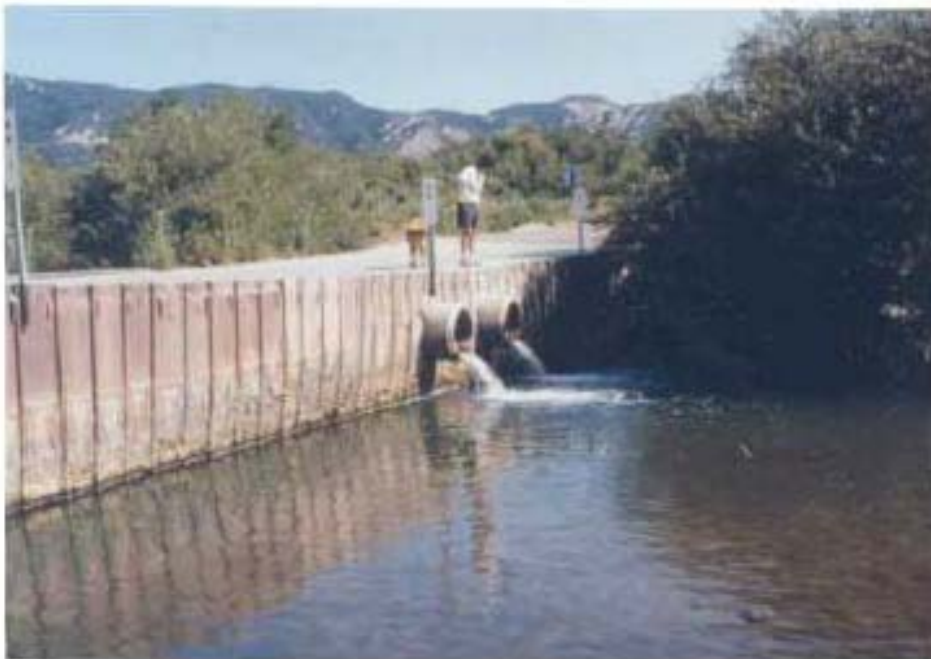
Photo #14 Gaviota Creek

located directly across northbound rest area on Highway 101, approximately 1 mile north of Gaviota State Park. One RT, 250-300 mm in length, was observed in a large pool. A series of road grade stabilization structures are present in the reach adjacent to Highway 101 between Gaviota State Park and the Highway 1 - 101 junction. These structures are approximately 1 to 2 m high and drop off a concrete apron, and probably impede or block passage at low flows. Another seasonal barrier is located downstream at the Gaviota State Park road crossing. Here the creek passes through two 50 cm culverts set in a concrete "fair weather" road crossing then falls 0.5-1 meter to a pool on the downstream side of the road² (photo 14).

² These culverts were replaced with a bridge in 1997, hence passage is no longer blocked or impeded at this site.
