STREAM INVENTORY REPORT

Right Bank Tributary One to Alder Creek

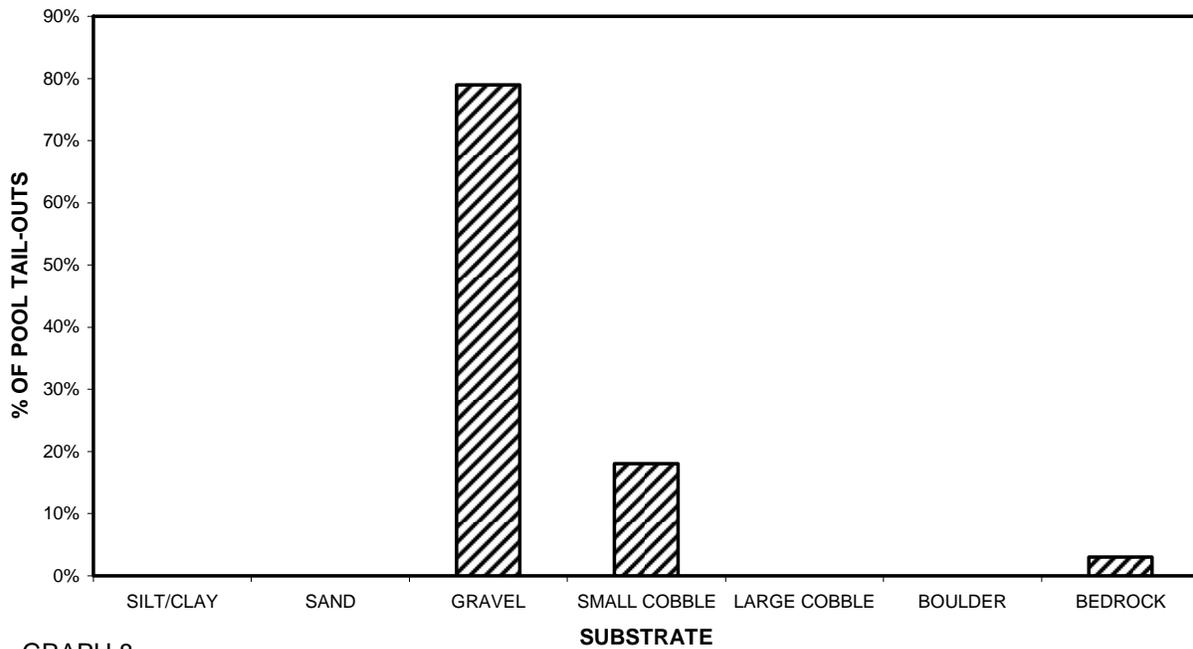
GRAPH 8

Table 6 summarizes the dominant substrate by habitat type. Graph 8 depicts the dominant substrate observed in pool tail-outs. Gravel was the dominant substrate observed in 77% of pool tail-outs while small cobble was the next most frequently observed substrate type, at 18%.

ALDER CREEK, RIGHT BANK TRIBUTARY ONE SUBSTRATE COMPOSITION IN POOL TAIL-OUTS
