STREAM INVENTORY REPORT

Unnamed Tributary to Dunn Creek

A stream inventory was conducted from September 9 to September 10, 2008 on an unnamed tributary to Dunn Creek. The survey began at the confluence with Dunn Creek and extended upstream 0.6 miles.

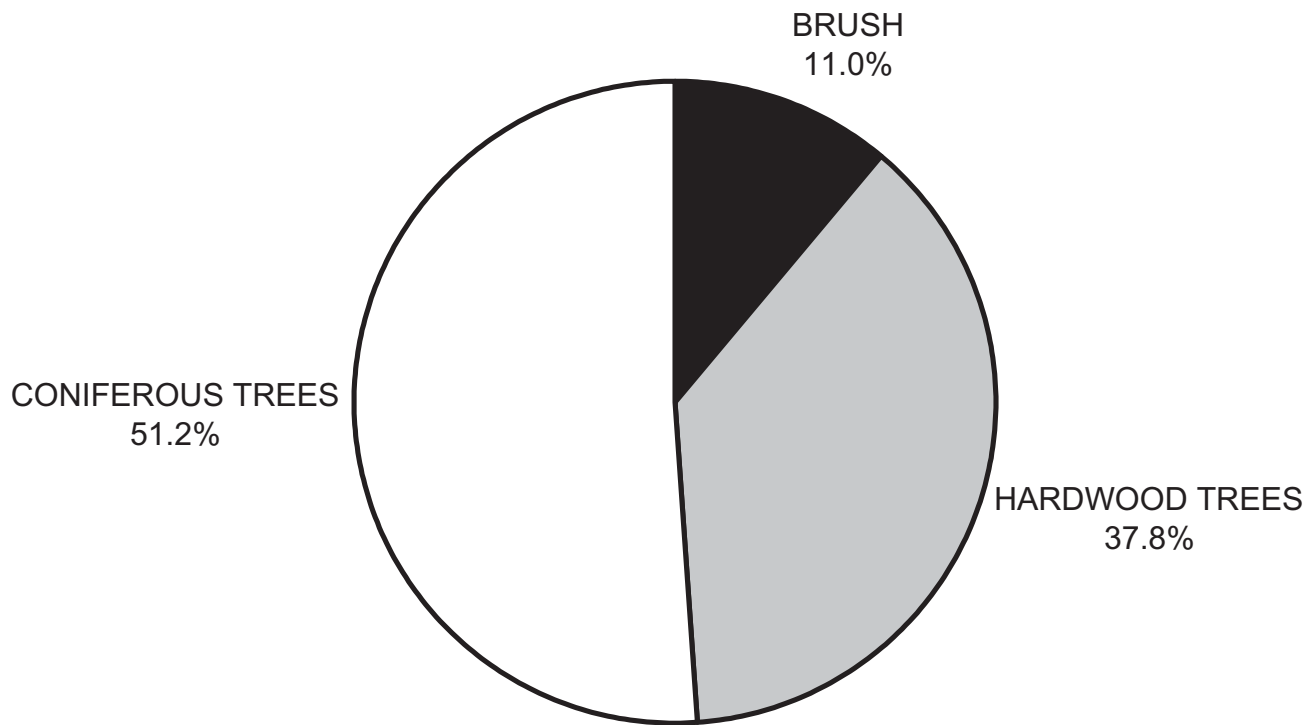
GRAPH 11

For the stream reach surveyed, the mean percent right bank vegetated was 50%. The mean percent left bank vegetated was 50%. The dominant elements composing the structure of the stream banks consisted of 100% sand/silt/clay (Graph 10). Coniferous trees were the dominant vegetation type observed in 51.2% of the units surveyed. Additionally, 37.8% of the units surveyed had hardwood trees as the dominant vegetation type, and 11% had brush as the dominant vegetation type (Graph 11).

The percentage of right and left bank covered with vegetation was 50% and 50%, respectively. In areas of stream bank erosion or where bank vegetation is sparse, planting endemic species of coniferous and hardwood trees, in conjunction with bank stabilization, is recommended.
