SECOND ANNUAL RESTORATION MONITORING REPORT (YEAR 2)

SOUZA II RESTORATION PROJECT
CONTRA COSTA COUNTY, CALIFORNIA

NOVEMBER 2011

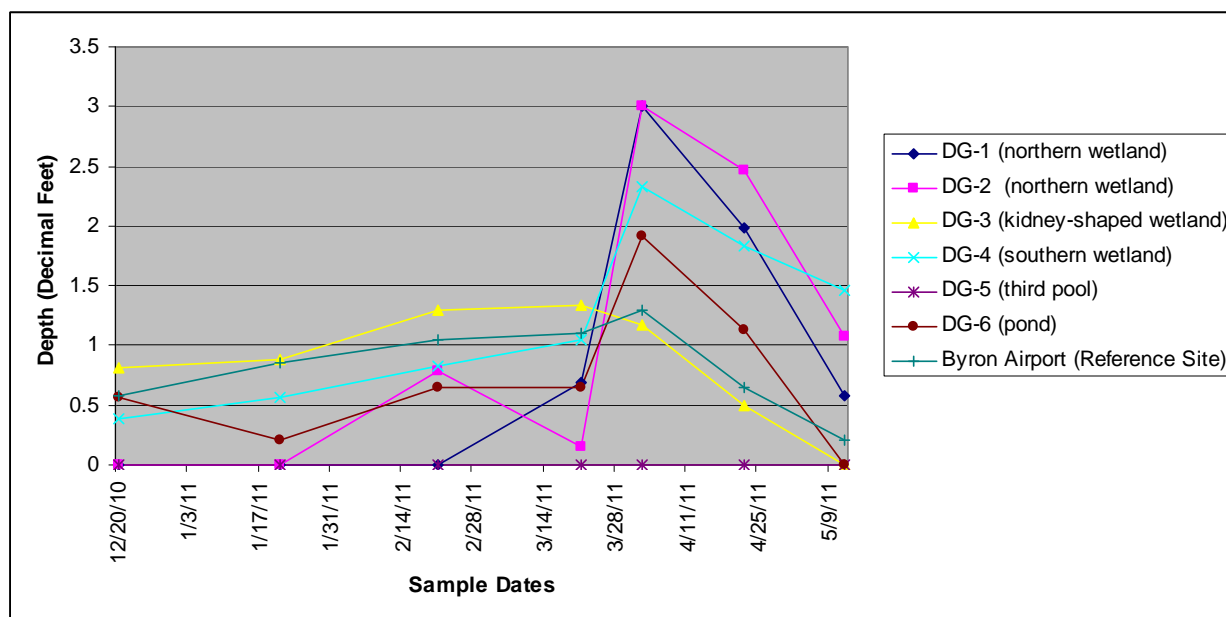
Figure 6. Depth of Water at each of the Sample Dates at Souza II.

Table 10 and Figure 6 show the results of the monthly depth gage monitoring. Table 11 and Figure 7 show the results of the monthly depth gage monitoring at Souza I for comparison.

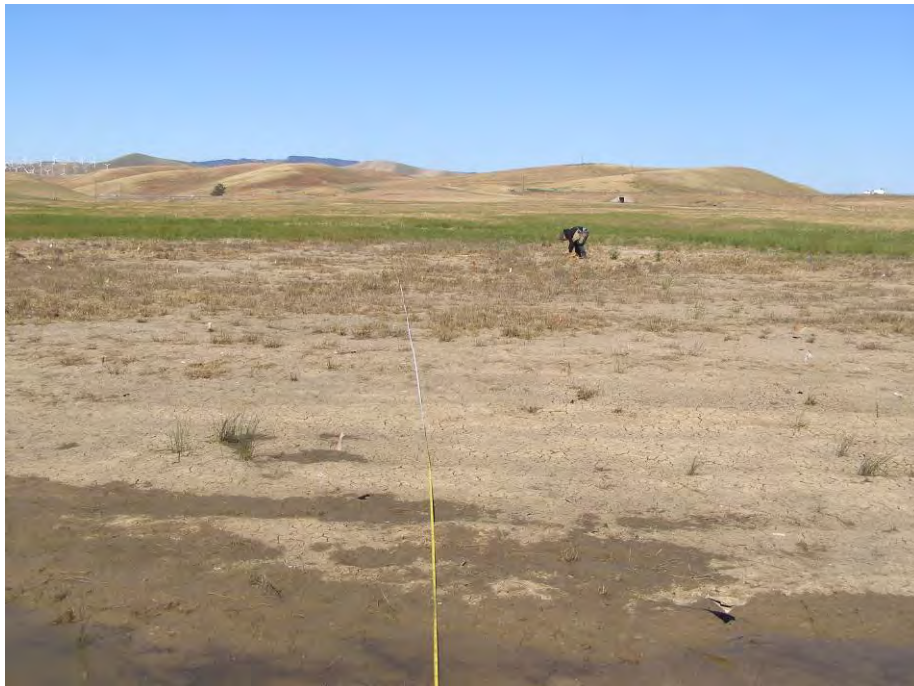
Total absolute cover (including both native and non-native plants) was very low (<10%) in the wetland areas and higher in the grassland areas (40-65%). The areas that were ponded had very little vegetation during the May sampling because the water had just dried (Photo 2 in Appendix B), and was still ponding in some areas (Photo 1 in Appendix B). During the August 12, 2011 site visit, the wetland areas were filled with annual weeds including rabbitfoot grass (*Polypogon monspeliensis**), pigweed amaranth (*Amaranthus albus**), Russian thistle (*Salsola tragus*), spiny cocklebur (*Xanthium spinosum**), and swamp grass (*Crypsis schoenoides**) (Photo 30 in Appendix B). Saltgrass and creeping wildrye were also doing well.

Photo 2. Transect 2. Facing west. May 12, 2011.

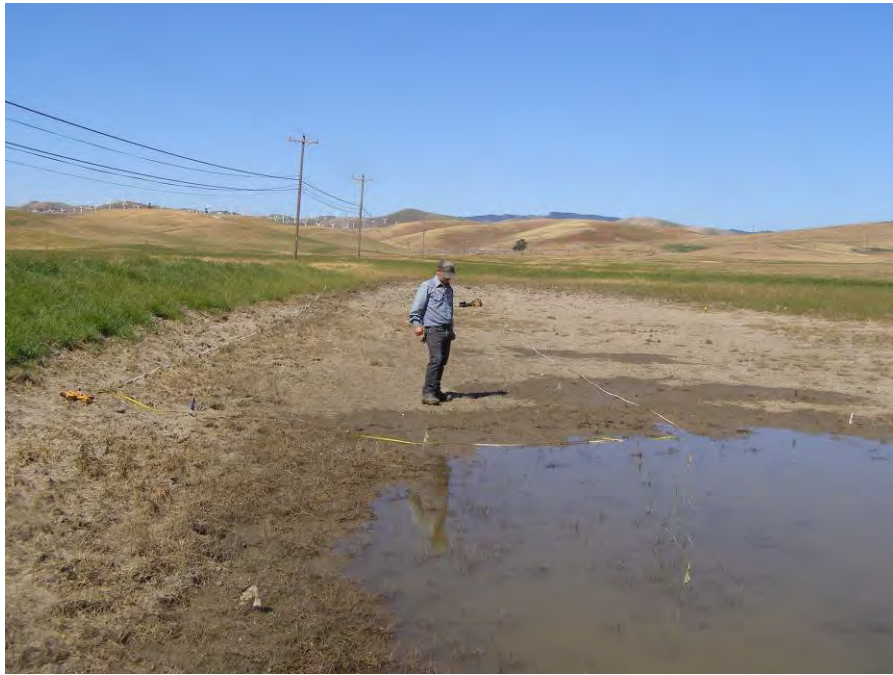
Photo 3. Transect 3. Facing west. May 12, 2011.

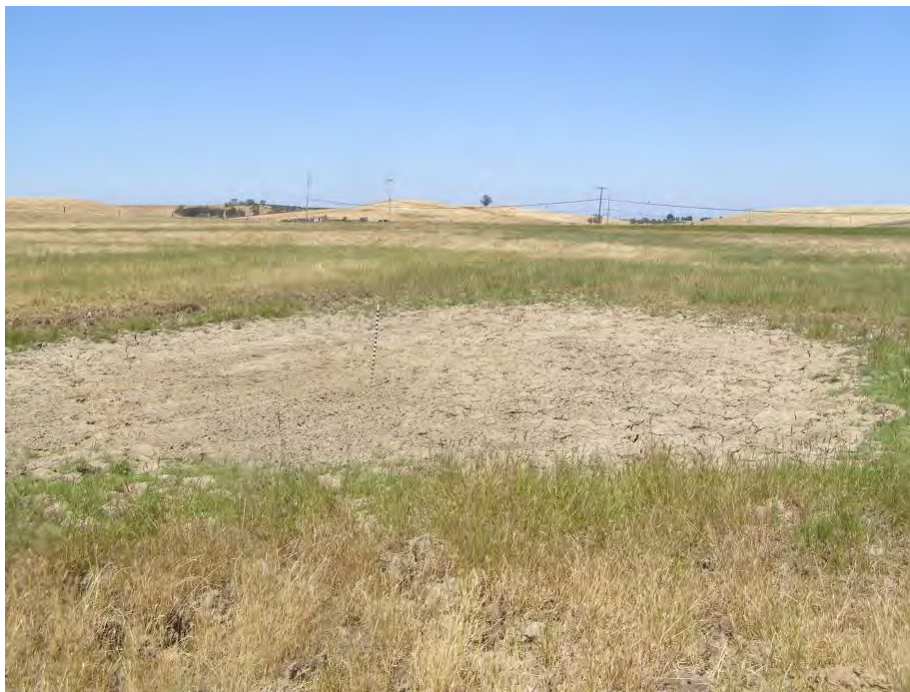
The kidney-shaped wetland (DG-3) and the Byron Airport pond, which are both naturally occurring, show similar behavior. Both filled early in the season, by December 20, 2011 and stayed the same depth throughout the winter through early April. They did not increase greatly in depth after the major storms in late March, likely because they are shallow pools which overtopped their banks when they reached their maximum depth.

Photo 11. Depth gage 3 in the kidney-shaped wetland. May 12, 2011

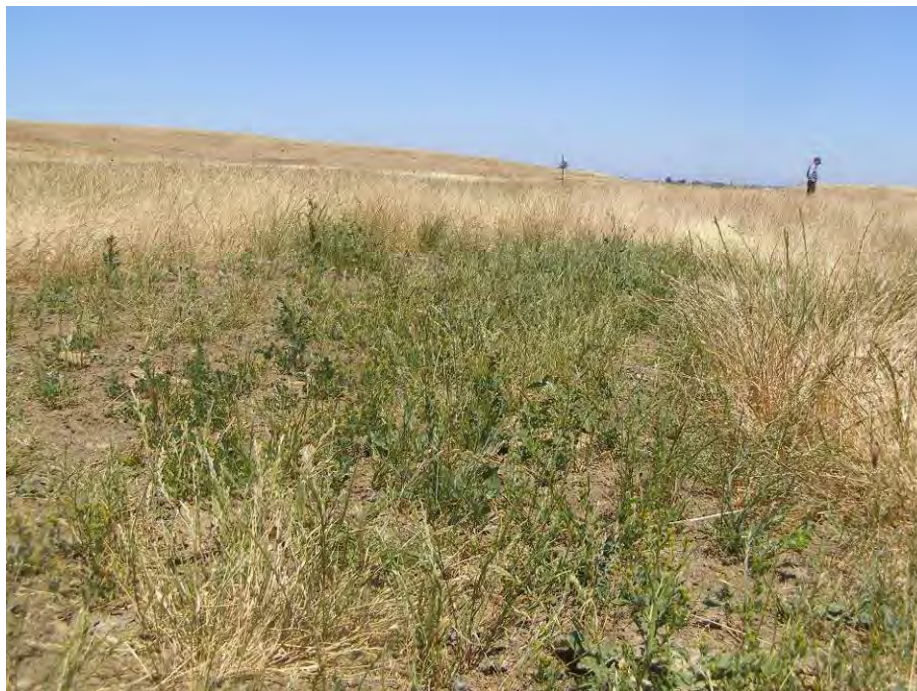
The transplant site contained weeds including annual yellow sweet clover (*Melilotus indica**), tocalote (*Centaurea melitensis*), and black mustard (*Brassica nigra**) (Photo 16 in Appendix B). Weeds were hand pulled, bagged, and removed from the site on May 26, 2011. Grasses were not weeded.

Photo 16. View of the soil translocation site. May 12, 2011.

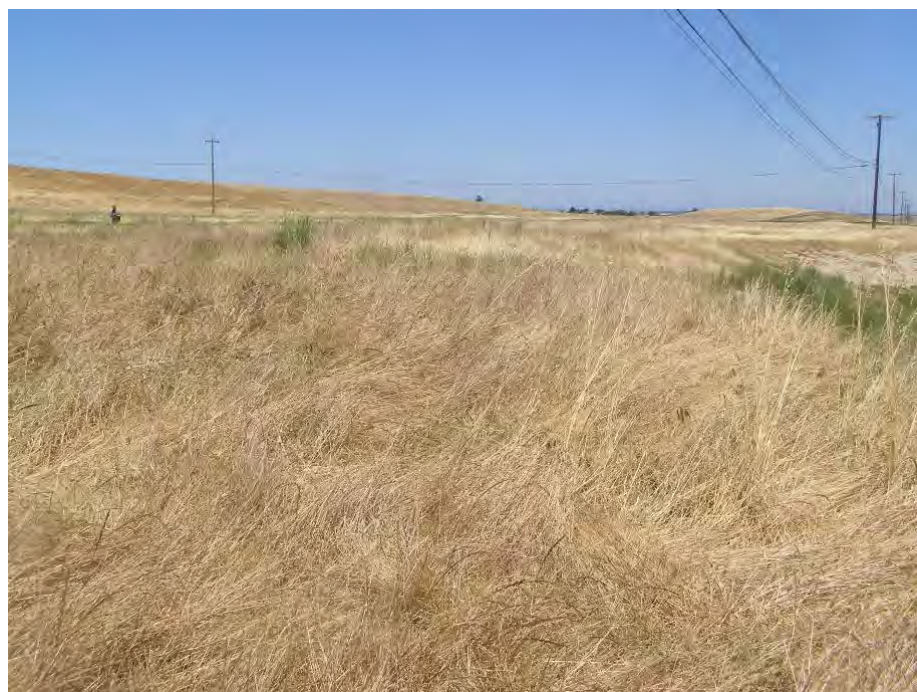
Photo 22. Ungrazed grassland. May 12, 2011.

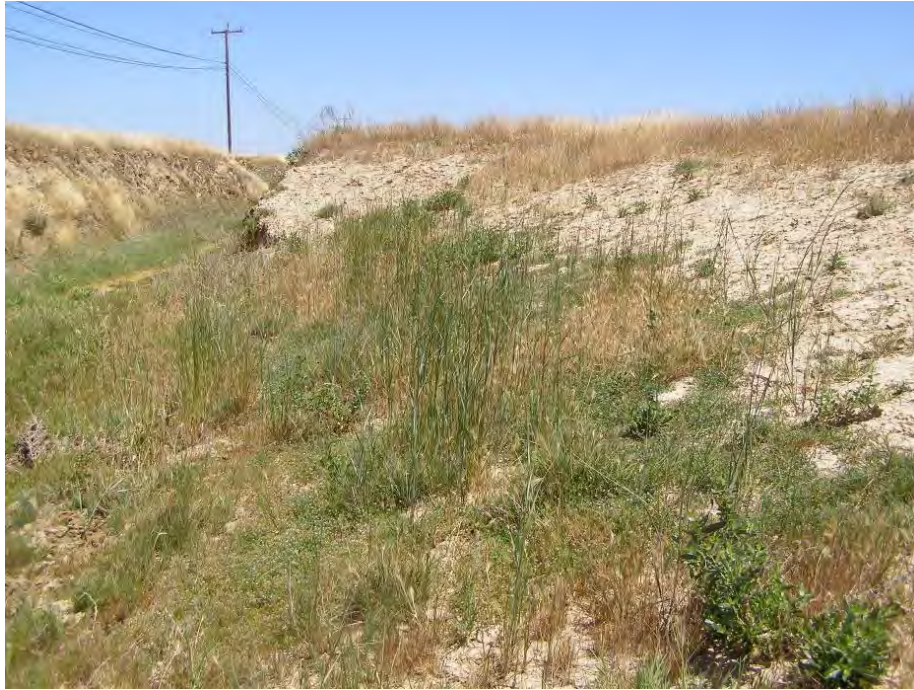
In some areas where the bank was laid back, the bank was well armored with dense stands of saltgrass and other vegetation (Photo 25 and 26 in Appendix B). In other areas where the bank was laid back, the banks were mostly bare of vegetation and erosion was occurring. Most of these areas contained rills that were several inches wide and a few inches deep and occurred every several feet (Photo Point I and K in Appendix C). At Photo Point I, these rills were present, as well as a gully one foot wide and one foot deep

Photo 25. Laid back bank vegetated with saltgrass and blue wildrye. May 12, 2011.

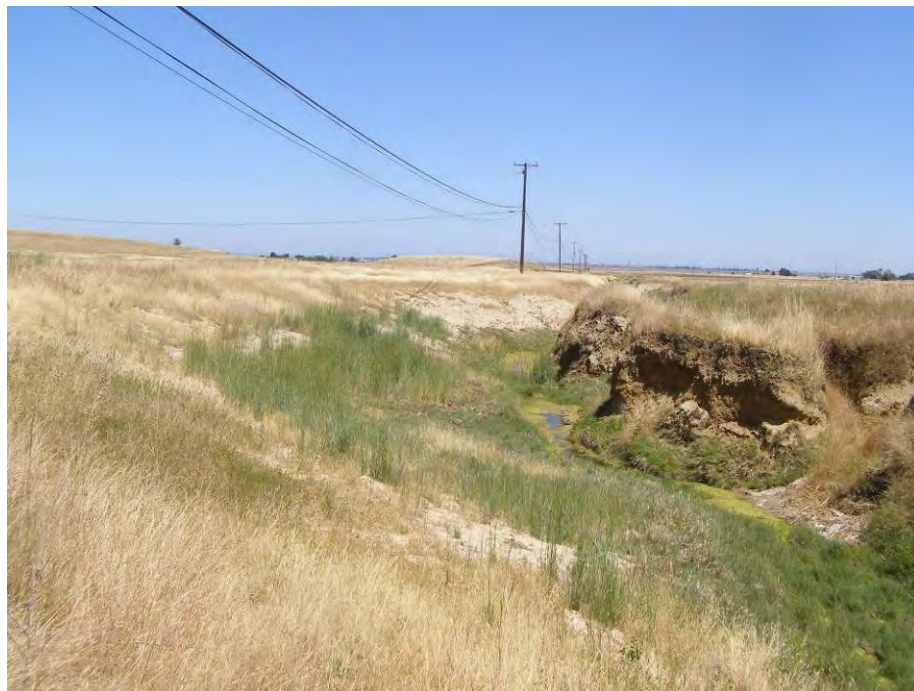
Photo 26. Vegetated bank. May 12, 2011.
