THIRD ANNUAL RESTORATION MONITORING REPORT (YEAR 3)

SOUZA II RESTORATION PROJECT
CONTRA COSTA COUNTY, CALIFORNIA

DECEMBER 2012

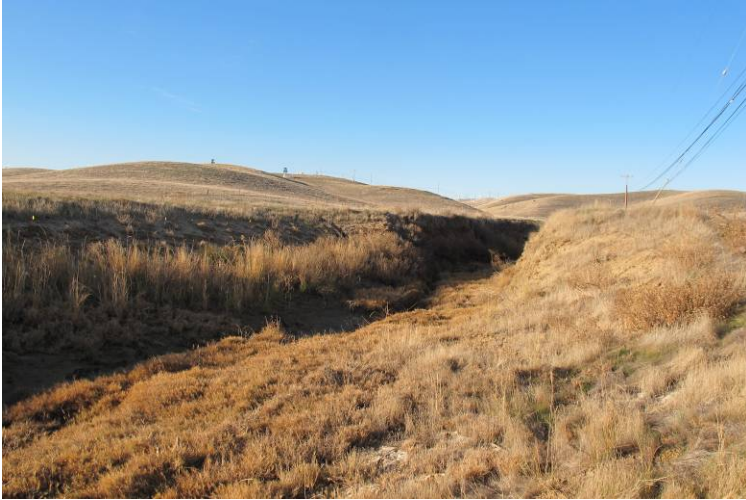
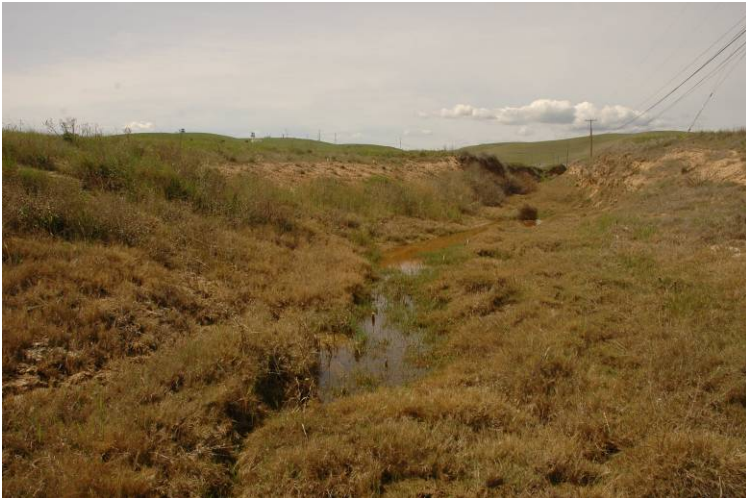
Photo Point I: Erosion monitoring

In some areas where the bank was laid back, the banks are unvegetated and erosion is occurring. We recommend continued planting of saltgrass plugs to armor the banks. The large erosional feature is scheduled for repair in 2012.

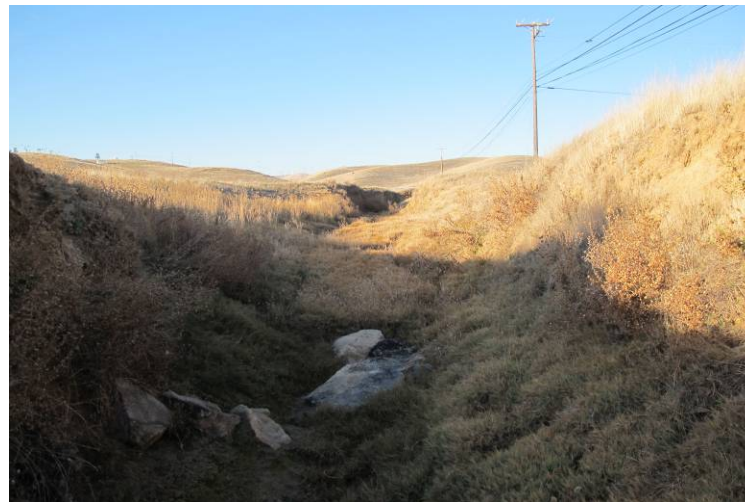
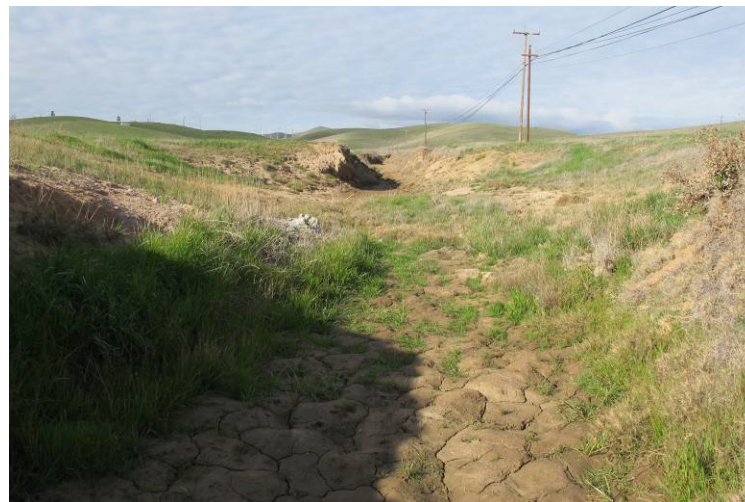
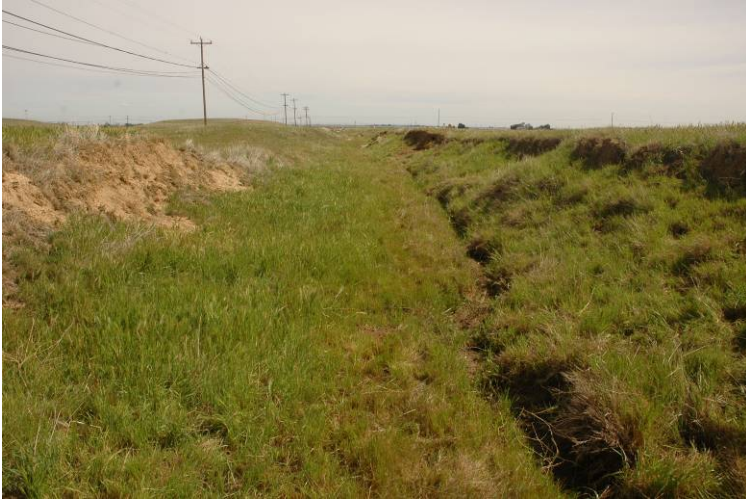
Photo Point L: Hydrologic connectivity monitoring

Water has not been observed flowing over the constructed overflow and into the southern wetland complex at any time, including in March, 2011 immediately following the major storm.
