FINAL REPORT ◦ FEBRUARY 2014

Evaluation of Barriers to Pacific Lamprey Migration in the Eel River Basin

P R E P A R E D B Y

Stillwater Sciences
850 G Street, Suite K
Arcata, CA 95521

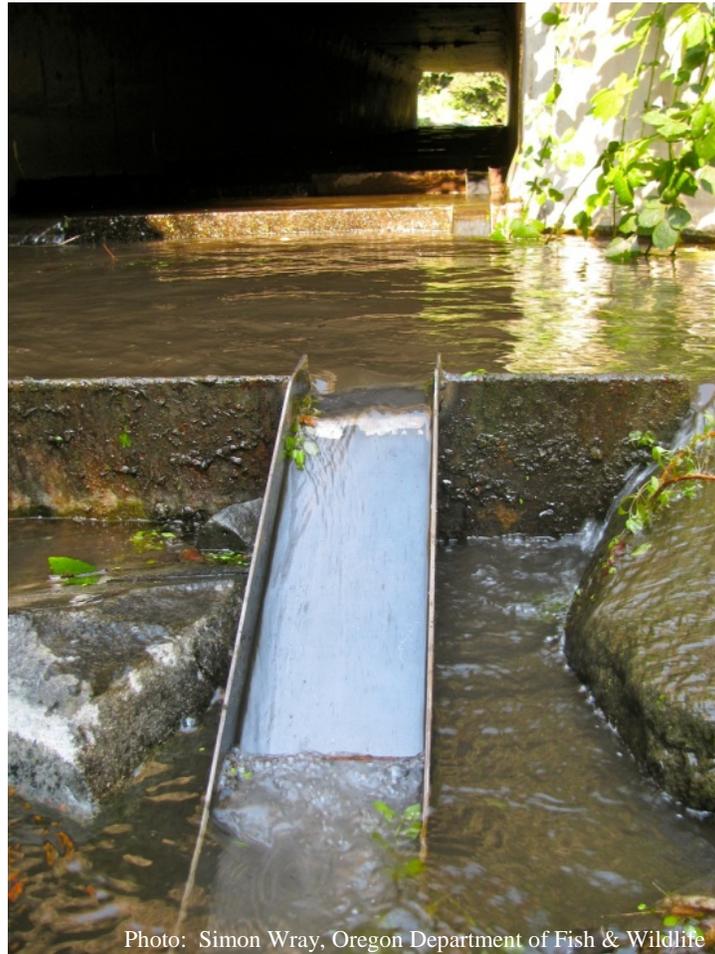
Figure 5-2. Example of installation of lamprey ramps to improve passage in Threemile Creek, Oregon.

- Where replacement of a perched culvert or culvert outlet apron is not possible or is cost-prohibitive, consider installing lamprey passage systems or similarly designed lamprey ramps (Moser et al. 2011). These systems take advantage of the unique attachment and climbing behavior of Pacific lampreys and have been used to improve passage efficiency through large hydropower dams (Keefer et al. 2010, Moser et al 2011). Similar technology

has recently been applied by Oregon Department of Transportation and Oregon Department of Fish and Wildlife to improve lamprey passage through culverts with internal baffles (Figure 5-2). Design and installation of these ramps are relatively simple and affordable compared with culvert replacement in most cases (M. Fox, Confederated Tribes of Warm Springs, pers. comm., 8 November 2013). We recommended exploring this approach for short- or long-term remediation of 10 of the 24 barriers sites identified in this study.

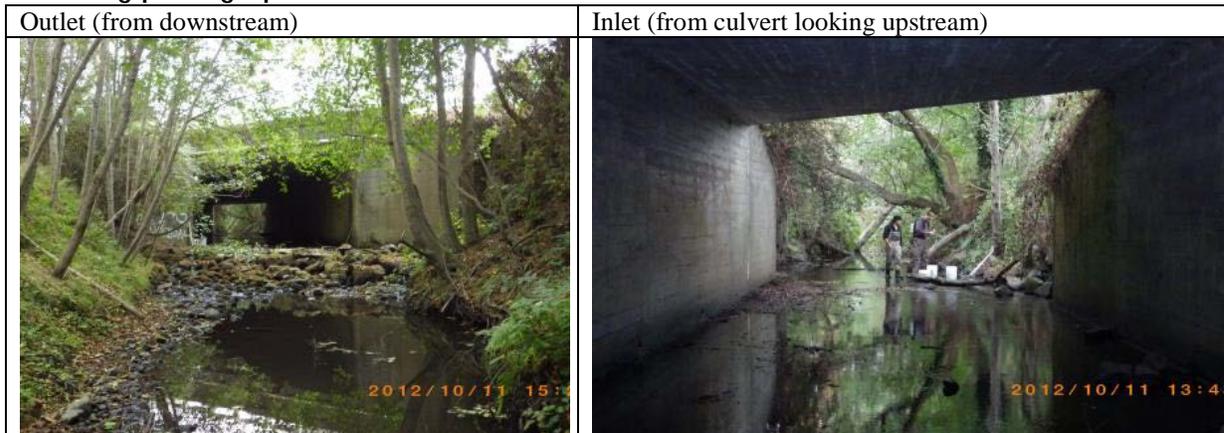
Crossing photographs

Strong's Creek flows through the city of Fortuna and is crossed by numerous other roads, several of which are not listed in the PAD. Downstream of the S. Fortuna Blvd. crossing, we evaluated passage at PAD ID 715460. We also photo documented bridge crossings downstream at Eel River Dr. and Riverwalk Dr. and determined they were likely not barriers at migration flows based on professional judgment. An examination of Google Earth indicates that Strong's Creek is crossed by several other public and private crossings upstream (including PAD ID 715455) that require future passage evaluation.

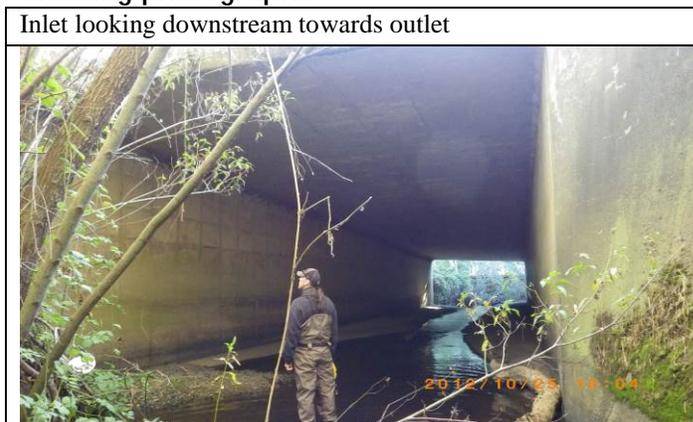
Crossing photographs

Strong's Creek flows through the city of Fortuna and is crossed by numerous other roads, several of which are not listed in the PAD. Upstream of HWY 101, we evaluated passage at PAD ID 715459. We also photo documented bridge crossings at Eel River Dr. and Riverwalk Dr. and determined they were likely not barriers at migration flows based on professional judgment. An examination of Google Earth indicates that Strong's Creek is crossed by several other public and private crossings upstream (including PAD ID 715455) that require future passage evaluation.

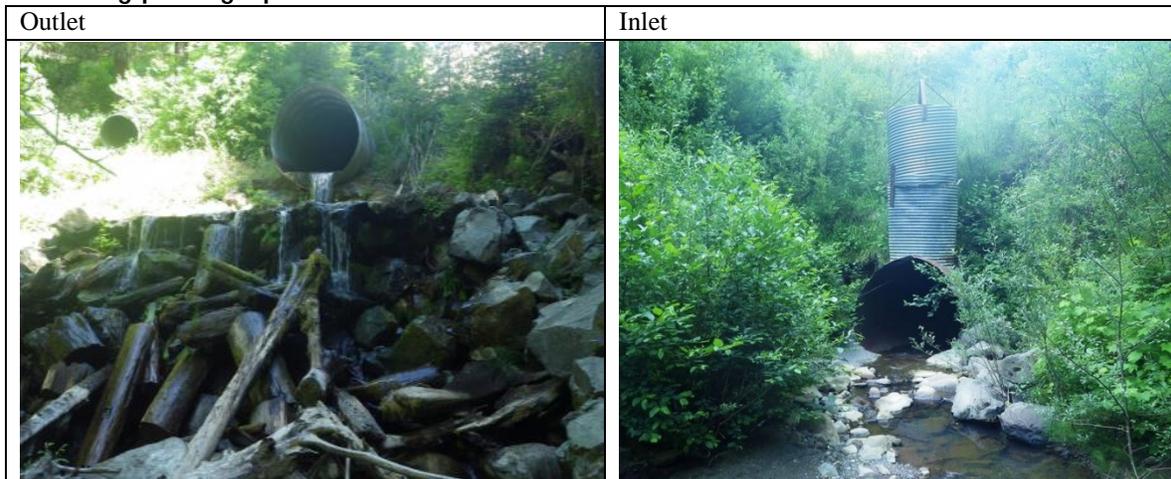
Crossing photographs

PAD ID 712002, located approximately 300 m downstream, is a railroad trestle with narrow concrete footing that does not appear to be a total barrier, but could impede passage at higher flows. In addition the PAD lists two waterfalls of unknown Pacific lamprey passage status approximately 300 m and 600 m upstream, respectively.

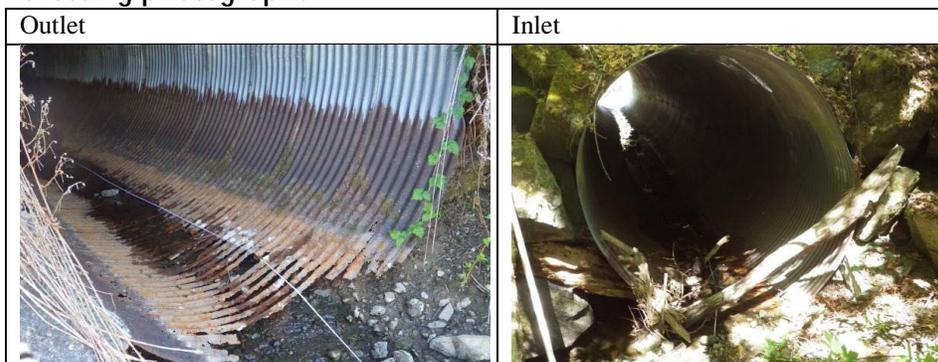
Crossing photographs

No additional PAD crossings or crossings visible in Google Earth are located in the main stem of Mountain Creek upstream or downstream.

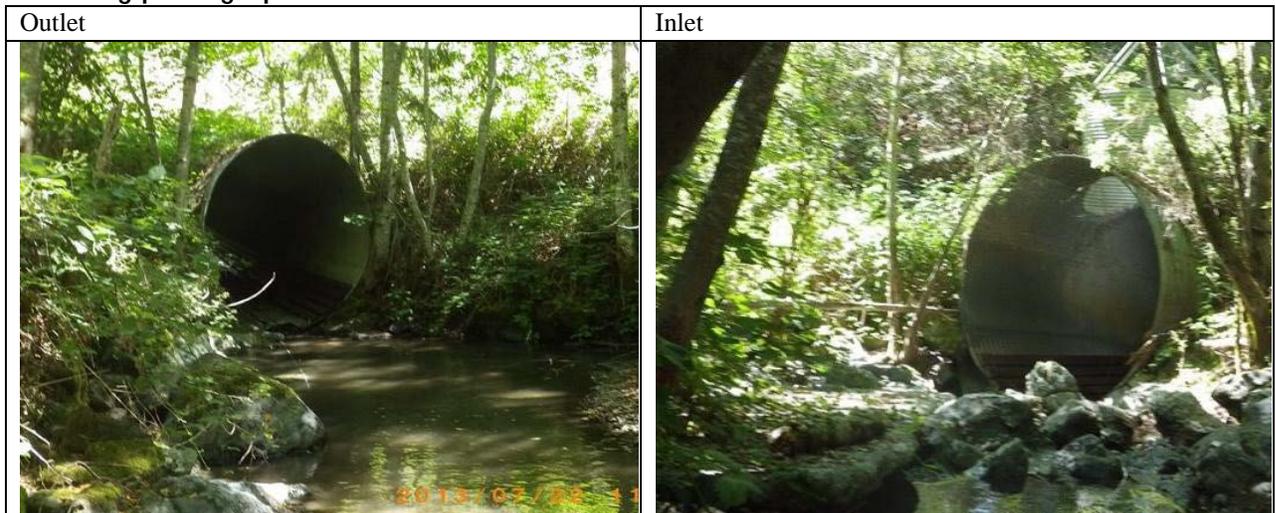
Crossing photographs

The PAD lists an 8 ft waterfall just downstream of Alderpoint Rd (PAD ID# 736847). It is unknown whether this site is a barrier to lampreys. No additional PAD crossings or crossings visible in Google Earth are located in Mill Creek.

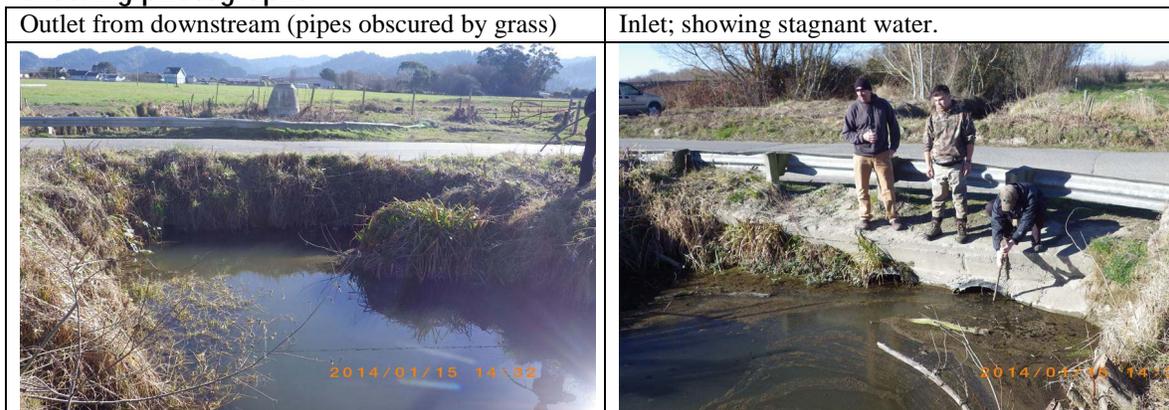
Crossing photographs

No other Francis Creek crossings are listed in the PAD, but upstream Francis Creek flows through numerous culverts with unknown passage status in downtown Ferndale. Several other private crossings upstream of Ferndale are apparent based on examination of Google Earth imagery.

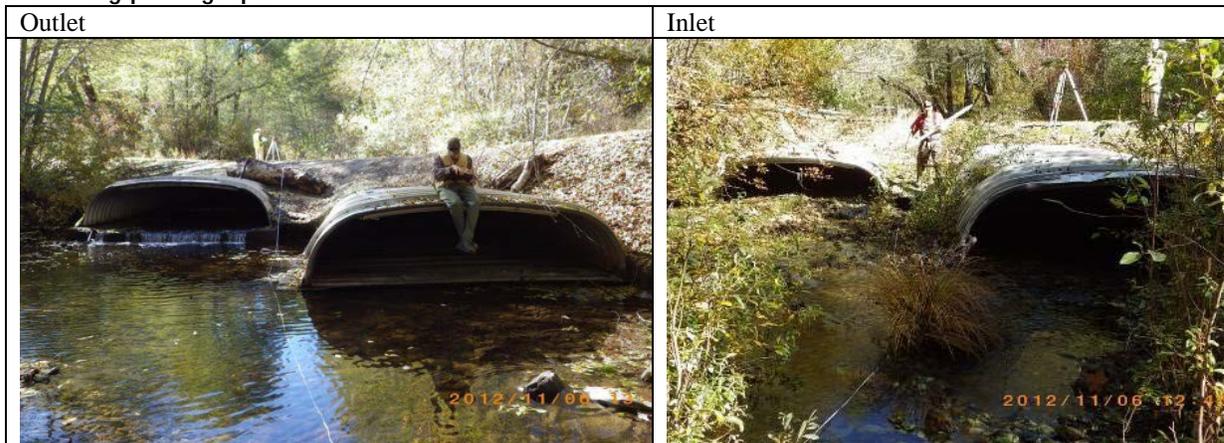
Crossing photographs

A road crossing approximately 1.3 miles upstream is listed in the PAD (ID 723653); a rock weir has been installed below this site to improve salmonid passage. Photo documentation of this site indicates that this site is most likely not a barrier to salmonids, but further evaluation is needed. Google Earth indicates several other private crossings may be present upstream of PAD ID 715481 in tributaries to Butte Creek.

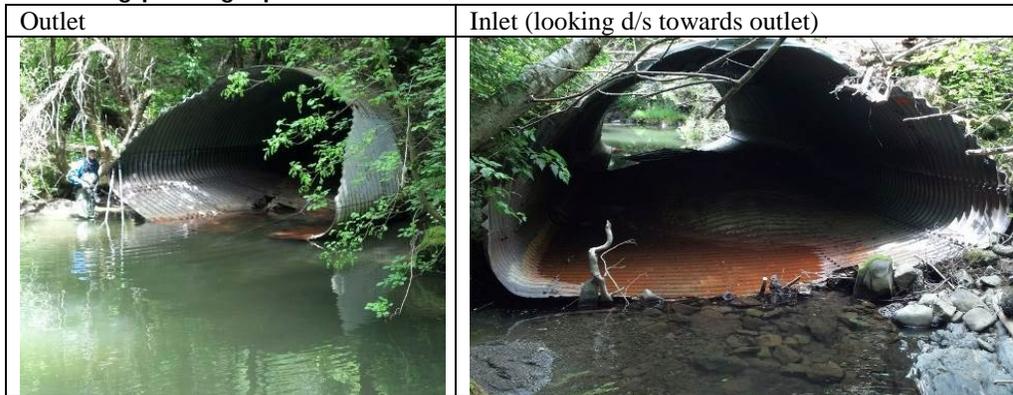
Crossing photographs

The PAD lists another crossing of mainstem Yager Cr. by Redwood House Rd. (PAD ID 715471) approximately 4 miles upstream. Google Earth indicates that this site may not actually be a crossing, but its status should be evaluated. The PAD also lists two high-gradient natural features approximately 5 miles downstream in mainstem Yager Cr. that are considered potential migration obstacles to salmonids. Evaluation of these sites for lamprey passage was beyond the scope of this study, but they are not likely to be barriers since steelhead have been observed upstream according to the PAD.

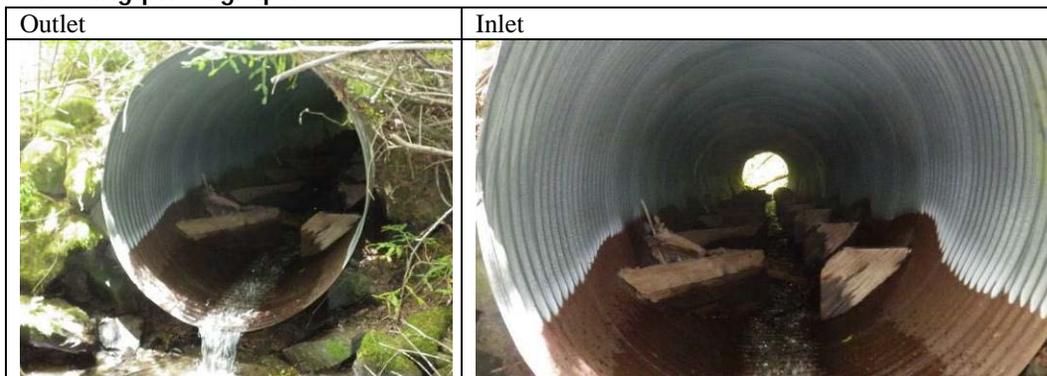
Crossing photographs

With the exception of the very upper portion of the watershed, no other road crossings are apparent in Strawberry Creek based on examination of Google Earth imagery.

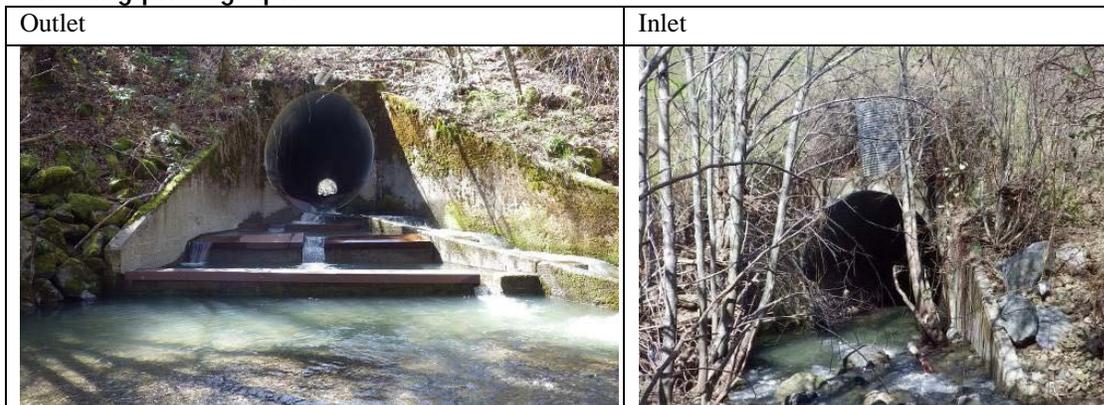
Crossing photographs

No additional PAD records exist for the watershed. Inspection of Google Earth imagery indicates the presence of at least one private road crossing upstream.

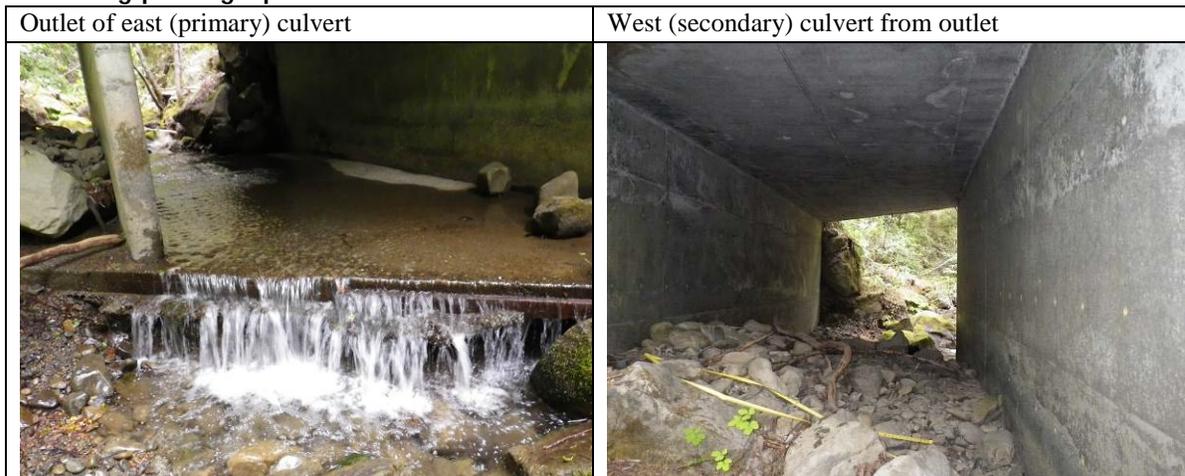
Crossing photographs

Source	Summary, rationale, and assumptions
Initial passage filter	Indeterminate
FishXing analysis	Site not suitable for FishXing analysis.
Field evaluation observations and data	At the moderate stream flows observed during the 5/21/13 field visit (and possibly across the range of migration flows), the site appears to be a total lamprey passage barrier. At the least, it is a major obstacle to passage. The concrete structure spans the active channel and is elevated approximately 1.5–4 ft above the streambed. Most of the structure has a sharp 90° angle edge where water pours over, which would likely deter lamprey passage. There are a couple of locations where the angle of the edge is slightly more rounded due to erosion. It is possible that parts of the site began to backwater at the higher end of migration flows, but water velocities are likely to be too high to allow lampreys to climb the structure and round the sharp corners at high flows. The ability of lampreys to climb and traverse vertical 90° corners needs further evaluation to improve confidence in designating passage status of this site.

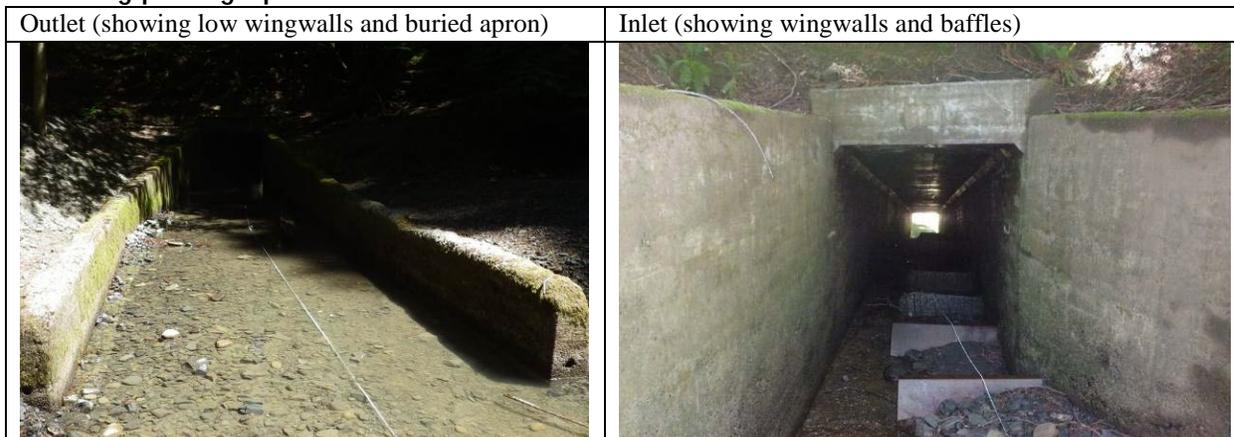
Crossing photographs

Skew from road	Inlet type	Outlet configuration	Baffles, weirs, or other internal structures	Fish ladder at outlet?	Tailwater control d/s of outlet	Crossing condition
90°	Wingwall <30°	South = free-fall into pool; North = at grade of high flow gravel bar.	No	No	Pool tailout	Culvert in good shape, but outlet wingwalls broken and in creek

The concrete outlet wingwalls have broken on both sides and fallen into channel immediately downstream of outlet, possibly influencing water surface elevation of tailwater pool during higher flows and increasing the potential of South bay of culvert to backwater.

Source	Summary, rationale, and assumptions
Initial passage filter	Indeterminate
FishXing analysis	FishXing results should be viewed with caution due to the complexity of the site (2 culvert bays and broken wingwalls in channel). For the South bay, the model predicts that the 90° perched outlet will begin to backwater at flows higher than 21.9 cfs. We conservatively assume that lampreys cannot enter the culvert at flows lower than 21.9 cfs. The model predicts that water velocities will remain below the maximum burst swimming speed (2.7 m/s) at all migration flows, and thus lampreys can pass once they are able to enter the South outlet. For the North bay, the model predicts that water depth at gravel bar at the outlet will be below the minimum depth criteria of 0.1 ft until flows reach 37.4 cfs, when lampreys could presumably begin to enter the culvert. The model also predicts that water velocities are well below maximum burst swimming speed in North bay at all migration flows and thus passage would be possible once lampreys can enter.

Field evaluation observations and data	The perched outlet drop at the South bay is expected to be a barrier to lamprey migration at the low flows occurring (7/3/2013 survey). The South bay is low gradient and has ample attachment points and would likely be passable if the outlet backwatered enough for lampreys to enter at higher flows. The broken concrete outlet wingwalls in the channel downstream of outlet may influence water surface elevation of the tailwater during higher flows, possibly backwatering the outlet and allowing lampreys to enter at lower flows than predicted by FishXing. The North bay has over 1 ft of gravel substrate at the inlet that blocks passage at low flows. If water velocities remain low enough when the water level exceeds the gravel bar at the outlet, then lampreys could presumably enter and pass the North bay. Overall, the site appears to block passage at low migration flows and likely allows passage at moderate to higher migration flows.

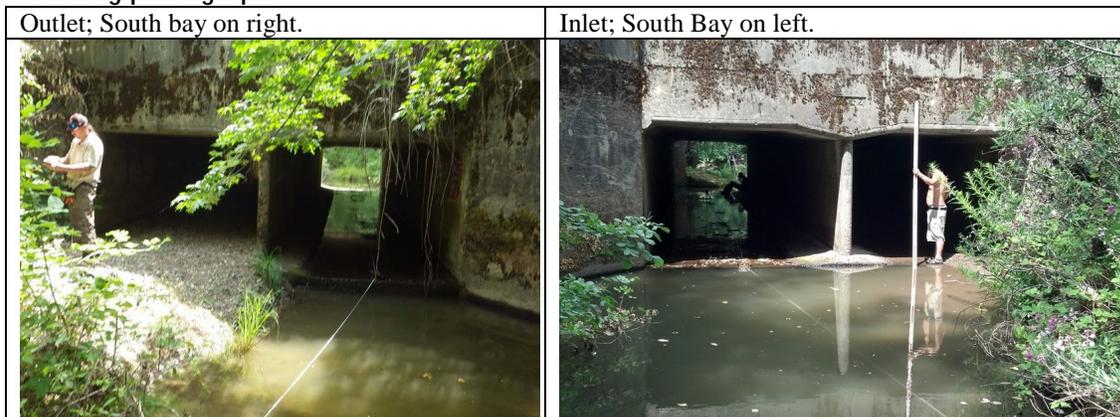
Crossing photographs

Skew from road	Inlet type	Outlet configuration	Baffles, weirs, or other internal structures	Fish ladder at outlet?	Tailwater control d/s of outlet	Crossing condition
~60-70°	Wingwall < 30°	Outlet apron at stream grade then cascade over rock at end of wingwall; Fish ladder on river right	25 concrete weirs spanning culvert width	Denil style fish ladder. 14 pairs of ¼" steel plate baffles attached to stepped concrete	Pool tailout	Overall good; minor cracks in concrete seams.

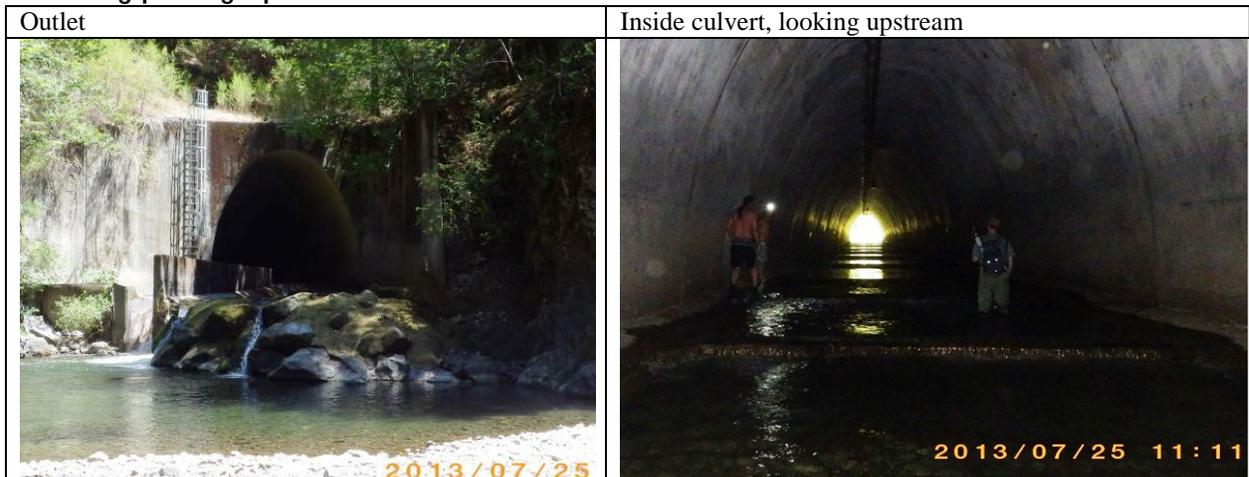
Crossing photographs

Skew from road	Inlet type	Outlet configuration	Baffles, weirs, or other internal structures	Fish ladder at outlet?	Tailwater control d/s of outlet	Crossing condition
45°	Wingwall <30°	At stream grade	8 concrete baffles approx. 6 ft. long X 18 in wide; 7 reinforced boulder piles	No	Concrete baffle and small boulders	Good condition

Field evaluation observations and data	The open bottom arch culvert has a natural stream bed, relatively low gradient, and internal baffles across part of the channel that reduce velocity at higher flows. During late-summer field surveys, there was sufficient water depth to provide passage. There are ample attachment points present through the crossing to allow for burst-and-attach swimming.
Ammocoete surveys	Pacific lamprey ammocoetes were located upstream of the crossing.
PAD	In 2010, a corrugated “U” shaped culvert was replaced with the existing culvert by Caltrans.
Other evaluations	None

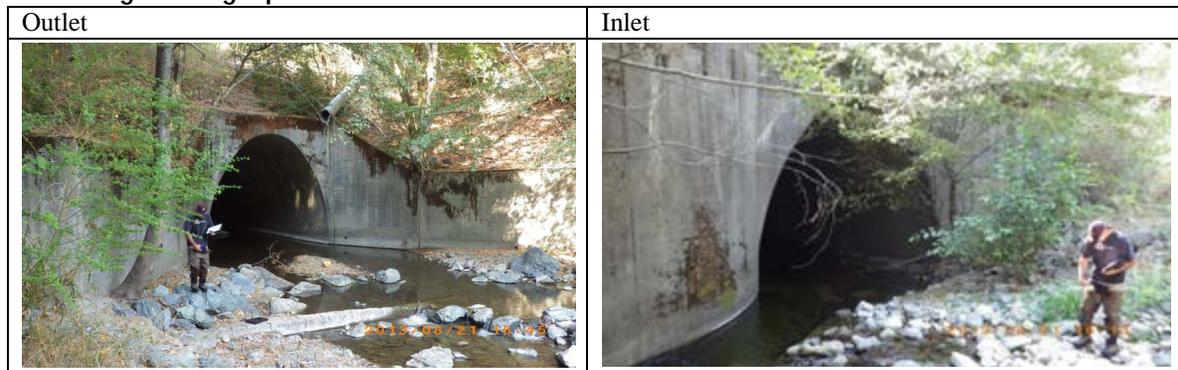
Crossing Photographs

Skew from road	Inlet type	Outlet configuration	Baffles, weirs, or other internal structures	Fish ladder at outlet?	Tailwater control d/s of outlet	Crossing condition
90°	Wingwall < 30°	At stream grade	No	No	Pool tailout	Overall good, but embedded with sediment and appears to be undersized

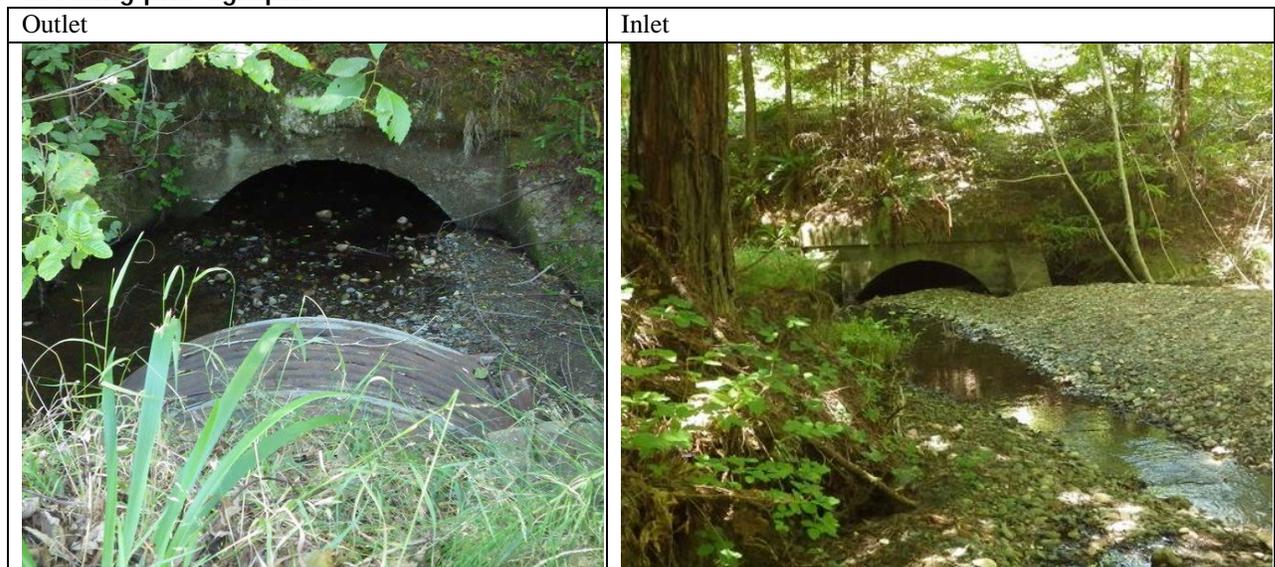
Crossing photographs

Skew from road	Inlet type	Outlet configuration	Baffles, weirs, or other internal structures	Fish ladder at outlet?	Tailwater control d/s of outlet	Crossing condition
90°	Projecting	At stream grade	No	No	Pool tailout	Poor condition; undersized, some structural damage; blockage from sediment

PAD	Repeats information from RTA (2005)
Other evaluations	RTA (2005) state: “FishXing determined that the current crossing provides unimpeded passage for adult salmonids and partial passage for juvenile salmonids. However, from a road maintenance point-of view the current crossing is due for replacement; the culvert is in poor condition and both the culvert and road prism are over-topped on less than a five-year storm flow.”

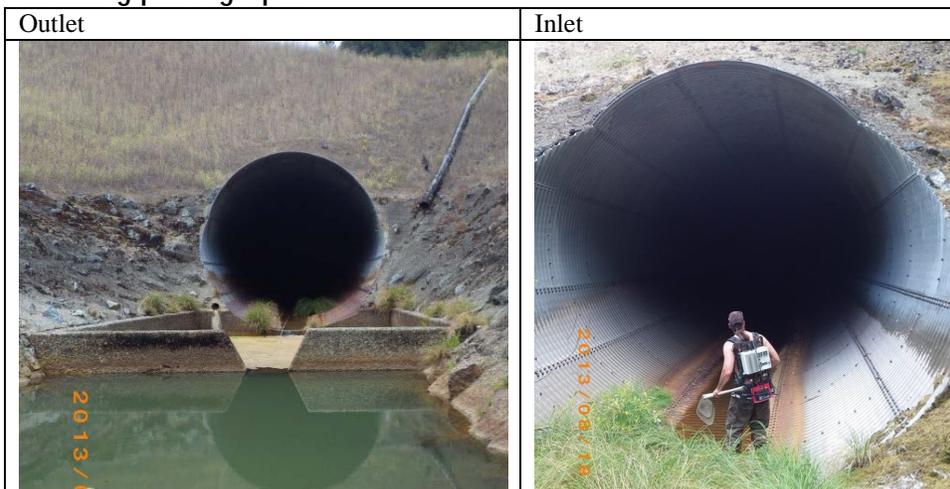
Crossing photographs

Skew from road	Inlet type	Outlet configuration	Baffles, weirs, or other internal structures	Fish ladder at outlet?	Tailwater control d/s of outlet	Crossing condition
75°	Headwall	Concrete apron gradually sloping and ending in ~1 ft drop at rip rap pile.	Lower elevation trough focuses water on river right (0.3–0.9 ft lower elevation than river left and 24 in wide)	No	Pool tailout, but rip rap may affect water elevation and velocity at outlet during higher flows.	Culvert in fair condition overall. Some erosion under concrete outlet apron. Right of culvert worn and rebar exposed
