STREAM INVENTORY REPORT

Mill Creek

A stream inventory was conducted during June 4, 2007 to June 13, 2007 on Mill Creek. The survey began at the confluence with Bull Creek and extended upstream 1.2 miles.

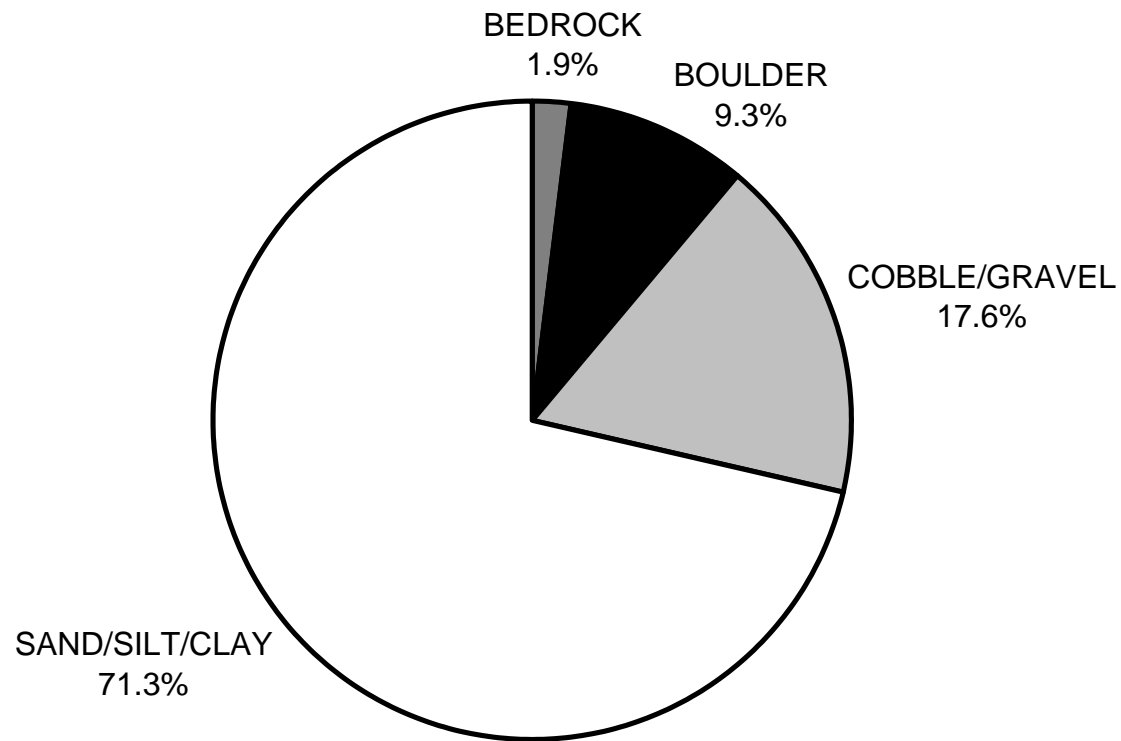
GRAPH 10

For the stream reach surveyed, the mean percent right bank vegetated was 79%. The mean percent left bank vegetated was 83%. The dominant elements composing the structure of the stream banks consisted of 71% sand/silt/clay, 18% cobble/gravel, 9% boulder, and 2% bedrock (Graph 10). Hardwood trees were the dominant vegetation type observed in 51% of the units surveyed. Additionally, 24% of the units surveyed had coniferous trees as the dominant vegetation type, and 15% had grass as the dominant vegetation (Graph 11).

MILL CREEK 2007
DOMINANT BANK COMPOSITION IN SURVEY REACH

The percentage of right and left bank covered with vegetation was high at 79% and 83%, respectively. In areas of stream bank erosion or where bank vegetation is sparse, planting endemic species of coniferous and hardwood trees, in conjunction with bank stabilization, is recommended.

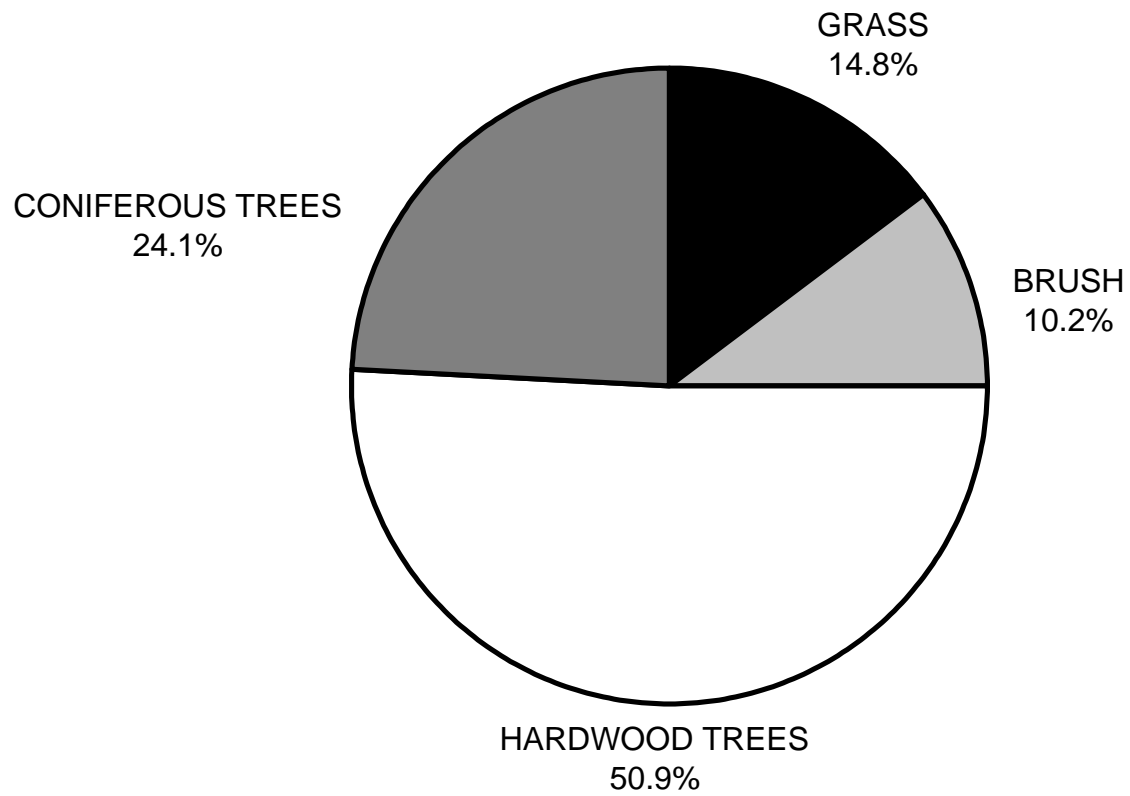
GRAPH 11

MILL CREEK 2007
DOMINANT BANK VEGETATION IN SURVEY REACH
