STREAM INVENTORY REPORT

Mill Creek

A stream inventory was conducted on July 20, 2009 on Mill Creek. The survey began at the confluence with Salmon Creek and extended upstream 0.5 miles.

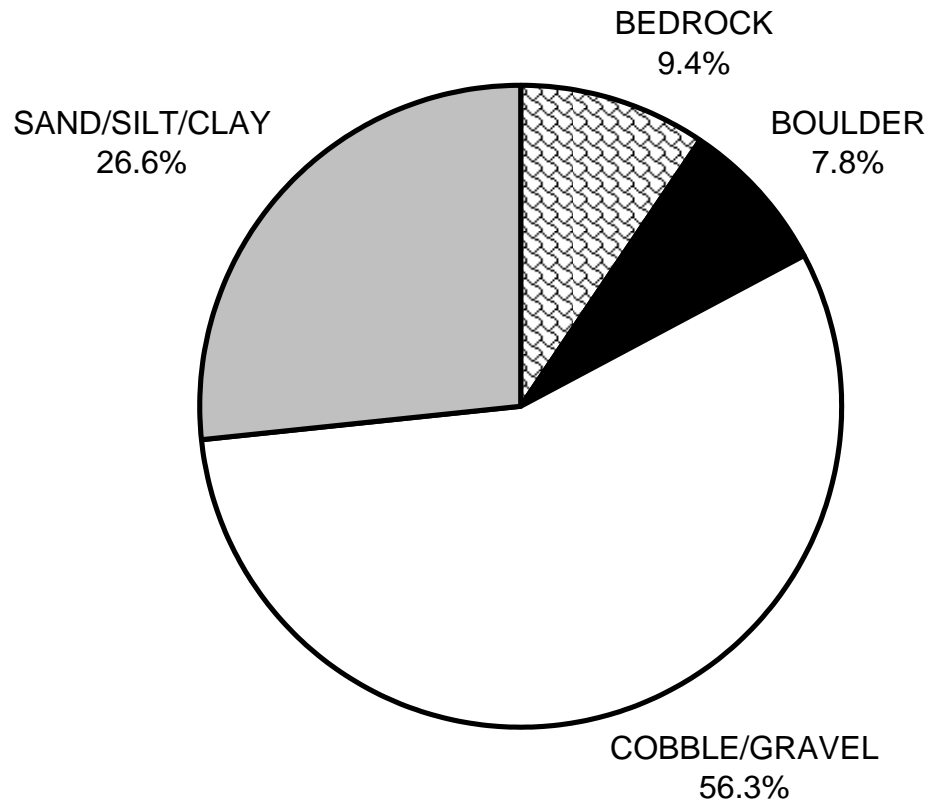
GRAPH 10

For the stream reach surveyed, the mean percent right bank vegetated was 93%. The mean percent left bank vegetated was 92%. The dominant elements composing the structure of the stream banks consisted of 56% cobble/gravel, 27% sand/silt/clay, 9% bedrock, and 8% boulder (Graph 10). Deciduous trees were the dominant vegetation type observed in 47% of the units surveyed. Additionally, 36% of the units surveyed had coniferous trees as the dominant vegetation type, 14% had brush, and 2% had grass as the dominant vegetation type (Graph 11).

The percentage of right and left bank covered with vegetation was 93% and 92%, respectively. In areas of stream bank erosion or where bank vegetation is sparse, planting endemic species of coniferous and hardwood trees, in conjunction with bank stabilization, is recommended.
