STREAM INVENTORY REPORT

Upper Redwood Creek aka "Pollock Creek"

A stream inventory was conducted from June 23 to July 9, 2009 on the upper reach of Redwood Creek commonly known as and hereinafter referred to as Pollock Creek. The survey began at the confluence with China Creek and extended upstream 2.7 miles.

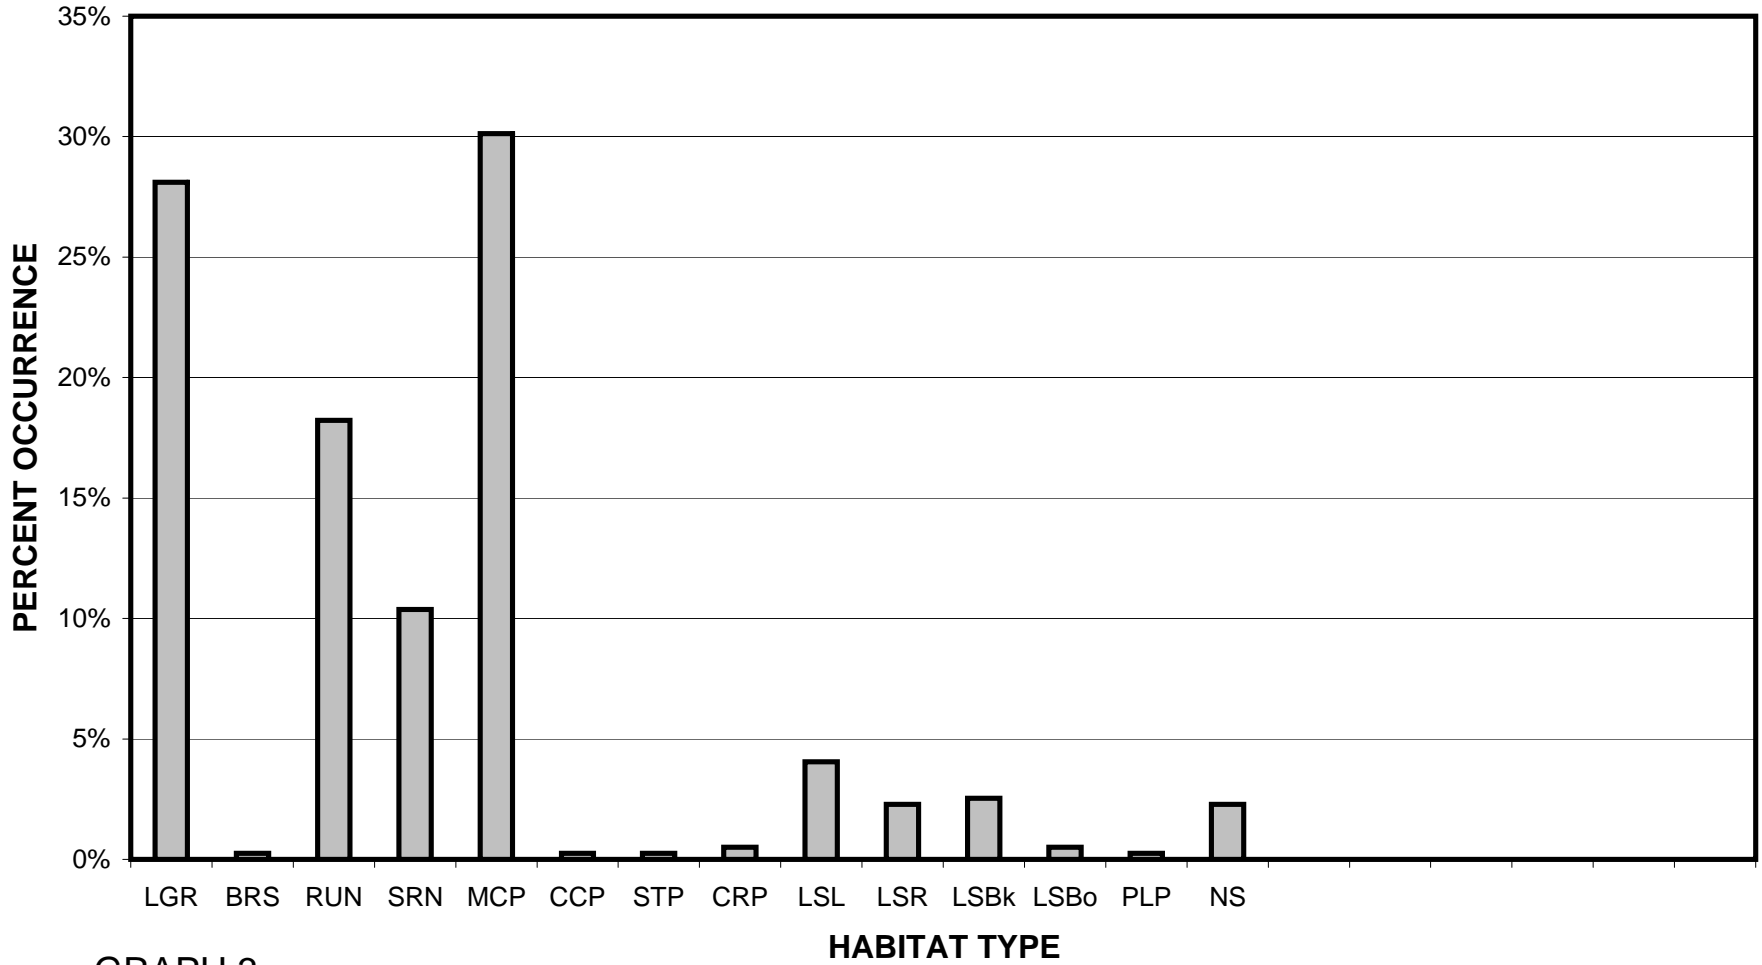
GRAPH 2

REDWOOD CREEK 2009 HABITAT TYPES BY PERCENT OCCURRENCE

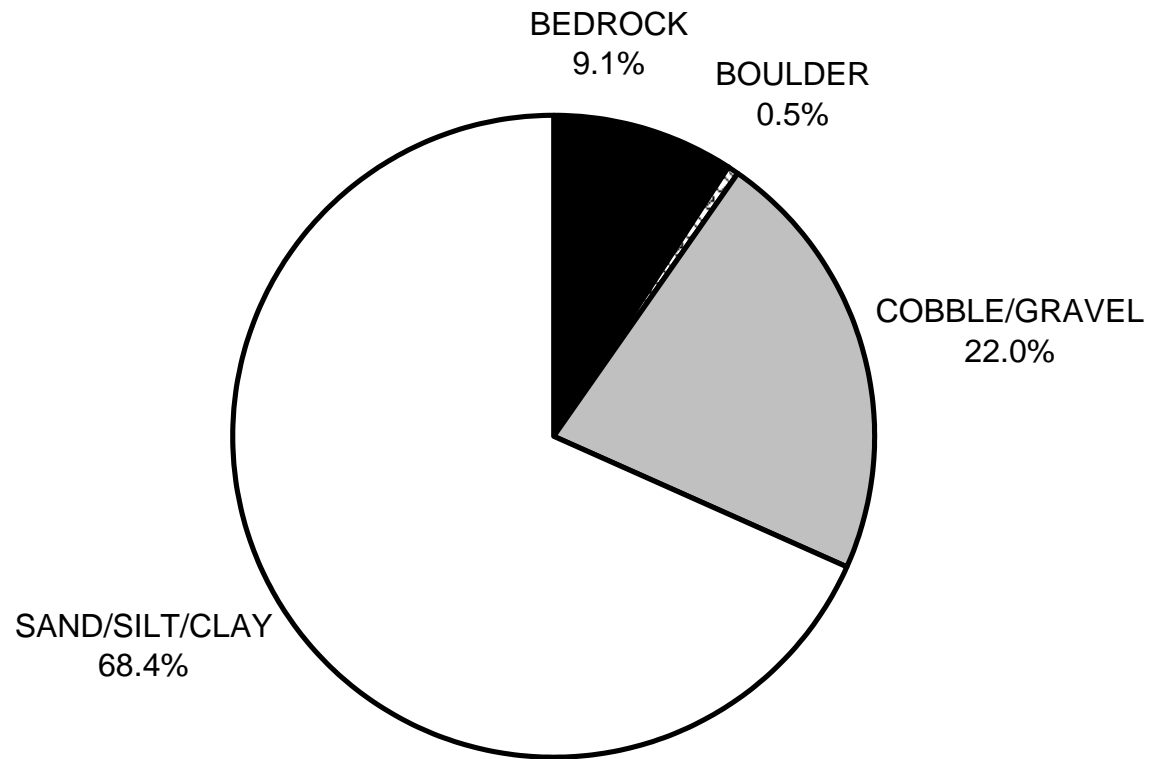
GRAPH 9

For the stream reach surveyed, the mean percent right bank vegetated was 91%. The mean percent left bank vegetated was 92%. The dominant elements composing the structure of the stream banks consisted of 68% sand/silt/clay, 22% cobble/gravel, 9% bedrock, and 1% boulder (Graph 10). Hardwood trees were the dominant vegetation type observed in 58% of the units surveyed. Additionally, 37% of the units surveyed had coniferous trees as the dominant vegetation type, and 5% had brush as the dominant vegetation type (Graph 11).

REDWOOD CREEK 2009 DOMINANT BANK COMPOSITION IN SURVEY REACH

The percentage of right and left bank covered with vegetation was 91% and 92%, respectively. In areas of stream bank erosion or where bank vegetation is sparse, planting endemic species of coniferous and hardwood trees, in conjunction with bank stabilization, is recommended.
