# **STREAM INVENTORY REPORT**

## **Salmon Creek**

A stream inventory was conducted during October 3, 2007 to October 29, 2007 on Salmon Creek. The survey began at the confluence with the South Fork Eel River and extended upstream 7.3 miles.

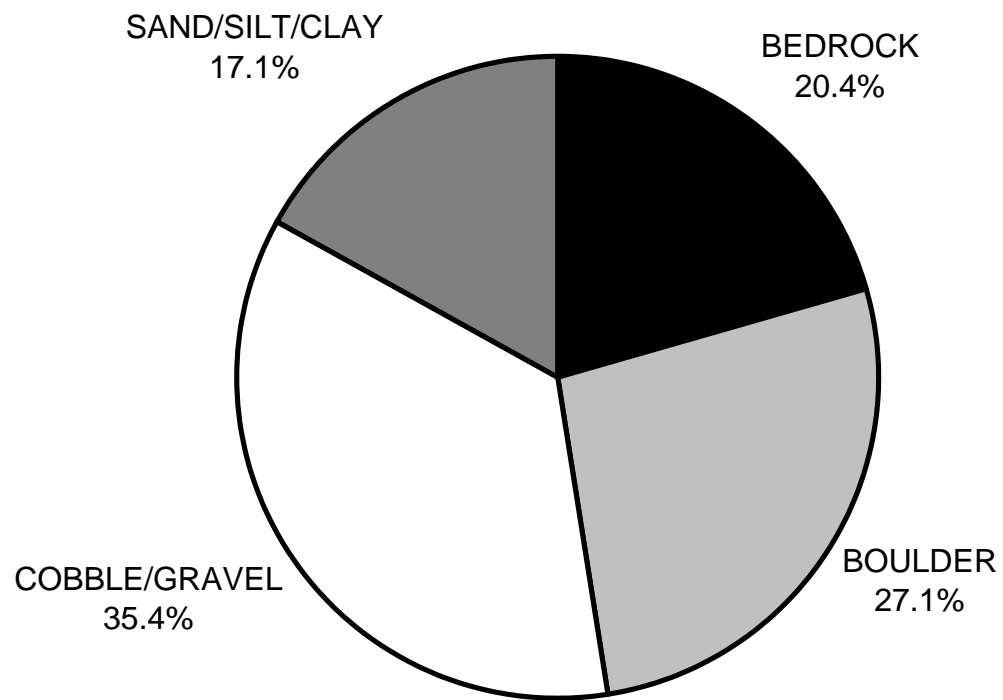
GRAPH 9

For the stream reach surveyed, the mean percent right bank vegetated was 68%. The mean percent left bank vegetated was 66%. The dominant elements composing the structure of the stream banks consisted of 35% cobble/gravel, 27% boulder, 20% bedrock, and 17% sand/silt/clay (Graph 10). Hardwood trees were the dominant vegetation type observed in 62% of the units surveyed. Additionally, 18% of the units surveyed had coniferous trees as the dominant vegetation type, and 16% had brush as the dominant vegetation (Graph 11).

**SALMON CREEK 2007**  
**DOMINANT BANK COMPOSITION IN SURVEY REACH**

The percentage of right and left bank covered with vegetation was moderate at 68% and 66%, respectively. In areas of stream bank erosion or where bank vegetation is sparse, planting endemic species of coniferous and hardwood trees, in conjunction with bank stabilization, is recommended.
