STREAM INVENTORY REPORT

Glenbrook Gulch

A stream inventory was conducted from September 25 to October 2, 2013 on Glenbrook Gulch. The survey began at the confluence with Kaisen Gulch and extended upstream 0.6 miles.

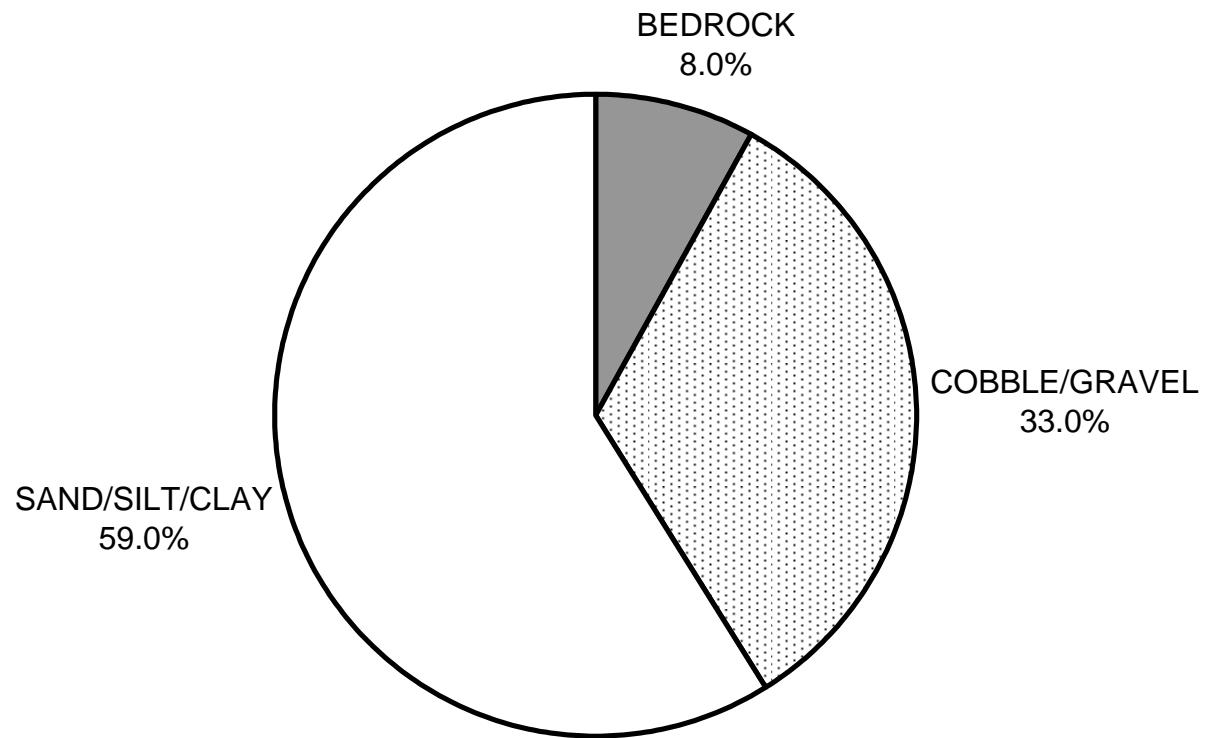
GRAPH 9

For the stream reach surveyed, the mean percent right bank vegetated was 93%. The mean percent left bank vegetated was 96%. The dominant elements composing the structure of the stream banks consisted of 59% sand/silt/clay, 33% cobble/gravel, and 8% bedrock (Graph 10). Coniferous trees were the dominant vegetation type observed in 36% of the units surveyed. Additionally, 30% of the units surveyed had grass as the dominant vegetation type, and 21% had brush as the dominant vegetation type (Graph 11).

GLENBROOK GULCH 2013 DOMINANT BANK COMPOSITION IN SURVEY REACH
