STREAM INVENTORY REPORT

North Fork Gualala River (Upper Watershed)

A stream inventory was conducted beginning August 28 and ending November 4, 2003 on North Fork Gualala River. The survey began on the mainstem near an unnamed left bank tributary, upstream of Stewart Creek. The survey extended upstream 14,832 feet.

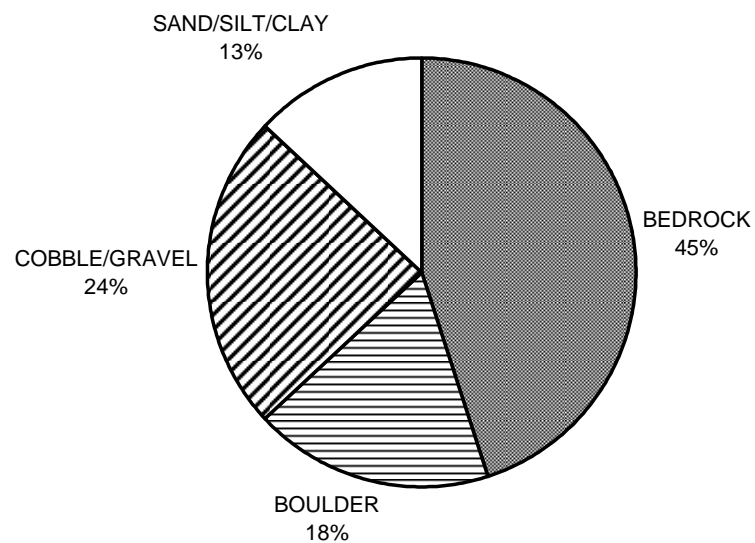
GRAPH 9

For the stream reach surveyed, the mean percent right bank vegetated was 49%. The mean percent left bank vegetated was 51%. The dominant elements composing the structure of the stream banks consisted of 45% bedrock, 24% cobble/gravel, 18% boulder, and 13% sand/silt/clay (Graph 10). Deciduous trees were the dominant vegetation type observed in 67% of the units surveyed. Additionally, 31% of the units surveyed had coniferous trees as the dominant vegetation type, 1% brush, and 1% grass as the dominant vegetation (Graph 11).

NORTH FORK GUALALA RIVER DOMINANT BANK COMPOSITION IN SURVEY REACH
