STREAM INVENTORY REPORT

Unnamed Tributary to Johnson Creek

A stream inventory was conducted on June 5, 2012 on an unnamed tributary to Johnson Creek. The survey began at the confluence with Johnson Creek and extended upstream 0.3 miles.

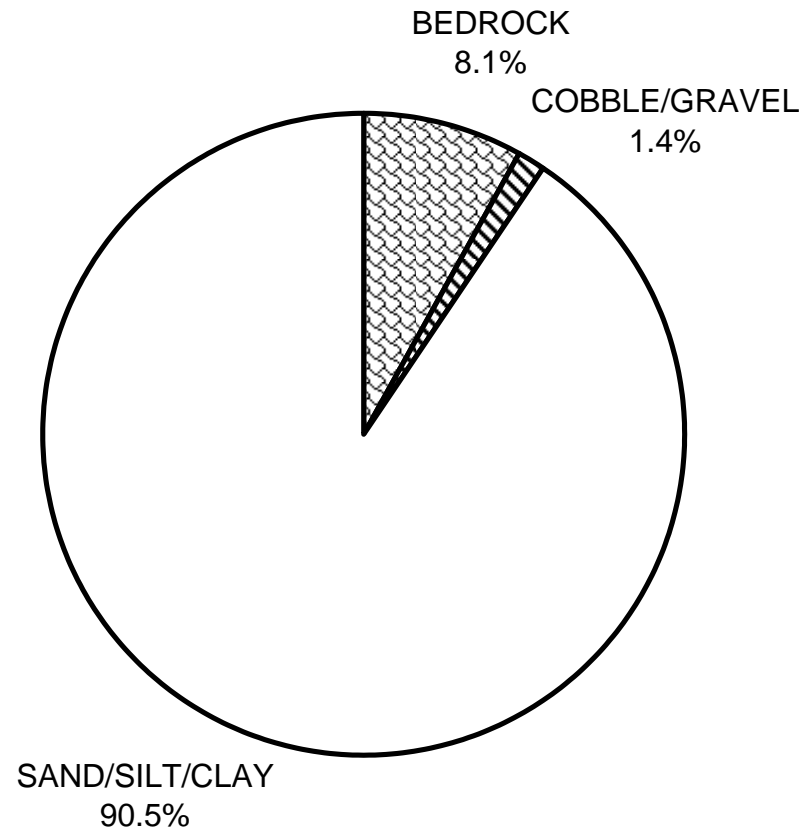
GRAPH 9

For the stream reach surveyed, the mean percent right bank vegetated was 100%. The mean percent left bank vegetated was 100%. The dominant elements composing the structure of the stream banks consisted of 91% sand/silt/clay, 8% bedrock, and 1% cobble/gravel (Graph 10). Coniferous trees were the dominant vegetation type observed in 42% of the units surveyed. Additionally, 37% of the units surveyed had deciduous trees as the dominant vegetation type, and 22% had brush as the dominant vegetation type (Graph 11).

**UNNAMED TRIBUTARY TO JOHNSON CREEK 2012
DOMINANT BANK COMPOSITION IN SURVEY REACH**
