# STREAM INVENTORY REPORT

## Burbeck Creek

A stream inventory was conducted from May 21 to May 23, 2013 on Burbeck Creek. The survey began at the confluence with the Noyo River and extended upstream 1.2 miles.

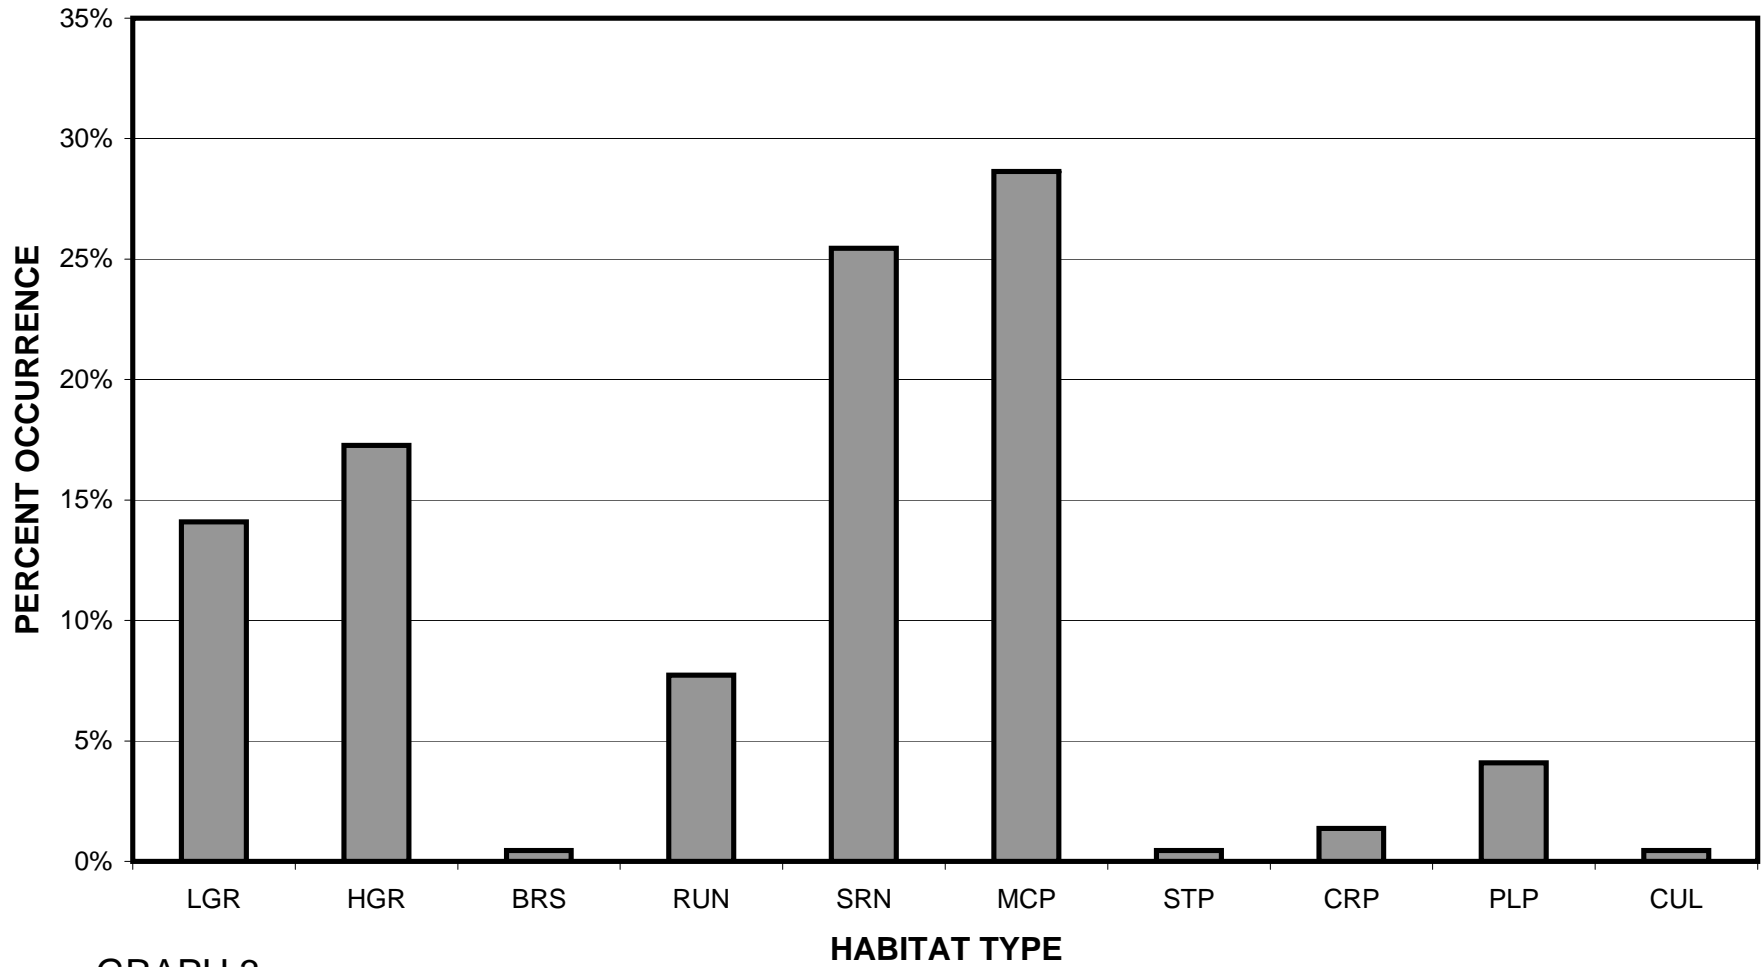
GRAPH 2

# BURBECK CREEK 2013 HABITAT TYPES BY PERCENT OCCURRENCE

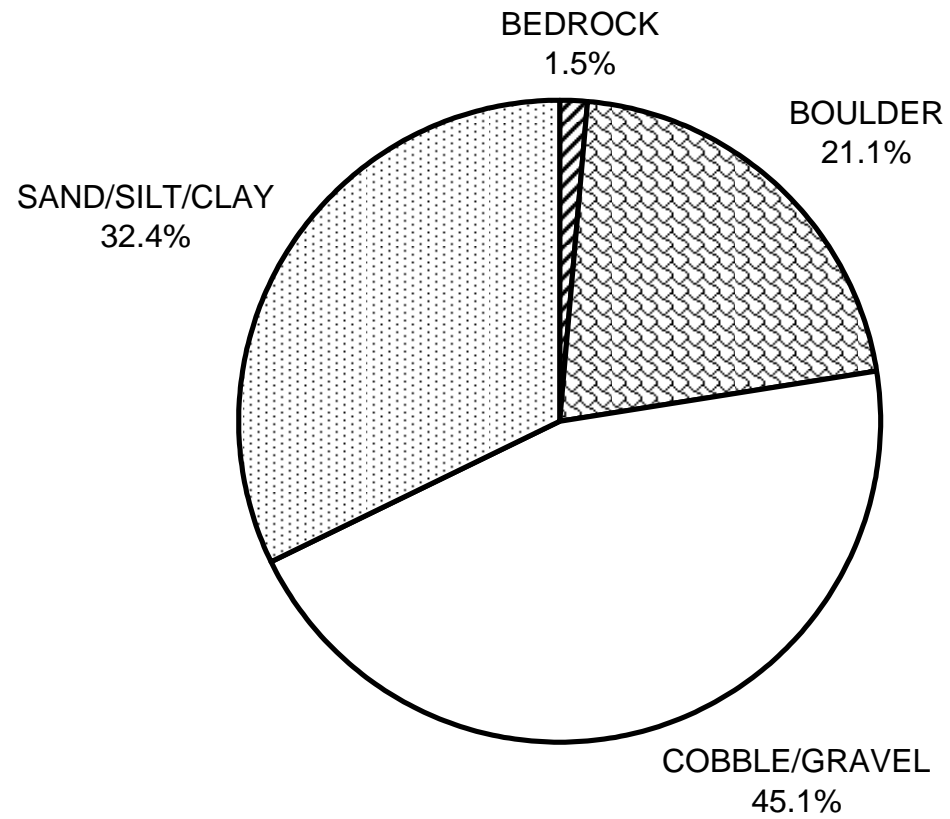
GRAPH 9

For the stream reach surveyed, the mean percent right bank vegetated was 96%. The mean percent left bank vegetated was 91%. The dominant elements composing the structure of the stream banks consisted of 45% cobble/gravel, 32% sand/silt/clay, 21% boulders, and 1% bedrock (Graph 10). Coniferous trees were the dominant vegetation type observed in 46% of the units surveyed. Additionally, 29% of the units surveyed had hardwood trees as the dominant vegetation type, and 20% had brush as the dominant vegetation type (Graph 11).

# BURBECK CREEK 2013 DOMINANT BANK COMPOSITION IN SURVEY REACH
