STREAM INVENTORY REPORT

“Panther Gulch”

A stream inventory was conducted from July 22 to July 30, 2013 on an unnamed tributary to Hayworth Creek commonly known as, and herein after referred to as, Panther Gulch. The survey began at the confluence with Hayworth Creek and extended upstream 0.8 miles.

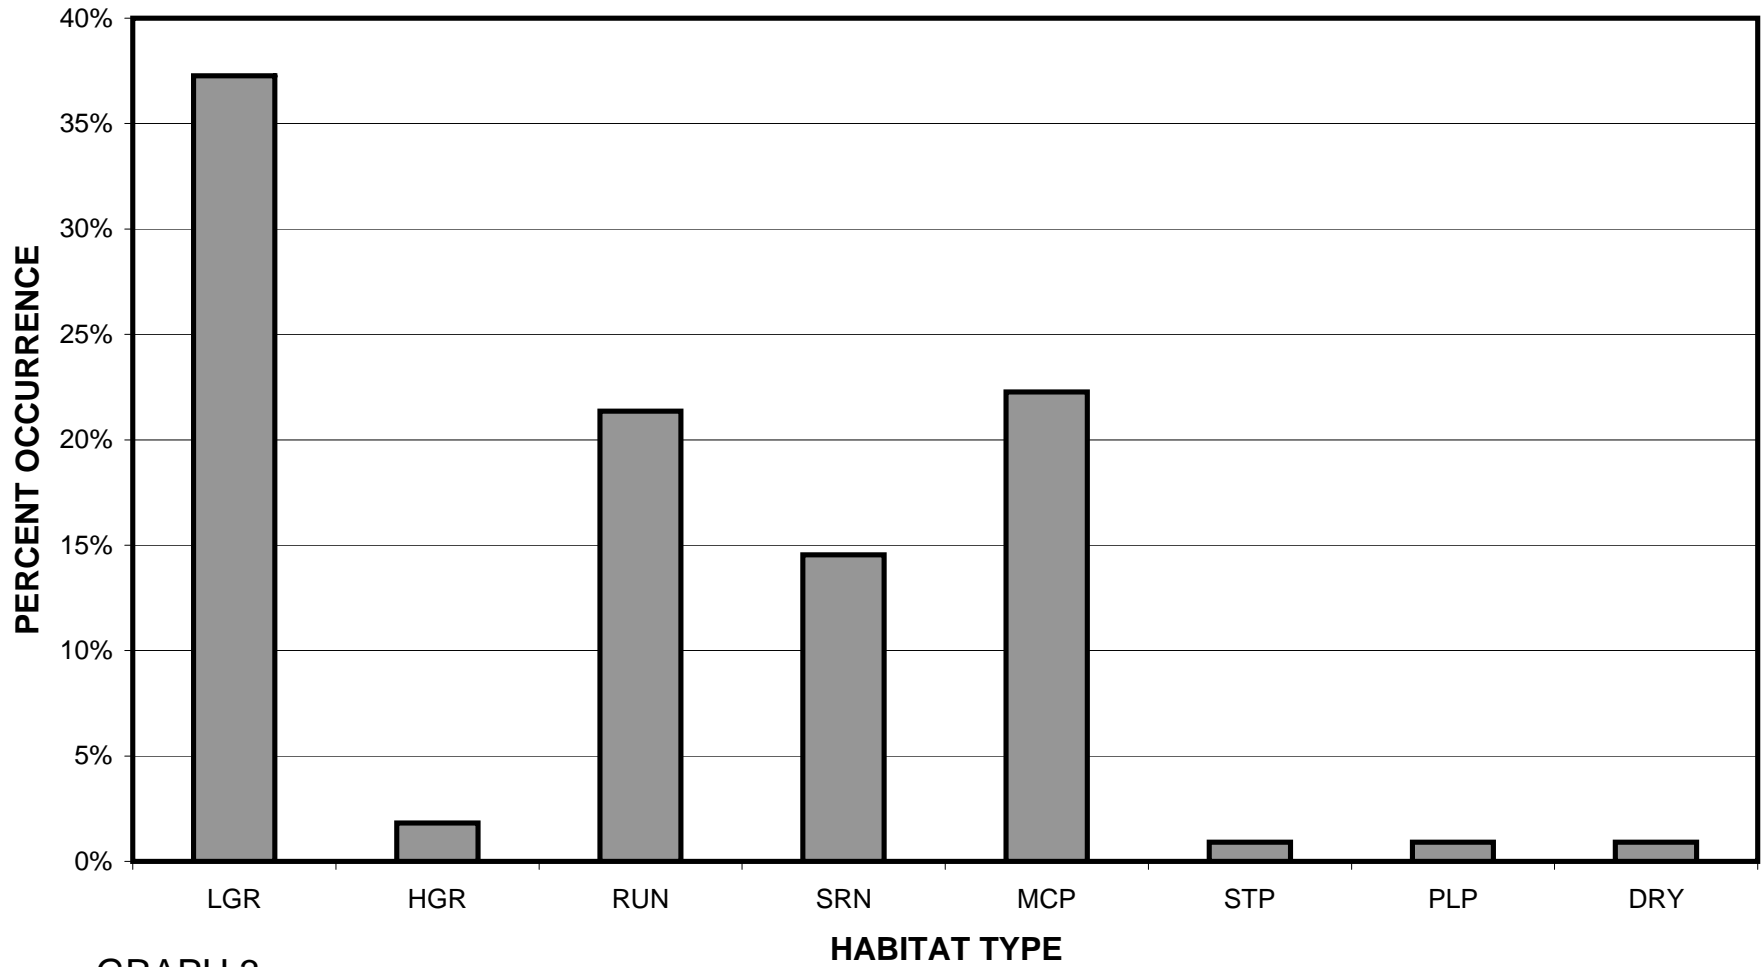
GRAPH 2

"Panther Gulch" 2013 HABITAT TYPES BY PERCENT OCCURRENCE

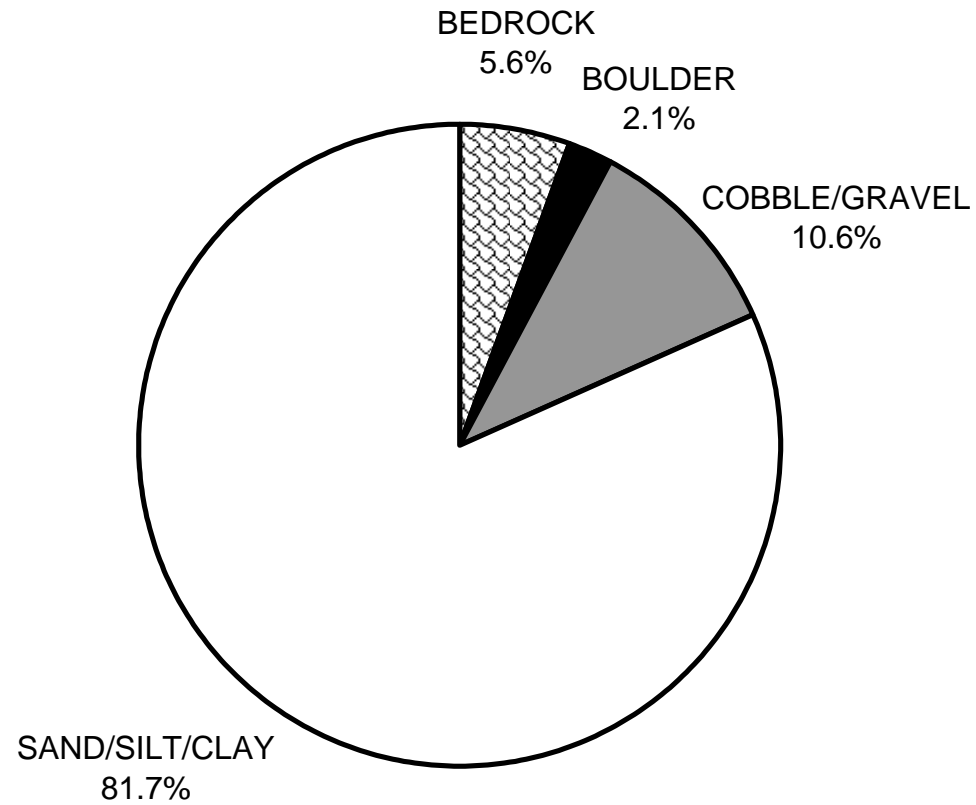
GRAPH 9

For the stream reach surveyed, the mean percent right bank vegetated was 97%. The mean percent left bank vegetated was 96%. The dominant elements composing the structure of the stream banks consisted of 82% sand/silt/clay, 11% cobble/gravel, 6% bedrock, and 2% boulders (Graph 10). Coniferous trees were the dominant vegetation type observed in 46% of the units surveyed. Additionally, 37% of the units surveyed had deciduous trees as the dominant vegetation type, and 17% had brush as the dominant vegetation type (Graph 11).

**"Panther Gulch" 2013
DOMINANT BANK COMPOSITION IN SURVEY REACH**
