STREAM INVENTORY REPORT

Buckhorn Creek

A stream inventory was conducted from October 23 to October 30, 2012 on Buckhorn Creek. The survey began at the confluence with Little North Fork Ten Mile River and extended upstream 1.8 miles.

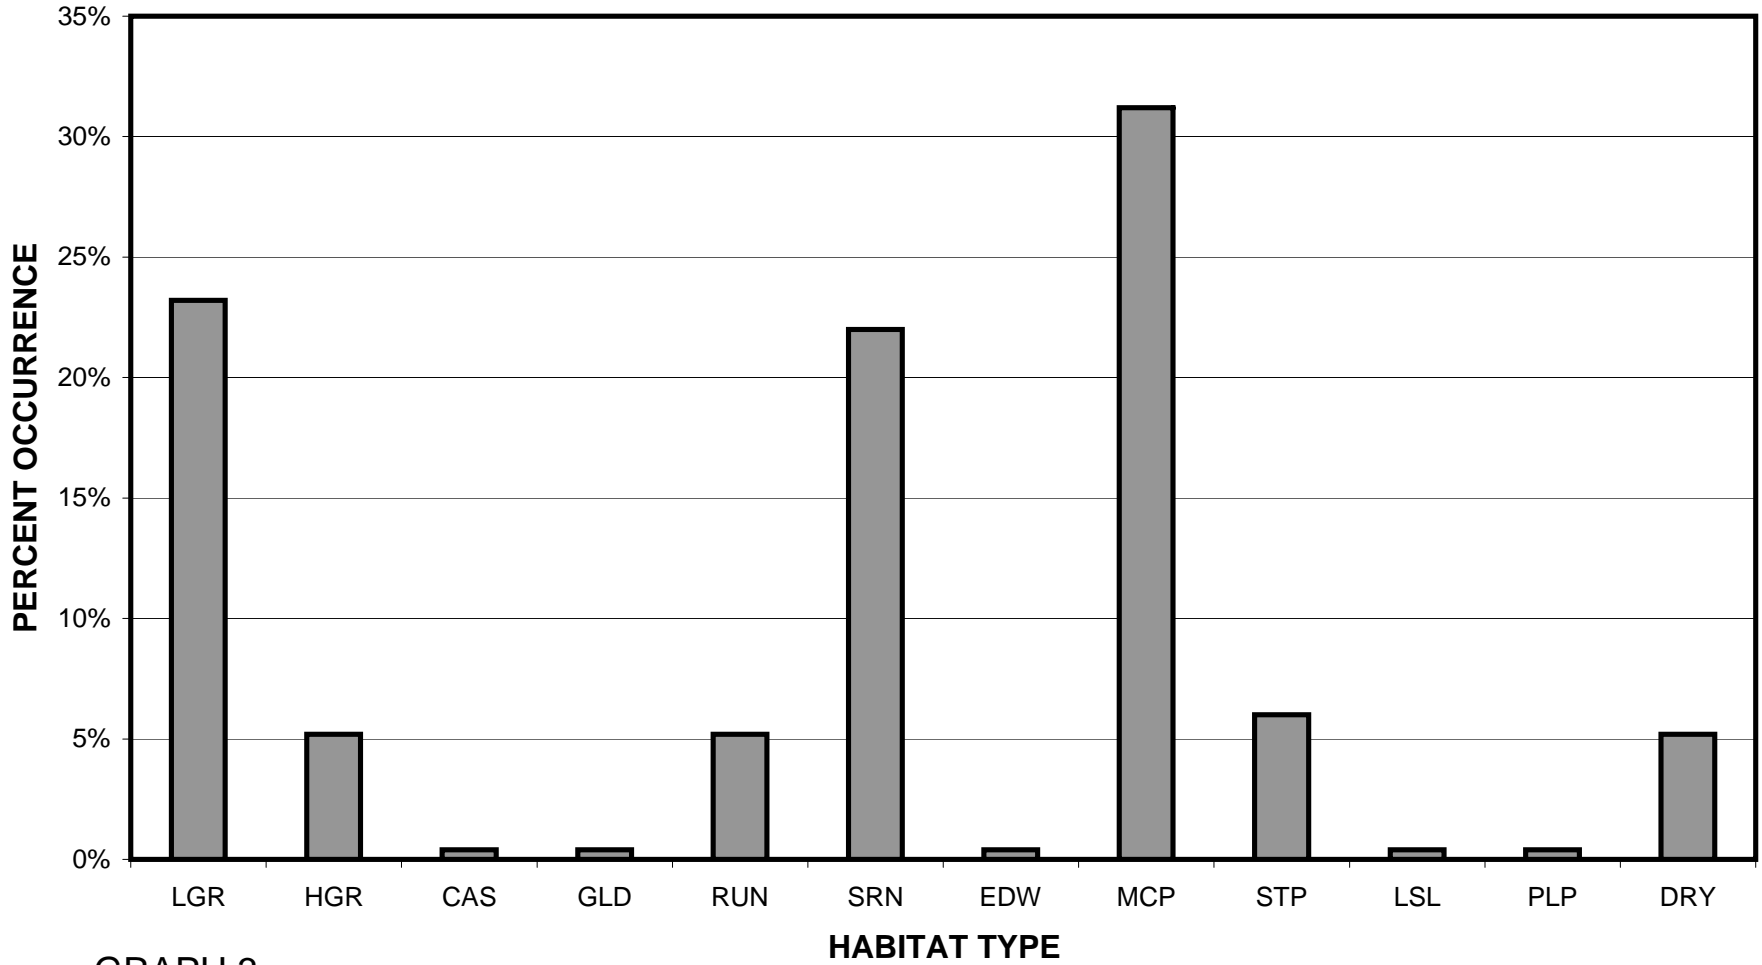
GRAPH 2

BUCKHORN CREEK 2012 HABITAT TYPES BY PERCENT OCCURRENCE

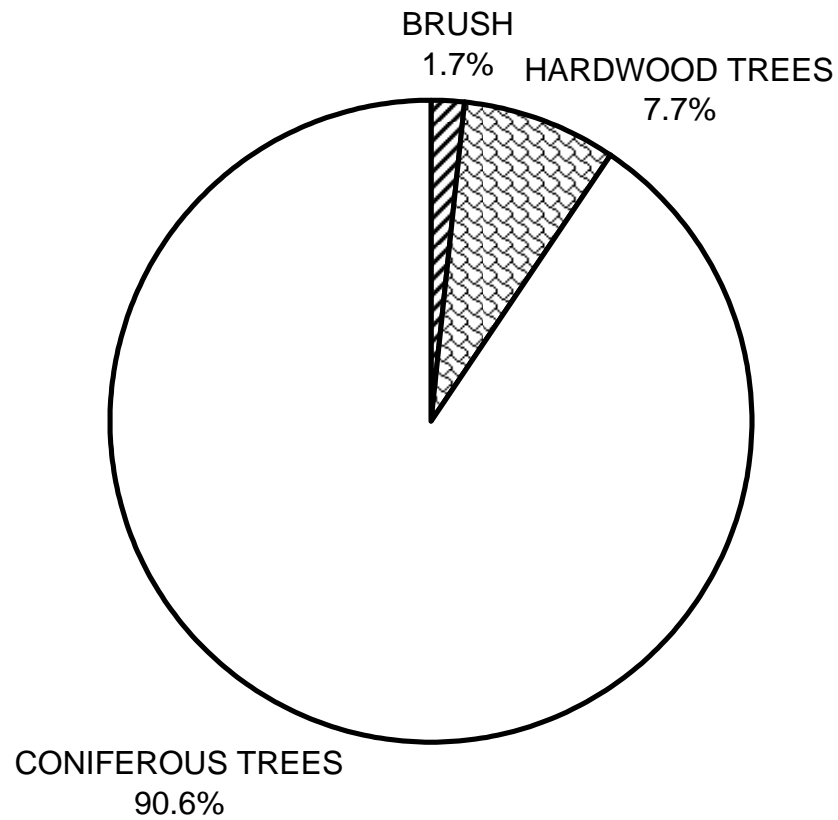
GRAPH 10

For the stream reach surveyed, the mean percent right bank vegetated was 97%. The mean percent left bank vegetated was 97%. The dominant elements composing the structure of the stream banks consisted of 71% cobble/gravel, 19% sand/silt/clay, 9% bedrock, and 1% boulders (Graph 10). Coniferous trees were the dominant vegetation type observed in 91% of the units surveyed. Additionally, 8% of the units surveyed had deciduous trees as the dominant vegetation type, and 2% had brush as the dominant vegetation type (Graph 11).

BUCKHORN CREEK 2012 DOMINANT BANK VEGETATION IN SURVEY REACH
