# STREAM INVENTORY REPORT

## Mill Creek

A stream inventory was conducted from October 2 to October 10, 2012 on Mill Creek. The survey began at the confluence with Ten Mile River and extended upstream two miles.

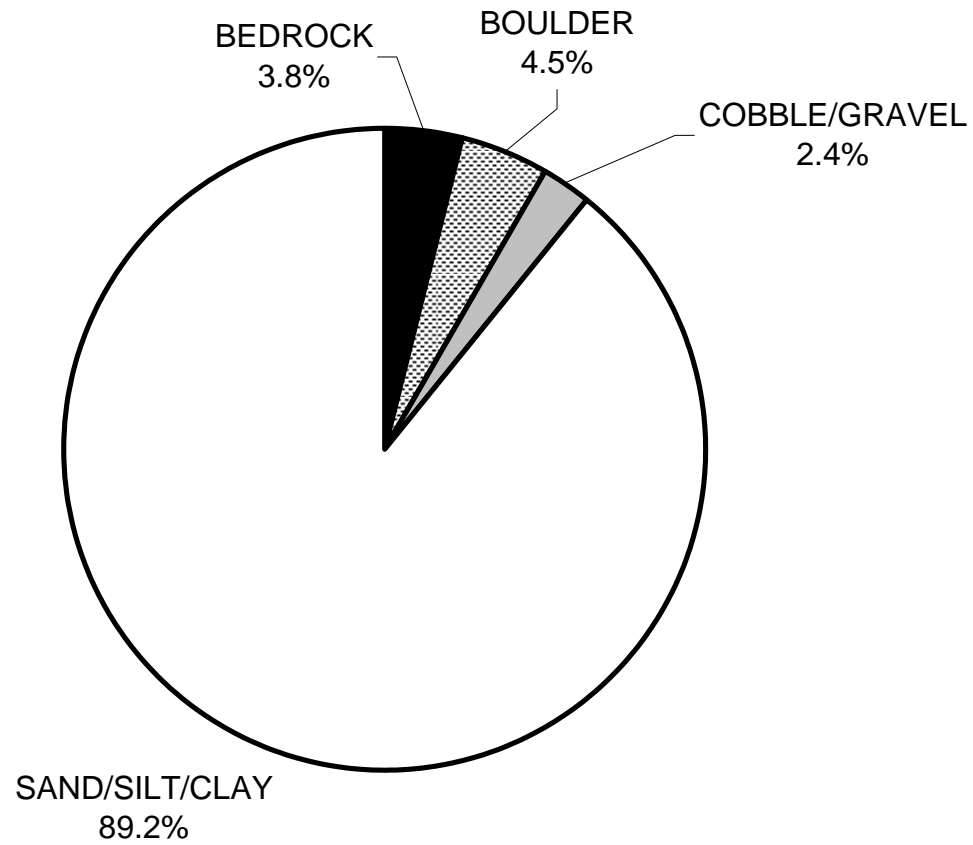
GRAPH 9

For the stream reach surveyed, the mean percent right bank vegetated was 99%. The mean percent left bank vegetated was 98%. The dominant elements composing the structure of the stream banks consisted of 89% sand/silt/clay, 5% boulders, 4% bedrock, and 2% cobble/gravel (Graph 10). Deciduous trees were the dominant vegetation type observed in 57% of the units surveyed. Additionally, 35% of the units surveyed had brush as the dominant vegetation type, and 7% had coniferous trees as the dominant vegetation type (Graph 11).

**MILL CREEK 2012  
DOMINANT BANK COMPOSITION IN SURVEY REACH**

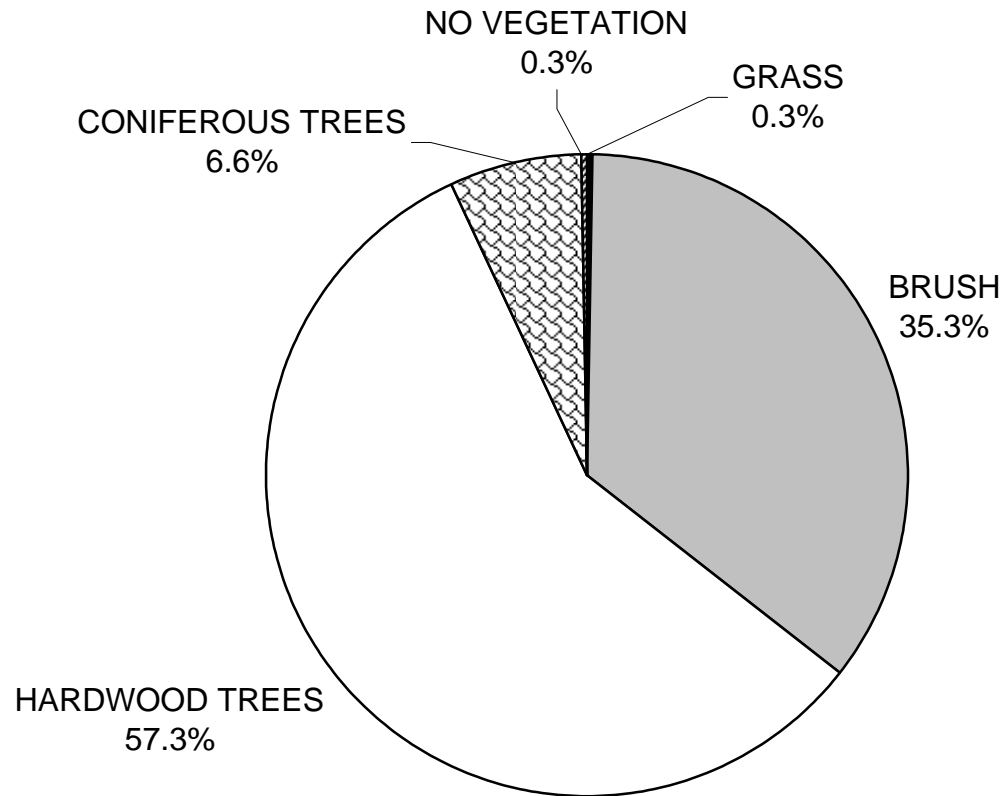
GRAPH 10

# MILL CREEK 2012 DOMINANT BANK VEGETATION IN SURVEY REACH
