Site Name: Hwy 150 Bridge (52-105) with Grade Control Structure

Stream Name: Santa Paula Creek

Structure Owner: California Department of Transportation

Year Remediated: 2012

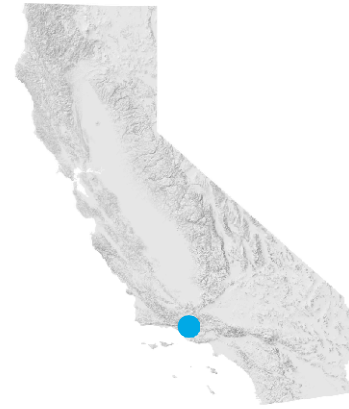
Site Status After Remediation: Remediated, fish response unconfirmed

Barrier Description Prior to Remediation: Total

Notes: Per USGS flow gauge d/s, the lowest cfs was 0.5 this summer (below historical average). The fish passage project at this site was designed to pass all life stages and through all flows, but the flow is currently going subsurface - need a good rainy season. In November, finished installation of 15 rock weir step pools to make stream bed level. The waterfall/drop structure was a barrier to steelhead. No steelhead were observed at or above site on Santa Paula Creek because of a dry 2013 year. Before: Total barrier per DFG Restoration Manual by Stoecker Environmental Consulting. Even prior to changes caused by the 2005 stream flows, this series of grade controls represented a severe migration barrier to upstream migrating steelhead. The pre-2005 conditions failed to meet DFG and NOAA passage criteria at all flows for strongest swimming species presumed present due to excessive outlet drops on 4 of 7 curbs and excessive slope on one curb. Following the devastation caused by the 2005 flows the series of grade controls continues to fail DFG and NOAA passage requirements for the same reasons mentioned above minus one curb that was eliminated.
