CALIFORNIA DEPARTMENT OF FISH AND GAME  
STREAM INVENTORY REPORT

Russian River

Assessment Completed 2003

Report Completed 2006

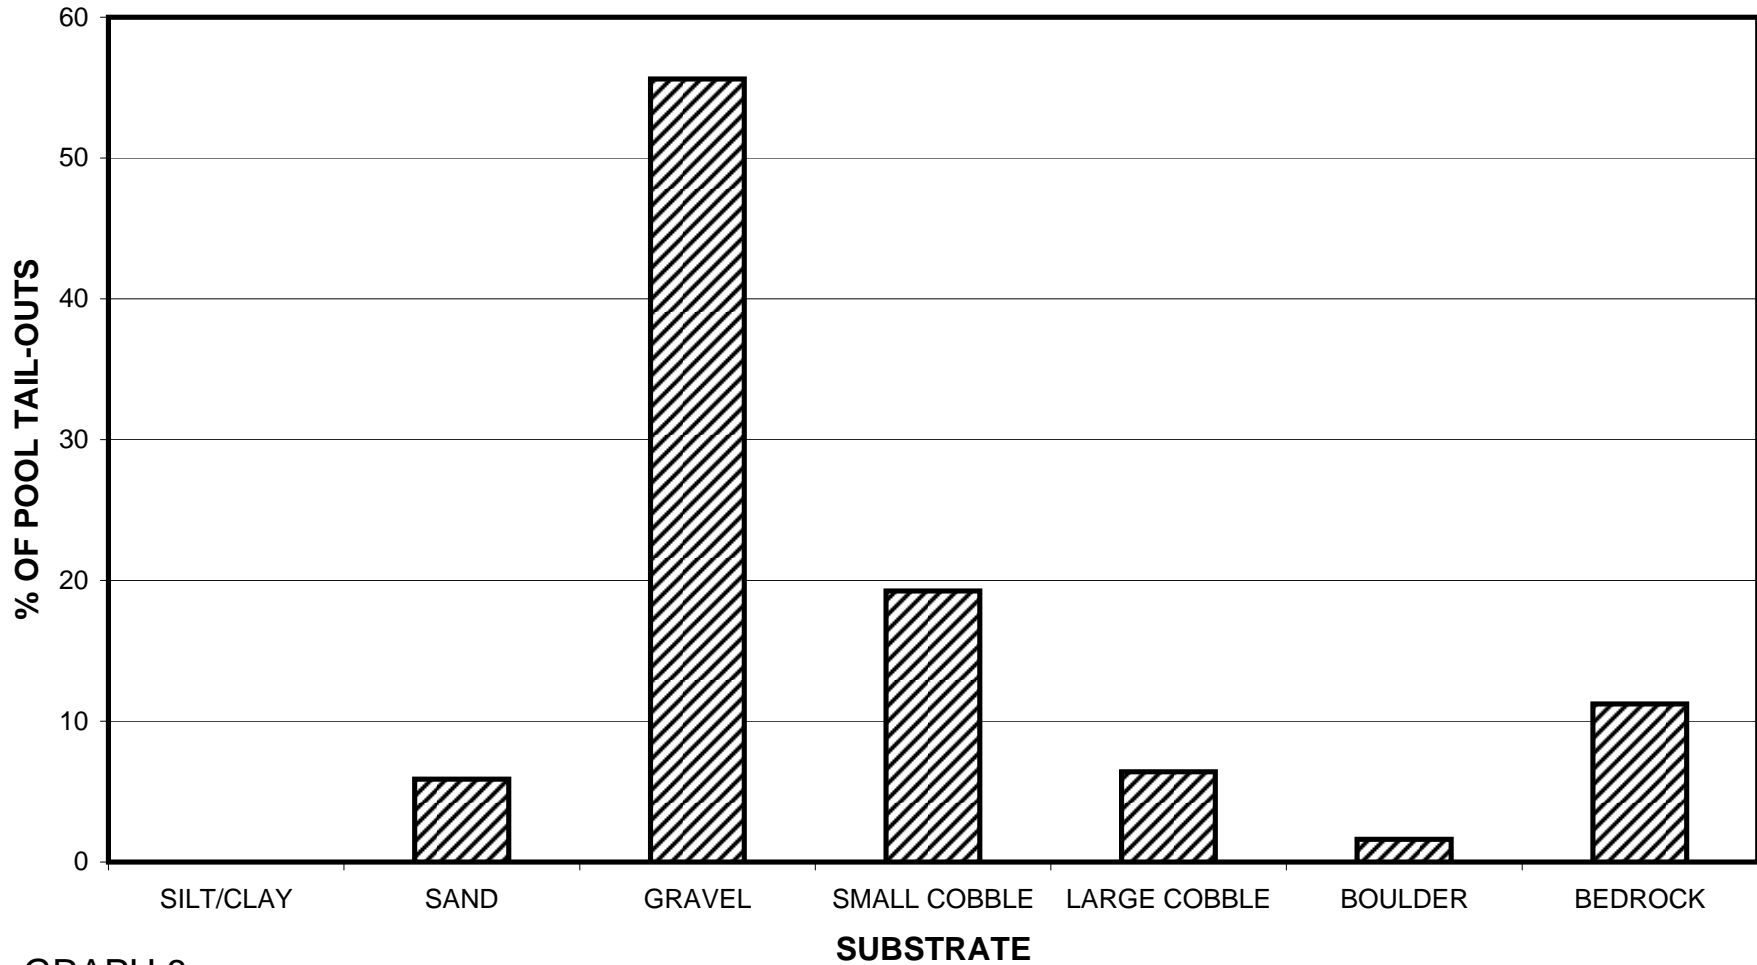
GRAPH 8

Table 6 summarizes the dominant substrate by habitat type. Graph 8 depicts the dominant substrate observed in pool tail-outs. Gravel observed in 56% of pool tail-outs, small cobble observed in 19% of pool tail-outs, and bedrock observed in 11% of pool tail-outs.

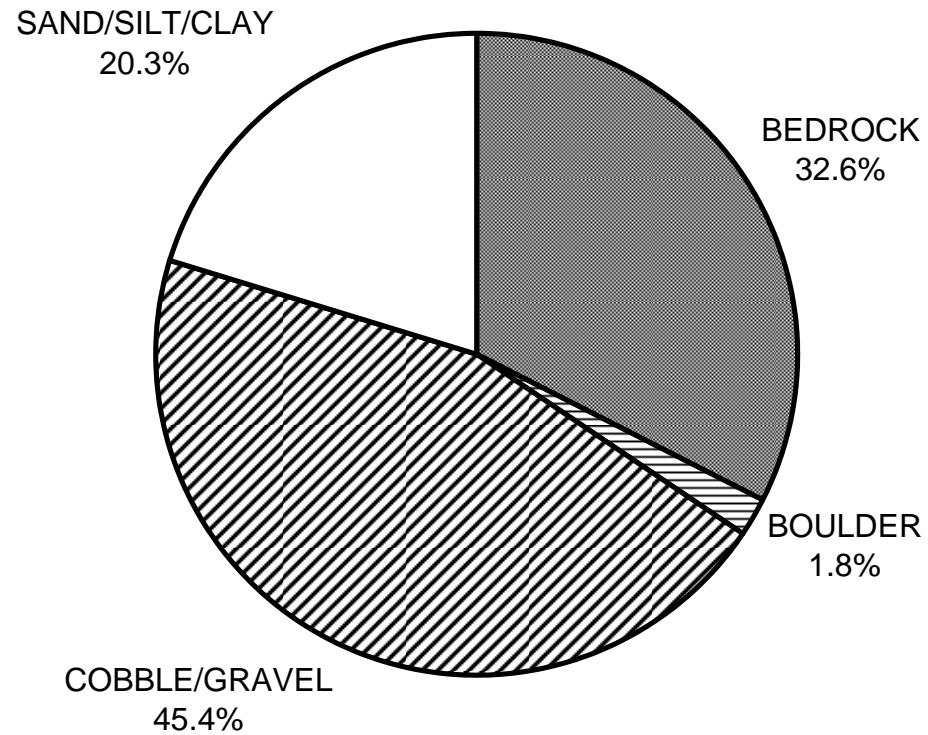
GRAPH 10

For the stream reach surveyed, the mean percent right bank vegetated was 48%. The mean percent left bank vegetated was 48%. The dominant elements composing the structure of the stream banks consisted of 33% bedrock, 2% boulder, 45% cobble/gravel, 20% sand/silt/clay, (Graph 10). Brush was the dominant vegetation type observed in 16% of the units surveyed. Additionally, 56% of the units surveyed had hardwood trees as the dominant vegetation type, and 15% had coniferous trees as the dominant vegetation (Graph 11).
