**California Department of Fish and Wildlife  
Sonoma County  
Russian River Watershed  
Stream Habitat Assessment Reports**

# **The North Fork of Mark West Creek**

*Surveyed 2012*

### STREAM INVENTORY REPORT

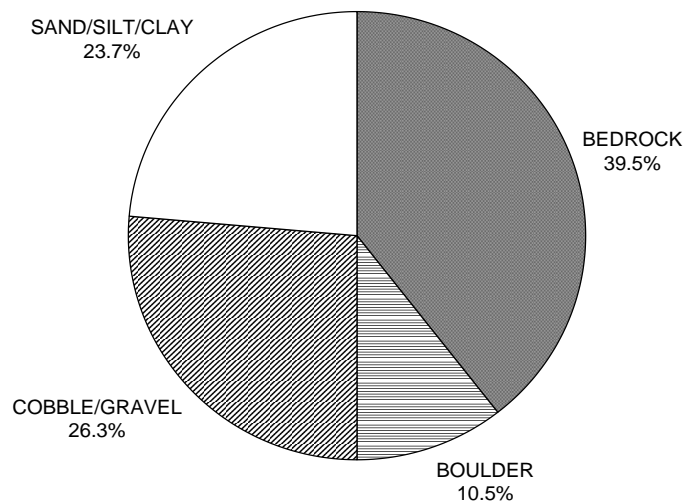
GRAPH 10

For the stream reach surveyed, the mean percent right bank vegetated was 72%. The mean percent left bank vegetated was 72% (Table 7). The dominant elements composing the structure of the stream banks consisted of 39% bedrock, 26% cobble/gravel, 24% sand/silt/clay, and 11% boulder (Graph 10). Deciduous trees were the dominant vegetation type observed in 50% of the units surveyed. Additionally, 26% of the units surveyed had coniferous trees as the dominant vegetation type, and 16% had brush as the dominant vegetation type (Graph 11).

**North Fork Mark West Creek 2012  
DOMINANT BANK COMPOSITION IN SURVEY REACH**

The percentage of right and left bank covered with vegetation was 72% and 72%, respectively. In areas of stream bank erosion or where bank vegetation is sparse, planting endemic species of coniferous and hardwood trees, in conjunction with bank stabilization, is recommended.
