CALIFORNIA DEPARTMENT OF FISH AND GAME
STREAM INVENTORY REPORT
South Branch Robinson Creek
Report Revised April 14, 2006
Report Completed 2005
Assessment Completed 2001

A stream inventory was conducted during 6/11/2001 to 6/18/2001 on South Branch Robinson Creek. The survey began at the confluence with Robinson Creek and extended upstream 1.5 miles.

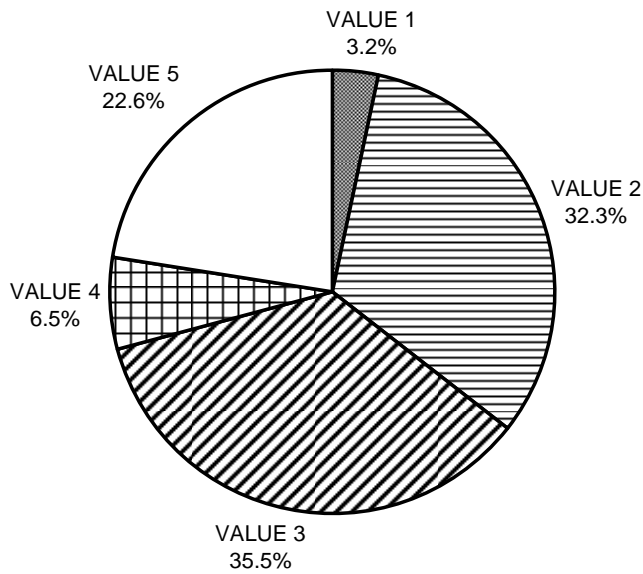
GRAPH 5

The depth of cobble embeddedness was estimated at pool tail-outs. Of the 31 pool tail-outs measured, one had a value of 1 (3.2%); ten had a value of 2 (32.3%); eleven had a value of 3 (35.5%); two had a value of 4 (6.5%); and seven had a value of 5 (22.6%); (Graph 6). On this scale, a value of 1 indicates the best spawning conditions and a value of 4 the worst. Additionally, a value of 5 was assigned to tail-outs deemed unsuited for spawning due to inappropriate substrate like bedrock, log sills, boulders.

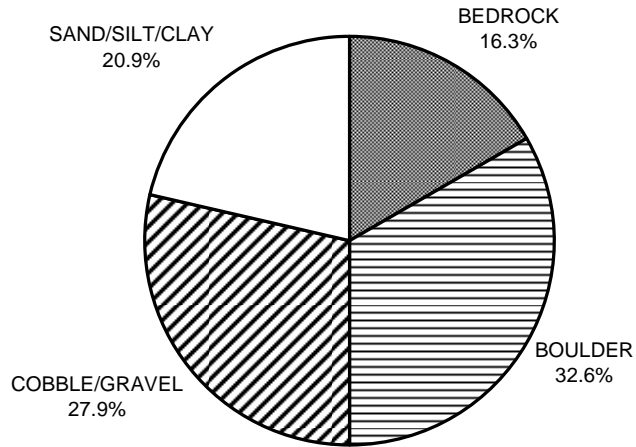
GRAPH 9

For the stream reach surveyed, the mean percent right bank vegetated was 35%. The mean percent left bank vegetated was 36%. The dominant elements composing the structure of the stream banks consisted of 16% bedrock, 33% boulder, 28% cobble/gravel, 21% sand/silt/clay, (Graph 10). Grass was the dominant vegetation type observed in 29% of the units surveyed. Additionally, 25.6% of the units surveyed had hardwood trees as the dominant vegetation type, and 24.4% had coniferous trees as the dominant vegetation (Graph 11).

The percentage of right and left bank covered with vegetation was LOW at 35% and 36%, respectively. In areas of stream bank erosion or where bank vegetation is sparse, planting endemic species of coniferous and hardwood trees, in conjunction with bank stabilization, is recommended.
