**California Department of Fish and Wildlife
Santa Cruz County
Big Basin Coastal Watersheds
Stream Habitat Assessment Report**

Mill Creek

Surveyed 2010

STREAM INVENTORY REPORT

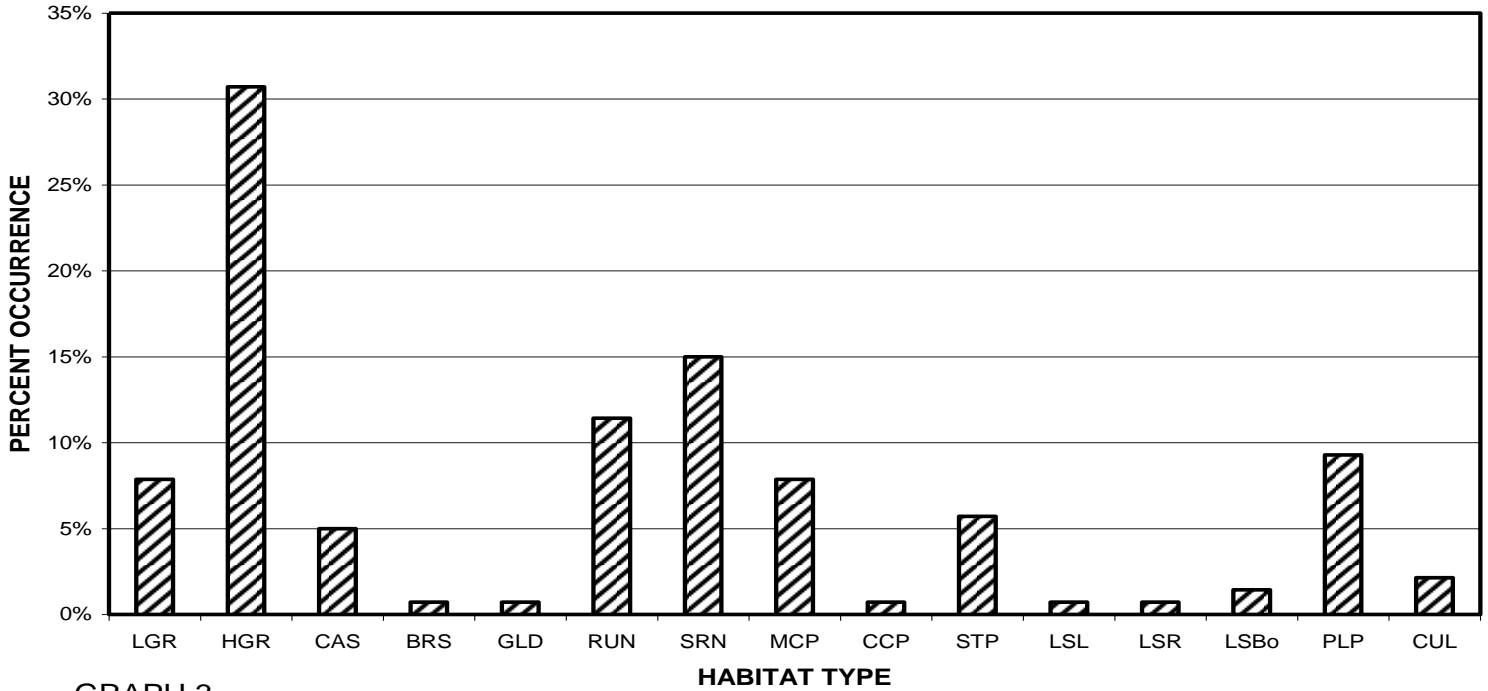
GRAPH 2

MILL CREEK 2010 HABITAT TYPES BY PERCENT OCCURRENCE

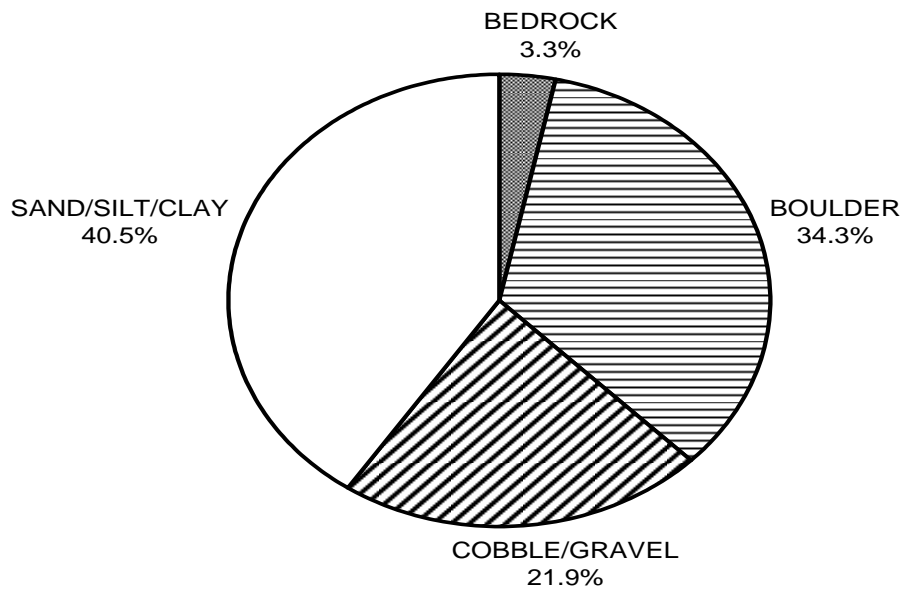
GRAPH 9

For the stream reach surveyed, the mean percent right bank vegetated was 63%. The mean percent left bank vegetated was 60%. The dominant elements composing the structure of the stream banks consisted of 3% bedrock, 34% boulder, 22% cobble/gravel, and 41% sand/silt/clay (Graph 10). Coniferous trees were the dominant vegetation type observed in 40.5% of the units surveyed. Additionally, 35.0% of the units surveyed had hardwood trees as the dominant vegetation type, 23.4% had brush as the dominant vegetation and 0.4% had grass as the dominant vegetation (Graph 11).

MILL CREEK 2010 DOMINANT BANK COMPOSITION IN SURVEY REACH

The percentage of right and left bank covered with vegetation was at 63% and 60%, respectively. In areas of stream bank erosion or where bank vegetation is sparse, planting endemic species of coniferous and hardwood trees, in conjunction with bank stabilization, is recommended.
