**California Department of Fish and Wildlife**  
**Santa Cruz County**  
**Big Basin Coastal Watershed**  
**Stream Habitat Assessment Reports**

# **San Vicente Creek**

*Surveyed 2010*

# STREAM INVENTORY REPORT

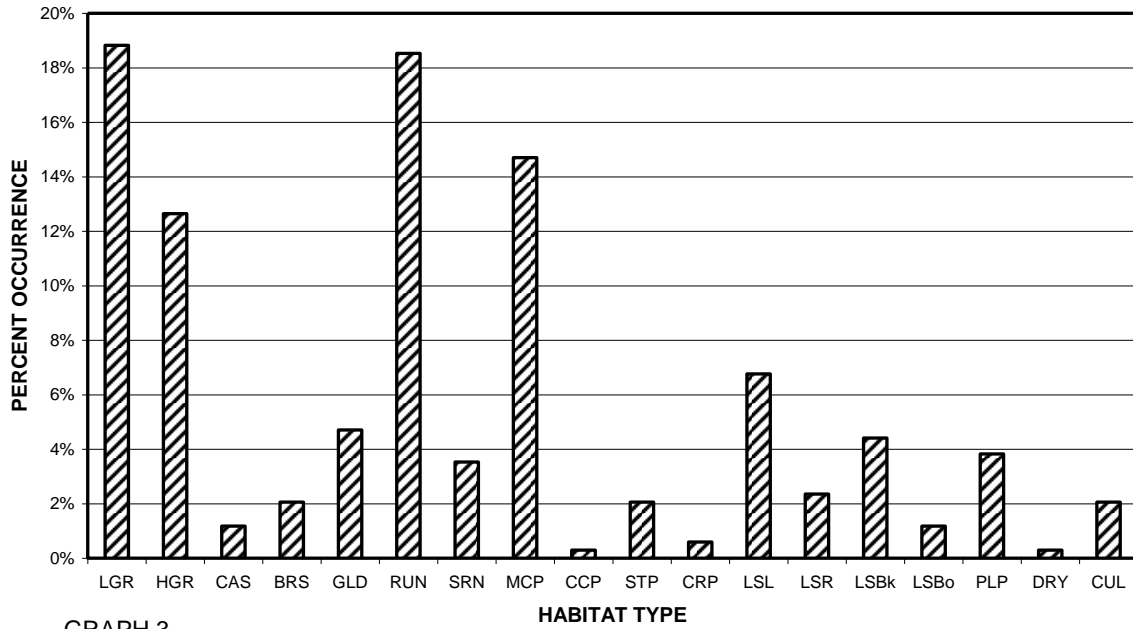
GRAPH 2

**SAN VICENTE CREEK 2010  
HABITAT TYPES BY PERCENT OCCURRENCE**

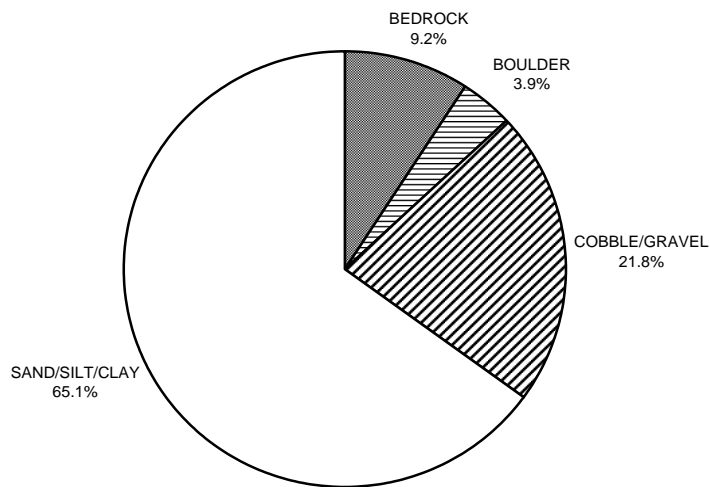
GRAPH 9

For the stream reach surveyed, the mean percent right bank vegetated was 77%. The mean percent left bank vegetated was 80% (Table 7). The dominant elements composing the structure of the stream banks consisted of 65% sand/silt/clay, 22% cobble/gravel, 9% bedrock, 4% boulder (Graph 10). Deciduous trees were the dominant vegetation type observed in 83% of the units surveyed. Additionally, 9% of the units surveyed had coniferous trees as the dominant vegetation type, and 6% had brush as the dominant vegetation type (Graph 11).

**SAN VICENTE CREEK 2010  
DOMINANT BANK COMPOSITION IN SURVEY REACH**
