**California Department of Fish and Game  
Marin Coastal Watershed  
Stream Habitat Assessment Reports  
Green Gulch**

## STREAM INVENTORY REPORT

*Surveyed Summer 2008*

### Green Gulch

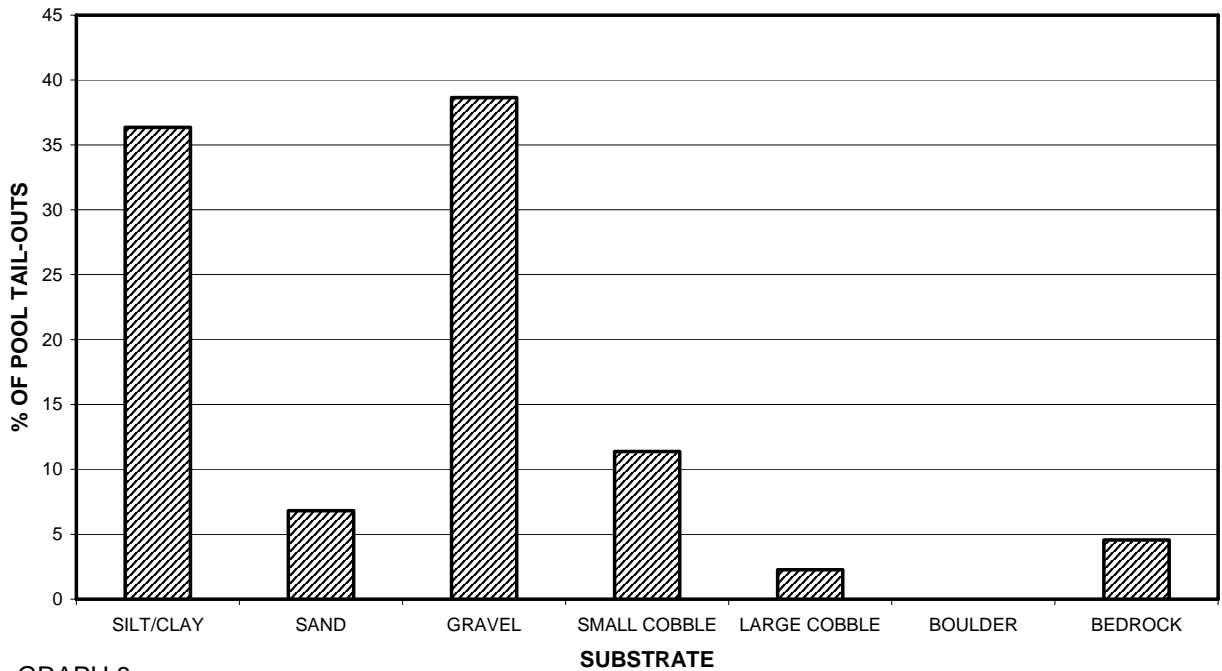
GRAPH 8

Table 6 summarizes the dominant substrate by habitat type. Graph 8 depicts the dominant substrate observed in pool tail-outs. Gravel was observed in 39% of pool tail-outs and a silt/clay substrate type was observed in 36% of pool tail-outs.

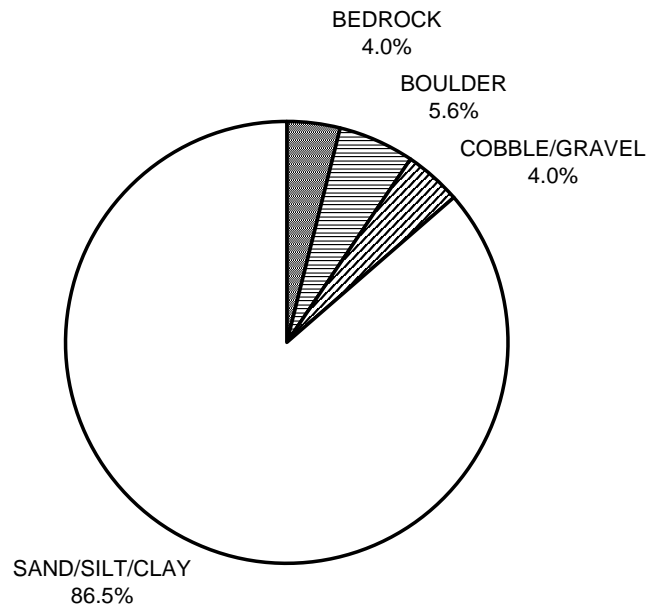
GRAPH 10

For the stream reach surveyed, the mean percent right bank vegetated was 88%. The mean percent left bank vegetated was 89%. The dominant elements composing the structure of the stream banks consisted of 87% sand/silt/clay, 6% boulder, 4% bedrock and 4% cobble/gravel (Graph 10). Deciduous trees were the dominant vegetation type observed in 47% of the units surveyed. Additionally, 44% of the units surveyed had grass as the dominant vegetation type, and 8% had brush as the dominant vegetation (Graph 11).
