**California Department of Fish and Game**  
**Petaluma River Watershed**  
**Stream Habitat Assessment Reports**  
**East Washington Creek**

### **East Washington Creek**

*Surveyed Summer 2007*

*Report Completed March 2008*

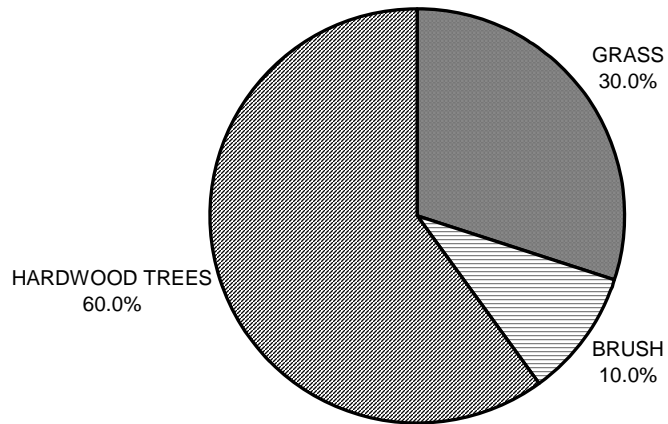
GRAPH 11

For the stream reach surveyed, the mean percent right bank vegetated was 24%. The mean percent left bank vegetated was 26%. The dominant elements composing the structure of the stream banks consisted of 100% sand/silt/clay (Graph 10). Deciduous trees were the dominant vegetation type observed in 60% of the units surveyed. Additionally, 30% of the units surveyed had grass as the dominant vegetation type, and 10% had brush as the dominant vegetation (Graph 11).

**East Washington 2007  
DOMINANT BANK VEGETATION IN SURVEY REACH**

The percentage of right and left bank covered with vegetation was low at 24% and 26%, respectively. In areas of stream bank erosion or where bank vegetation is sparse, planting endemic species of coniferous and hardwood trees, in conjunction with bank stabilization, is recommended.
