**California Department of Fish and
Wildlife
East Marin County
San Francisco Bay Watersheds
Stream Habitat Assessment Reports**

Coyote Creek

Surveyed 2009

STREAM INVENTORY REPORT

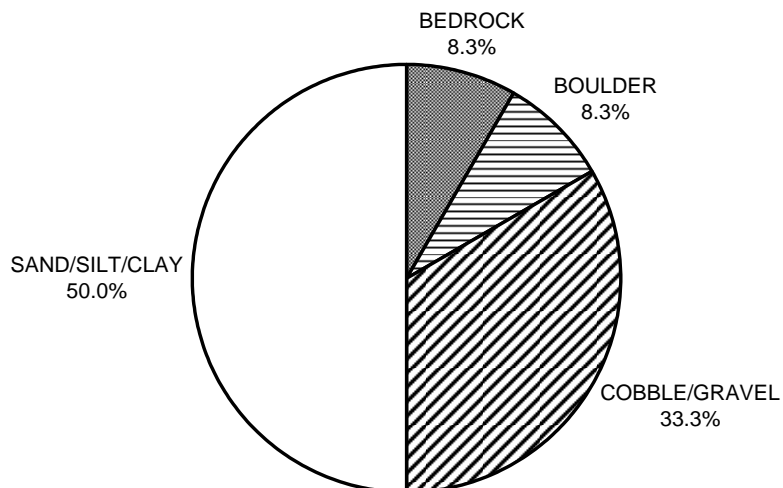
GRAPH 10

For the stream reach surveyed, the mean percent right bank vegetated was 33%. The mean percent left bank vegetated was 47%. The dominant elements composing the structure of the stream banks consisted of 8.3% bedrock, 8.3% boulder, 33.3% cobble/gravel and 50% sand/silt/clay (Graph 10). Hardwood trees were the dominant vegetation type observed in 66.7% of the units surveyed. Additionally, 20.8% of the units surveyed had brush as the dominant vegetation type, and 12.5% was dominated by no vegetation (Graph 11).

COYOTE CREEK 2009 DOMINANT BANK COMPOSITION IN SURVEY REACH

The percentage of right and left bank covered with vegetation was 33% and 47%, respectively. In areas of stream bank erosion or where bank vegetation is sparse, planting endemic species of coniferous and hardwood trees, in conjunction with bank stabilization, is recommended.
